# SHIRLEY'S BROOK AND KIZELL DRAIN/WATTS CREEK

## FLUVIAL GEOMORPHOLOGY EXISTING CONDITIONS REPORT

*29 January 2015*

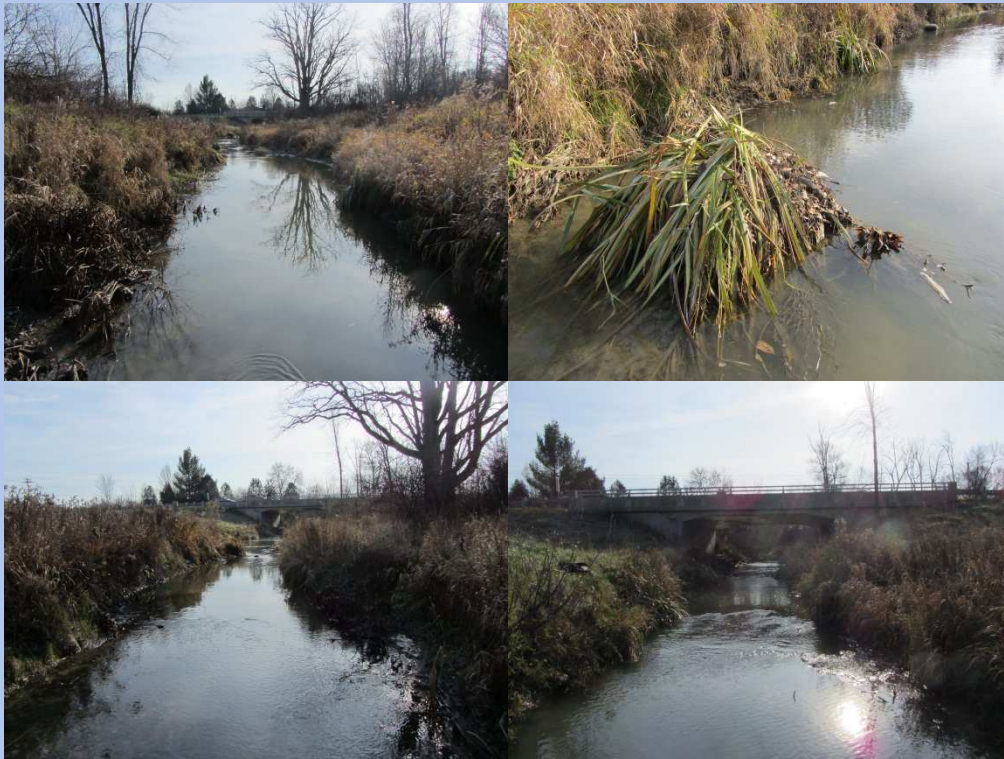
<b>PROJECT</b>	<b>Shirley's Brook and Watts Creek/Kizell Drain</b>
<b>CREEK</b>	Watts Creek
<b>REACH</b>	WDR-1
<b>GPS COORDINATES</b>	431486, 5021968

This reach is immediately downstream of Carling Avenue and represents the furthest downstream section of channel where access was permitted. The creek is rather straight in this section, with some bank erosion occurring more so as a gentle process (considered natural), though some clumps are found. The bed is a combination of very loose sediment as silty bars with some consolidated clay sections. Banks are steeply sloped but there appear to be no undercuts, indicating the channel is not trying to widen. Depth to floodplain elevation is high, indicating disconnection under more frequent flows.

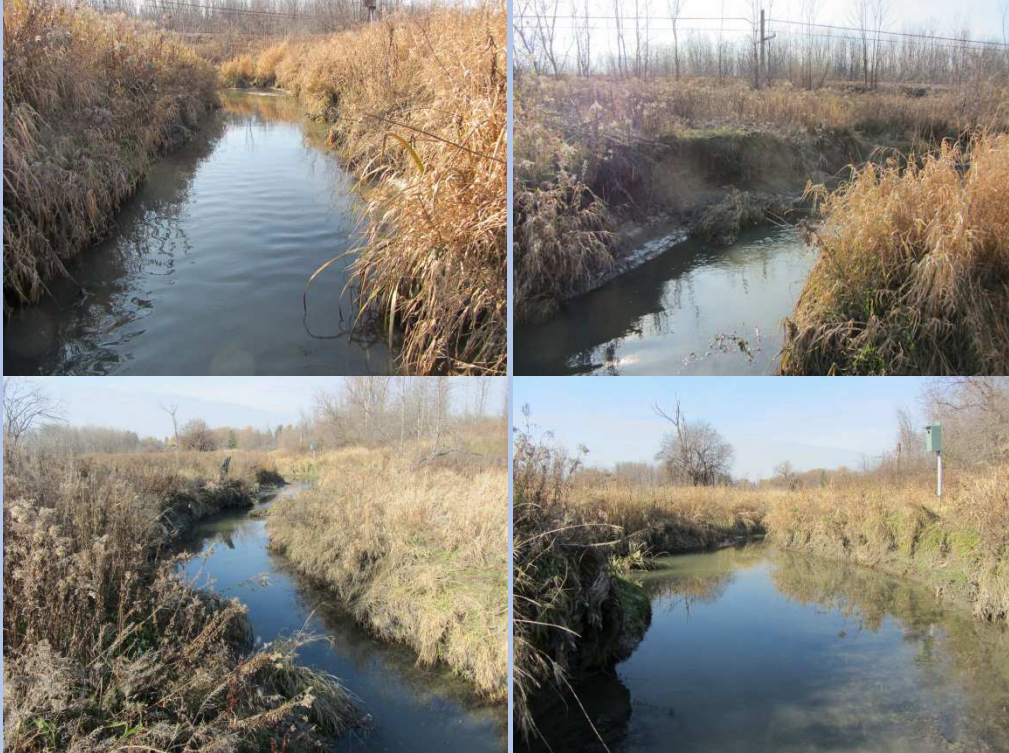
<b>PROJECT</b>	<b>Shirley's Brook and Watts Creek/Kizell Drain</b>
<b>CREEK</b>	Watts Creek
<b>REACH</b>	WDR-2
<b>GPS COORDINATES</b>	431018, 5021119

This reach is within NCC lands and begins immediately downstream of the connection with the drain. The channel is very entrenched, is actively meandering (although within a tight meander belt), and there is considerable bank erosion. The bed is comprised of silt deposits which are deep in sections; there are some pools at a couple of bends (but not at all as would be expected). Rapid clump erosion appears to be the principle means of sediment delivery to the channel. Riparian cover is exclusively grasses.

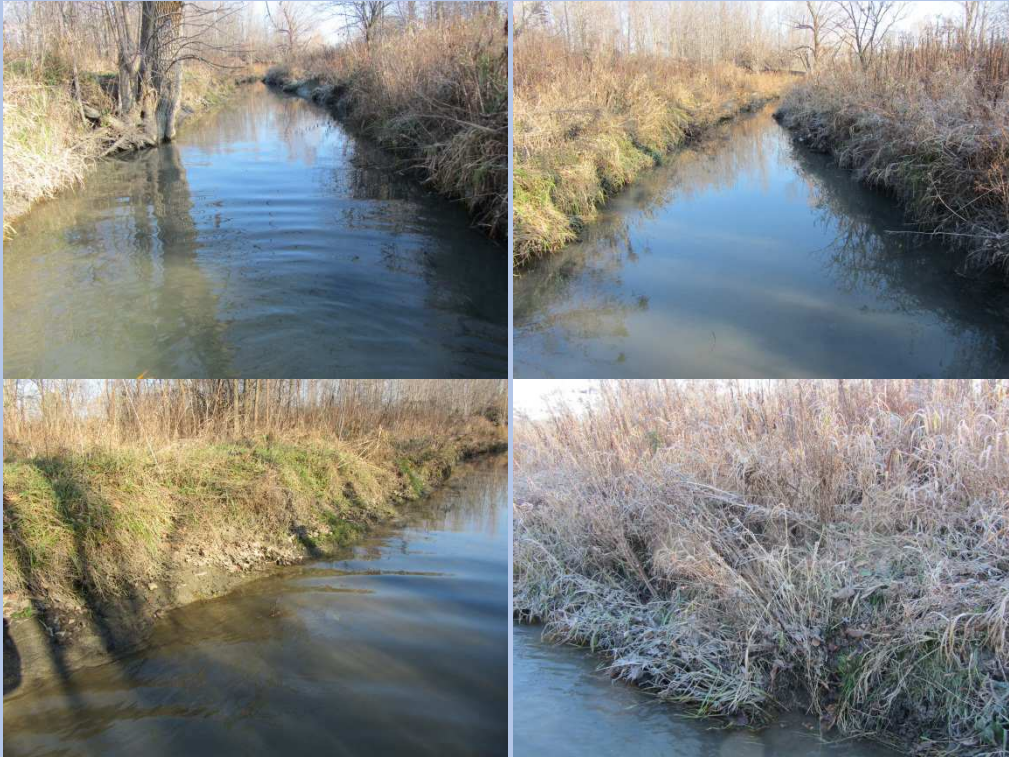
<b>PROJECT</b>	<b>Shirley's Brook and Watts Creek/Kizell Drain</b>
<b>CREEK</b>	Watts Creek
<b>REACH</b>	WDR-3
<b>GPS COORDINATES</b>	430568, 5020834

This reach is a straight section of channel which is approximately 60 metres upstream of the pedestrian trail crossing. It is upstream of the connection with the drain and was selected to represent a control reach with straight planform. The channel is somewhat disconnected from the floodplain, though not as much as downstream. Bank erosion is minimal and where it is occurring it appears to be as a result of natural processes. No undercutting is evident, indicating the creek is not trying to widen. The bed is a combination of silt deposits and consolidated clays. There are a few pools along the reach, some quite deep, though they are not associated with the outside bank of meanders. Riparian vegetation is primarily grasses with some large trees; there is one small woody debris feature along this reach.

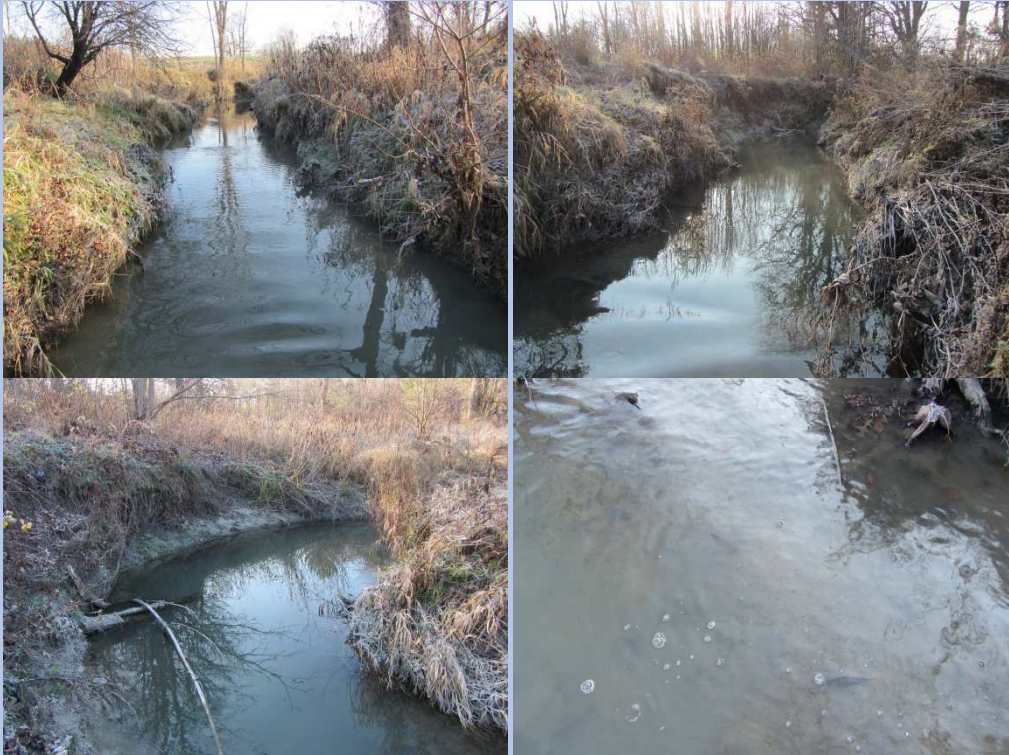
<b>PROJECT</b>	<b>Shirley's Brook and Watts Creek/Kizell Drain</b>
<b>CREEK</b>	Watts Creek
<b>REACH</b>	WDR-4
<b>GPS COORDINATES</b>	430487, 5020481

This reach is an actively meandering reach with strong cut banks on the outside bends. There is a lack of pool features at the bends which reflects the high sediment loading; however there is also a lack of point bar development on the inside bends which is reflective of the disconnect between flow and the floodplain. The bed is heavily silted. Riparian vegetation is primarily grasses with some climax vegetation (trees). This reach is a control reach for the actively meandering reaches downstream of the connection with Kizell Drain.

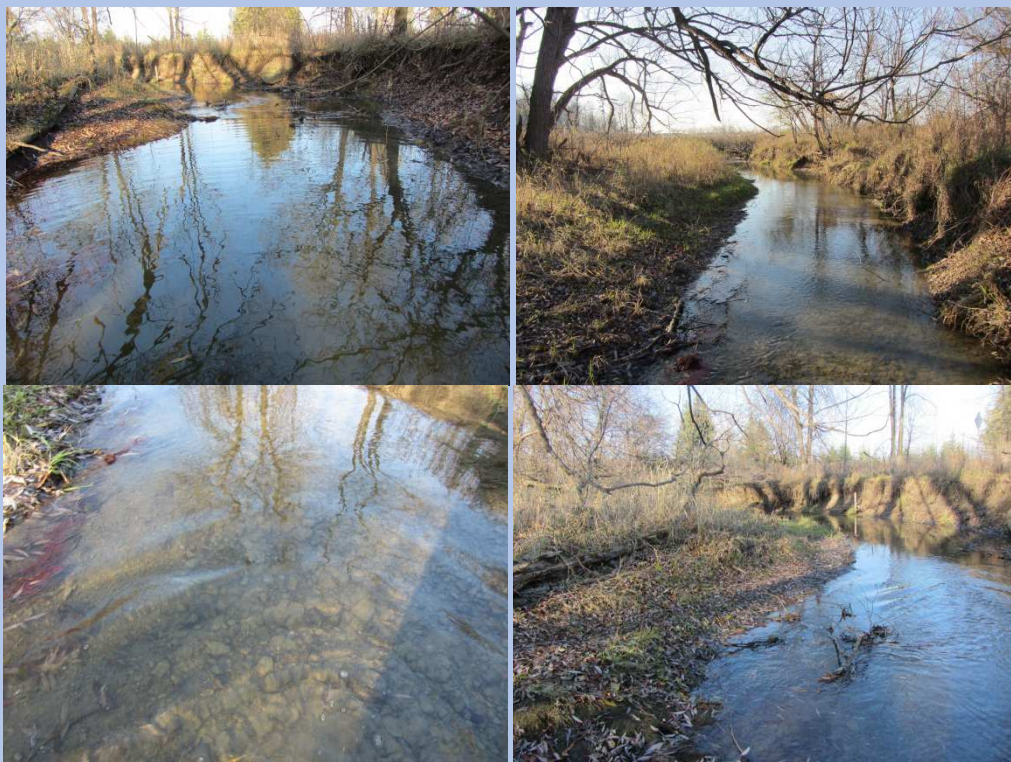
<b>PROJECT</b>	<b>Shirley's Brook and Watts Creek/Kizell Drain</b>
<b>CREEK</b>	Shirley's Brook
<b>REACH</b>	SBDR-1
<b>GPS COORDINATES</b>	427811, 5023886

This reach is the farthest downstream reach where access was permitted. It is located at the March Road crossing and extends upstream between the two existing stormwater ponds. The lower section of the reach is actively meandering within a tight meander belt; at one location it is within a few metres of the road and actively cutting in that direction. Eroding banks on outside bends are near vertical in most places, but not so in others (more gently sloped). The bed is comprised of silt accumulations in spots, primarily associated with inside bends, and exposed cohesive clay in other locations. Some point bar development occurs on bends, which allows for some floodplain connection and energy dissipation. Farther upstream the brook is joined by two stormwater connection channels and further upstream the channel is relatively straight. In this straight section there is accumulating silts from upstream and bank erosion is evident along the banks.

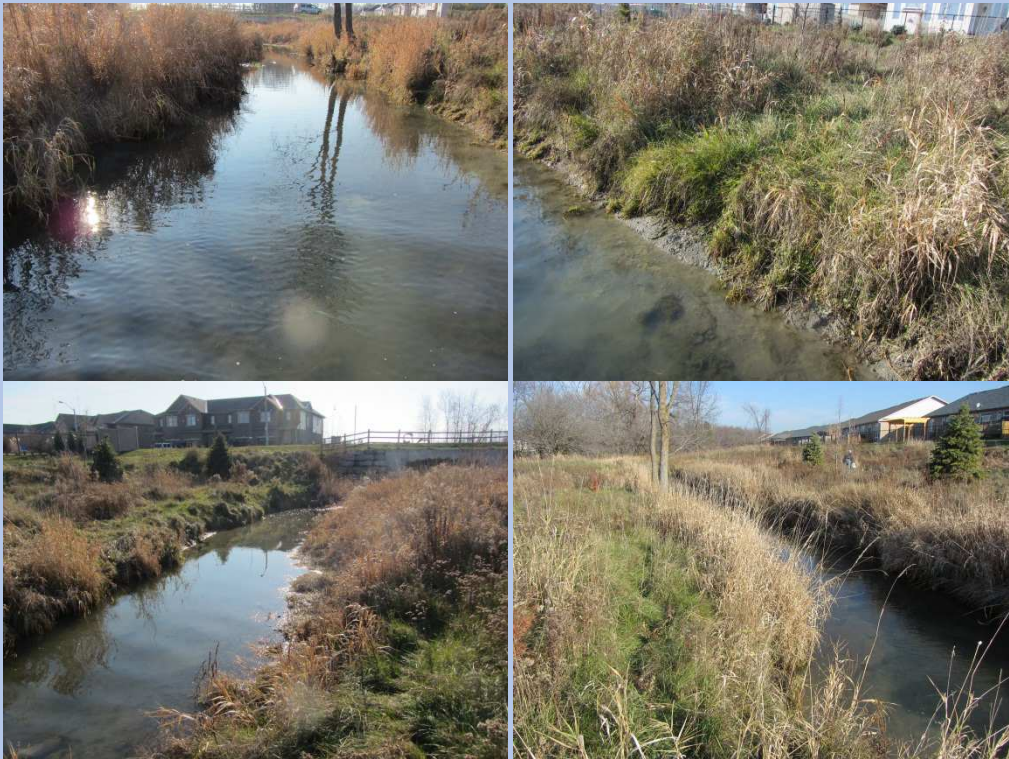
<b>PROJECT</b>	<b>Shirley's Brook and Watts Creek/Kizell Drain</b>
<b>CREEK</b>	Shirley's Brook
<b>REACH</b>	SBDR-2
<b>GPS COORDINATES</b>	427288, 5023369

This reach is in a corridor surrounded by residential development. The channel itself is rather straight and there is good connection to the floodplain along the reach. The floodplain is wide and is comprised of a mixture of meadow grasses and some mature trees. There are no tight constraints with the exception of one culvert at the upstream end of the reach, which is open-bottomed and does not appear to confine normal flow. Bank erosion is evident in some locations but it appears to be occurring at a normal, expected rate—there are no clumps of eroded bank along the reach. In the downstream section of the reach there is some meandering and there are pools associated with the outside bends, which is natural and expected. The substrate in the straight reach is comprised of thick deposits of silt over 90% of the bed, with the remaining substrate consolidated clays.

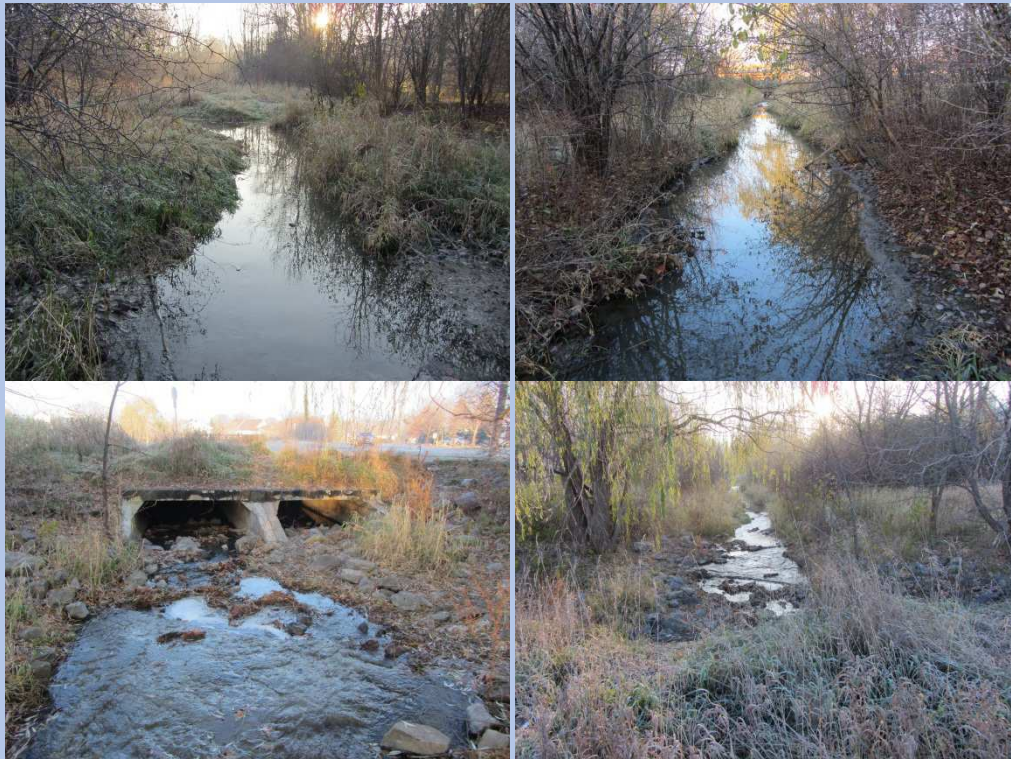
<b>PROJECT</b>	<b>Shirley's Brook and Watts Creek/Kizell Drain</b>
<b>CREEK</b>	Shirley's Brook
<b>REACH</b>	SBDR-3
<b>GPS COORDINATES</b>	427690, 5022518

This reach is upstream of a road crossing (Shirley's Brook Drive). It is located in a rather tight residential corridor for the first 100 metres or so and then widens out to a grassland/marsh floodplain area which has a number of channel pathways. Meandering is limited to the grassland/marsh area; the remainder of the reach is straight. Floodplain connection is strong throughout the reach. Substrate in the straight section is primarily exposed consolidated clays with some silt overlain in some locations. In the grassland/marsh area the substrate is primarily trapped silts, in some cases to a thickness of more than 0.30m. Erosion of the banks is not an issue in this reach. The culvert is a twin-cell concrete box with little clearance. The channel upstream is not eroding as a result of the presence of the culvert. On the downstream side of the road crossing is an online pond feature.

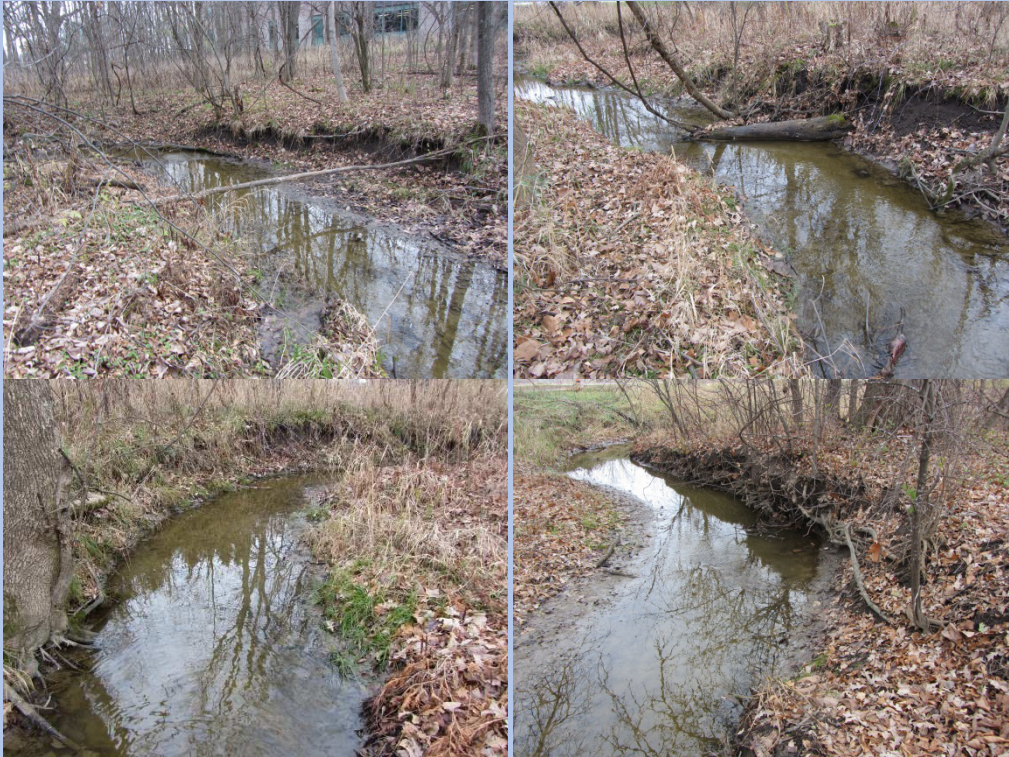
<b>PROJECT</b>	<b>Shirley's Brook and Watts Creek/Kizell Drain</b>
<b>CREEK</b>	Shirley's Brook
<b>REACH</b>	SBDR-4
<b>GPS COORDINATES</b>	427873, 5021371

This is a natural reach upstream of Hines Road where the brook flows through a well-vegetated floodplain and corridor. The alignment of the channel is natural, with meandering occurring and bank erosion. Outside bend erosion is evident on all meanders and in most can be considered extreme; however there is also erosion on some of the inside bends which indicates the channel wants to widen under higher flows. That said, there are also properly forming point bars on some inside bends that are well connected to the floodplain. The substrate is comprised of some clumps of recently eroded bank material as well as silt deposits that are significant in places.

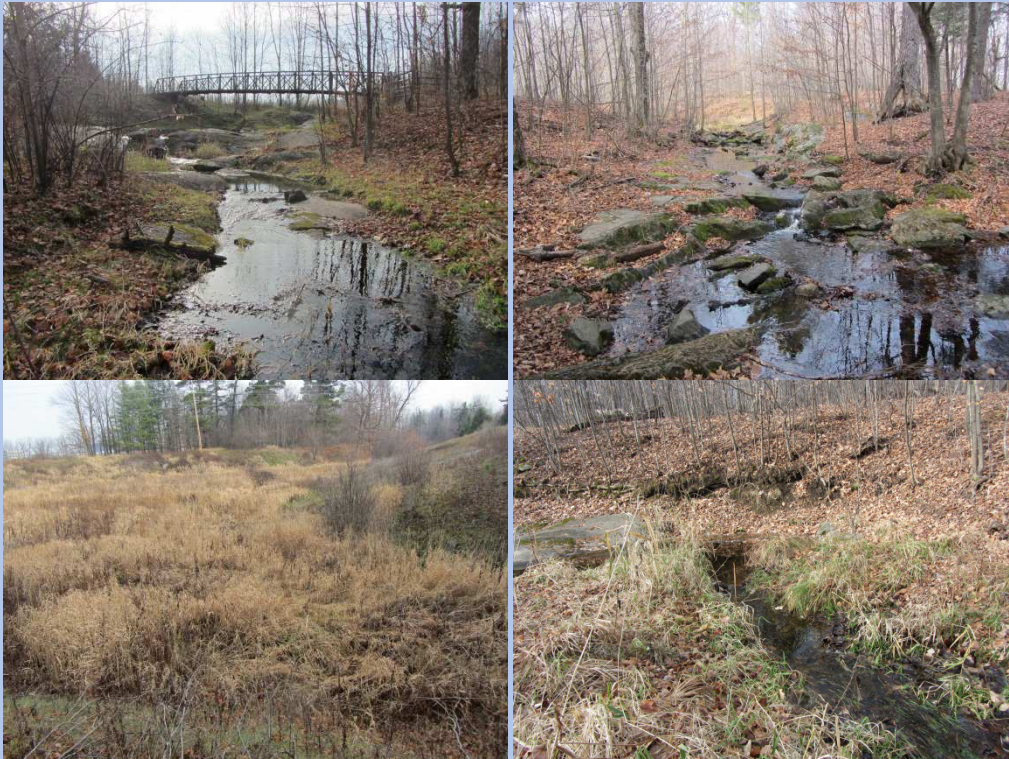
<b>PROJECT</b>	<b>Shirley's Brook and Watts Creek/Kizell Drain</b>
<b>CREEK</b>	Shirley's Brook
<b>REACH</b>	SBDR-5
<b>GPS COORDINATES</b>	427502, 5020939

This is a natural reach which flows through a marshy area at the upstream end and then flows into and through a bedrock outcrop. Banks of the channel are a mixture of clay and limestone in the upper section of the channel. The bed is comprised of silts and clays in the upper portion of the reach, however there does not appear to be any significant accumulations such as are found in other locations of the brook. In the section which is completely controlled by limestone there are no deposits on the bed. This reach was selected as a control reach as it functions as a transfer reach (meaning it neither supplies nor accumulates sediment—any sediment that meets the upper end of the reach is transported through to downstream sections) which can be used for long-term monitoring.

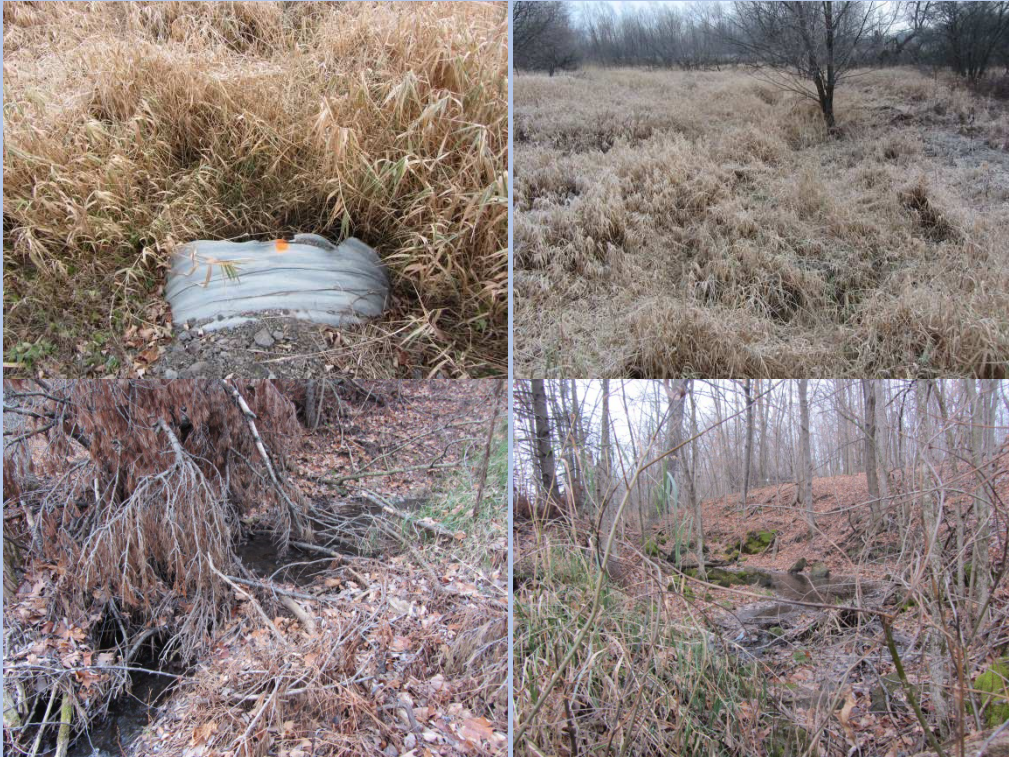
<b>PROJECT</b>	<b>Shirley's Brook and Watts Creek/Kizell Drain</b>
<b>CREEK</b>	Shirley's Brook
<b>REACH</b>	SBDR-6
<b>GPS COORDINATES</b>	426892, 5020263

This is the furthest upstream reach studied. The lower portion of the reach flows through a short, confined bedrock outcrop and then flows as a straight channel through cleared land which has been used for agriculture. Banks in the outcrop section are a combination of clays and rock, as is the bed. There are no significant silt deposits in the bed along this section; however the upper sections do have accumulated silts possibly related to the land use activity. There is no buffer along the brook in the upper reaches, and the brook flows straight with some purposeful changes in direction as it nears the outcrop location.

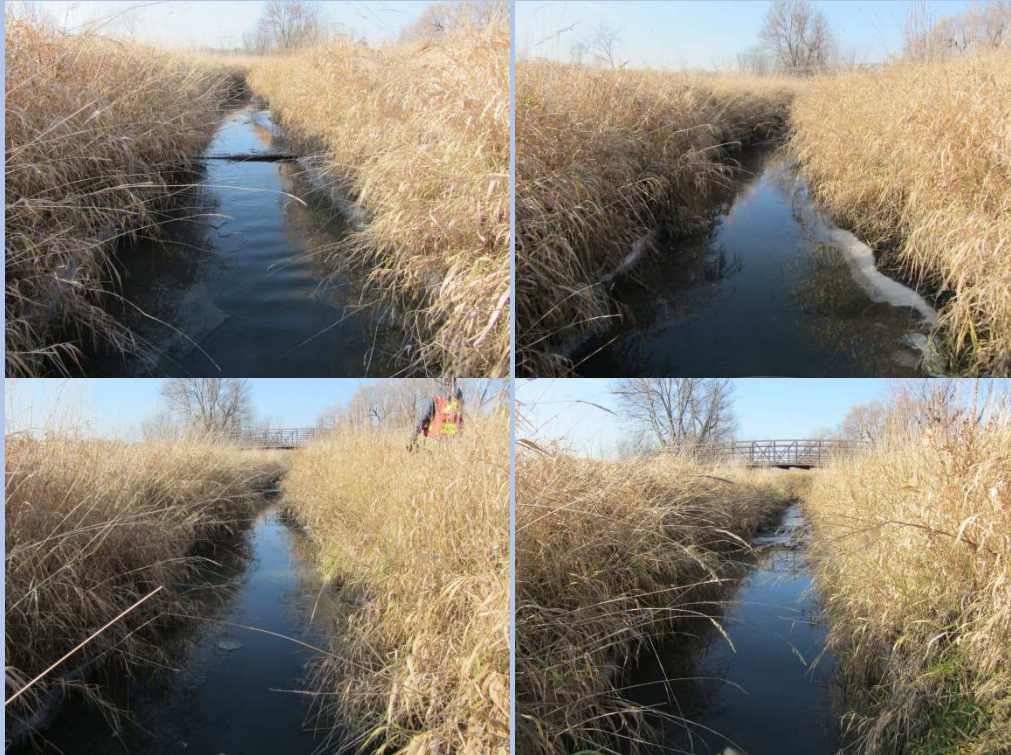
<b>PROJECT</b>	<b>Shirley's Brook and Watts Creek/Kizell Drain</b>
<b>CREEK</b>	Kizell Drain
<b>REACH</b>	KDR-1
<b>GPS COORDINATES</b>	430680, 5021166

This reach begins upstream of the connection with Watt's Creek. The drain is very straight and narrow here, and is quite disconnected from the floodplain. Floodplain areas are heavily vegetated in grasses; there are few trees though there is some wood debris in the channel at a couple of locations. The bed is comprised of deposits of silt ranging in thickness from about 0.10 to 0.45m. Banks are consolidated clays and are near vertical. Bank erosion is evident in some locations through undercutting, indicating the drain is trying to create a sinuous pattern.

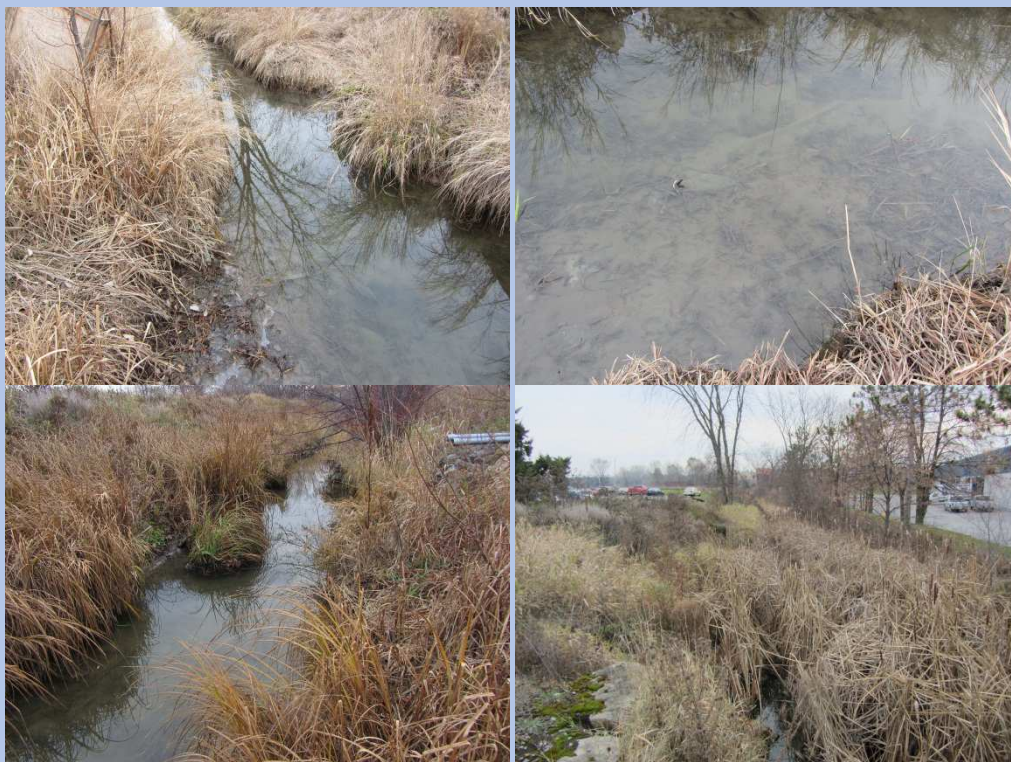
<b>PROJECT</b>	<b>Shirley's Brook and Watts Creek/Kizell Drain</b>
<b>CREEK</b>	Kizell Drain
<b>REACH</b>	KDR-2
<b>GPS COORDINATES</b>	429426, 5021362

This reach is located in a confined corridor within the commercial land use area. The valley form is trapezoidal and the drain flows in a somewhat sinuous pattern across the bottom of the valley. Riparian vegetation is primarily grasses with the occasional tree. The bed is comprised of accumulated silts of varying thickness delivered from upstream. Banks are not very high, there is good connection to the floodplain however the floodplain is not very wide so confinement of higher flows does occur. Bank erosion is somewhat limited by the rooting strength of the grassy vegetation; however there are the occasional scars along the bank and a couple of clumps of bank material, with grasses still attached, were found. This reach is rather flat and as a consequence there is some stagnancy to the water under normal water levels, this is evidenced by the wafting odour of decomposition of vegetation in the bed as the silts are disturbed.

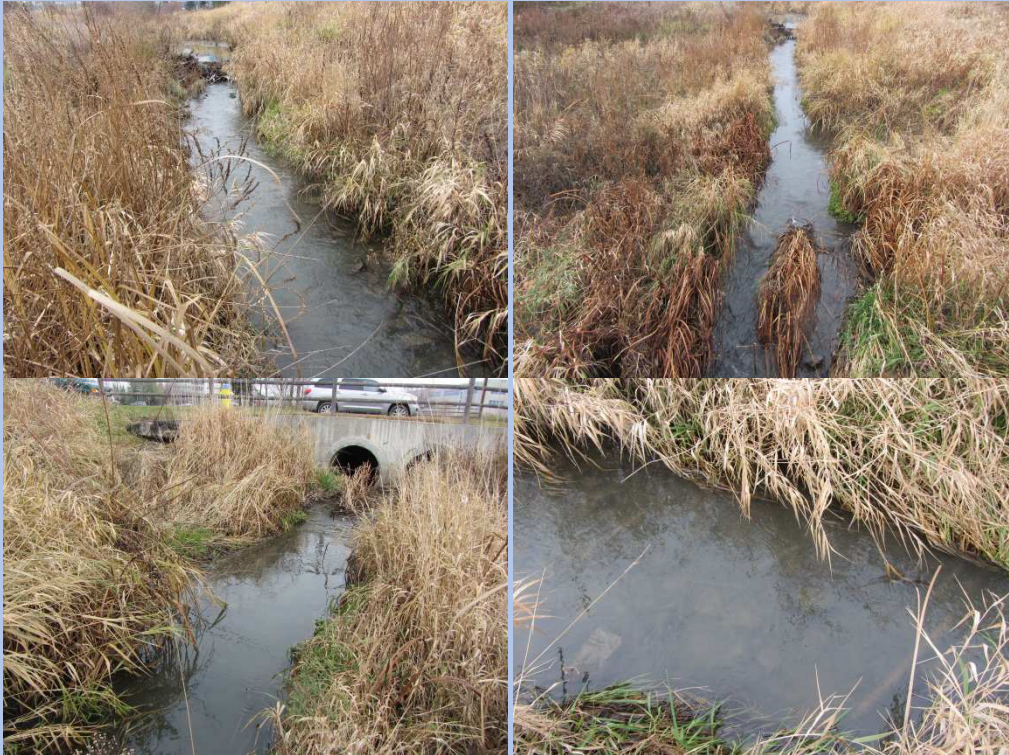
<b>PROJECT</b>	<b>Shirley's Brook and Watts Creek/Kizell Drain</b>
<b>CREEK</b>	Kizell Drain
<b>REACH</b>	KDR-3
<b>GPS COORDINATES</b>	428515, 5021424

This is a very straight section exhibiting similar constraints as KDR-2 with the exception that the reach is steeper and there is less stagnancy to the water under normal water conditions. Banks are well protected by grasses however in this section there is some undercutting indicating the drain is trying to alter its path. Some larger clump bank erosion is evident in the reach. Sediment on the bed consists of accumulated silt deposits from upstream, however they are not as thick as found in the downstream study reach.

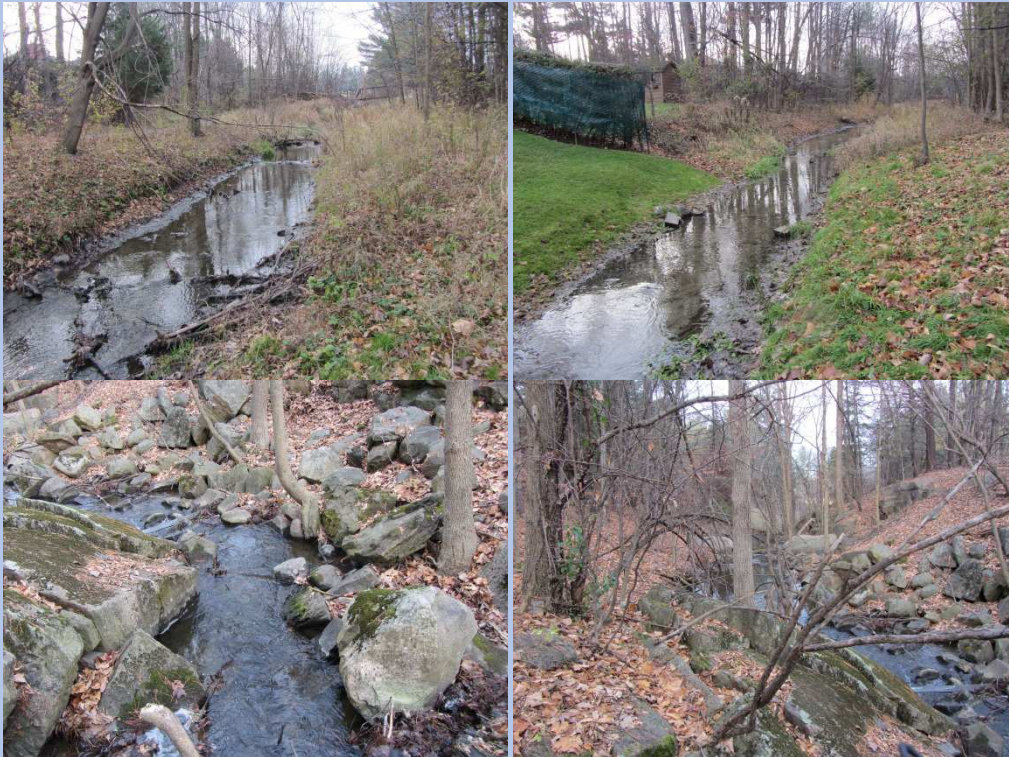
<b>PROJECT</b>	<b>Shirley's Brook and Watts Creek/Kizell Drain</b>
<b>CREEK</b>	Kizell Drain
<b>REACH</b>	KDR-4
<b>GPS COORDINATES</b>	428146, 5020429

This reach extends from Walden Road downstream to the bedrock outcrop location. The reach was selected as it represents the first formal drain section downstream of the Beaver Pond and this is where it is anticipated change will be noticed first if flows are altered. Residential yards on the east side extend to the edge of the drain with no buffer and some bank erosion is occurring in these sections. Floodplain connection is strong here as the banks are not too high on either side of the drain. Flow under normal water levels varies from still to rapid; this range is ideal as it provides for natural transfer of sediment. Bed material ranges from clays to limestone and there are minimal silt deposits on the bed.

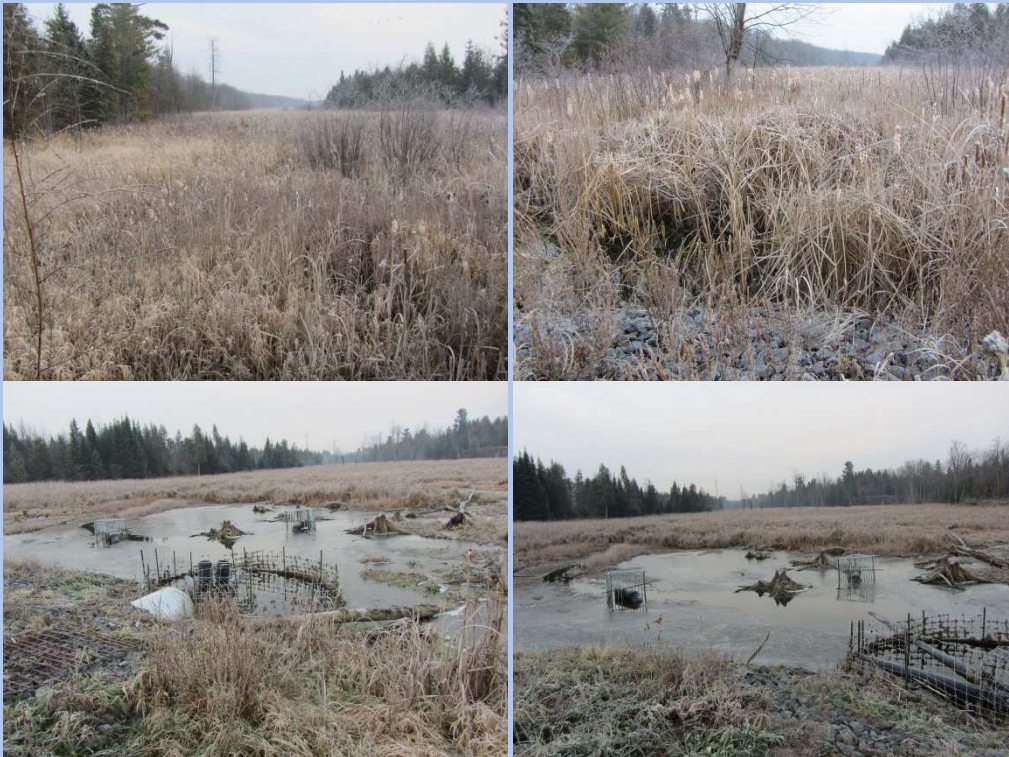
<b>PROJECT</b>	<b>Shirley's Brook and Watts Creek/Kizell Drain</b>
<b>CREEK</b>	Kizell Drain
<b>REACH</b>	KDR-5
<b>GPS COORDINATES</b>	427109, 5019855

This reach is upstream of the Beaver Pond in the area referred to as the Kizell Wetland. There is no formal channel in through here as there are multiple channel paths accessed under different flow conditions. Silt deposits in the wetland occur along channel margins and are quite deep in locations (up to 0.45m thick). The entire length of the watercourse along here has silt deposits; there are no exposures of rock or consolidated clays. Sands found in the deposits have their probable source in roadside applications along Golbourne Forced Road during winter. Channel banks are indeterminate for the most part. While not considered a formal part of the Drain, this location was assessed to provide context for comparison to downstream wetland sections which could be impacted by proposed diversions.

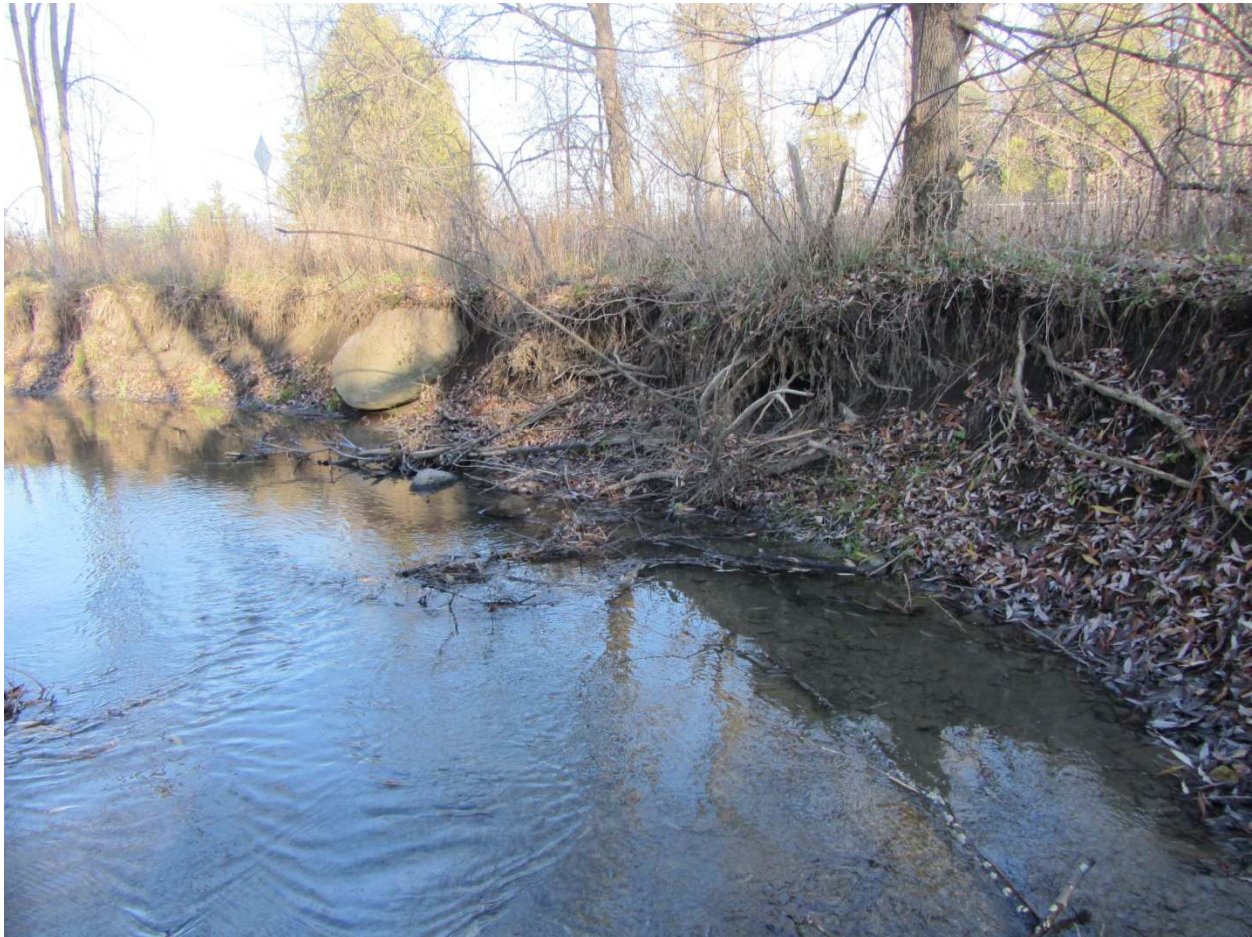
One location where there is a real risk to infrastructure occurs on Shirley's Brook where it flows alongside March Valley Road (within the lower reaches and located at SBDR-1). At this site the watercourse is eroding a large bank directly toward the road; this bank is on an outside bend and will continue to migrate in the direction of the road under existing conditions (as well as under proposed future conditions). Figure 2 is a photo of the site.

Figure 2: Eroding bank on Shirley's Brook adjacent to March Valley Road, GPS Coordinates 427832, 5023893.

Loss of land is problematic for the landowner and may, in time, require some intervention. It would be prudent to establish baseline conditions for these sites and establish a monitoring plan to observe changes.
