CONSERVATION PLAN

359 KENT STREET, 436 & 444 MACLAREN STREET, OTTAWA

March 2023

Application File Number: D02-02-21-0095 [ZBLA] & D01-01- 21-0015 [OPA]

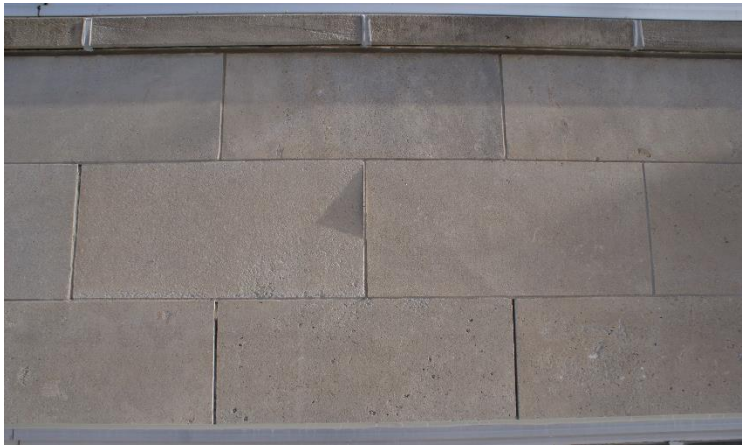
Condition: The limestone cladding is in good condition generally with a few stones at grade level that have been adversely affected by de-icing salts. A number of stones have surface defects or concretions that have not weathered well; however, they are limited in number. A detailed condition assessment of each stone panel will be completed as part of the dismantling process. There are a number of stone panels where the mortar is missing from the joints particularly in the area of the introduced Kent Street entrance providing a general sense of how difficult the removal of the mortar from the units may be during the salvage process.

Figures 7: View of the Niagara limestone cladding above the Kent Street entrance. Note the variations in the material, coursing and the window sill course band the length of units corresponding with the cladding coursing. Mortar is missing from a number of joints. Source: Commonwealth 2023.

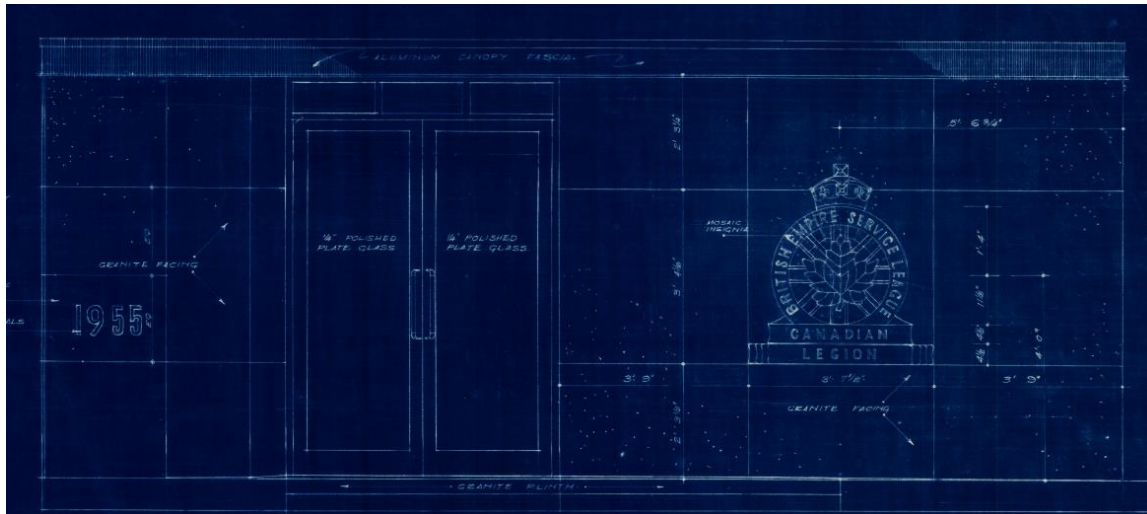
Figures 9: Elevation of the Gilmour Street entrance illustrating the arrangement of the granite cladding. The Royal Canadian Legion crest was removed in 2009 and the original granite panels removed and new material inserted possibly due to the poor condition of the material. Note the two radius cut granite panels to the left of the door and the panel arrangement to the right of the door. Source: 1955 Drawing Set A5

Condition: De-icing slats have had a major impact on the lower three stones set at floor level. The surfaces are disaggregated and crumble to the touch. The memorial stone with an incised date and inscription is in better condition although it is not clear when the inscription was incised.

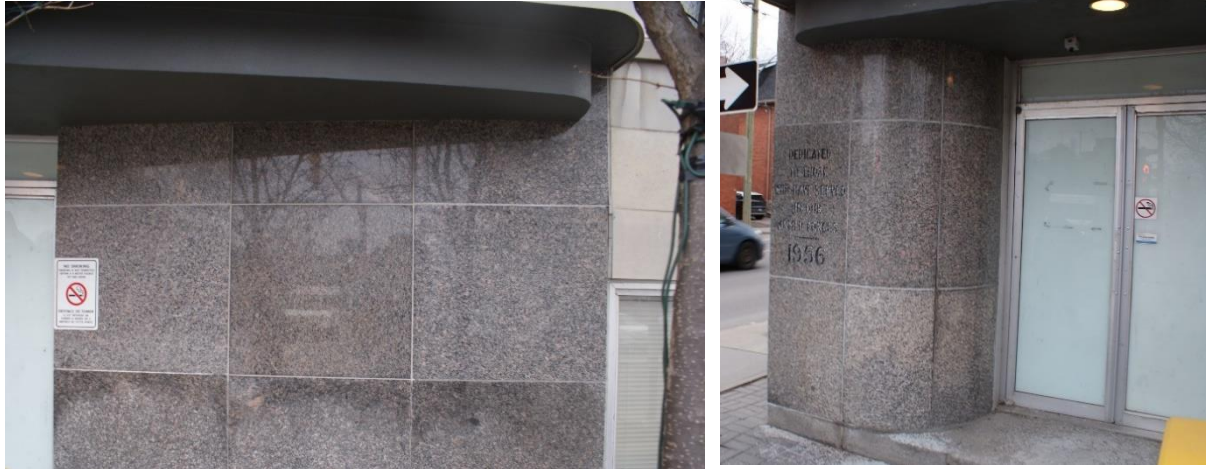
Figures 10 & 11: (6 -left) View of the introduced polished granite panels to the right of the Gilmour Street entrance. (7-right) View of the original polished granite panels. Source: Commonwealth 2023

Restoration: Reinstate new polished granite cladding to match the original material and panel configuration modified in width to accommodate an increased exit width to the right of the door where the original material was removed in 2009.

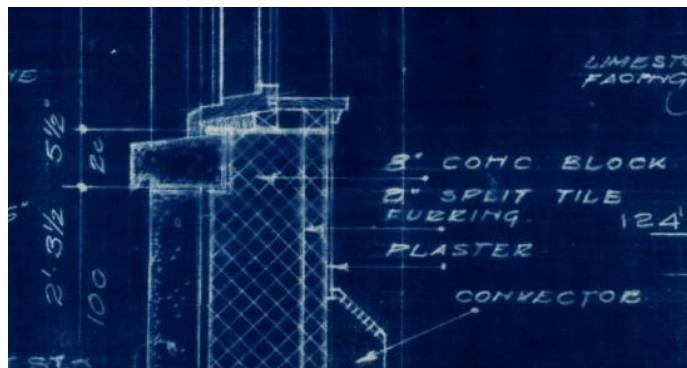
Figure 12; Detail section through the Kent and Gilmour facades illustrating the arrangement of the limestone sill course and limestone cladding. The sills are bonded to the limestone cladding and the concrete back-up wall making it difficult to salvage the window sill course material. The drip edge only adds to the difficulty of successfully salvaging the material for reuse. Source: 1955 Drawing Set A4

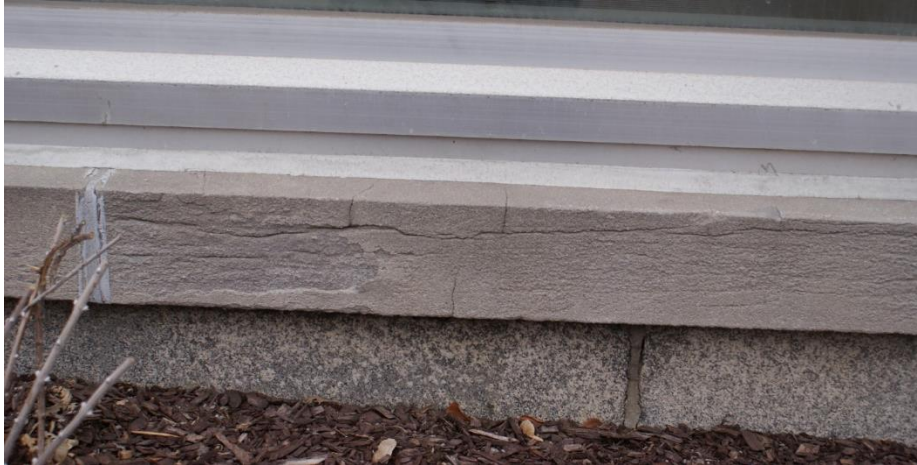
Condition: The limestone windowsills are relatively porous along cleavage planes, susceptible to de-icing salts, and freeze-thaw cycling to varying degrees dependent upon material defects within individual stones. Stones vary in quality as is evident on all elevations where sound stones are interspersed with poorer quality material that has failed. Typical failure patterns include delamination along cleavage planes after the surface has weathered and at the exposed surfaces where the material pops during freeze thaw cycling. Approximately 30% of the sill stones will need to be replaced, and further loss is expected during the dismantling, storage and reinstallation processes; however, between the four façades there should be enough good quality sill stones to complete the Gilmour and Kent street window sill courses.

Figure 13: View of a deteriorated limestone windowsill and the granite plinth course below. The cleavage planes within the limestone sills are evident where the sawn surface has weathered. The cleavages follow the layers of deposition of the sedimentary rock. Source: Commonwealth 2022.

Rehabilitation – The limestone sills will continue to weather and deteriorate over time. The limestone is not the highest quality material. Install new pre-cast concrete sills that are tinted to match the dimension, form and colour of the existing material. Replacing them all is the client's preference.

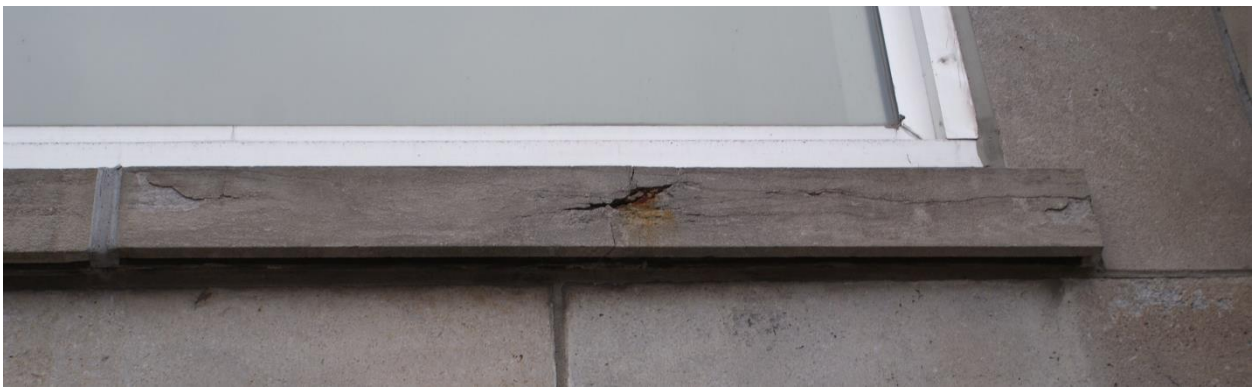
Figure 14: View of a deteriorated limestone windowsill. The cleavage planes within the limestone sills are evident where the sawn surface. The cleavages follow the layers of deposition of the sedimentary rock. Source: Commonwealth 2022.

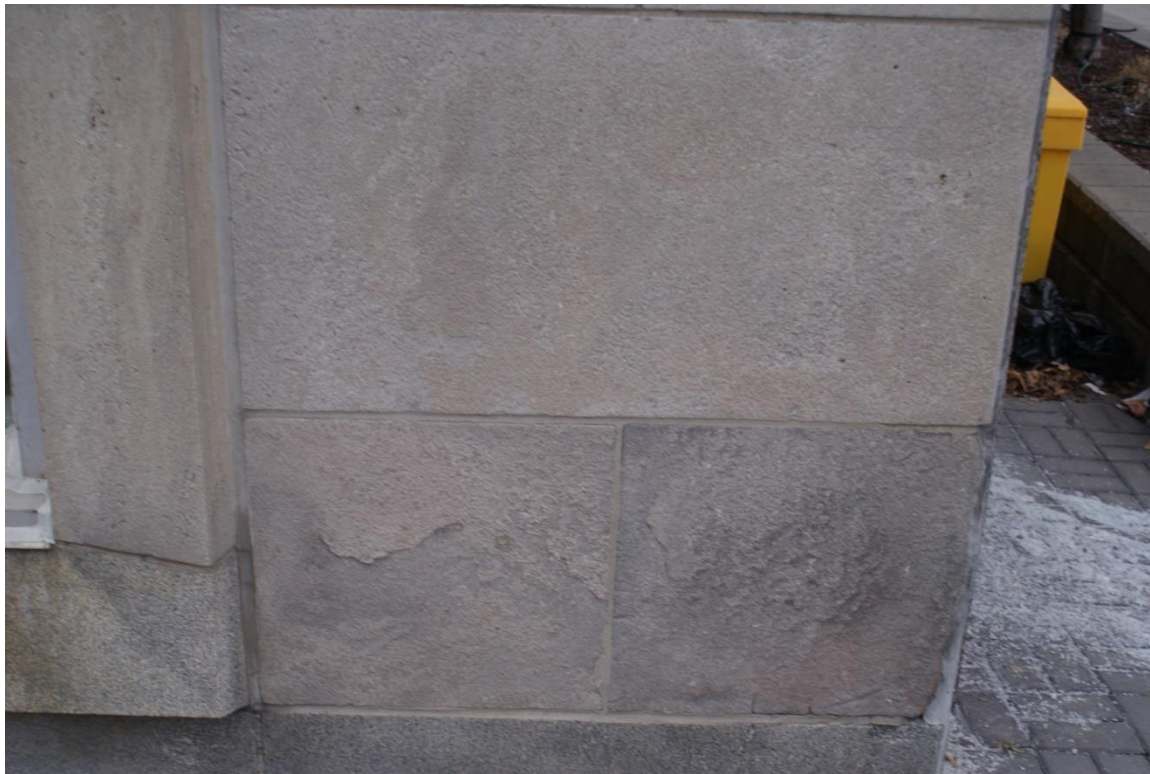
Condition: The limestone window surrounds on the multi-storey windows on Kent and Gilmour are generally in good condition. There is some deterioration of the surface due to de-icing salts where the units are in proximity to grade, some material defects, and rust staining of the material. The condition of the individual units will be assessed and noted during the dismantling phase.

Figure 15: Detail view at the base of the wall at the south-west corner. The surface of the two Niagara limestone panels at the base of the wall are scaling due to de-icing salts. The granite plinth course is evident at the bottom of the photo. The Niagara limestone window surround is the vertical element to the left and a granite window sill/surround below. Source: Commonwealth 2022.

Preservation of the limestone window surrounds and reinstallation in the Kent and Gilmour Street façades.

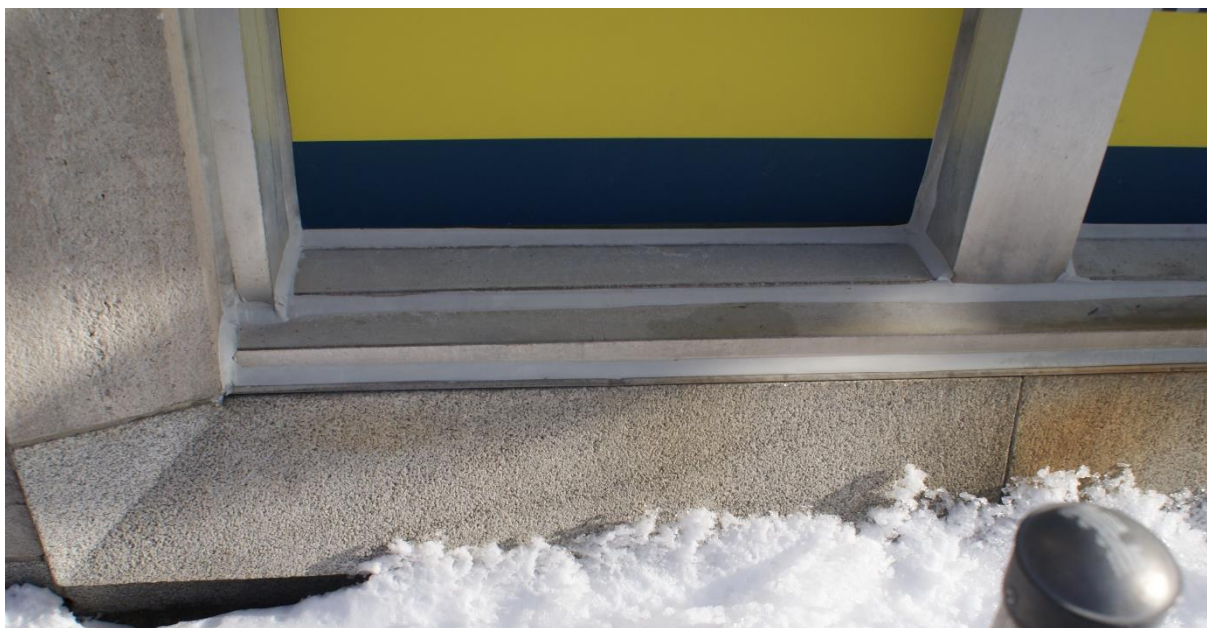
Figure 16: Detail view of the base of the Kent Street window. The horizontal units at the base of the window are formed of the same material as the granite plinth course. The vertical stone to the left is a limestone unit. Note the close match in colour and surface texture. Source: Commonwealth 2023

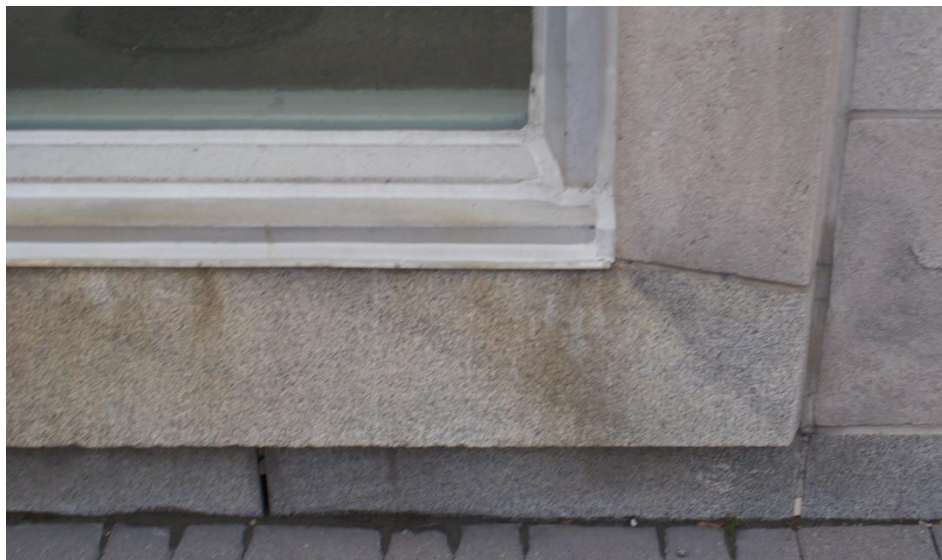
Condition: The granite sill on the Kent Street window is in good condition. The condition of the granite plinth course buried below grade has not been determined.

Figure 18: Detail of the granite plinth course and granite windowsill surround at the base of the three-storey Kent Street window. The colour of the granite sill is very close to the limestone cladding and window surrounds. Source: Commonwealth 2022.

Preservation of the intact granite sill and plinth course panels and reinstallation in the Kent and Gilmour Street façades forming an upstand wall supporting curtain wall glazing. The condition of the material buried below grade has not been determined.

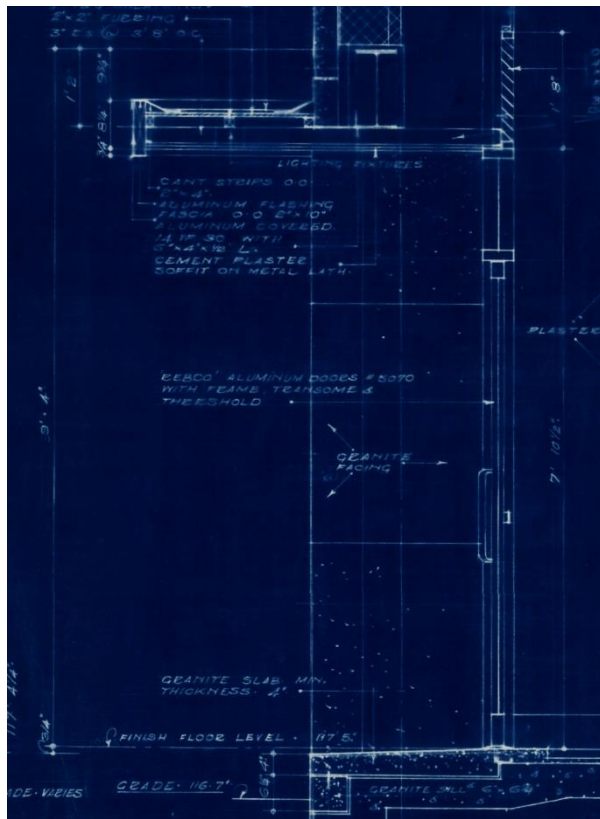
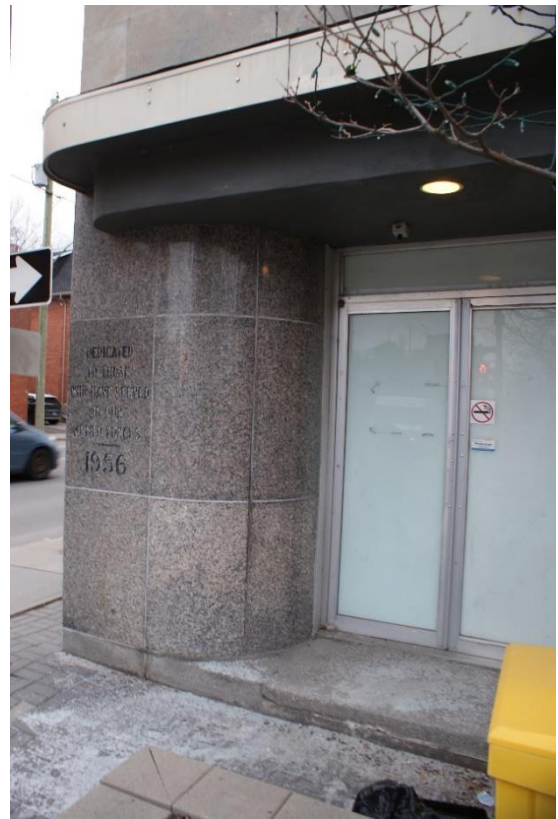
Condition: The canopy has been modified with a dropped modern enclosure with recessed lighting.

Figures 19 & 20: Detail section of the Gilmour Street Entrance illustrating the form and materials and the relationship to the entrance doors. Existing view of the canopy illustrating alterations to the canopy and entrance doors. Source: Original 1955 Drawing Set A5 & Commonwealth 2022.

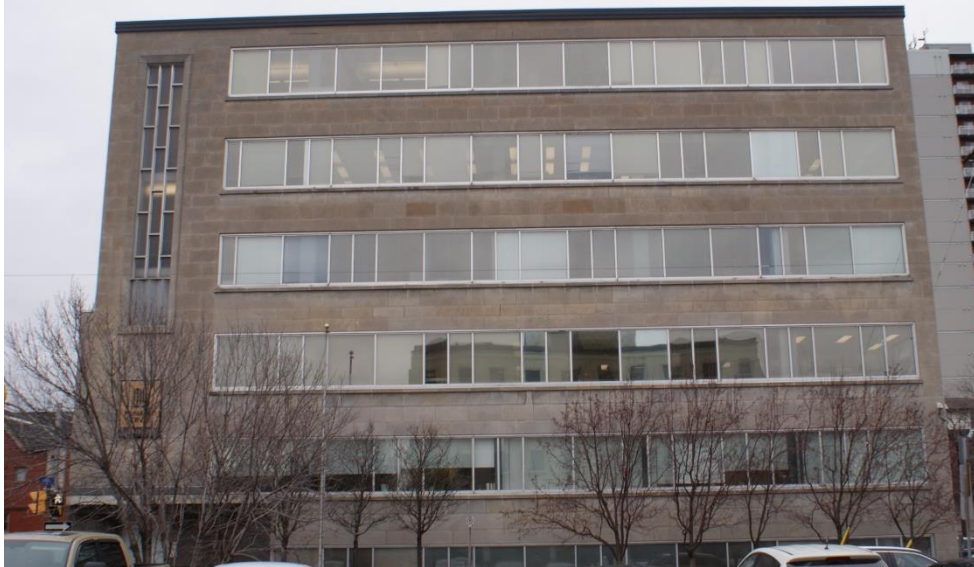
Condition: The existing windows are being replaced with new aluminium thermal units. The original vertical and horizontal division of the lights will be replicated in the three-storey windows on the Kent and Gilmour façades.

Figure 23: View of the windows on the Gilmour Street façade. All of the original windows have been replaced with the exception of the three-storey window above the Gilmour Street entrance. Source: Commonwealth 2022.

Rehabilitation – The windows are being replaced with a modern aluminum thermal unit. The horizontal and vertical arrangement of the original sash should be maintained in the new units. The horizontal division at the midpoint of the height of the units is an important feature adding to the horizontal sweep of the façades a character defining feature of the International Style.

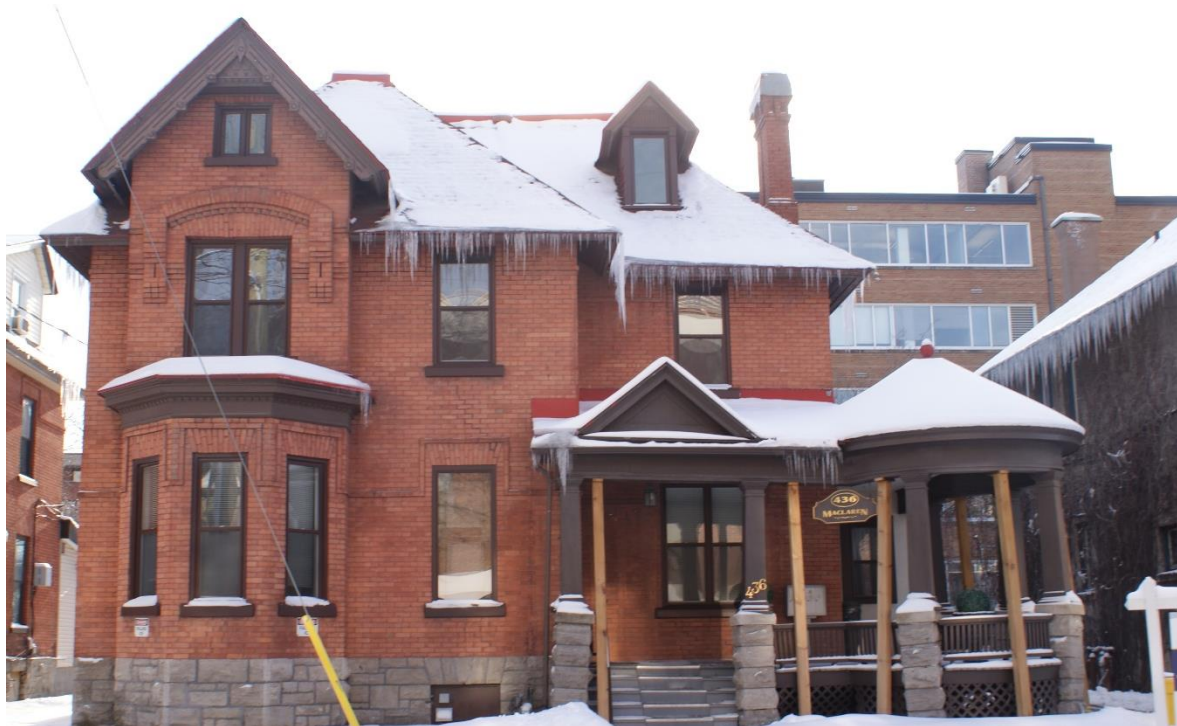
The building at 436 MacLaren is in good condition overall with the exception of the one-storey porch. The coursed limestone pillars supporting the deck structure need to be dismantled and rebuilt with a new foundation. The deck structure which is supported on the masonry piers will also need some attention.

Figure 25: View of 436 MacLaren Street. The masonry piers supporting the porch have settled due to inadequate foundation depth. A detailed assessment of the condition of the porch is required. Guidelines from the CHCDP provide guidance for the conservation approach to the materials and assemblies. Source: Commonwealth 2023.

e) Where a porch or balcony is badly deteriorated, it should be conserved, not replaced. Where components are beyond reasonable repair, new components should match the originals in terms of design and detail, with the same materials, style and size, as closely as possible.

i) Masonry piers that support historic porches should be conserved. Repairs should be made in kind.

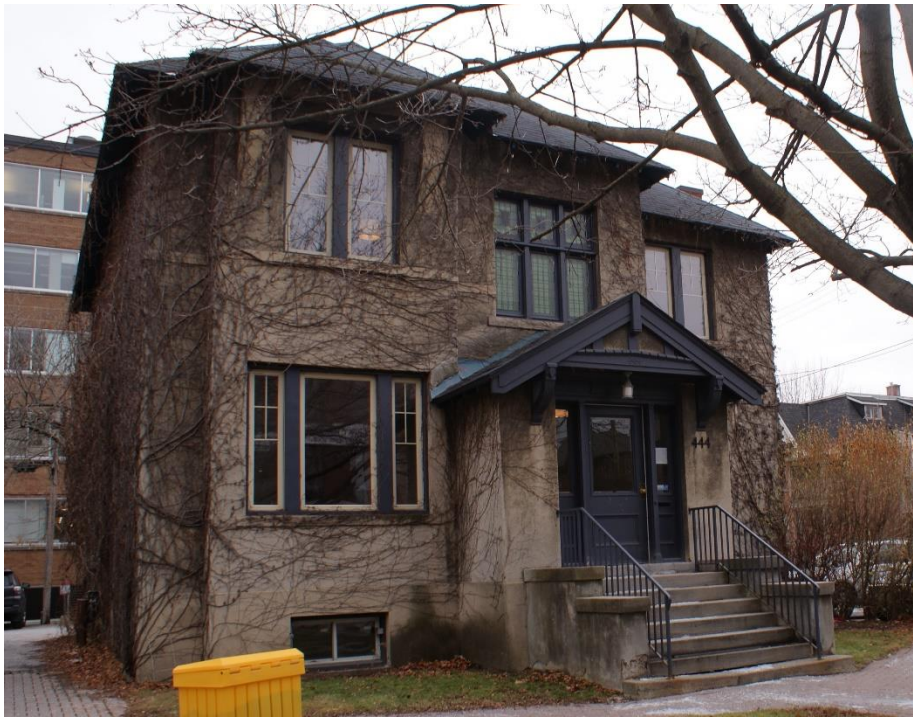
The building at 444 MacLaren is covered in vines that should be removed. The guidelines contained in the 2022 Centretown Heritage Conservation District Plan (CHCDP) are provided to guide the conservation work.

Figure 26: View of 444 MacLaren Street. The stuccoed exterior wall is covered in vines that should be removed before they have an adverse impact on the stucco finishes. Source: Commonwealth 2022

1. Conserve, maintain and repair historic masonry, stucco, and wood exterior cladding.

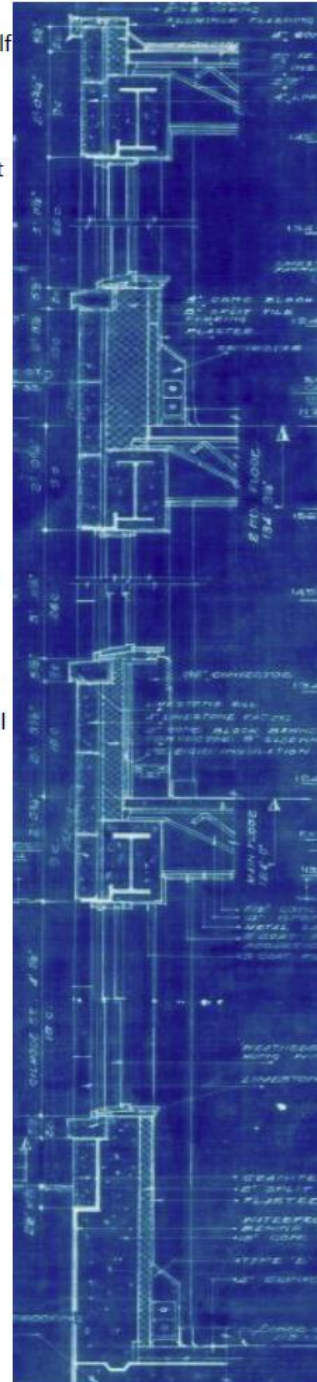
Figure 3. Wall Section

As shown, at right, in Figure 3, the 4" limestone veneer is supported by steel shelf angles at the suspended floor levels and on the concrete foundation wall, at the base. A concrete block wall is identified as the back-up to the stone veneer and would be relied upon to provide the lateral support to the limestone veneer. There is no indication of insulation or a significant air space, which are important features of cavity wall design.

The concrete masonry wall is only 4" thick at the ventilators but 8" thick, otherwise. The veneer and back-up walls are not bonded to act as one. The ties connecting the stone veneer to the concrete block back-up and the shelf angles are likely to be corroded after 66 years of service life. The condition of these important elements would need to be verified. There is no insulation in the wall and energy efficiency of the perimeter wall system would be very poor.

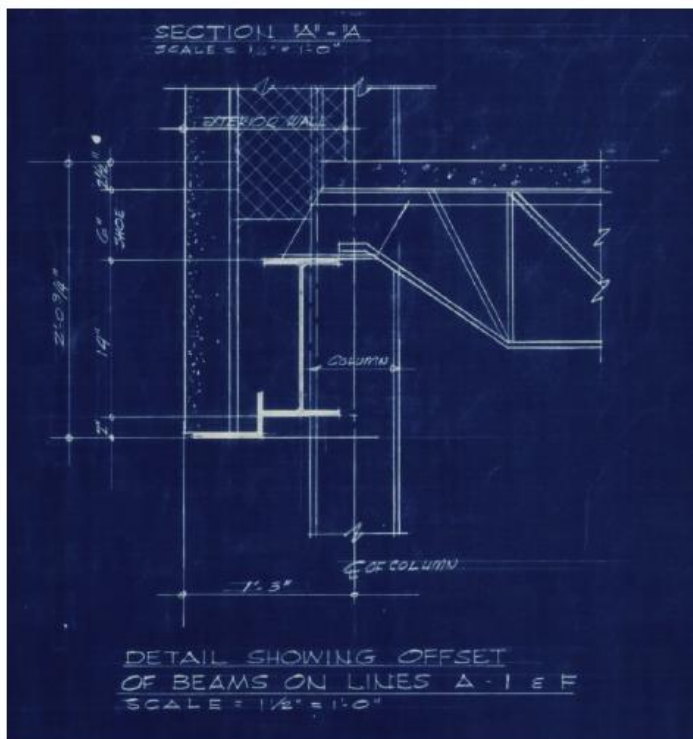
The existing floor joists bear on an offset beam on the gridlines considered for retention. The joist shoe is connected to an offset beam and the beam is cast in concrete for fire proofing purposes. The veneer and back-up masonry block wall bear on this concrete-encased at each floor and induce torsion on the beam (see Figure 4 for the typical detail). The joists brace the beam and provide resistance to the torsion created by the eccentric masonry loads. Removal of the interior joists will require compensating construction to deal with the eccentric loads and this complicates in situ retention of the facade.

Figure 4. Typical Off-Set Beam Detail at GL 1 and F.
