Tree Conservation Report 424 Churchill Avenue North Ottawa, Ontario

IBI GROUP DRAFT
TREE CONSERVATION REPORT
424 CHURCHILL AVENUE NORTH
OTTAWA, ONTARIO
Submitted to GSI PROPERTIES

TREE PRESERVATION PLAN

TPP-2

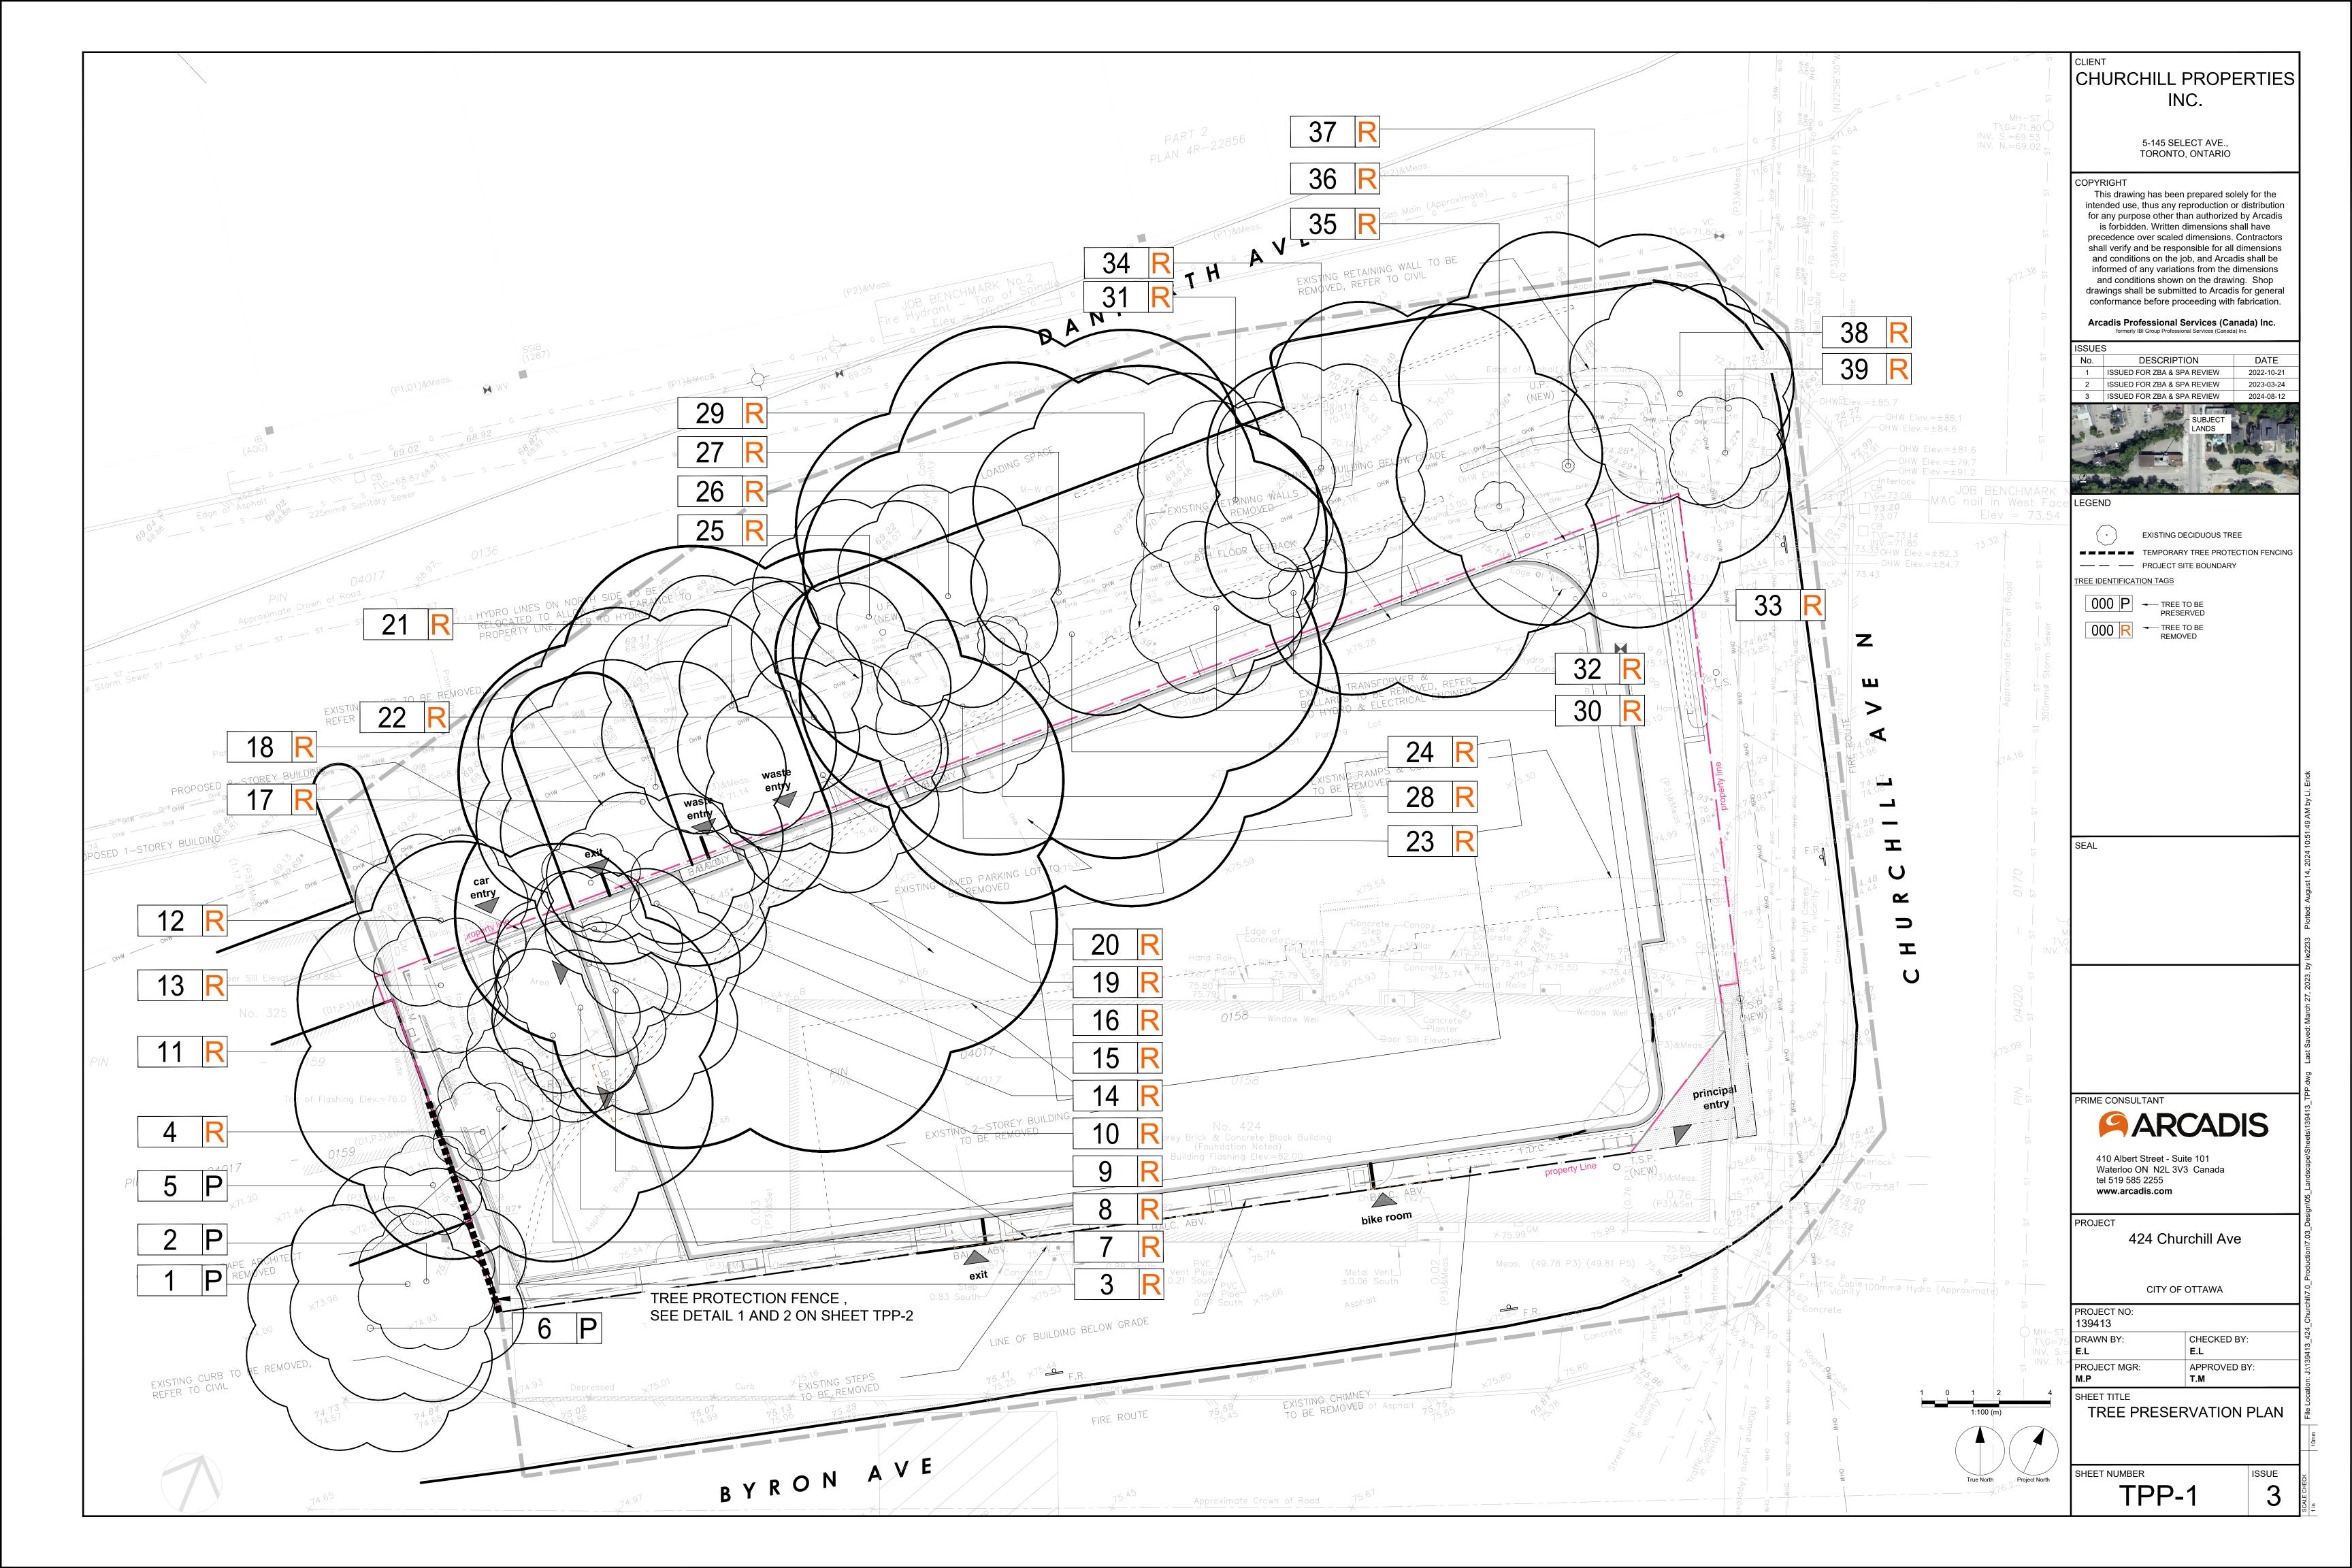
Tree Protection Fencing (TPF) is to be installed on site along the western property line to protect four (4) trees on the adjacent property (Appendix A). The limits of TPF have been indicated on the Tree Conservation Plan sheet TPP-1 and shall be considered to delineate the limits of work. All TPF shall conform to the City of Ottawa's current standards and Tree Protection Specification as shown on Detail 1-TPP2.

- 1. Tree Protection Fencing (TPF) should be installed to protect all trees identified for preservation. TPF should conform to City of Ottawa standards and the locations indicated on the TPP (Appendix A). Upon installation of the TPF, the Contractor should contact the Project Arborist to review and approve the fencing and its location prior to commencement of any site work. This should be coordinated with City staff for approval. The TPF should remain intact throughout the entire construction period, as specified on the plans. The TPF should be inspected monthly and repaired as required and should be removed at the completion of all site works.
