# Landslide Hazard Assessment

## Proposed Multi-Storey Building

3030 Saint Joseph Boulevard  
Ottawa, Ontario

Report PG6609 - 2 dated February 12, 2024

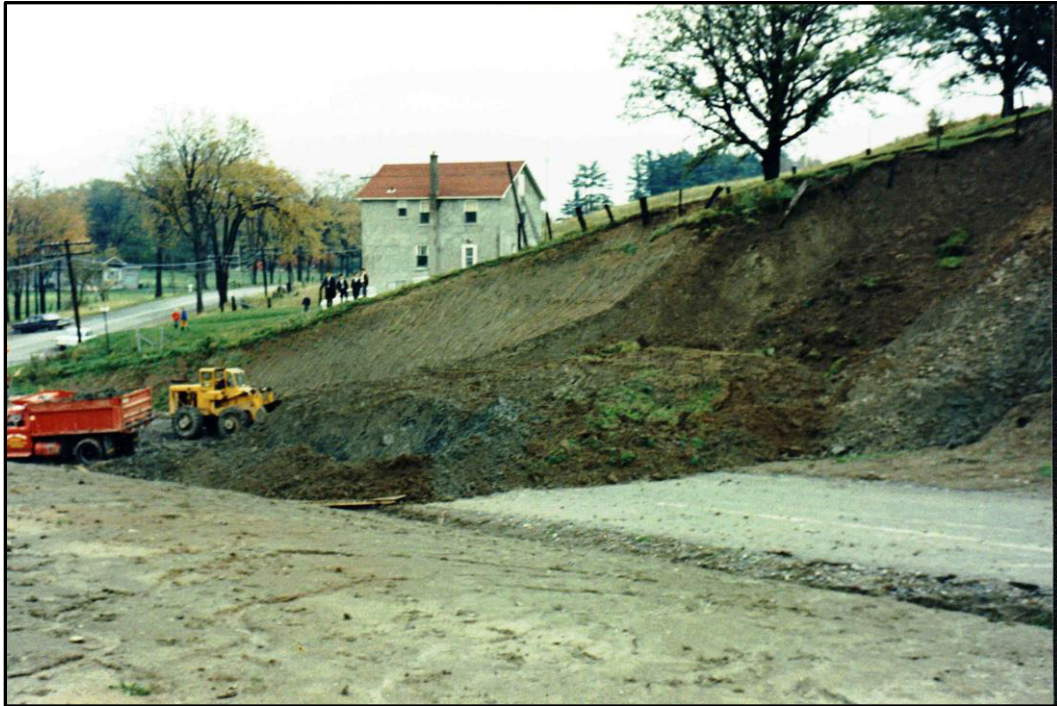
Section C was located within a former slope failure area. It is understood that a slope failure occurred along the east side of Duford Drive in the 1960s. Photographs of the slope failure were provided to Paterson for this response. Photographs 1 and 2 presented in Appendix 2 show a shallow slope failure across a limited section of overall slope face. Based on slope features noted in the photographs, such as lack of vegetation across the slope face and the soil surface in the area of Duford Drive, it appears that the slope failure occurred across a section of the slope, which had been recently re-shaped as part of the construction of Duford Drive.

The natural grade of the slope face was drastically changed during the construction of Duford Drive. It is expected that the slope failure can be directly contributed to the steepness of excavated slope face along with exposure to precipitation events before a vegetative layer could establish. It should be further noted that a vegetative layer across a slope face promotes surficial run-off during precipitation events and limits infiltration of rainwater into the slope soil. Infiltration of water from precipitation events into a slope reduces overall slope stability.

Photo 1: Localized slope failure occurring in the mid 1960s adjacent to Duford Drive. Subject site is located within the foreground of the photograph. St. Joseph Boulevard is in the background. Ground surface adjacent to Duford Drive is noted to be free of vegetation, which is indicative that construction of the subject roadway section and cutting of the subject slope was recently completed. It is suspected that the exposed slope was re-shaped to an unstable slope angle as part of the construction work at that time.

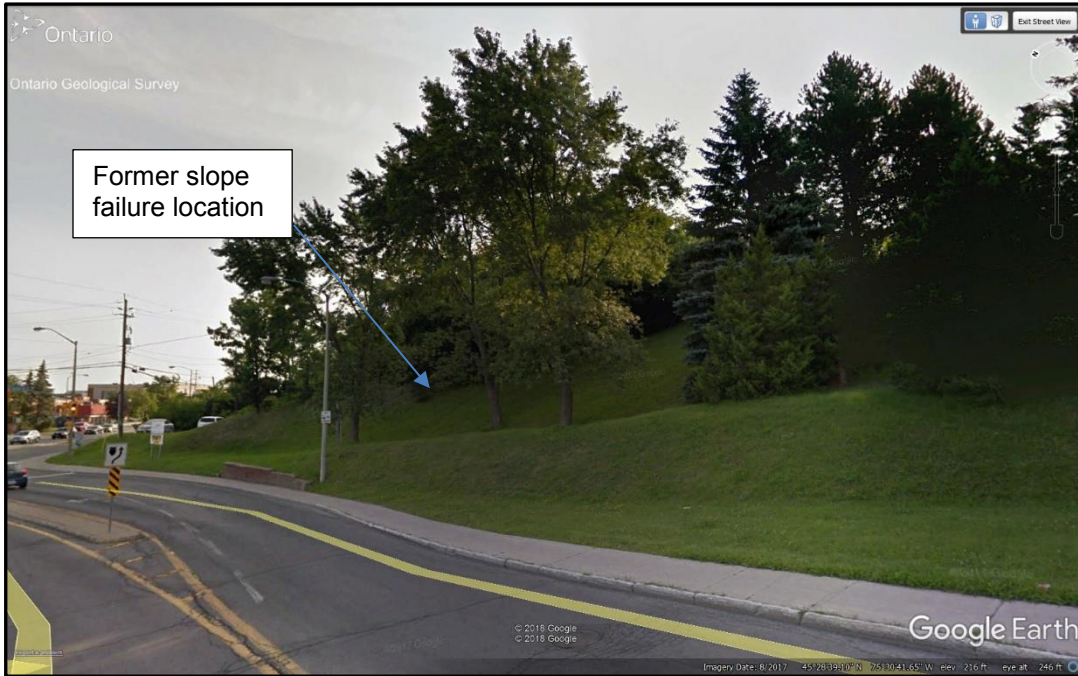
The current slope face was noted to include a terraced area along the base of the slope face in the area of the former slope failure (see Photos 3, 4 and 5 in Appendix 2). It is suspected that the terraced area was introduced after the initial slope failure to stabilize the reinstated slope. Currently, the slope face was noted to be grass covered with mature trees. No signs of slope instability were noted.

Photo 3: Street view image from Google Earth of former slope failure area (presented in Photos 1 and 2) adjacent to Duford Drive. Ground noted to be re-shaped with a terraced slope in front of reinstated slope.

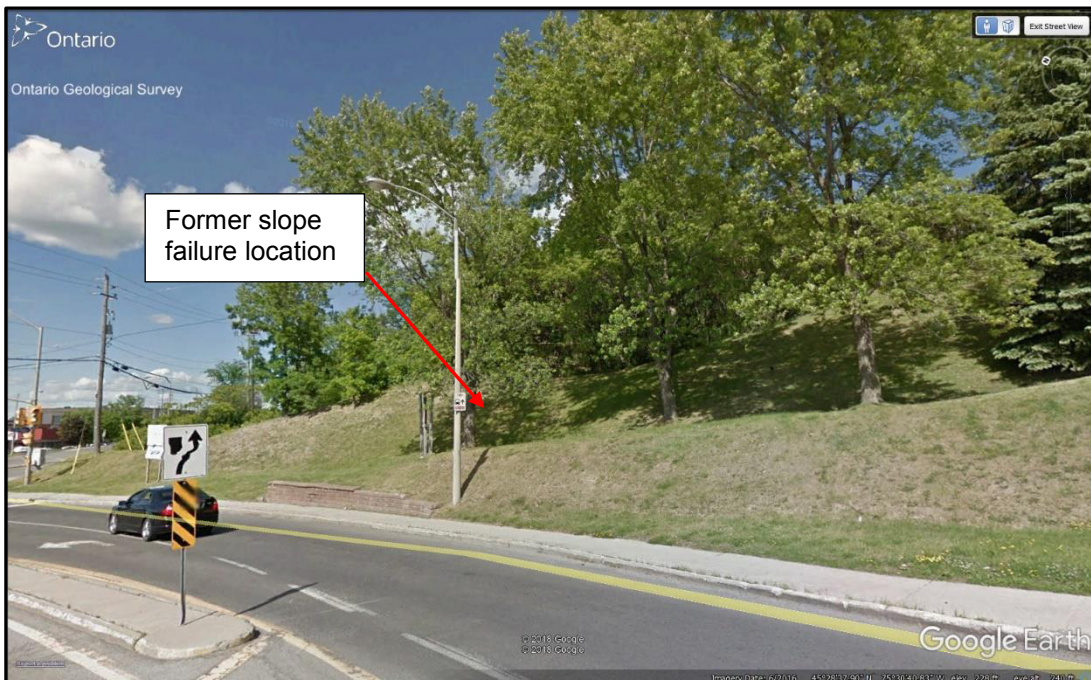
Photo 4: Street view image from Google Earth of the same former slope failure area presented in Photos 1 and 2. The ground surface is noted to be stable with no signs of slope instability.
