Theia Partners

Tree Conservation Report

30 Cleary Avenue

CIMA+ file number: A001443
November 17, 2023 – Review 002

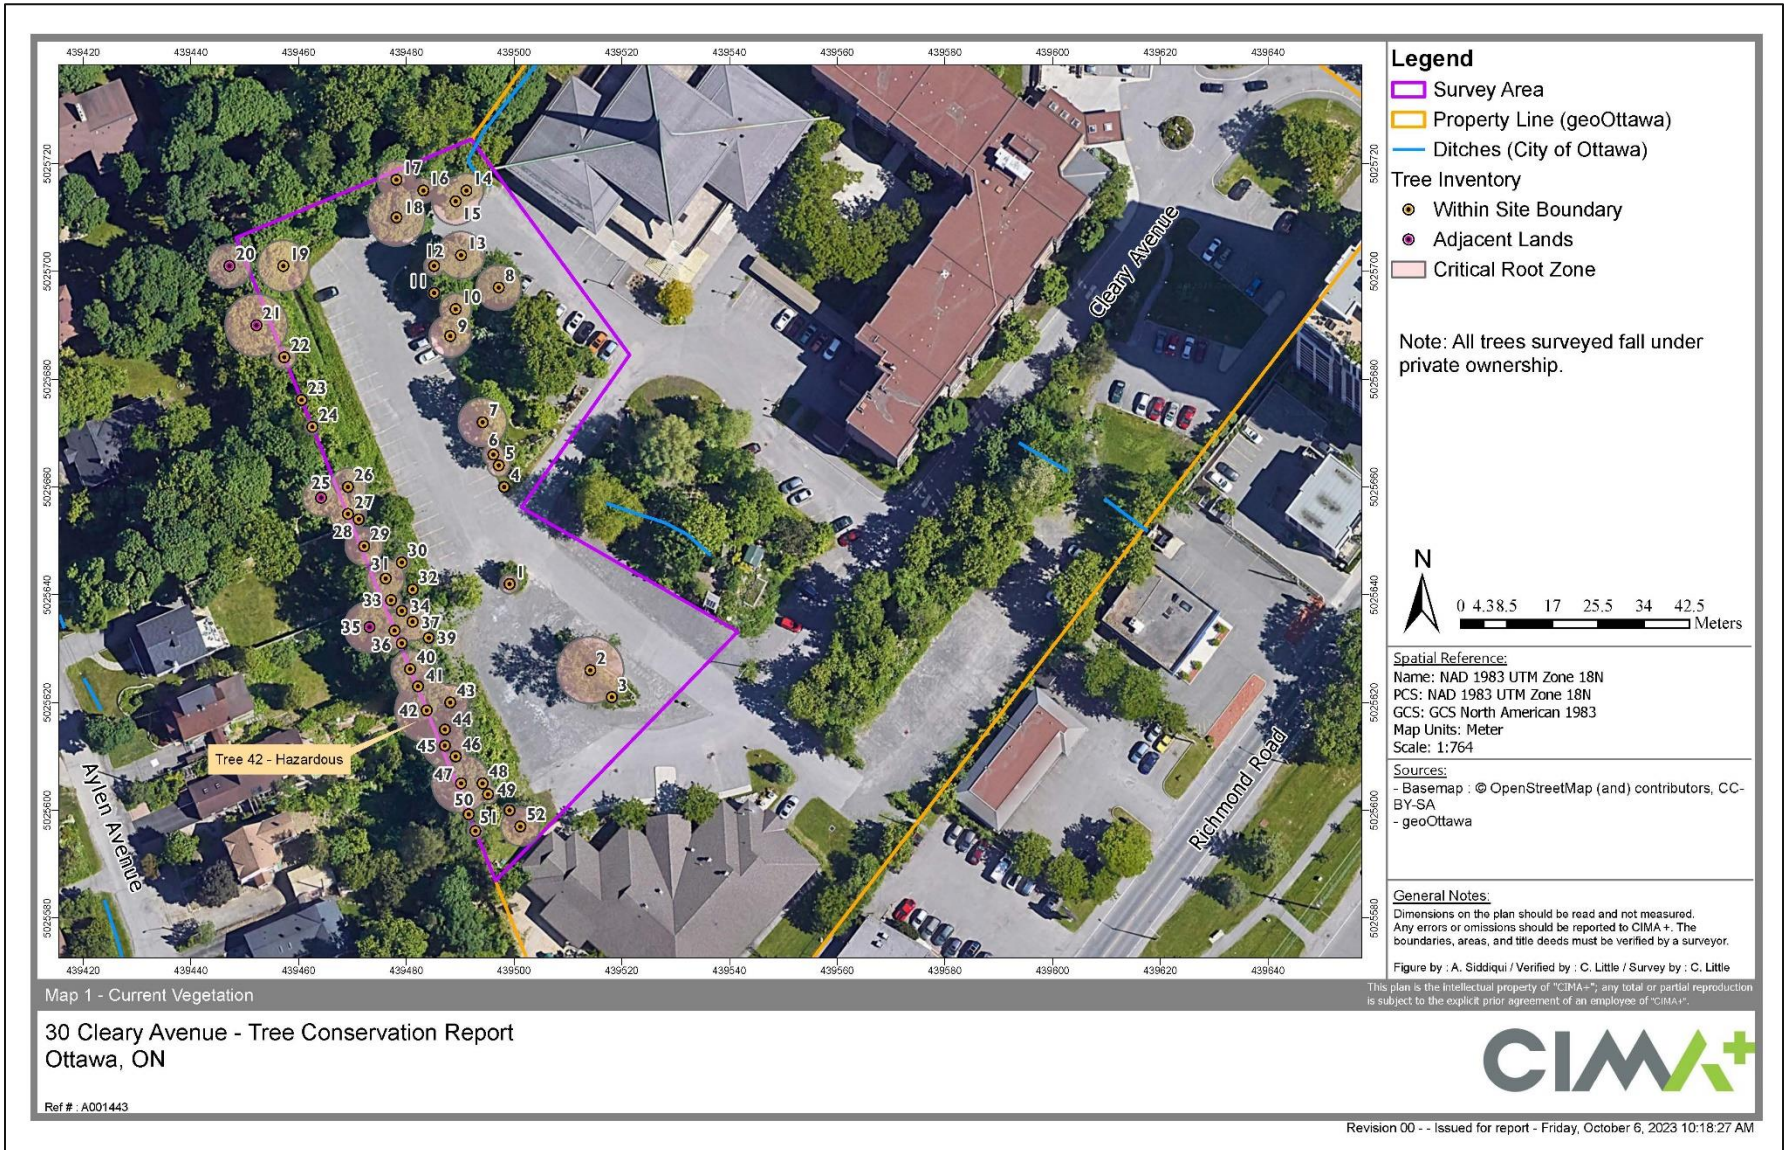
Figure 2 : Current Vegetation (Map 1 as per City Guidelines)

A total of 53 individual trees were assessed as part of this inventory. The condition of the trees on Site ranged from Good to Poor, 75% of which were in Good condition. The most common species were Norway maple (33%), red pine (26%), and Manitoba maple (9%). There are 28 trees that meet the definition of a ‘Distinctive Tree’ as per Tree Protection By-law No. 2020-340 (any tree located on private property with a DBH of 30 cm or greater, within the inner urban area).

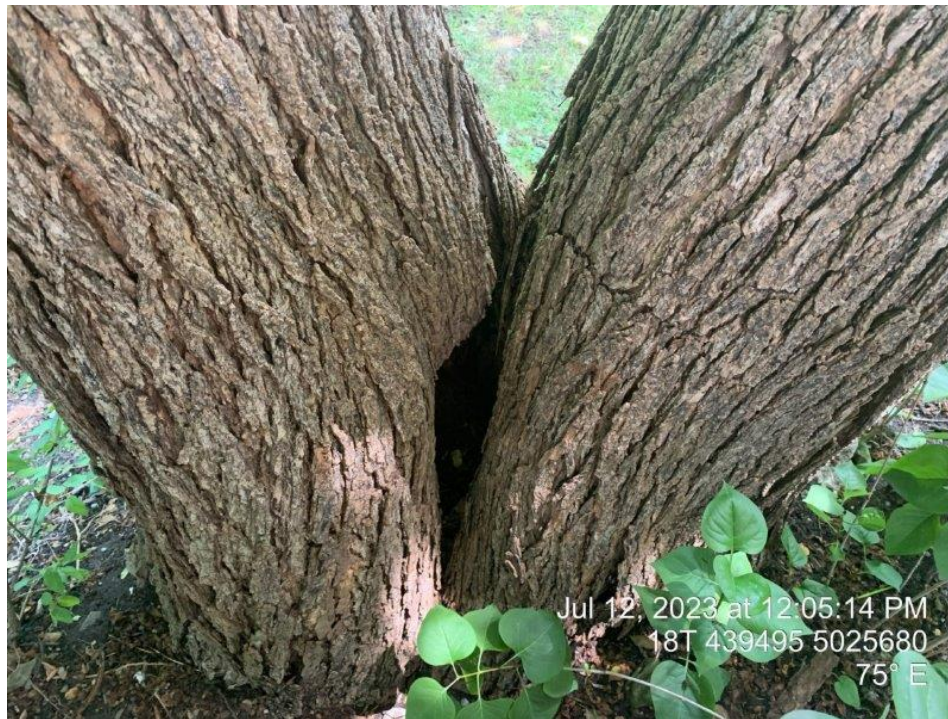
It should be noted that the condition of one (1), 2-stem northern catalpa (tree #7 - **Appendix A**) situated within the community garden was assessed as Good, however is experiencing some crotch decay. It is recommended that prior to construction, an ISA certified Tree Risk Assessor (ISA TRAQ) complete a Risk Assessment for this tree, and comment on its candidacy for cabling the 2 stems to strengthen its structure integrity. **Photo 1** below displays the codominant union of the trunks of tree #7.

Photo 1 : View of crotch decay and codominant leaders of Tree #7 – Northern Catalpa

A list of proposed avoidance and mitigation measures have been included in Section 7 of this report in relation to tree removals, tree protection, and tree preservation. This includes recommendation for further assessment of Tree #7 to determine the potential risk of the tree and whether it would be a good candidate for cabling to strengthen to codominant trunk union.

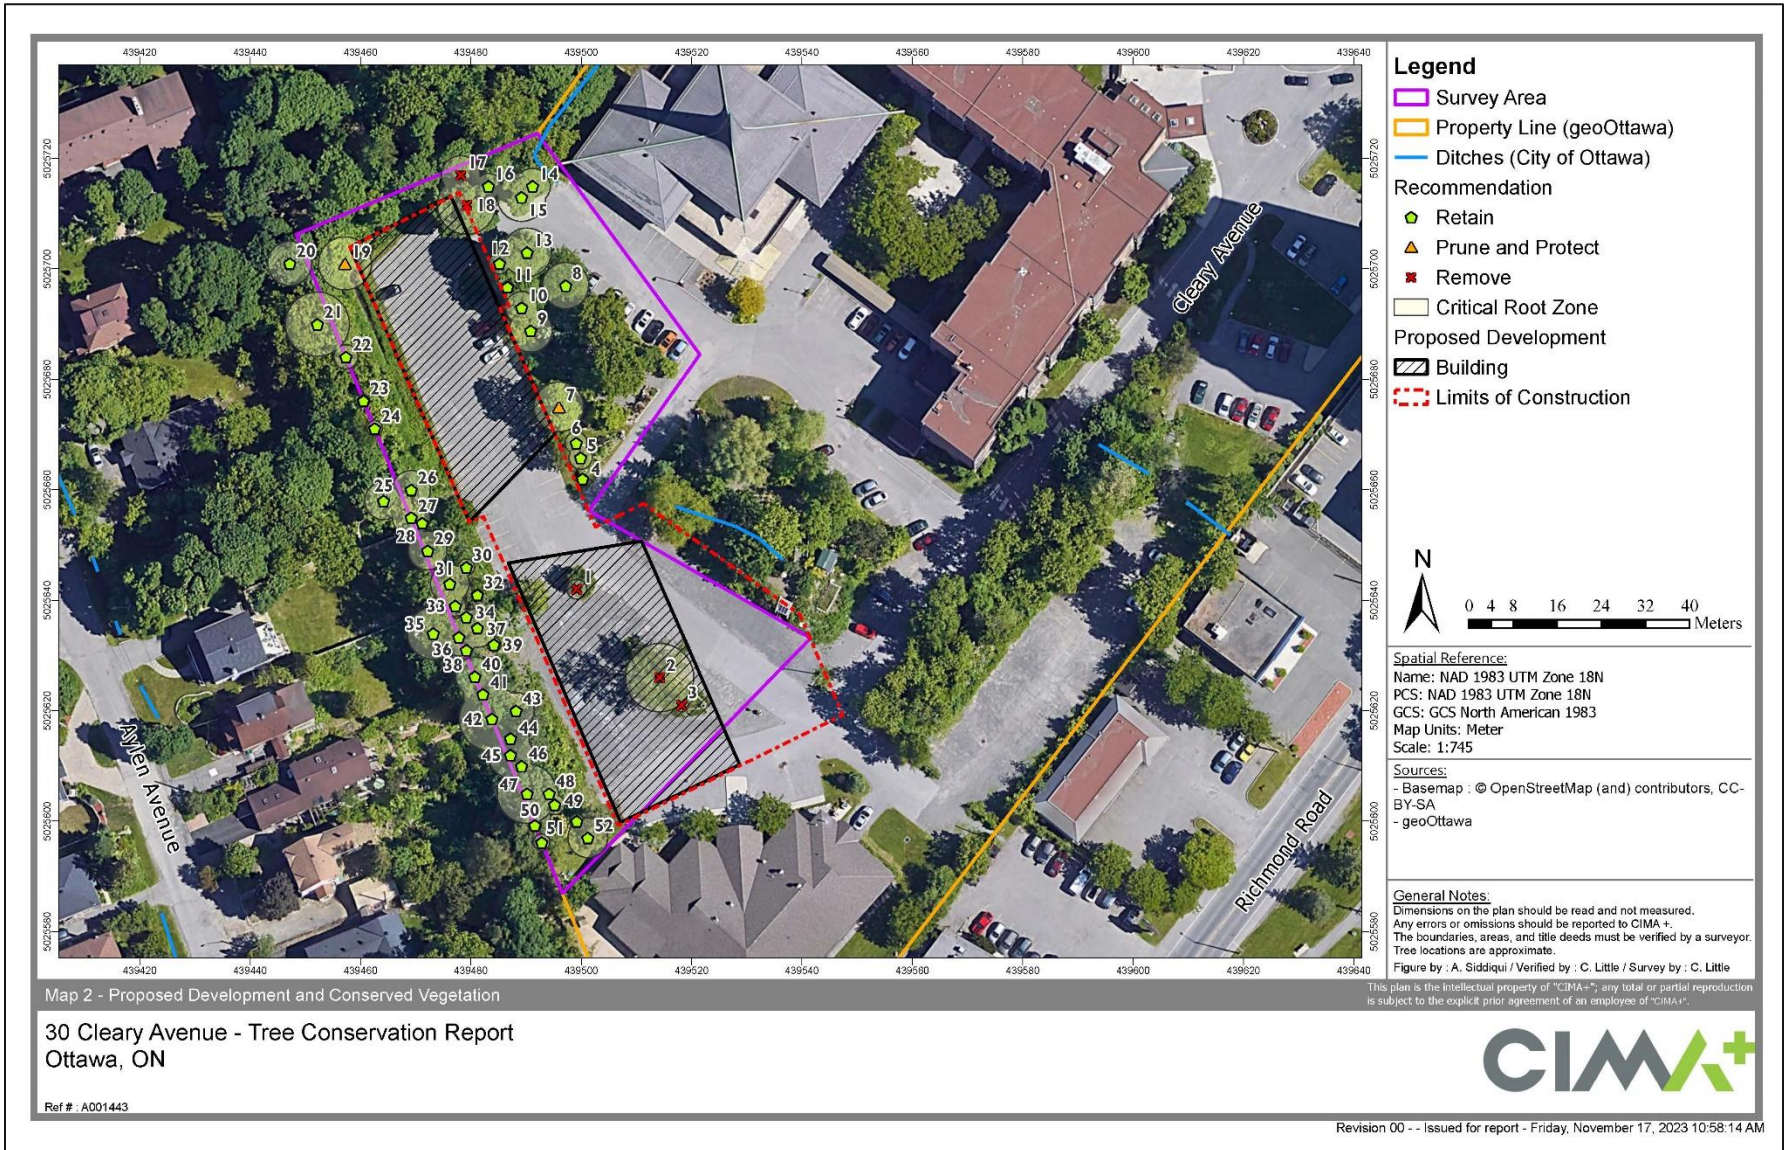
Figure 3 : Tree Impact Assessment and Proposed Recommendations (Map 2 as per City Guidelines)

Based on the conditions of the trees and extent of the proposed construction limits, **Table 3** summarizes the recommended actions of the 53 trees assessed within the Site. These details are depicted in **Figure 3** (mandatory Map 2 as per City of Ottawa, 2021).

Trees to be Removed	Trees to be Pruned	Trees/Groupings to be Retained
5	2	46
