February 7, 2022  
File: PE2830-LET.06

**1897365 Ontario Inc.**  
200-66 Colonnade Road N  
Ottawa, Ontario  
K2E 7K7

Subject: **Phase I Environmental Site Assessment Update  
Vacant Land/Construction Staging Yard  
1034 McGarry Terrace  
Ottawa, Ontario**

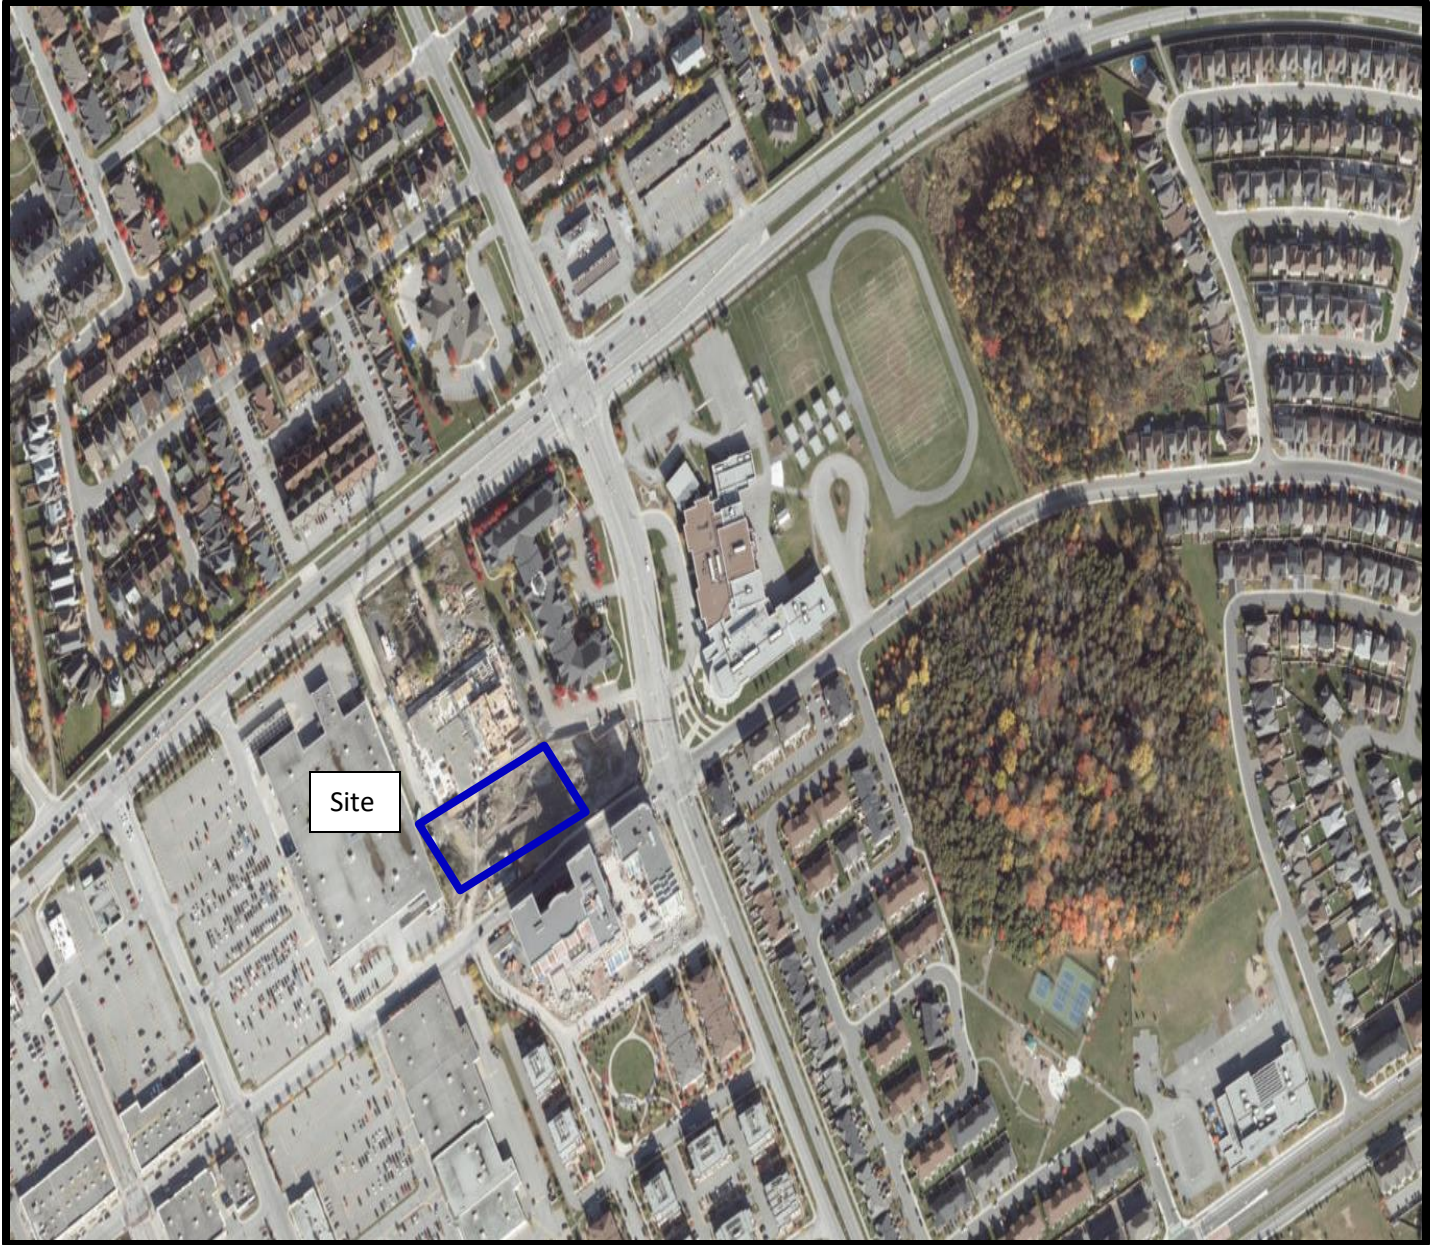
AERIAL PHOTOGRAPH  
2019

An aerial photograph from 2019, accessed via the City of Ottawa's online mapping tool, was reviewed as part of the current Phase I ESA Update. The storage garage has been demolished and vegetation has been stripped from the subject site. The properties immediately east, north and south of the subject site are under construction.

No environmental concerns with respect to the subject site were identified by the air photo review.
