January 26, 2010  
File: PG1887-LET.01R

Subject: **Slope Stability Analysis**  
**2175 Prince of Wales Drive**  
**Ottawa, Ontario**

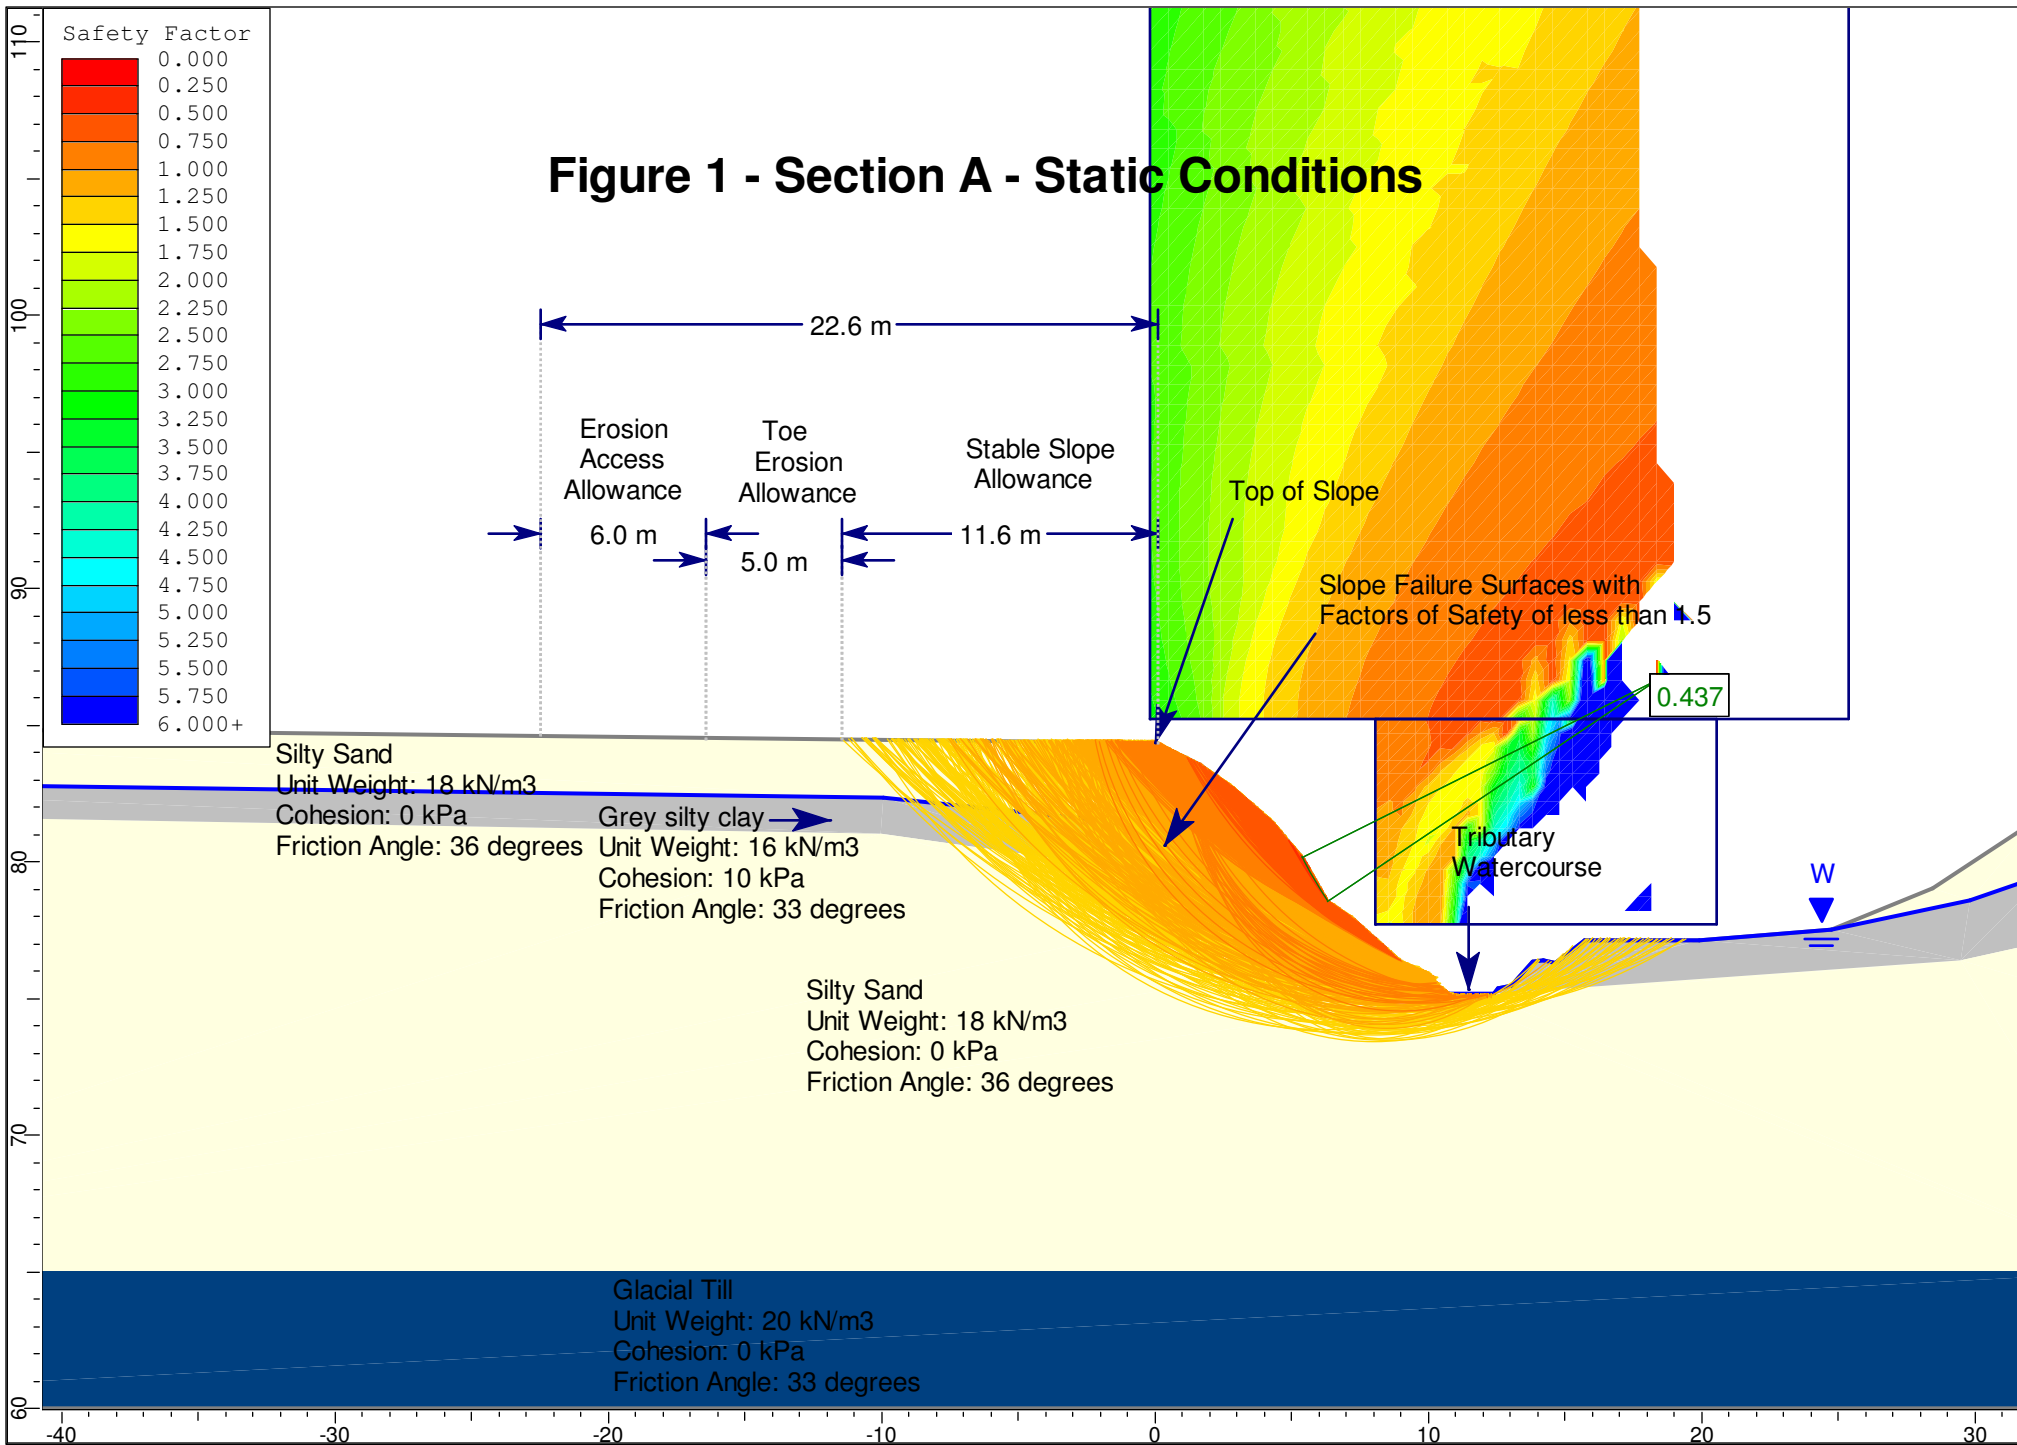
# Figure 1 - Section A - Static Conditions

The results for the existing slope conditions under static loading at Sections A and B are shown in Figures 1 and 3, respectively, attached to the present letter. The overall slope stability factors of safety for the subject sections were found to be less than 1.5. The stable slope allowance from top of slope required for a slope with a minimum factor of safety of 1.5 is identified for each profile in the attached figures.

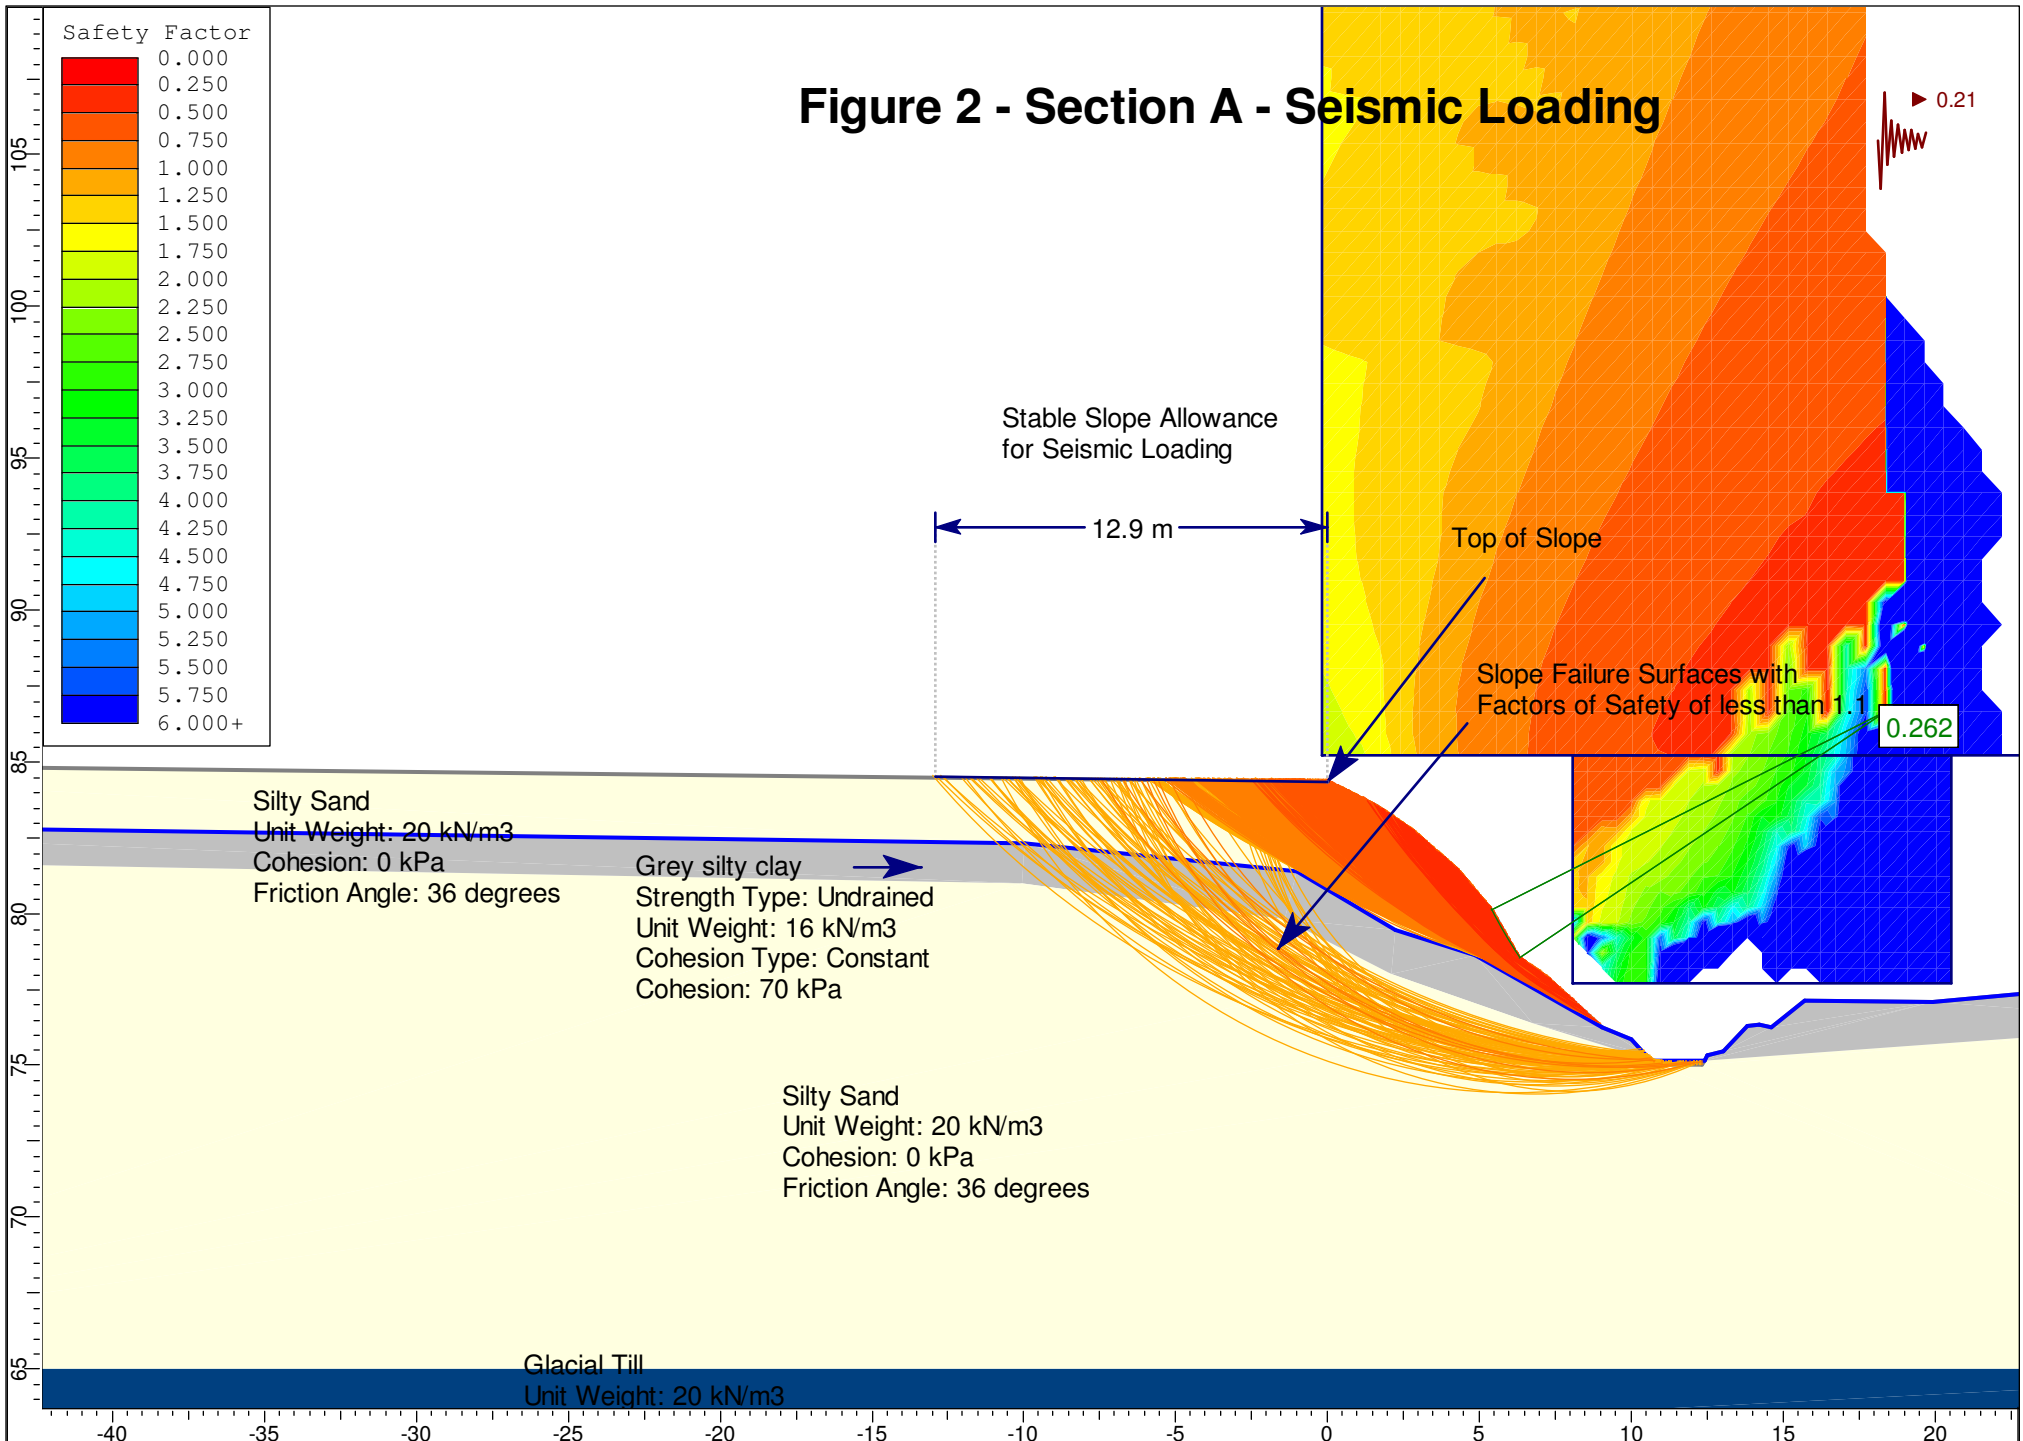
# Figure 2 - Section A - Seismic Loading

An analysis considering seismic loading was also completed. A horizontal seismic acceleration,  $K_h$ , of 0.1G was considered for the analyzed sections. A factor of safety of 1.1 is considered to be satisfactory for stability analyses including seismic loading.

The results of the analyses including seismic loading are shown in Figures 2 and 4 for the slope sections. Where the minimum factor of safety is less than 1.1, the stable slope allowance from top of slope required for the slope section is identified in the attached figures.

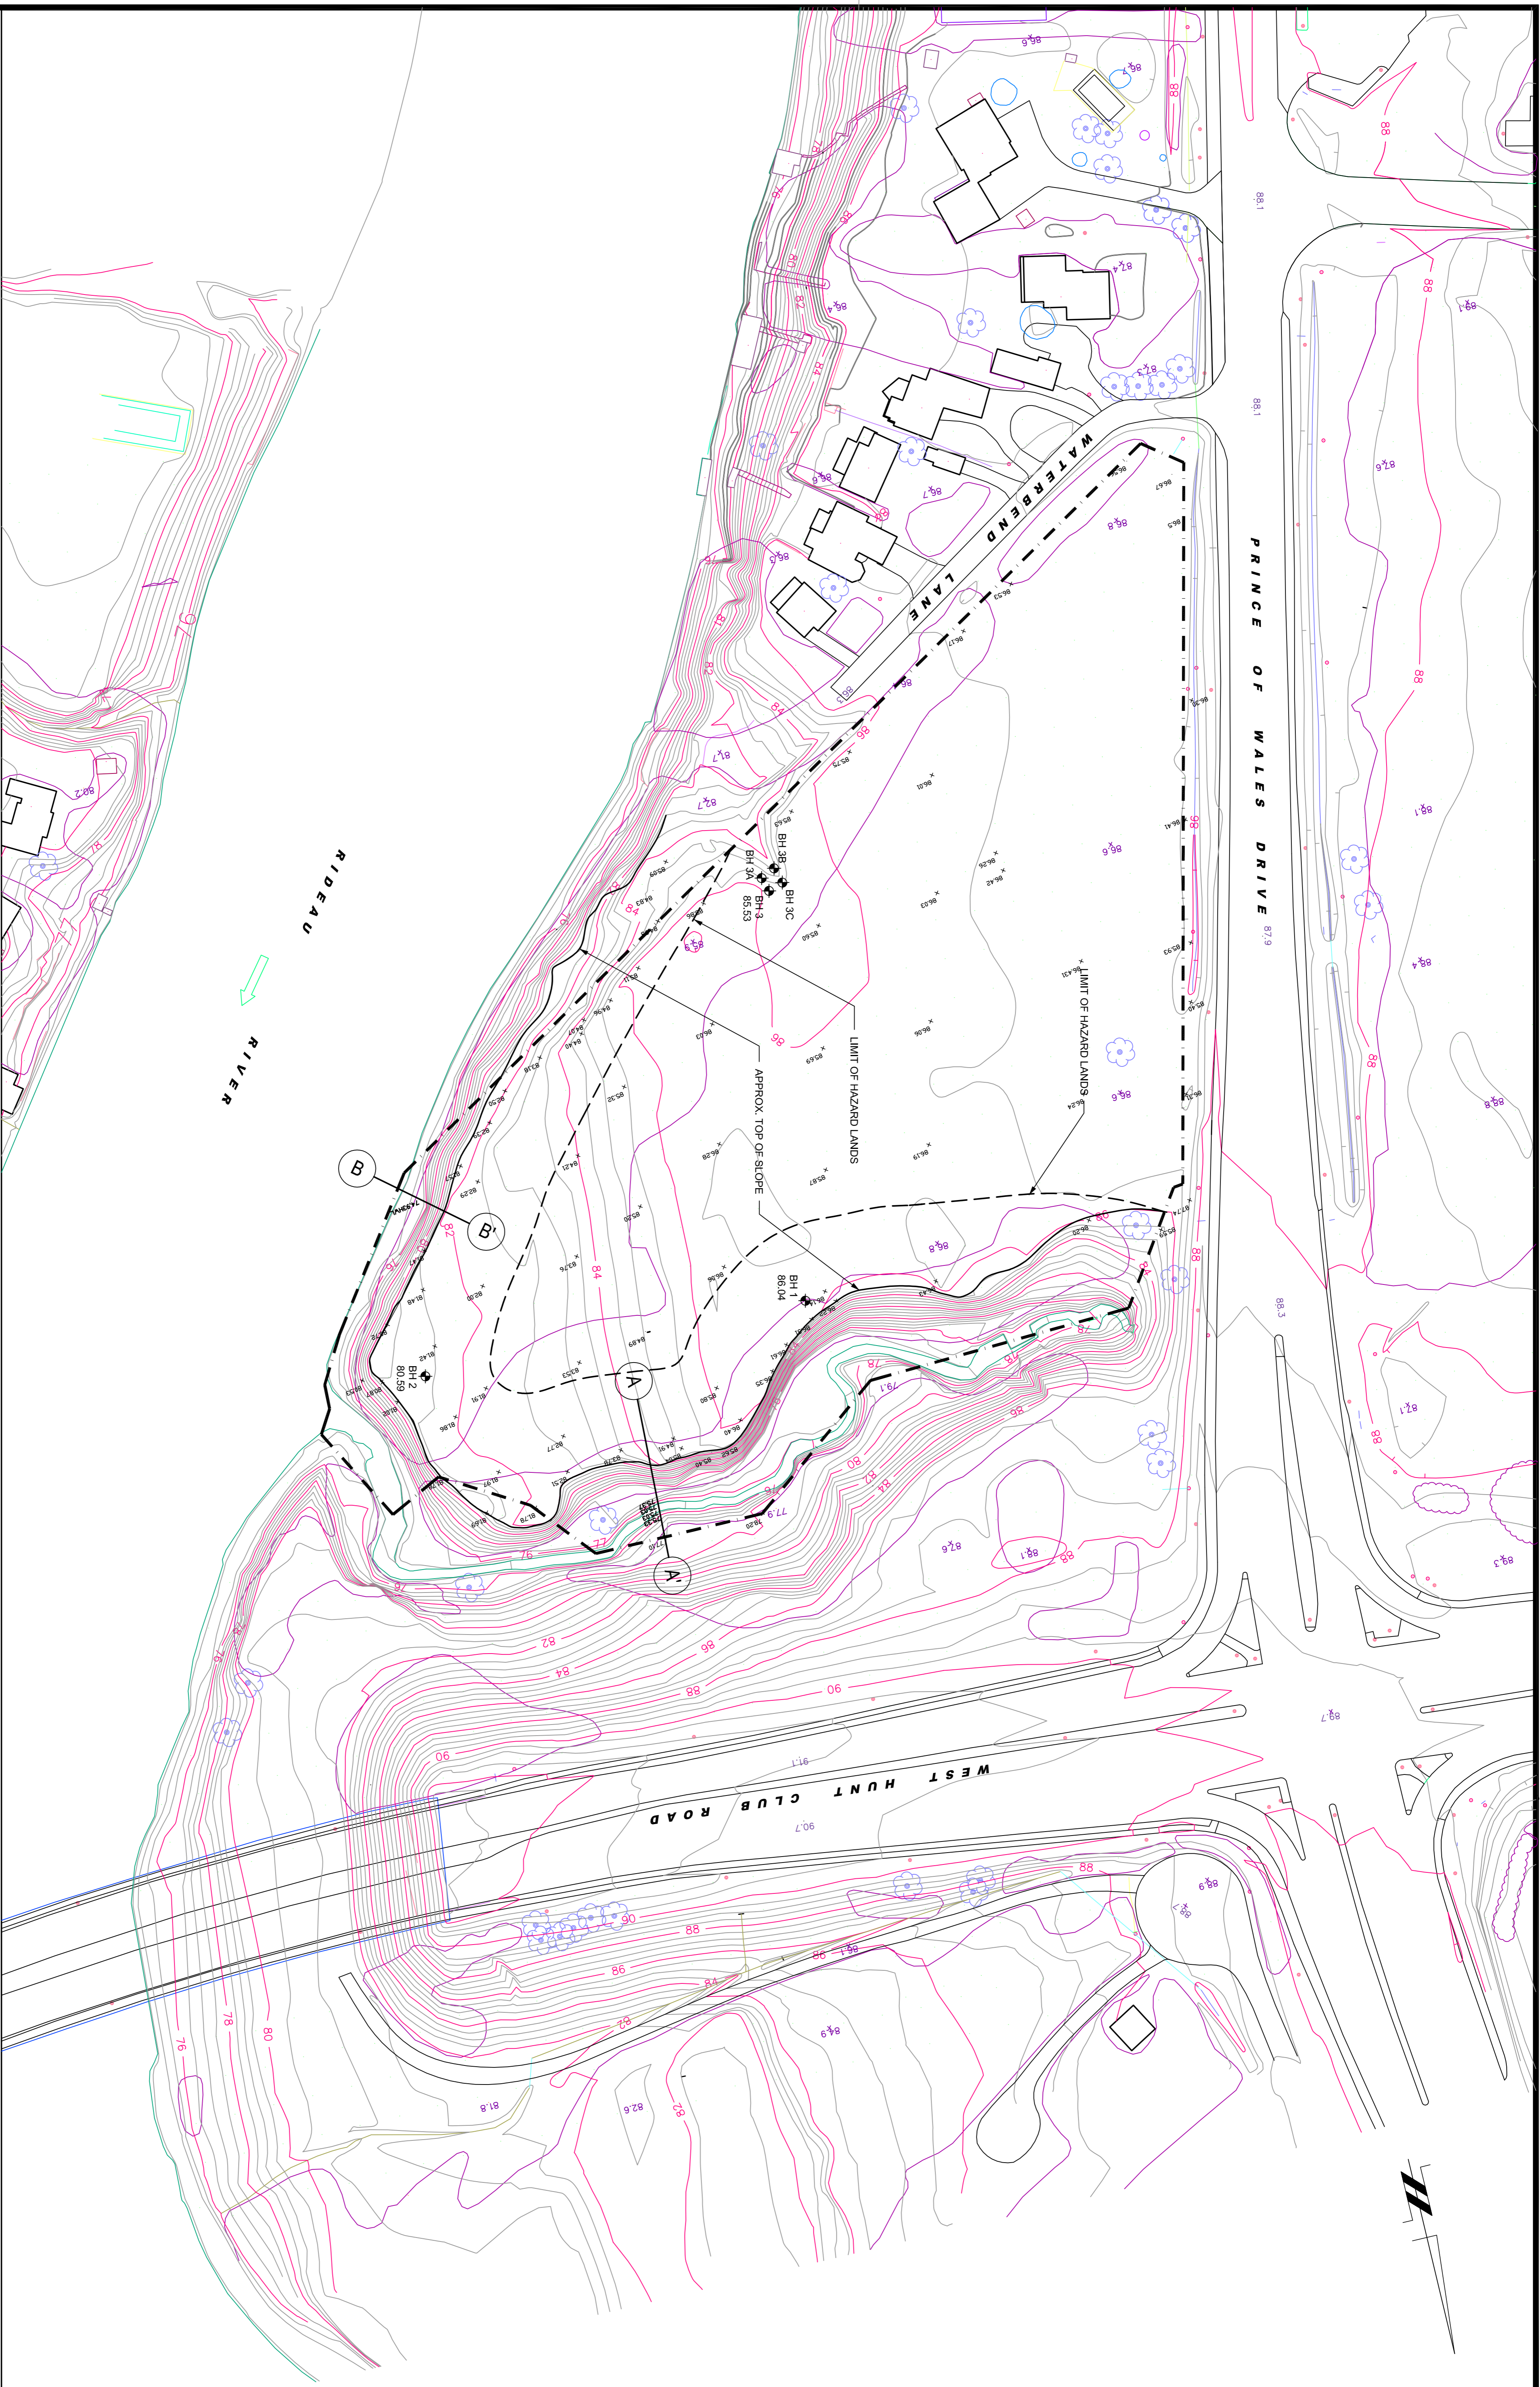
DWG. NO. PG1887-1

The limit of hazard lands includes a stable slope allowance taken from top of slope. The limit of hazard lands also includes a toe erosion and a 6 m erosion access allowance. The various allowances and the overall limit of hazard lands for the subject site are indicated on Drawing PG1887-1 - Site plan attached to the present letter.

The toe erosion allowance for the slopes was based on the nature of the soils, the observed current erosional activities and the width and location of the current watercourse. Signs of erosion were noted in areas where the existing watercourse has meandered in close proximity to the toe of the corridor wall of the north neighbouring tributary watercourse. It is considered that a toe erosion allowance of 5 m is appropriate for the tributary watercourse.

Some erosional activities were noted along the toe of the subject valley corridor wall for the Rideau River. It is considered that a toe erosion allowance of 8 m is appropriate for the subject slope along the Rideau River.
