June 1, 2017
File: PG1887-LET.02 Revision 1

Subject: **Addendum to Slope Stability Analysis**
2175 Prince of Wales Drive
Ottawa, Ontario

1.0 Current Slope Conditions Review

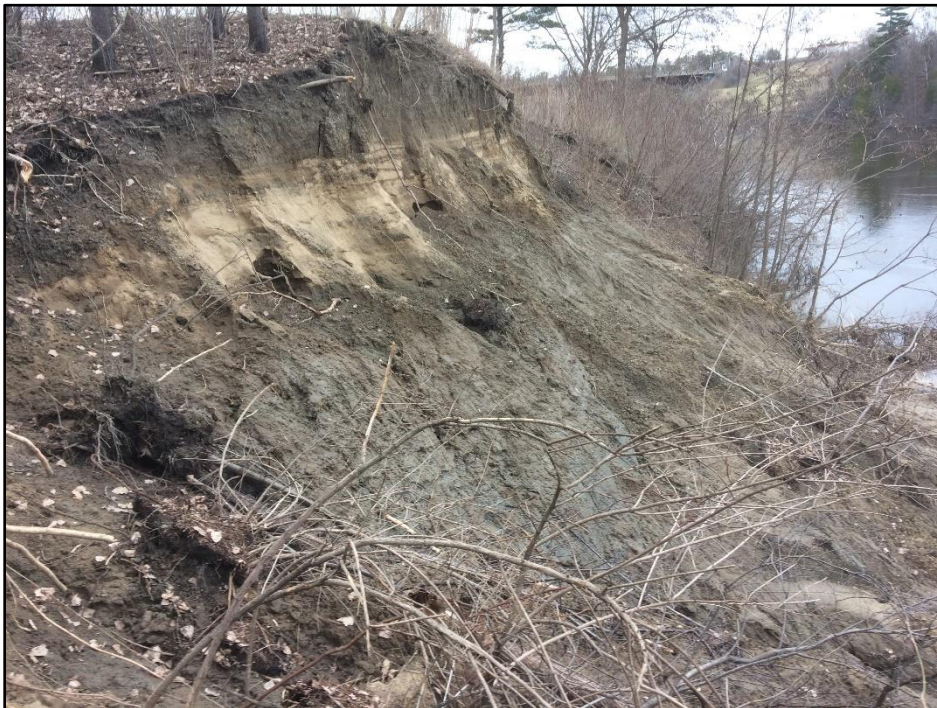
The observed slope failure which is located along the slope face within the City easement, which abuts the Rideau River to the southwest of the subject site. The approximate failure area is presented in Drawing PG1887-2 - Site Plan attached. General details for a remedial slope repair program are presented below.

Photo 2: Existing slope conditions along slope located to the southwest of the subject site. Recent slip failure has occurred and left steep backscarp.

- A legal surveyor should provide topographic information along current top of slope and along toe of the failure area, where access is possible.
- Failed slope material should be removed and a remedial slope program should be designed by a geotechnical consultant to re-establish the original top of slope along the impacted area and provide a stable slope.
- The slope toe should be protected against further toe erosion activities.

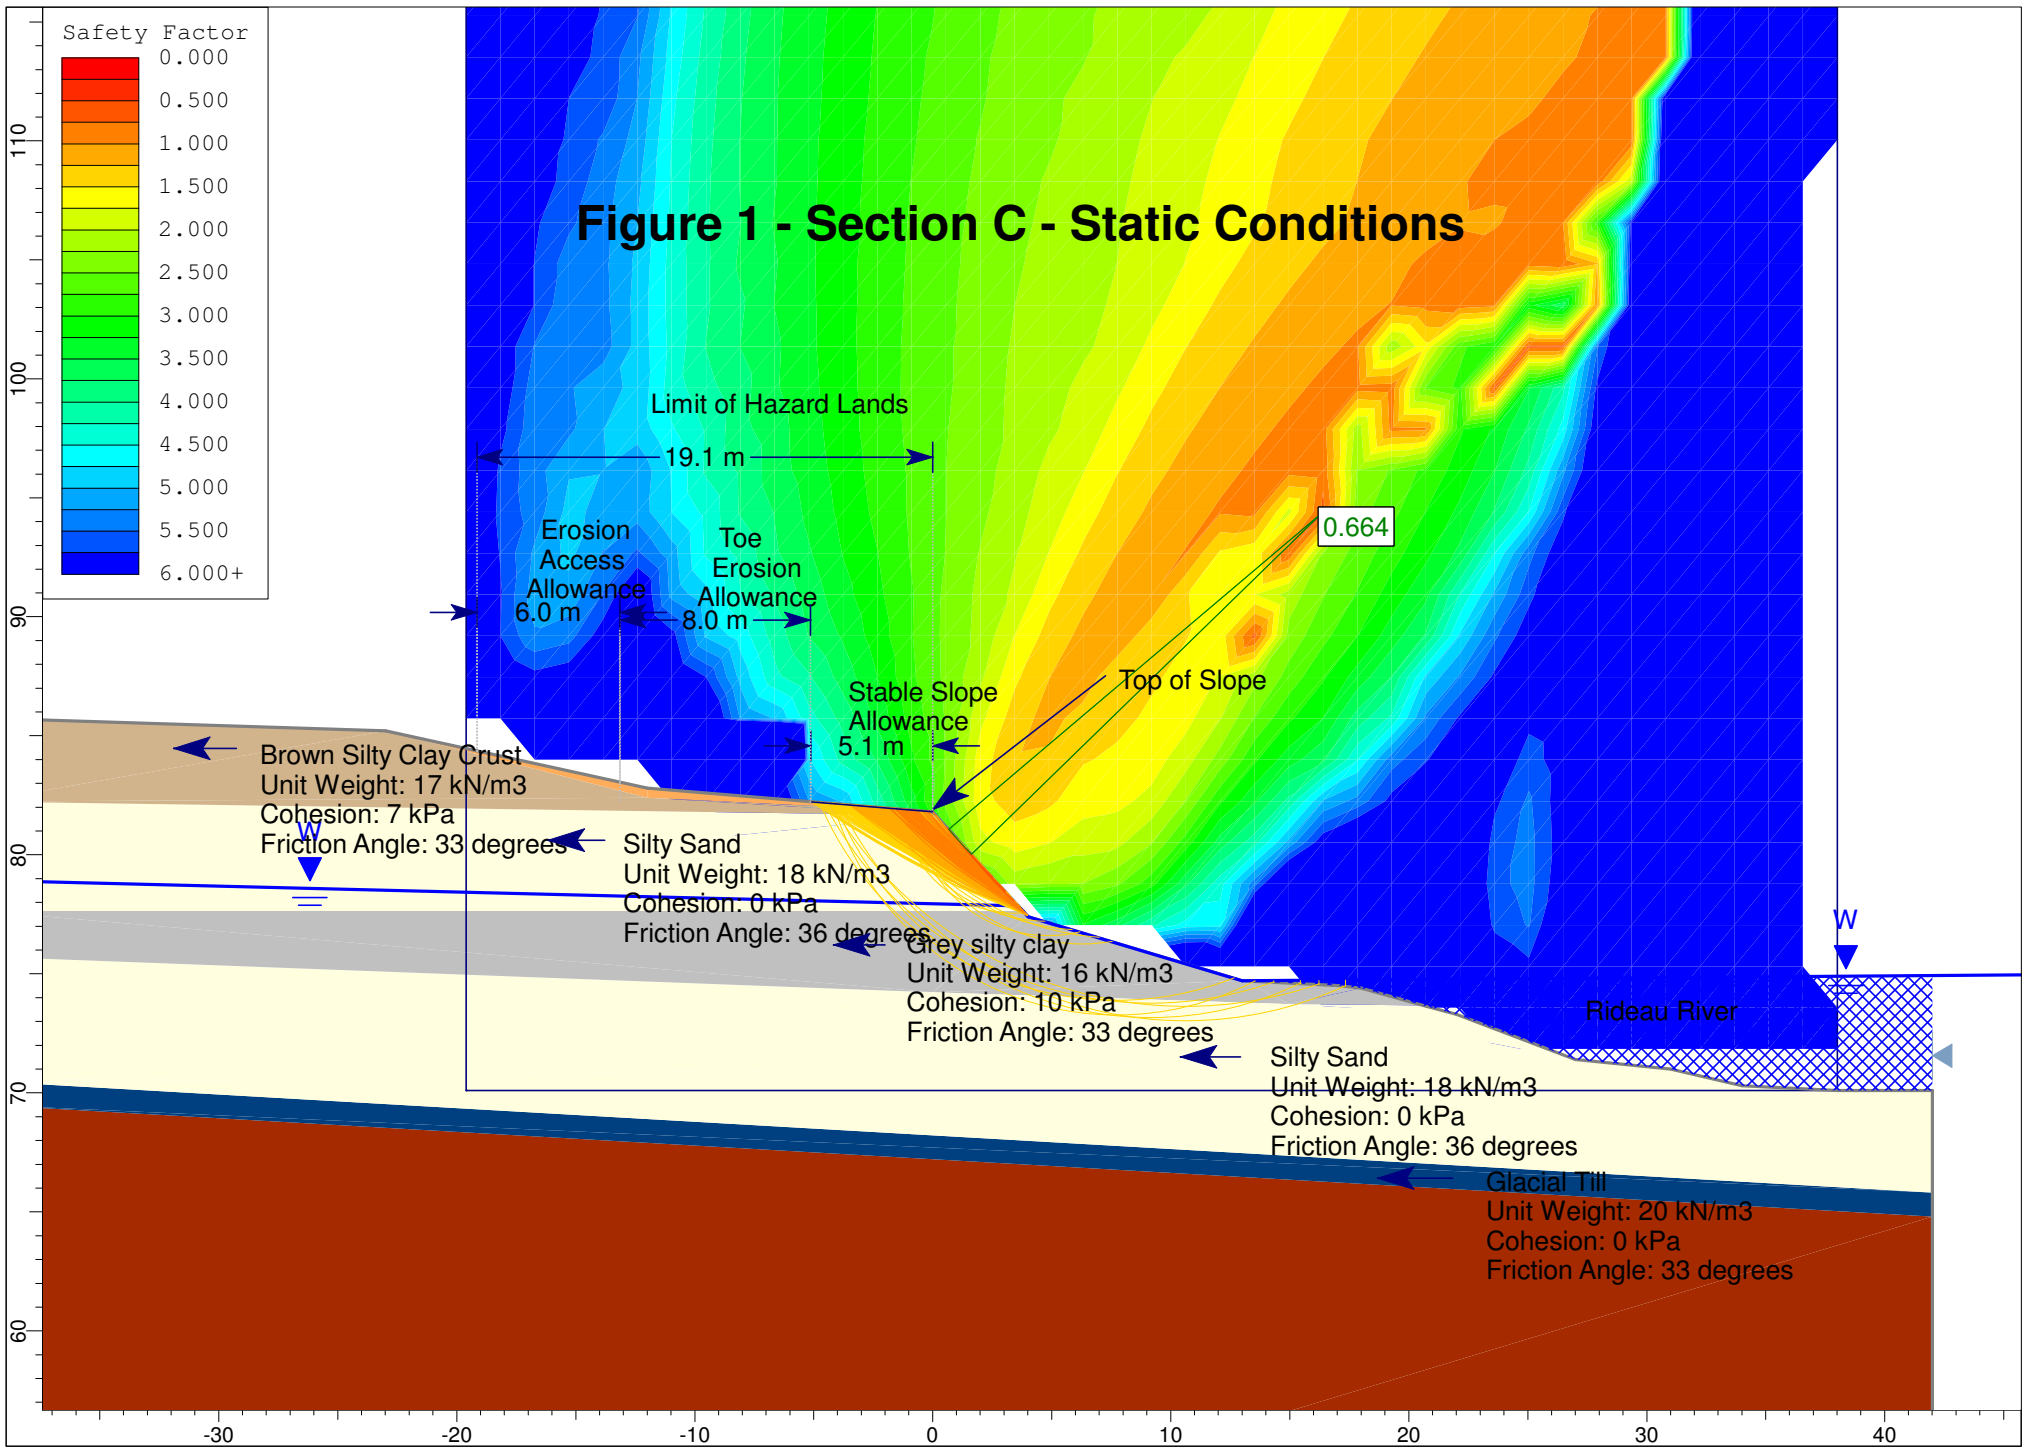
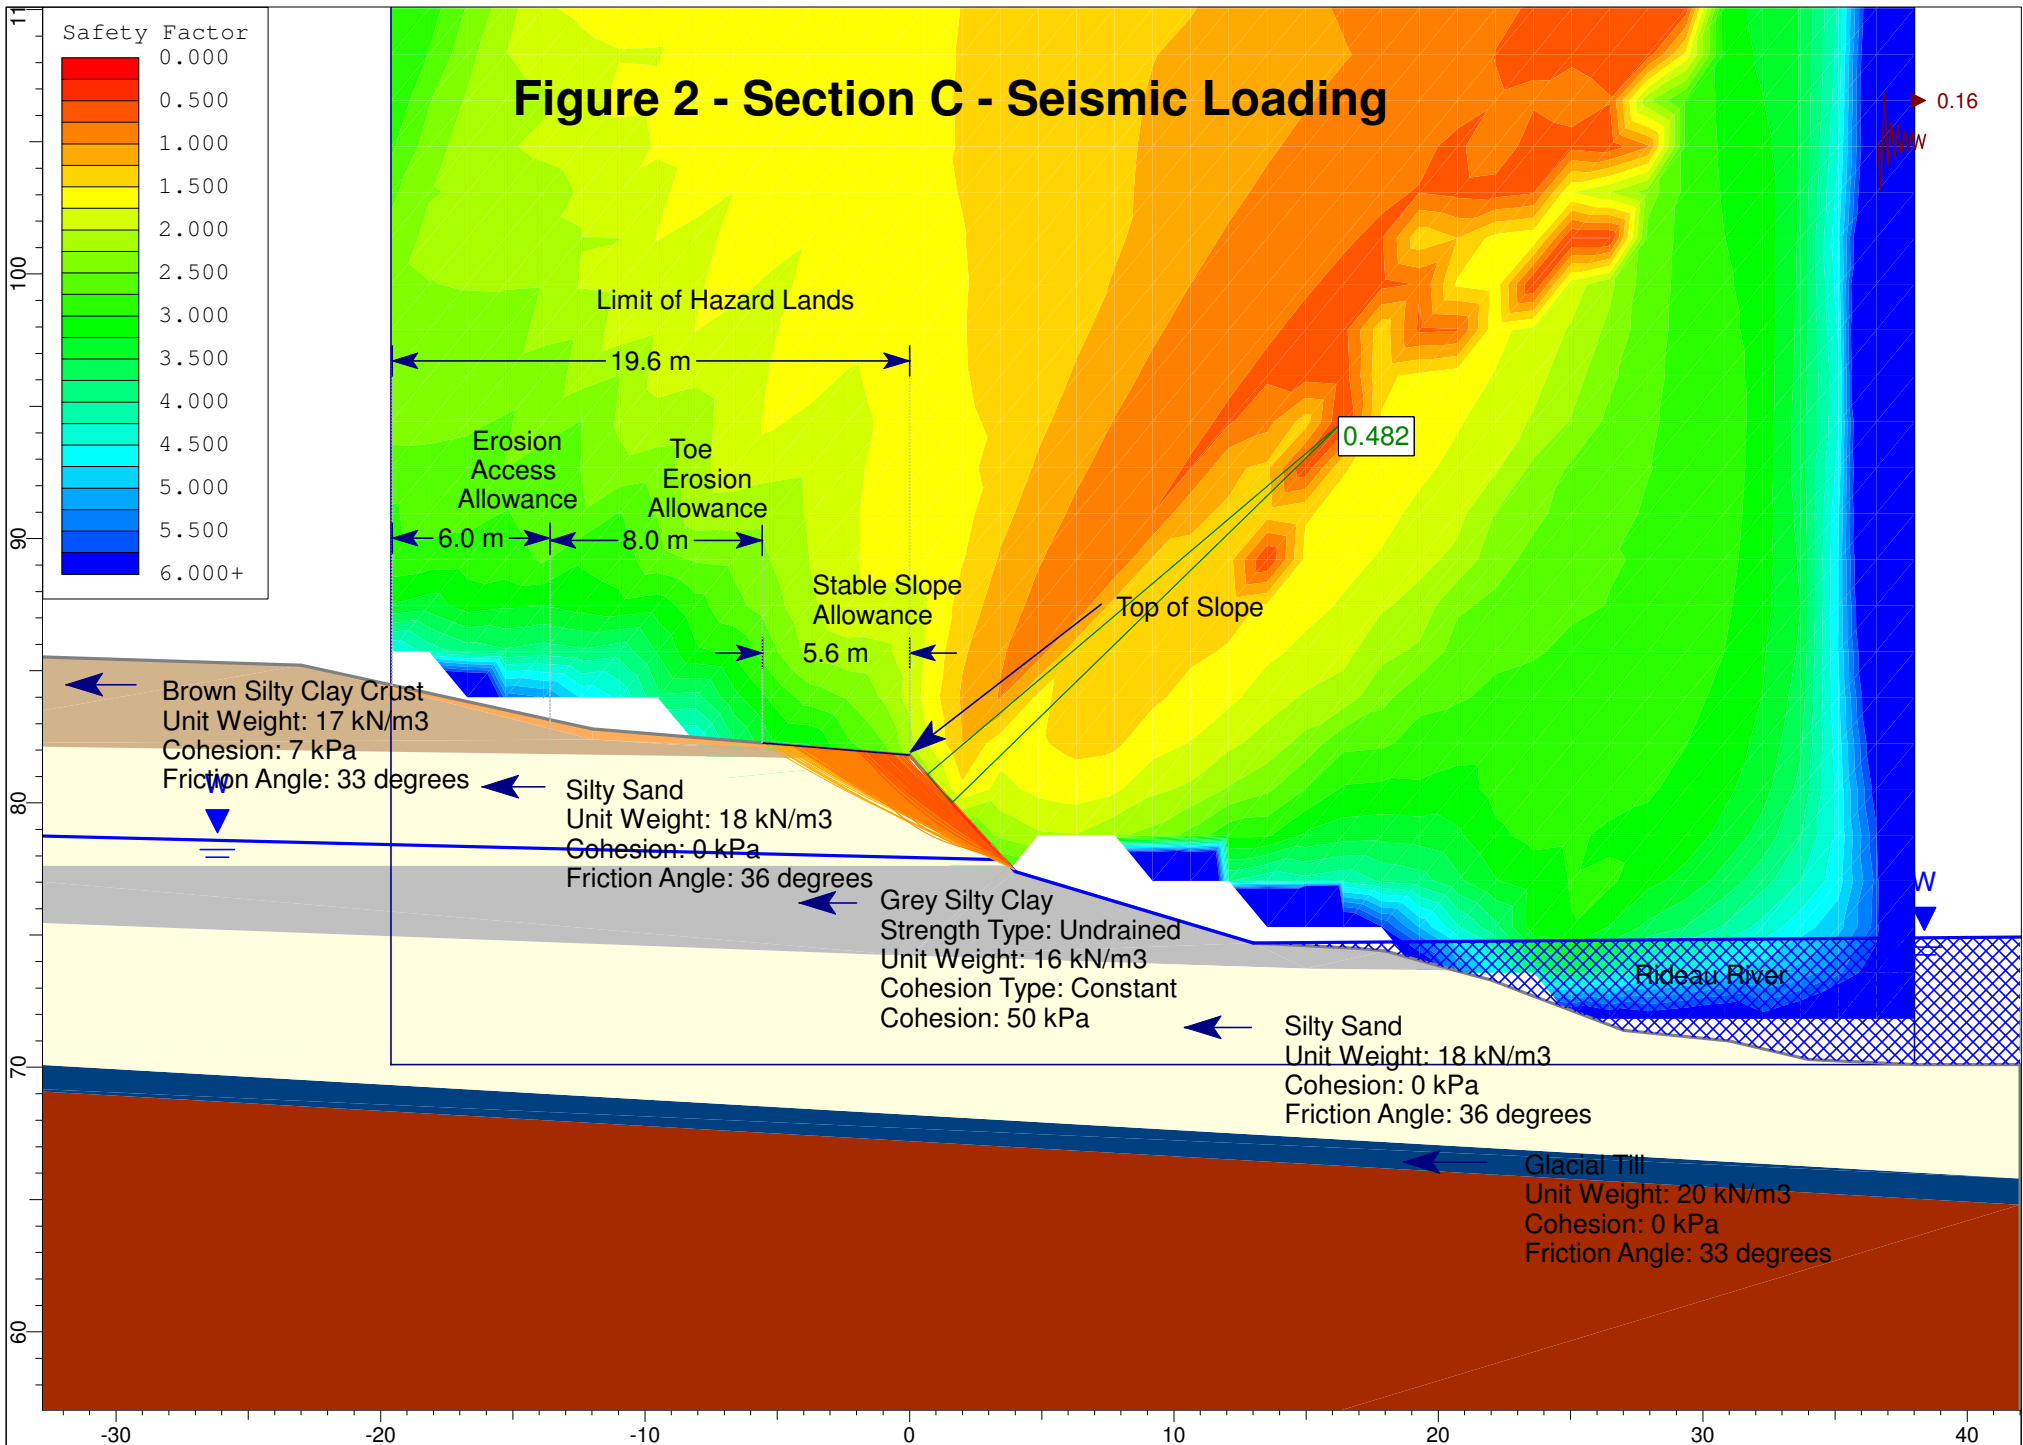
Figure 1 - Section C - Static Conditions

Based on our analysis, a setback from the top of the existing slope (stable slope allowance) is required in the area of the observed slope failure. However, the stable slope allowance recommended at Section C is still in compliance with our previous stable slope allowance for the area. The results of our analysis are presented in Figures 1 and 2 attached. **It should be noted that the limit of hazard lands line established by Paterson in 2010 does not have to be altered due to the slope failure observed in the City of Ottawa Right-of-Way. It should be further noted that our slope stability analysis and limit of hazard lands designation presented in our 2010 report adequately represent the current slope conditions for the subject site based on our analysis and site review.**

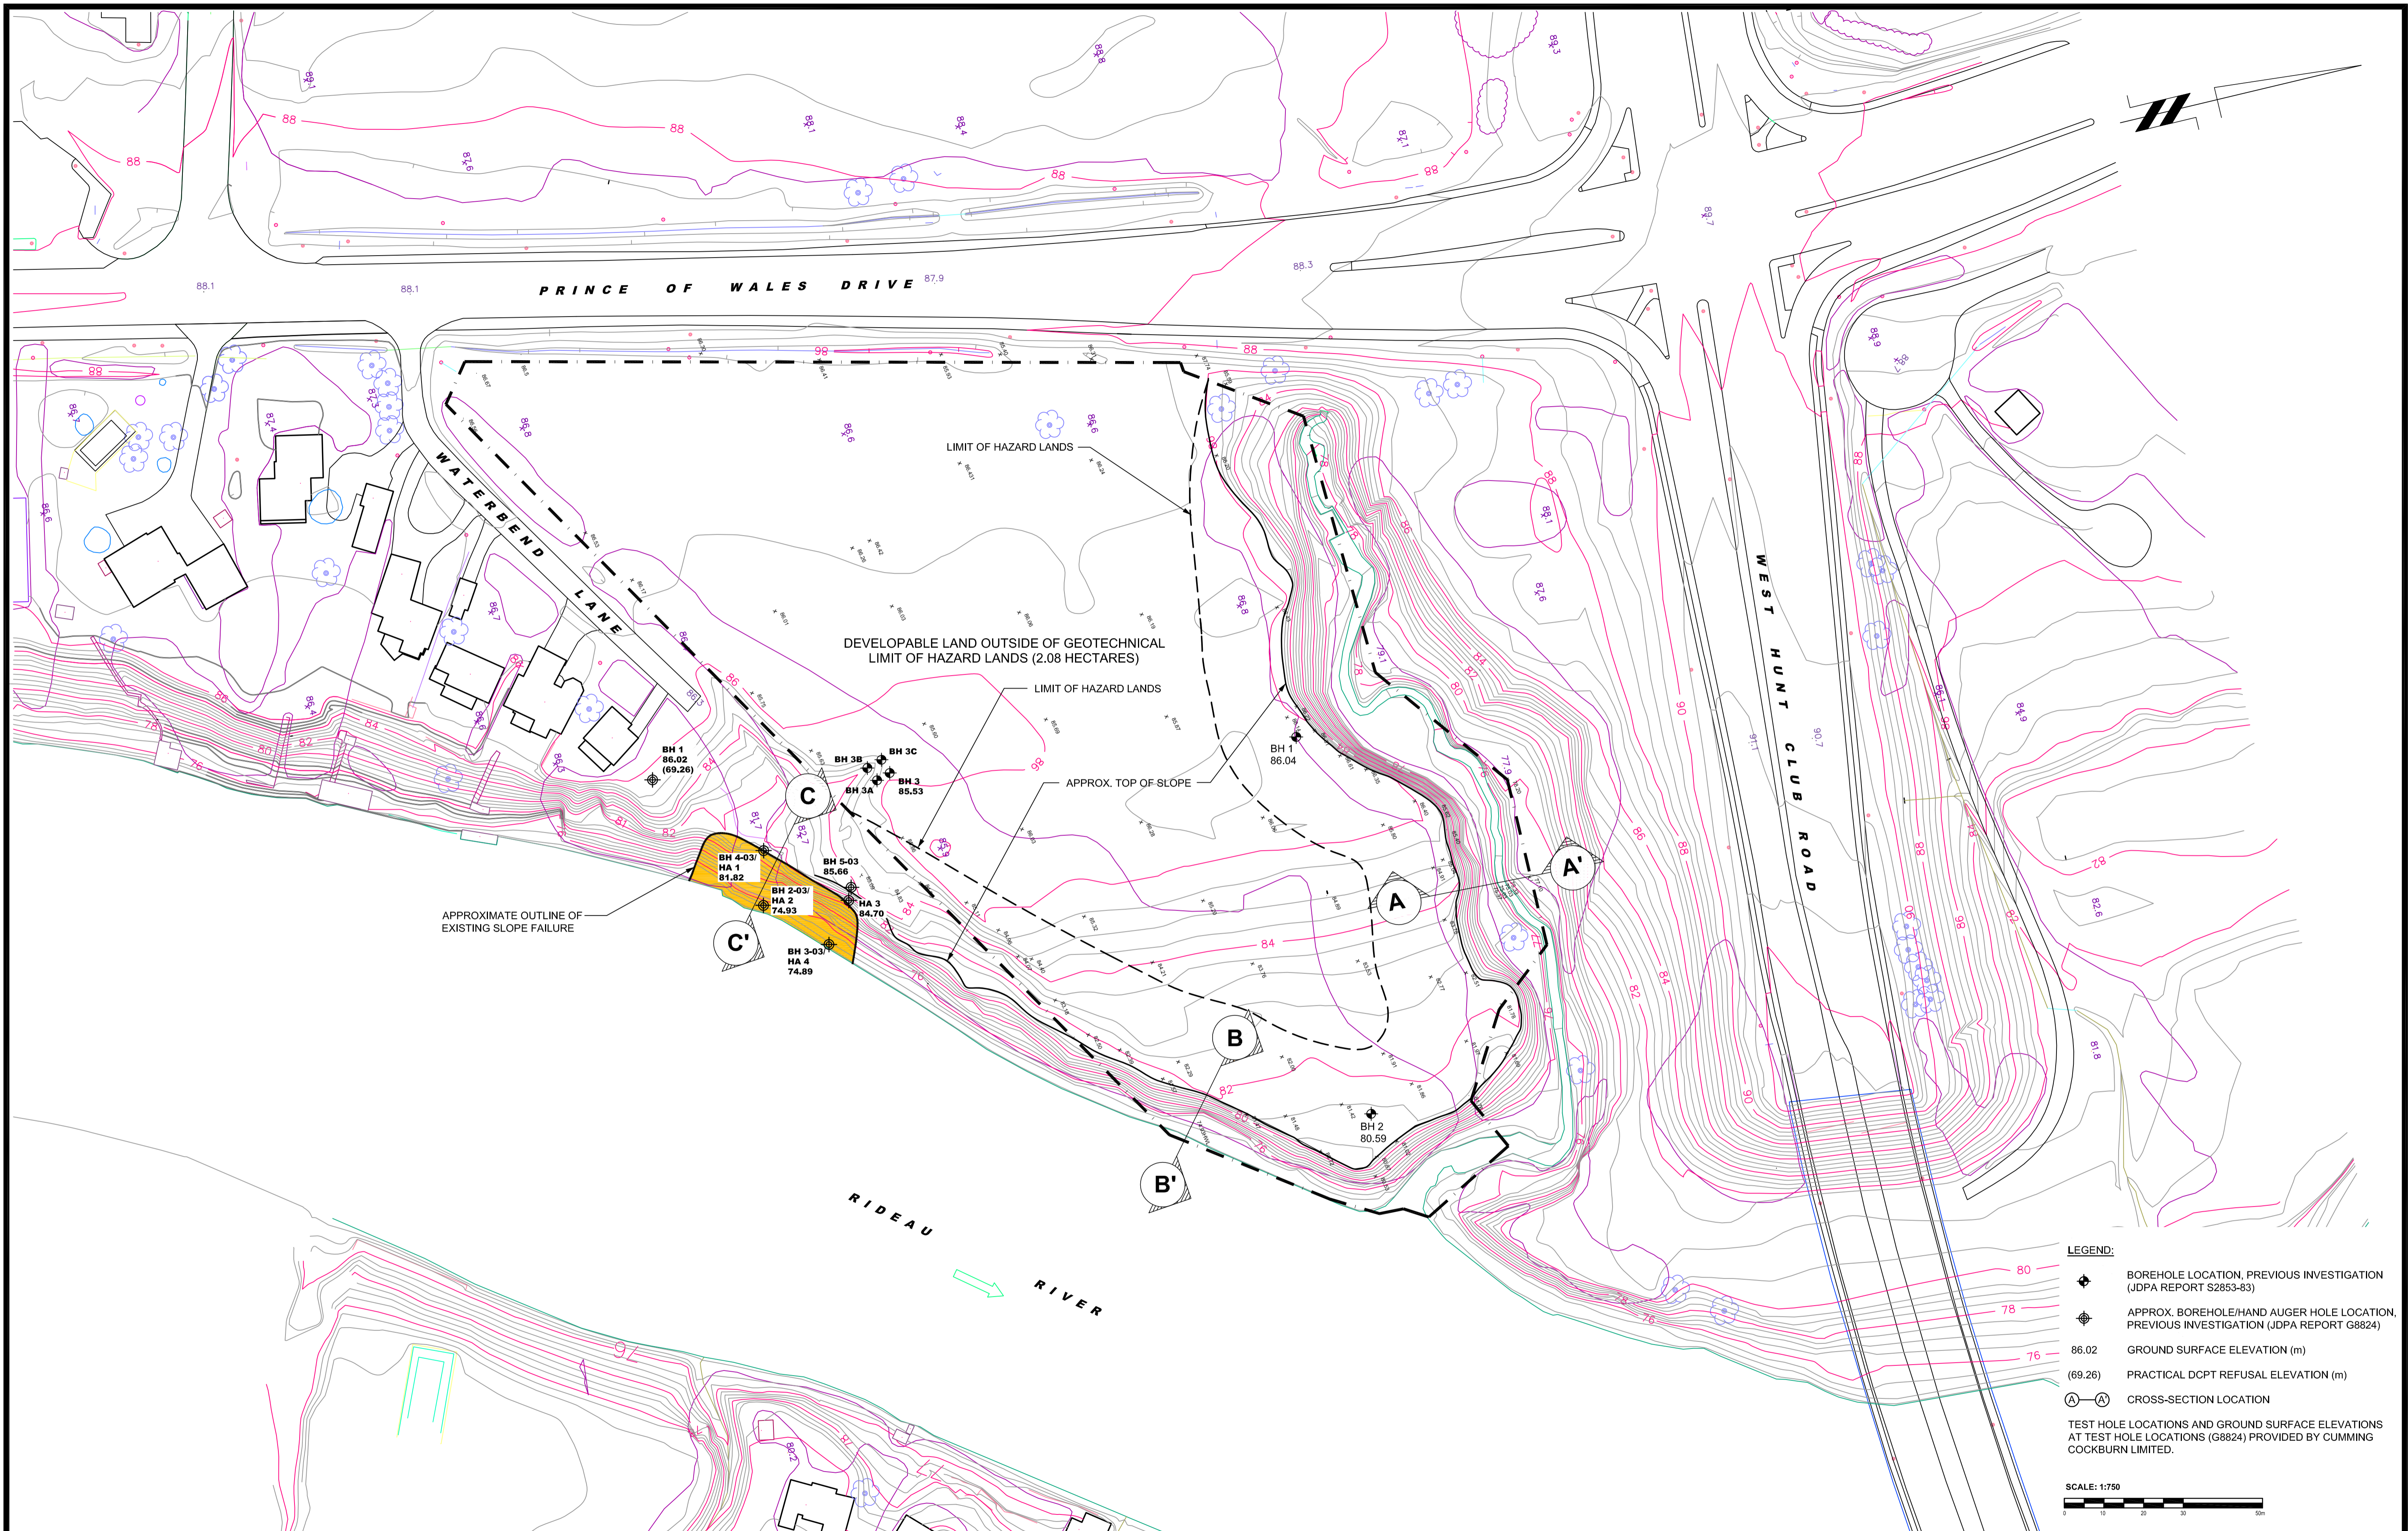
SITE PLAN

The riverbank and valley corridor wall along the Rideau River adjacent to the subject site is relatively unchanged since our original review in 2010. A recent large slope failure within the City of Ottawa Right-of-Way was noted along the Rideau River to the southwest of the subject site. A slope stability section based on our cursory review of the existing slope conditions was analyzed by Paterson (Section C). The cross-section location is presented in Drawing PG1887-2 - Site Plan attached.
