**KIZELL DRAIN EROSION ASSESSMENT**  
PROPOSED REDEVELOPMENT OF KANATA GOLF & COUNTRY CLUB  
7000 CAMPEAU DRIVE, OTTAWA

Prepared for:  
**MINTO COMMUNITIES – CANADA**  
on behalf of **CLUBLINK CORPORATION ULC**

Prepared by:  
**MATRIX SOLUTIONS INC.**

Version 1.0  
August 2019  
Ottawa, Ontario

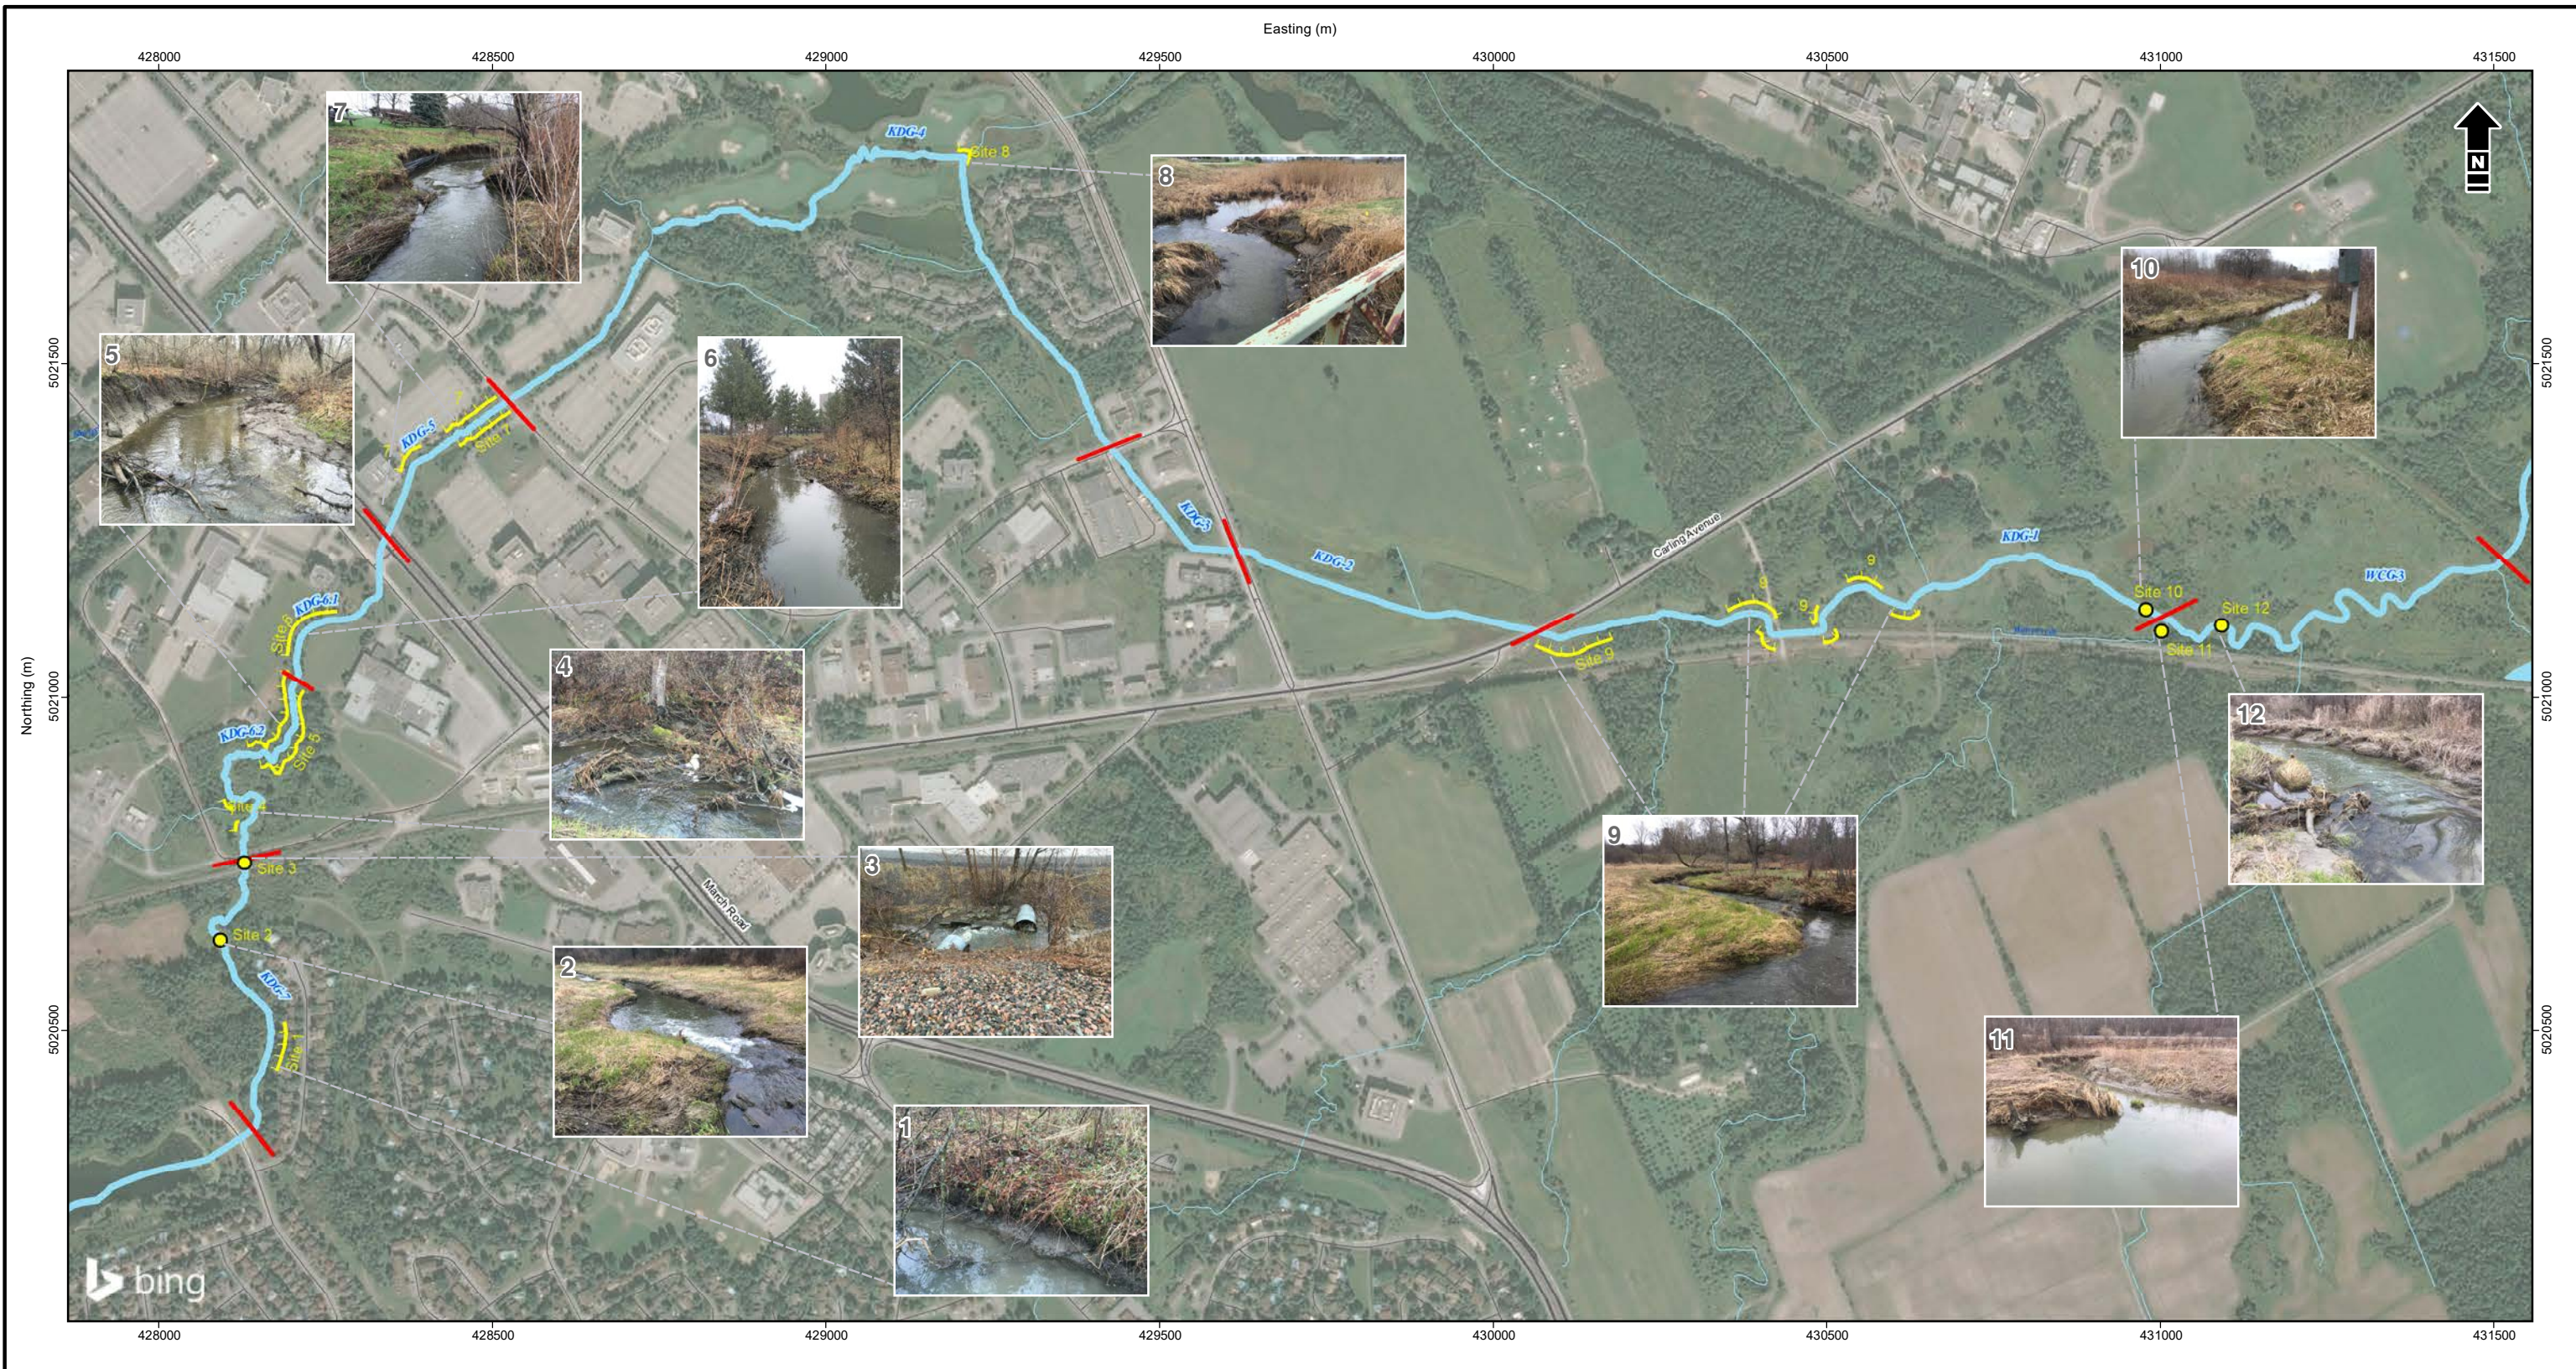
### Erosion Inventory Overview

| Site | Erosion Characteristics |
|---|---|
| 1 | Minor Toe Erosion |
| 2 | Scour Pool Downstream of Cascade |
| 3 | Poor Culvert Alignment |
| 4 | Valley Toe Erosion |
| 5 | Erosion Through Wooded Area |
| 6 | Minor Toe Erosion and Slumping |
| 7 | Bank Erosion/Failures |
| 8 | Erosion at 90 degree Bend |
| 9 | Erosion at Bends |

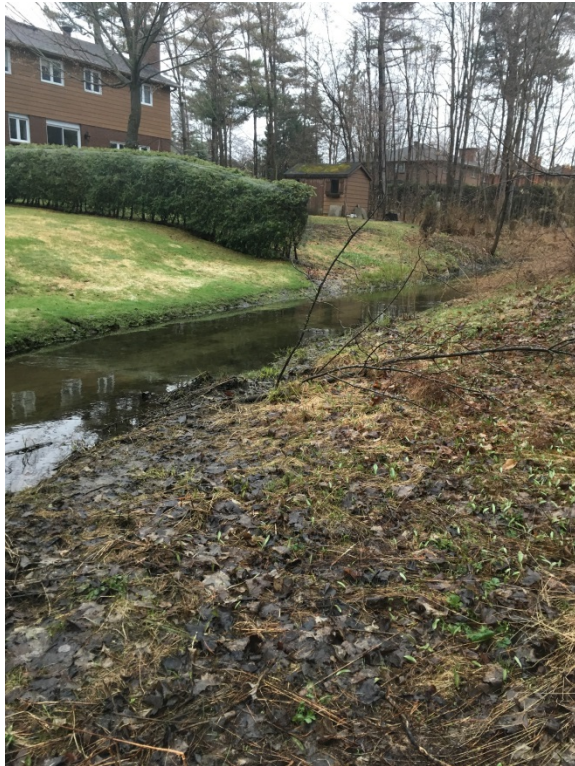
1. KDG-7 between outlet from pond and crest of cascade looking upstream.

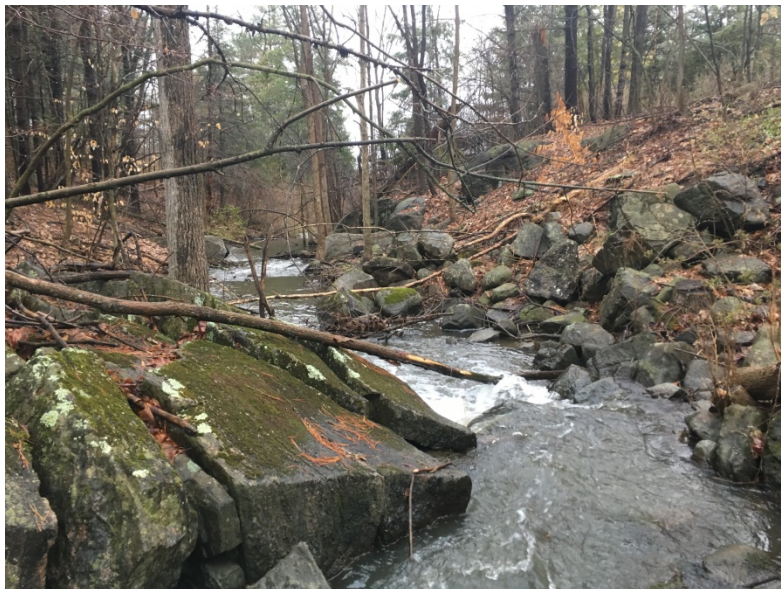
2. KDG-7 bedrock/large boulder cascade looking downstream.

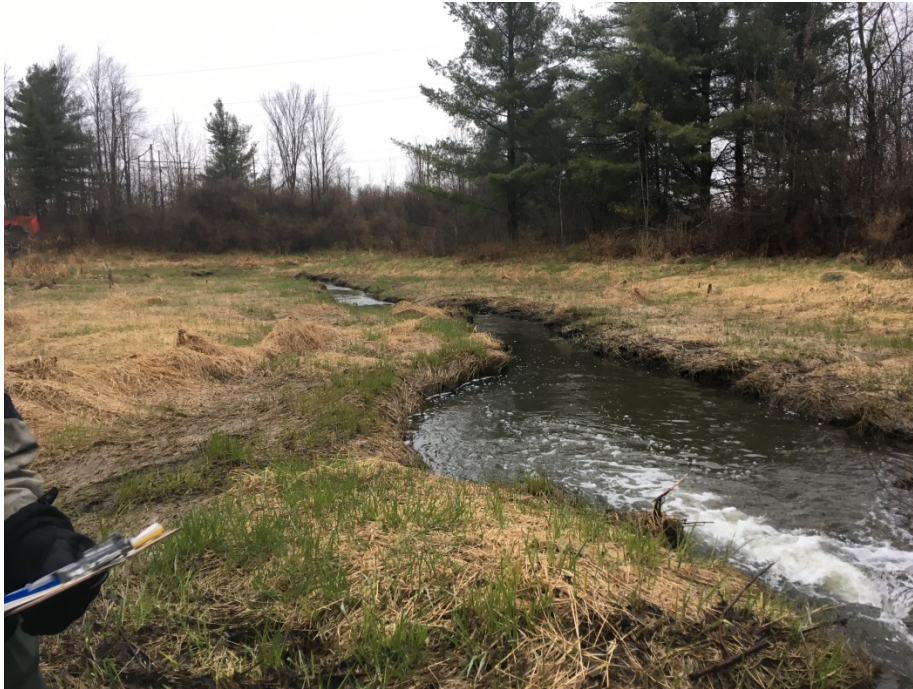
3. KDG-7 downstream of cascade looking downstream toward area under construction (left/west).

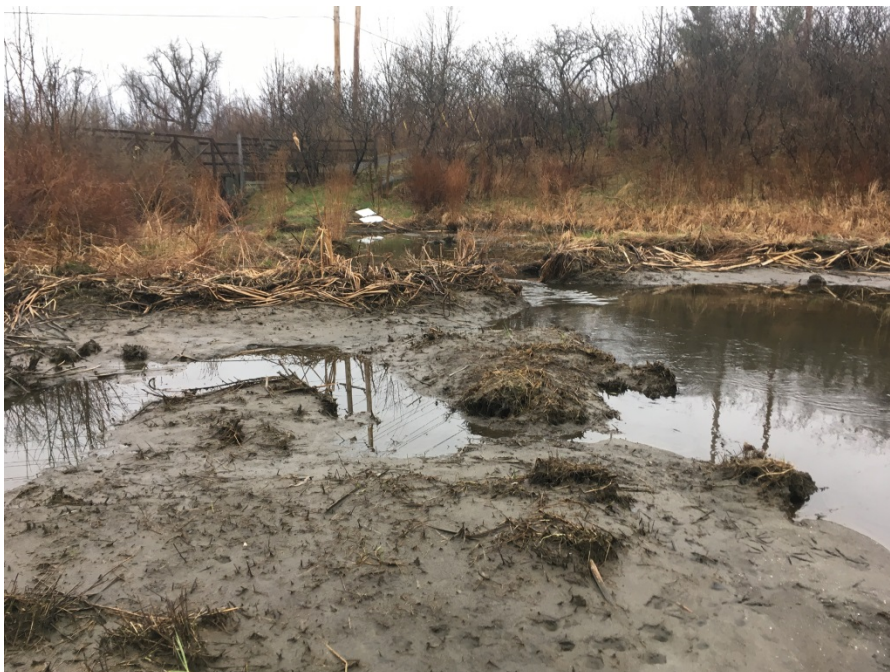
4. KDG-7, downstream extent where exposed bedrock and breached beaver dam have created a depositional area.

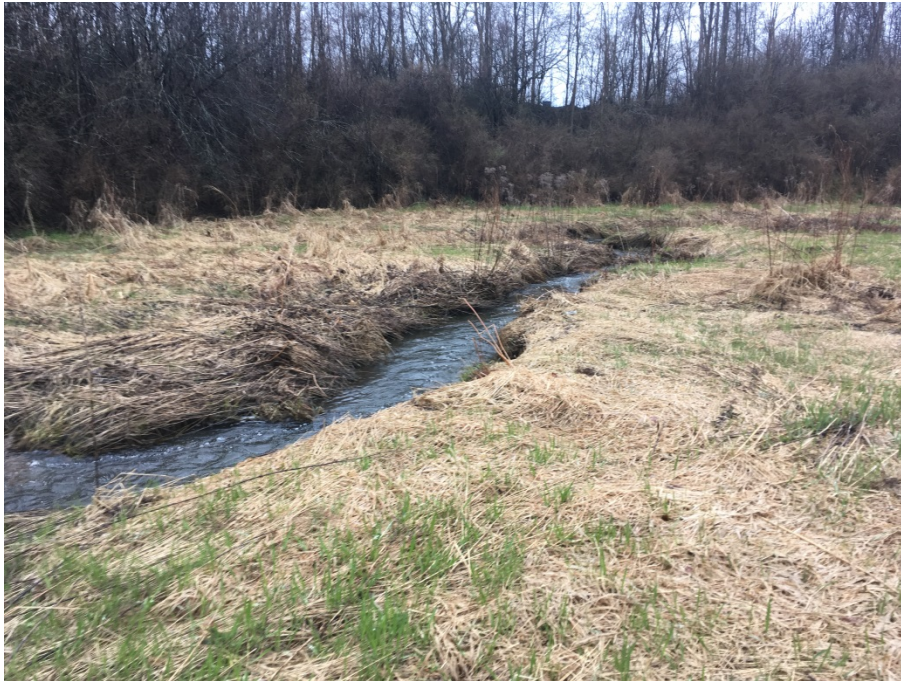
5. KDG-6.2, part of detailed survey location upstream of thicket looking downstream.

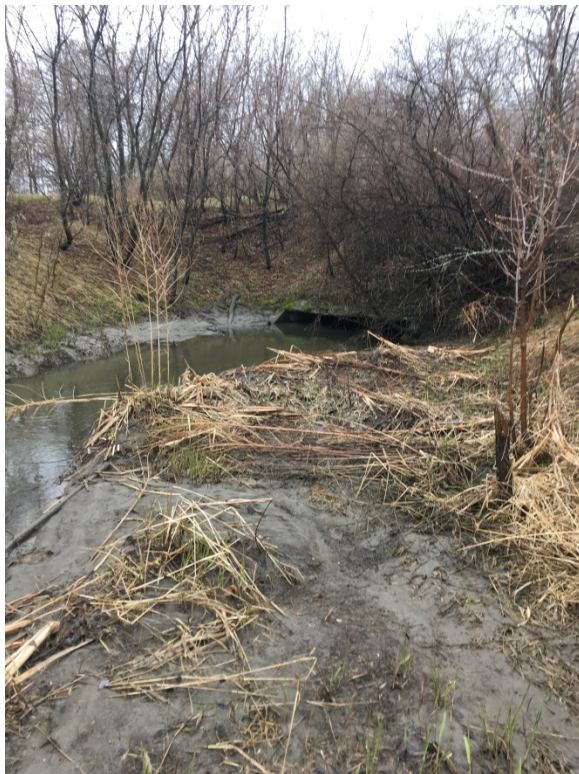
6. KDG-6.2/6.1 reach break at location of culvert.

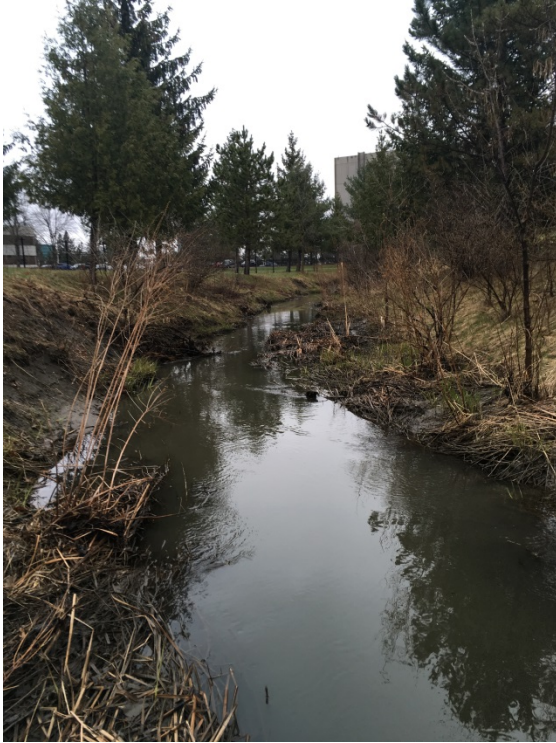
7. KDG-6.1, typical section looking downstream from reach break with KDG-6.2.

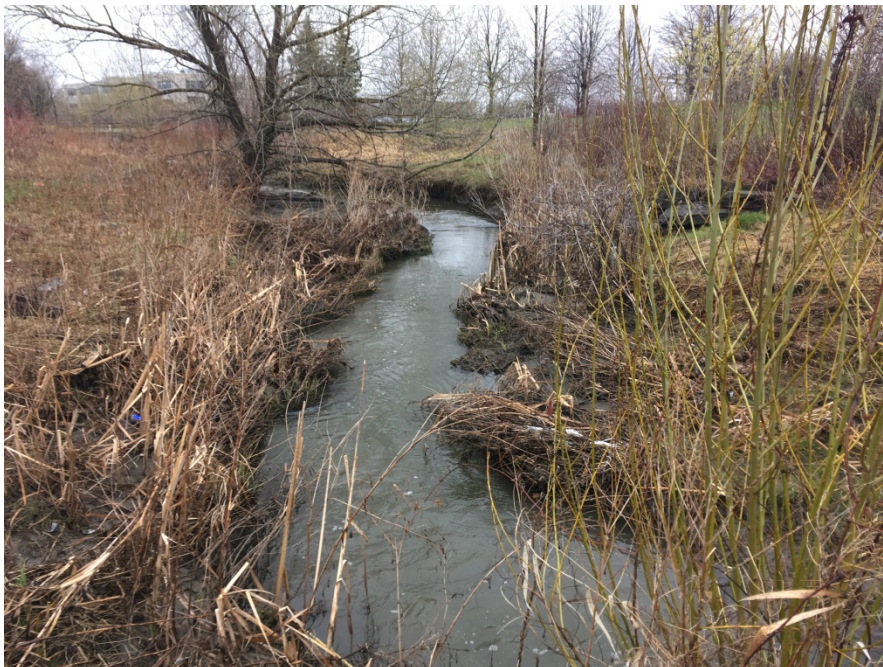
8. KDG-5 typical section looking downstream.

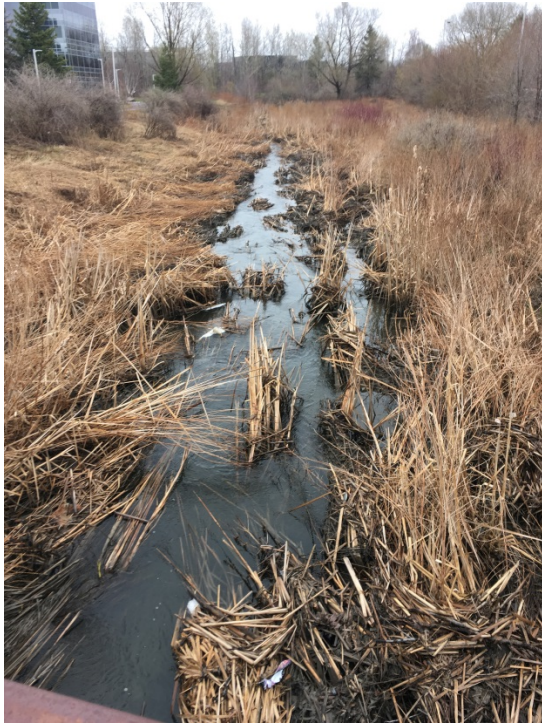
9. KDG-4 upstream of golf course looking downstream from pedestrian crossing.

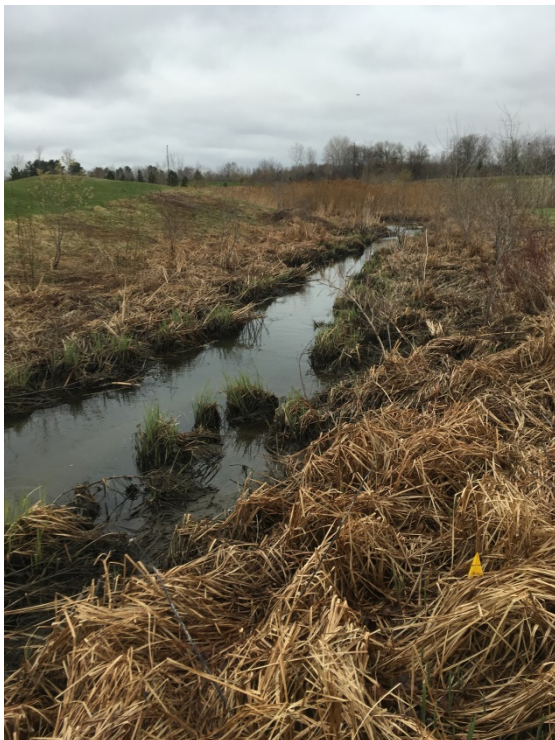
10. KSF-4 typical section.

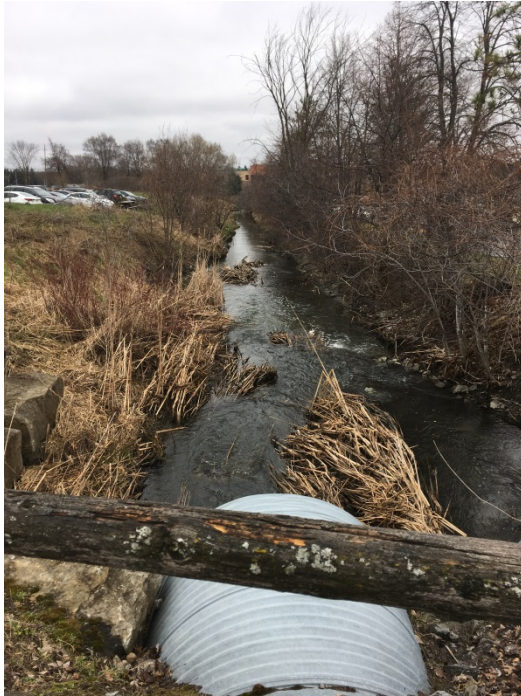
11. KDG-3, looking downstream from Legget Drive.

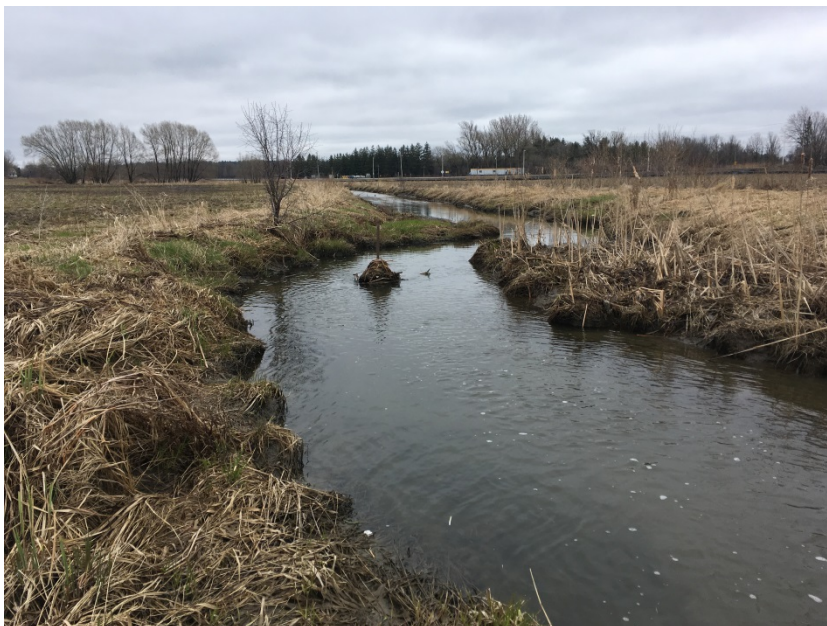
12. KDG-2 looking downstream from culvert at Herzberg Road.

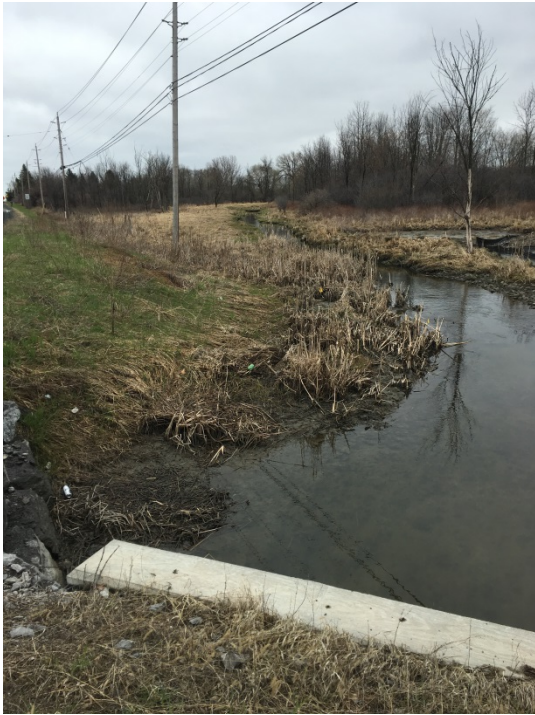
13. KDG-1 looking downstream from Carling Avenue.

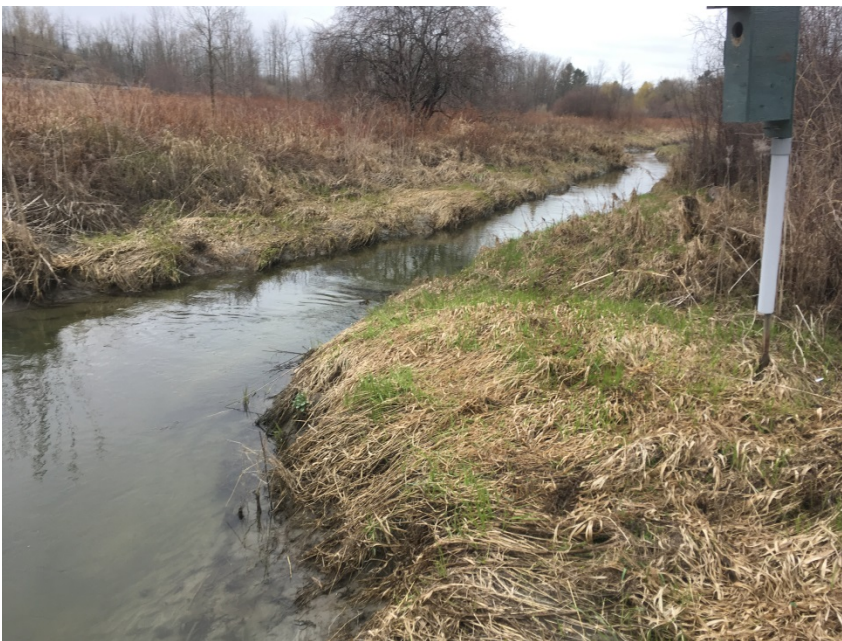
14. KDG-1 looking upstream of confluence with Watts Creek.

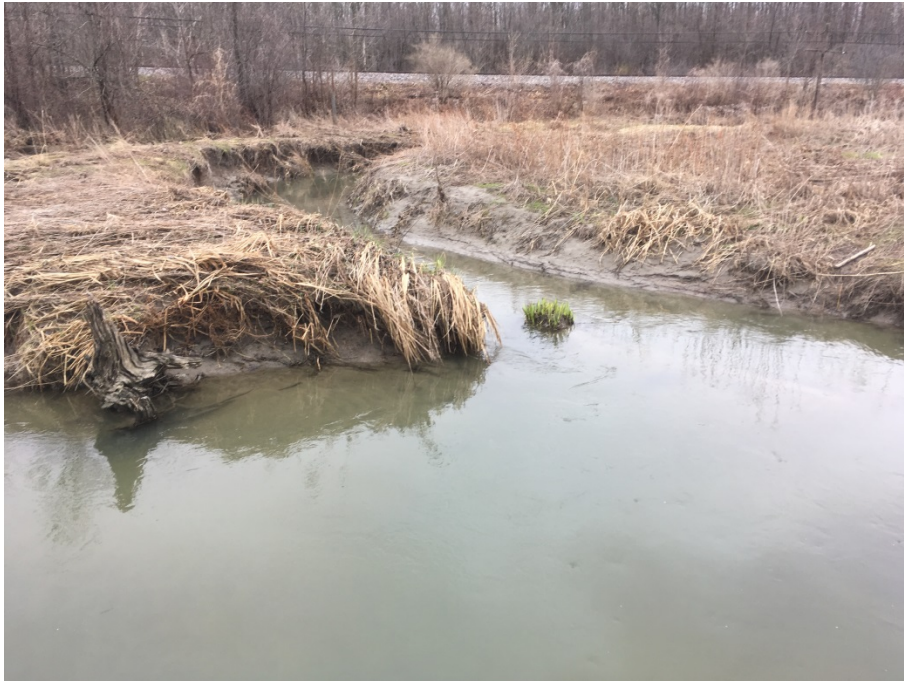
Watts Creek upstream and downstream of the confluence with the Kizell Drain is dominated by widening and degradation processes, including channel incision into undisturbed overburden, basal scour on the inside of meander bends, steep bank angles, basal scour through both sides of the channel, fracture lines along the top of bank and significant slumping.

15. Watts Creek upstream of confluence with the Kizell Drain.

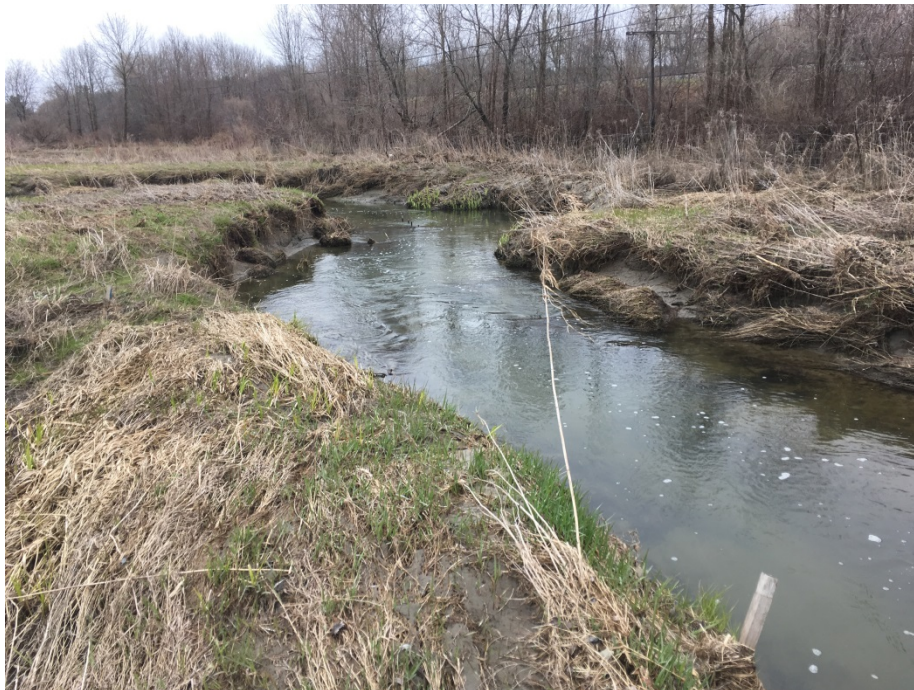
16. WCG-3 downstream of confluence with the Kizell Drain.
