Kizell Drain Downstream of 7000 Campeau Drive Geomorphological and Erosion Threshold Assessment

**Kizell Drain
Kanata, Ontario**

May 18, 2021
PN20053

Report Prepared by: GEO Morphix Ltd.
PO Box 205, 36 Main St. N.
Campbellville, ON L0P 1B0

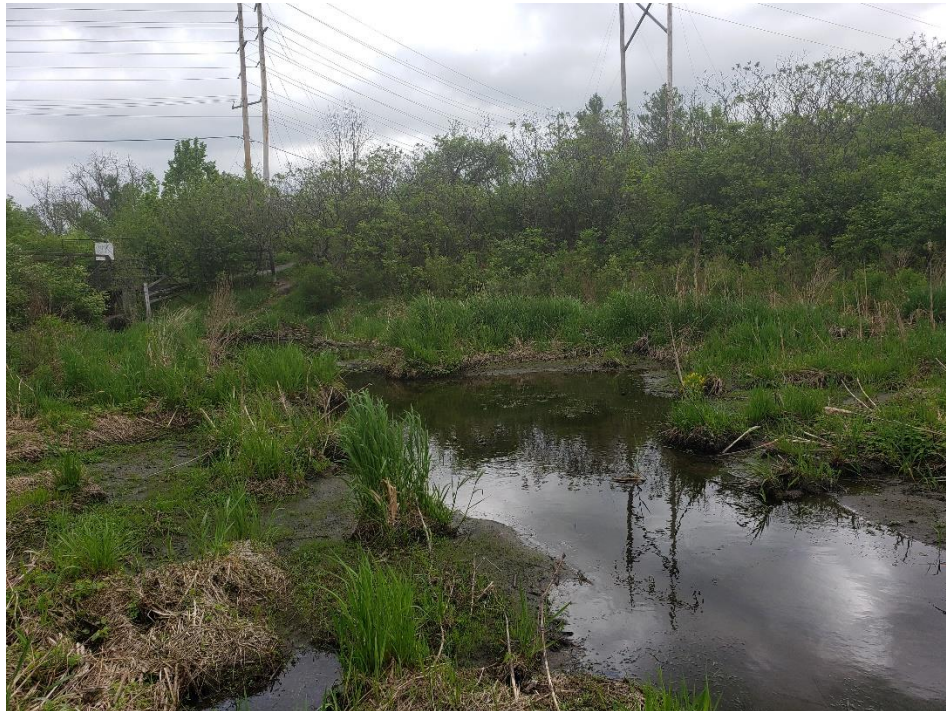
Photo 7
Kizell Drain, KDR-4 – Kanata, Ontario

At the downstream extent of the natural riparian area, the channel is backwatered by exposed bedrock creating a depositional area with a soft, unconsolidated sandy silt overlying cohesive clay on the channel bed.

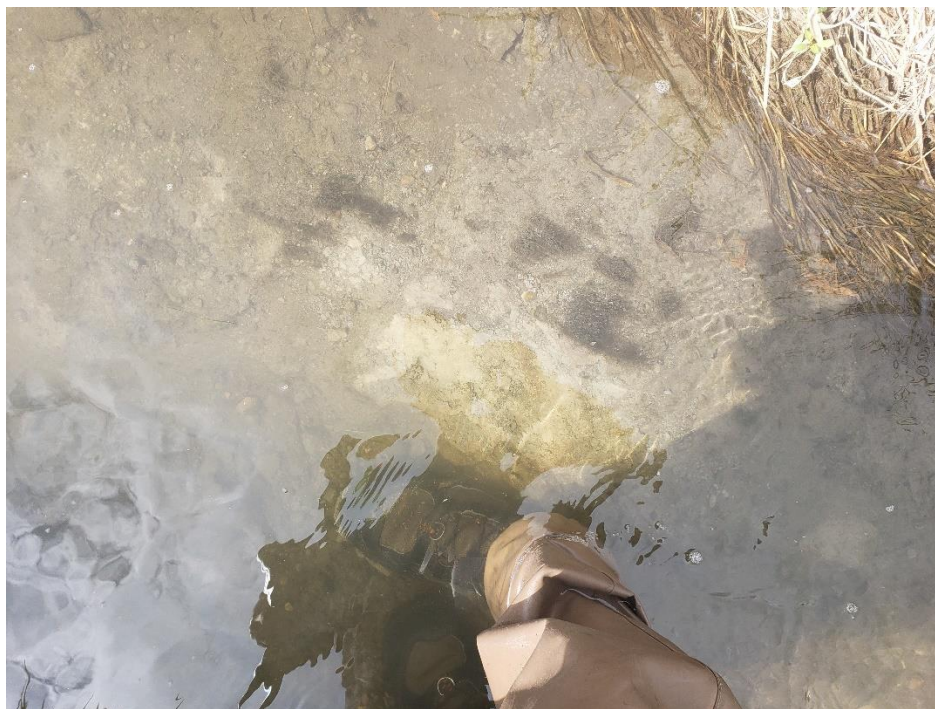
Photo 8
Kizell Drain, KDR-4 – Kanata, Ontario

Exposed compact grey clay was frequently observed along the bed of the channel.

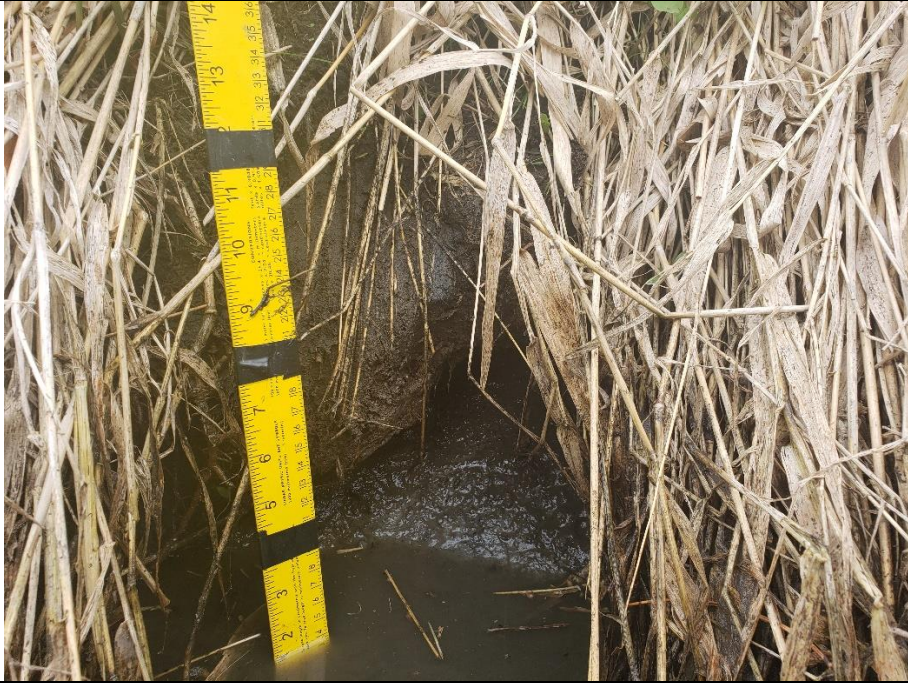
Photo 9
Kizell Drain, KDR-4 – Kanata, Ontario

Below the dense grass rooting structure, both banks through the natural riparian area of KDR-4 are composed of a loamy clay.

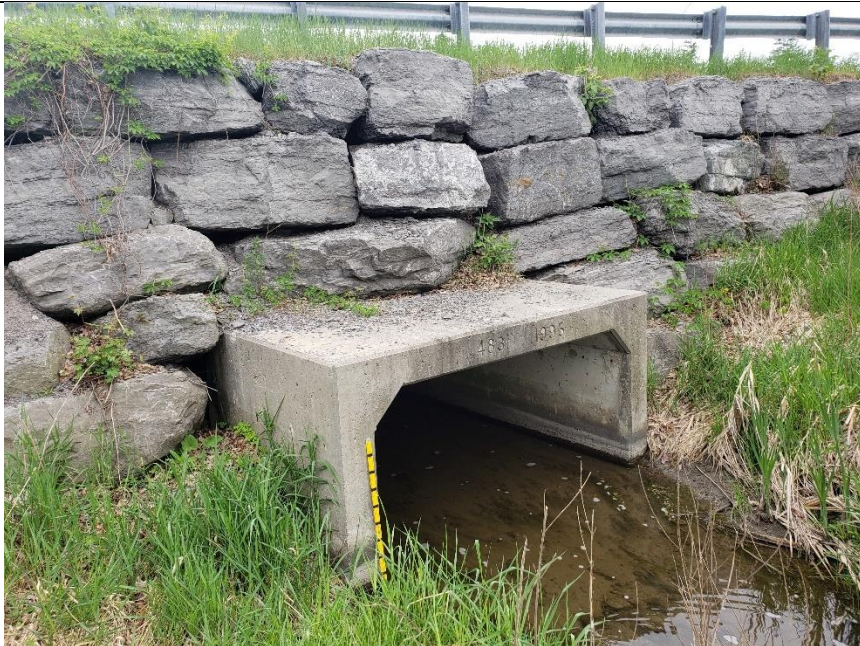
Photo 10
Kizell Drain, KDR-3 – Kanata, Ontario

Culvert marking the upstream extent of AECOM detailed reach, KDR-3. This reach was also partially backwatered in May, 2020 at the time of the rapid assessment when these photographs were taken.

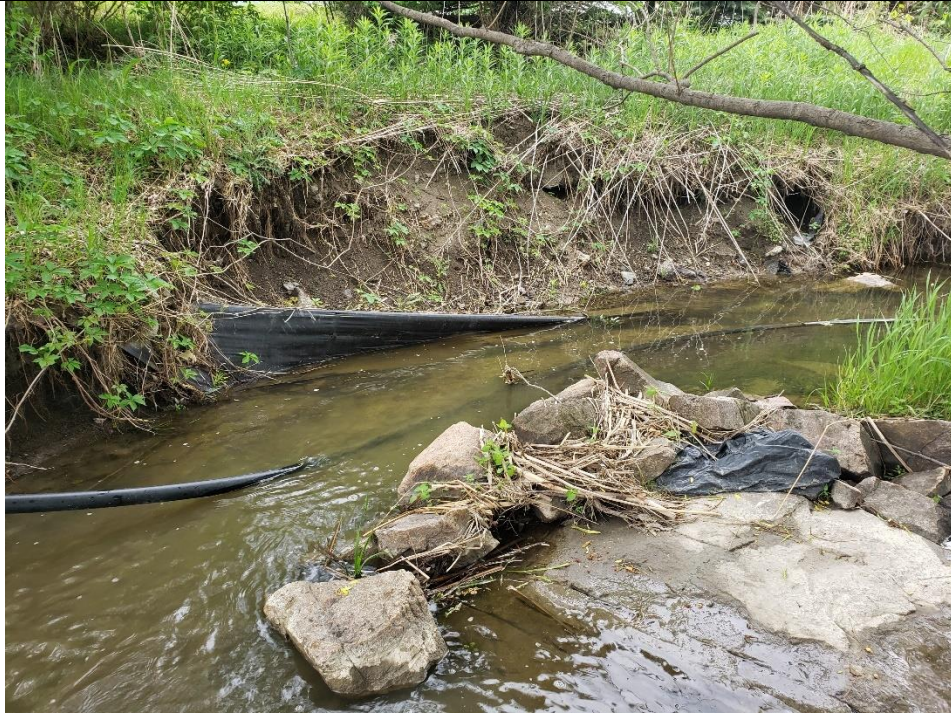
Photo 13
Kizell Drain, KDR-3 – Kanata, Ontario

Exposed filter cloth and bank erosion adjacent to exposed bedrock along the right bank. At this location, it is assumed that the presence of bedrock increases channel energy to the left bank.

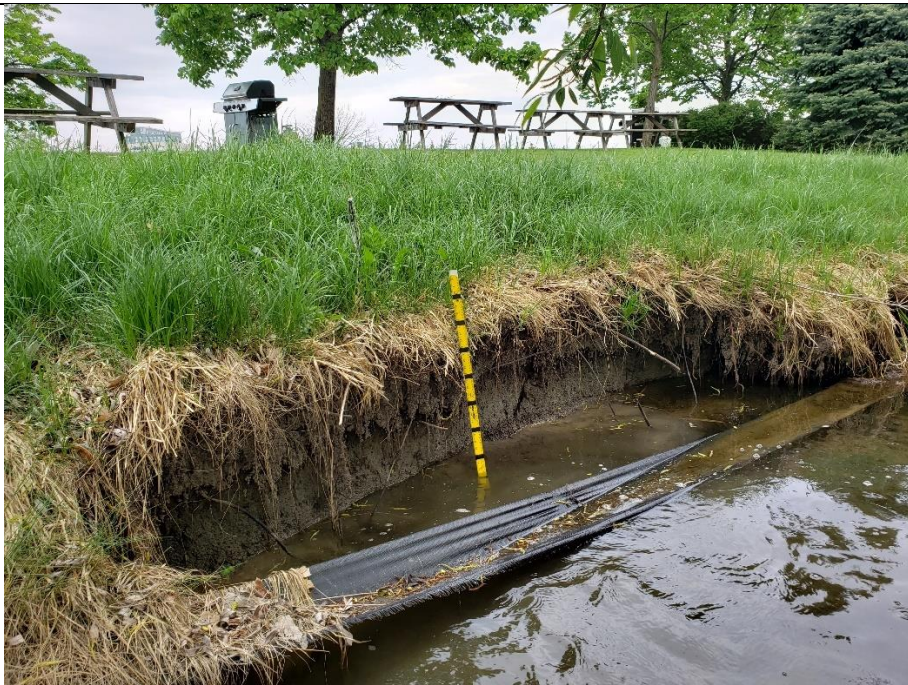
Photo 14
Kizell Drain, KDR-3 – Kanata, Ontario

In this instance of bank erosion, the riparian vegetation has been cut and maintained. The lack of riparian vegetation and rooting structure is assumed to have resulted in the increased erosion.

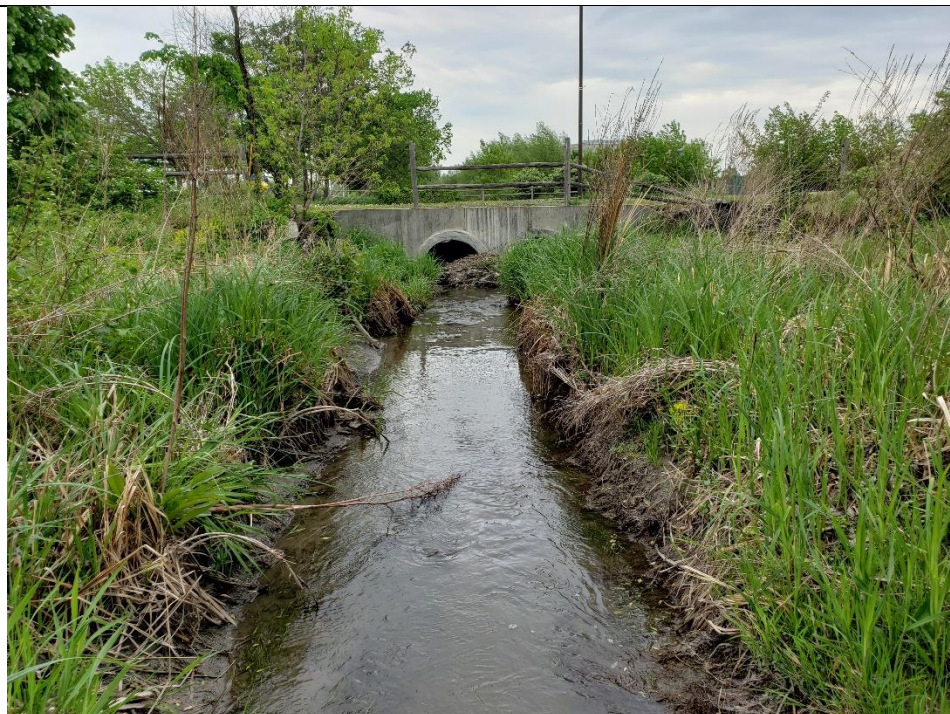
Photo 18
Kizell Drain, KDR-3 – Kanata, Ontario

View downstream of beaver dam where the exposed silt and clay toe of bank can be observed

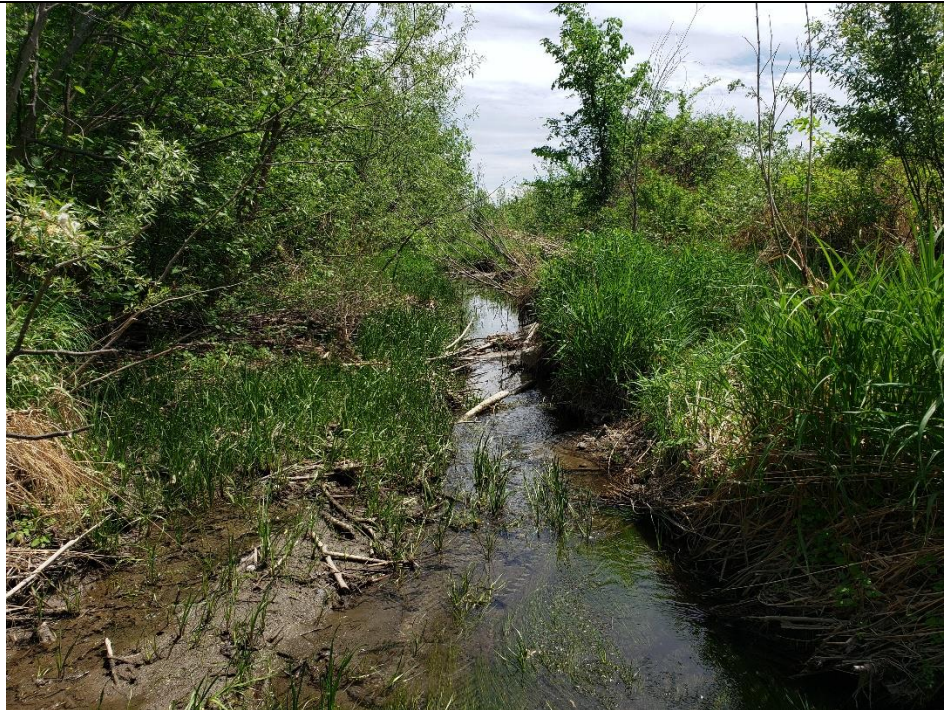
Photo 19
Kizell Drain, KDR-2 – Kanata, Ontario

Upstream extent of KDR-2 looking downstream. The channel is mostly depositional with loose unconsolidated sandy silt bed.

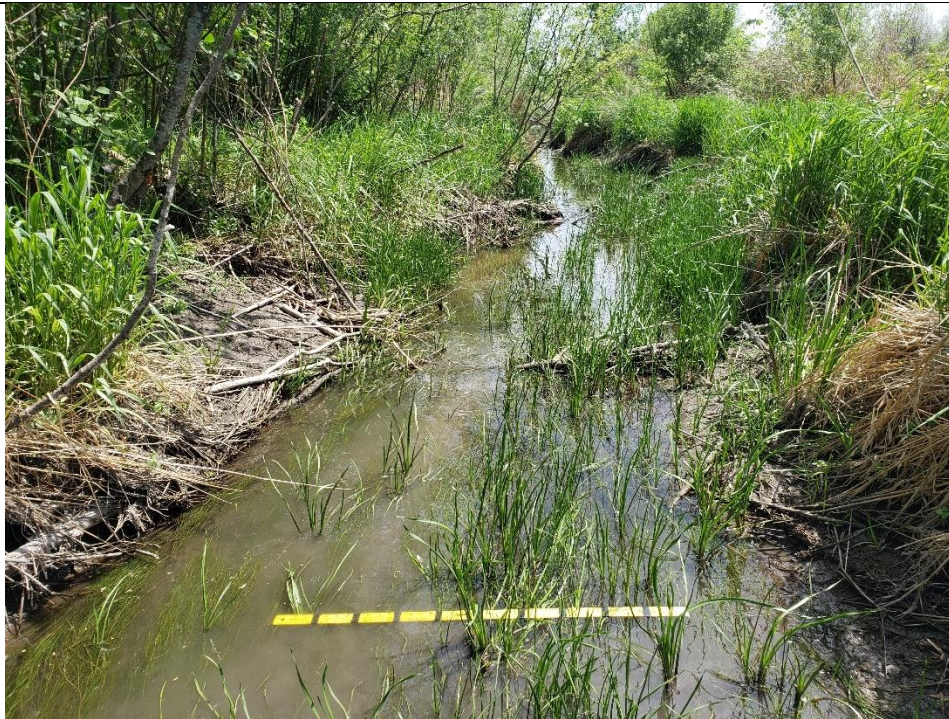
Photo 20
Kizell Drain, KDR-2 – Kanata, Ontario

Submergent and emergent aquatic vegetation were observed throughout the reach, suggesting that here the system has low energy.

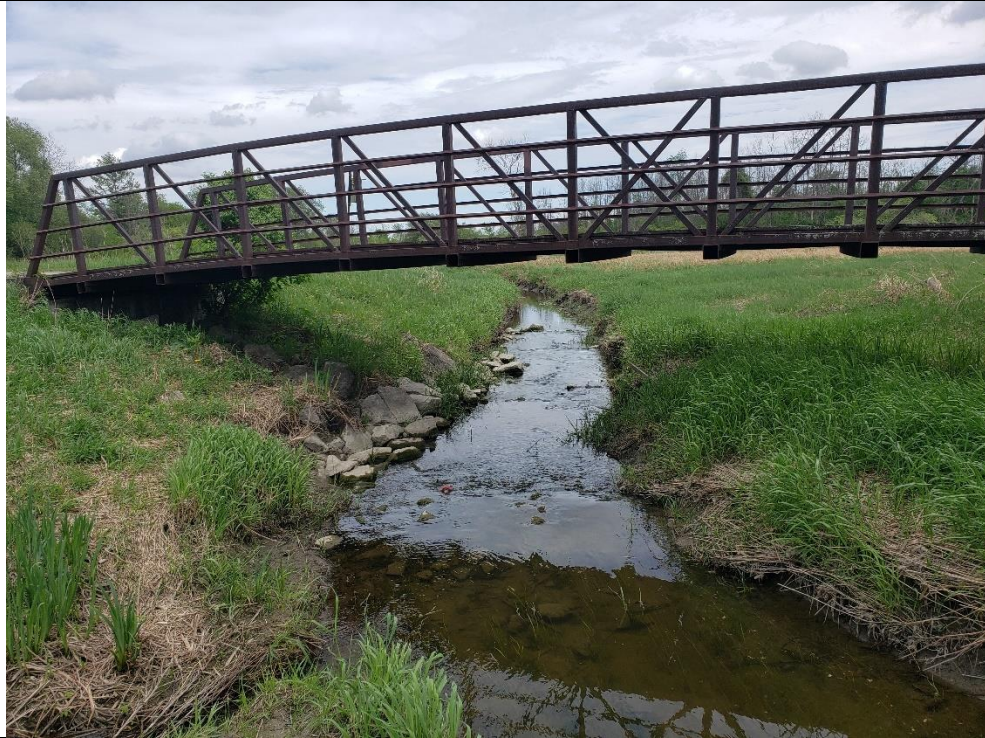
Photo 21
Kizell Drain, KDR-1 – Kanata, Ontario

Pedestrian bridge marking the upstream extent of KDR-1. Here, there is an approximately 15 m long riffle

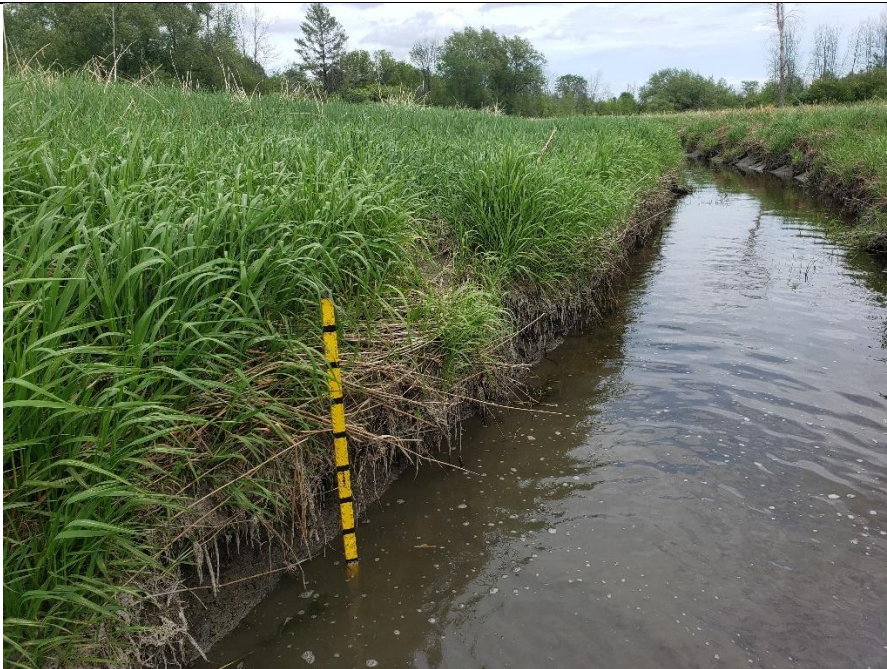
Photo 22
Kizell Drain, KDR-1 – Kanata, Ontario

KDR-1 is relatively straight and represents a section of the furthest downstream reach of the Kizell Drain before its confluence with Watts Creek. The channel in this location is incised into the compact clay at its bed with undercutting observed along the banks.

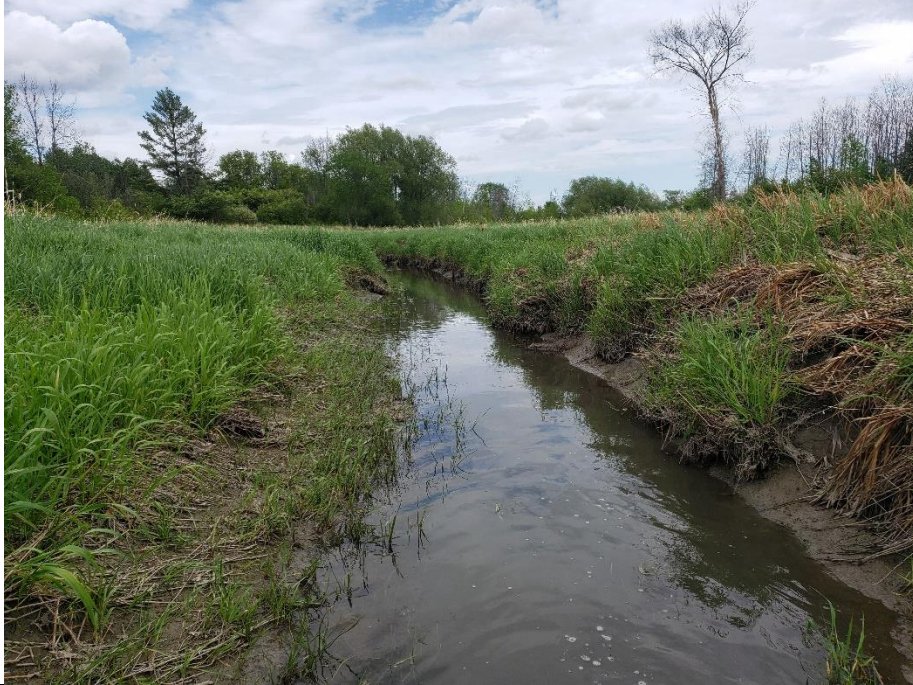
Photo 23
Kizell Drain, KDR-1 – Kanata, Ontario

Through KDR-1, there is evidence of lateral migration. In this photograph (looking downstream), deposition of sandy silts were observed along the left bank and slumping was observed along the right bank.
