Kizell Drain Downstream of 7000 Campeau Drive Geomorphological and Erosion Threshold Assessment

**Kizell Drain
Kanata, Ontario**

July 7, 2020
PN20053

Report Prepared by: GEO Morphix Ltd.
PO Box 205, 36 Main St. N.
Campbellville, ON L0P 1B0

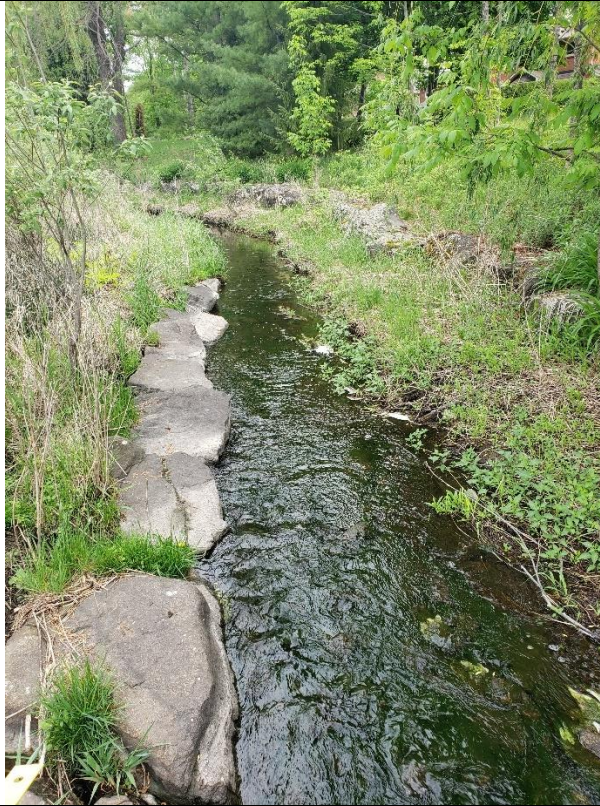
Photo 1
Kizell Drain, KDR-4 – Kanata, Ontario

Looking downstream at the furthest upstream extent of Site KDR-4, immediately downstream of the Beaver Pond outlet. Both banks are armoured and vegetated.

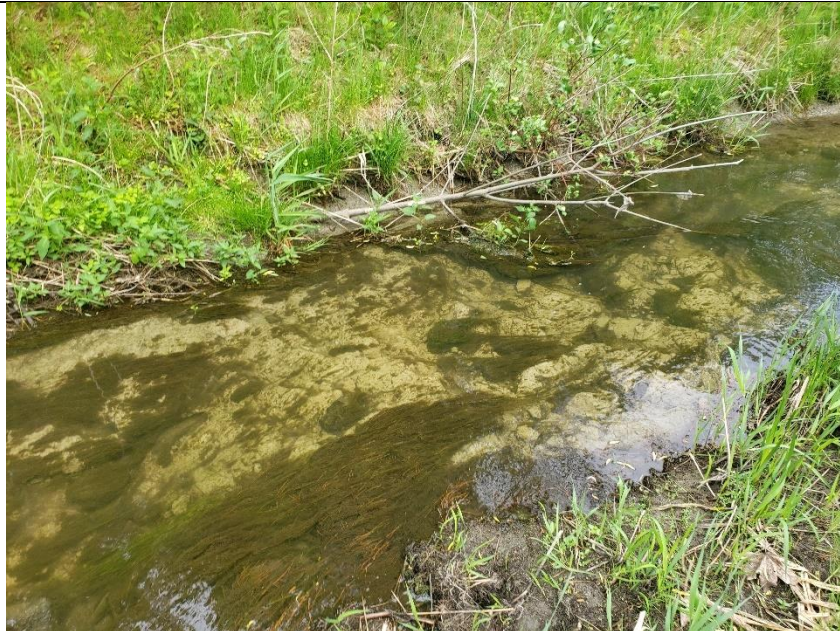
Photo 2
Kizell Drain, KDR-4 – Kanata, Ontario

Downstream of the armoured section near the pedestrian bridge, exposed compact clay was observed. This material was consistently observed as the underlying material throughout Kizell Drain.

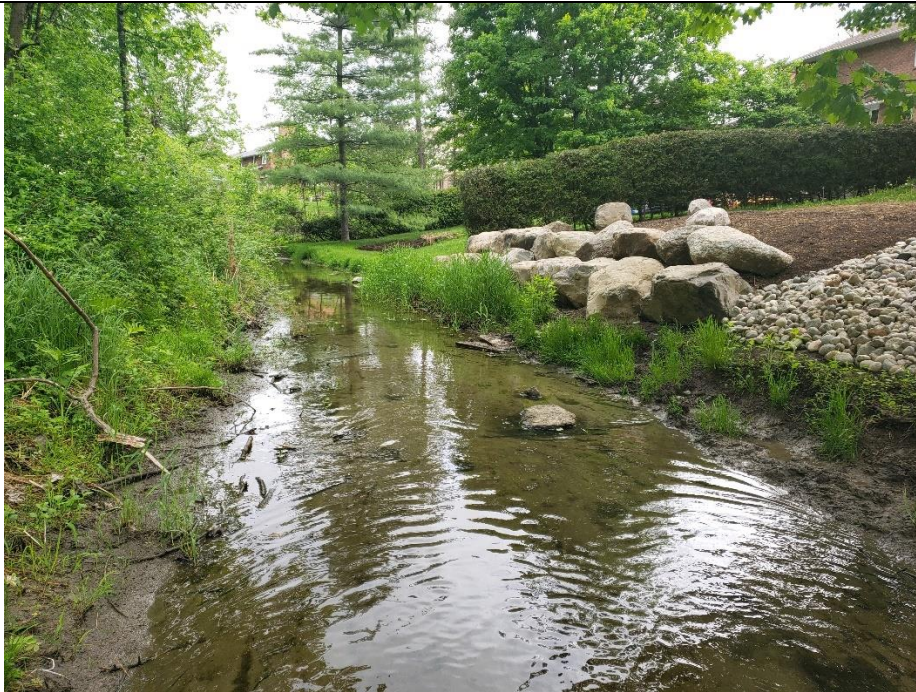
Photo 3
Kizell Drain, KDR-4 – Kanata, Ontario

Between the pedestrian bridge (upstream) and the bedrock outcrop (downstream), the channel is partially backwatered, depositional, and heavily altered along the right bank.

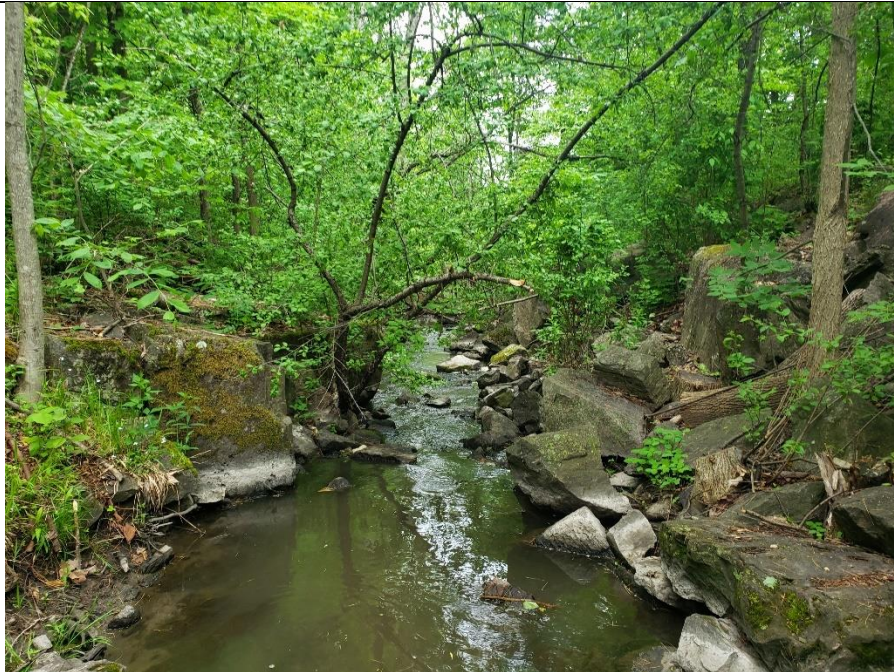
Photo 4
Kizell Drain, KDR-4 – Kanata, Ontario

Upstream extent of an approximately 90 m bedrock outcropping which appeared to be composed of native bedrock and deposited boulders

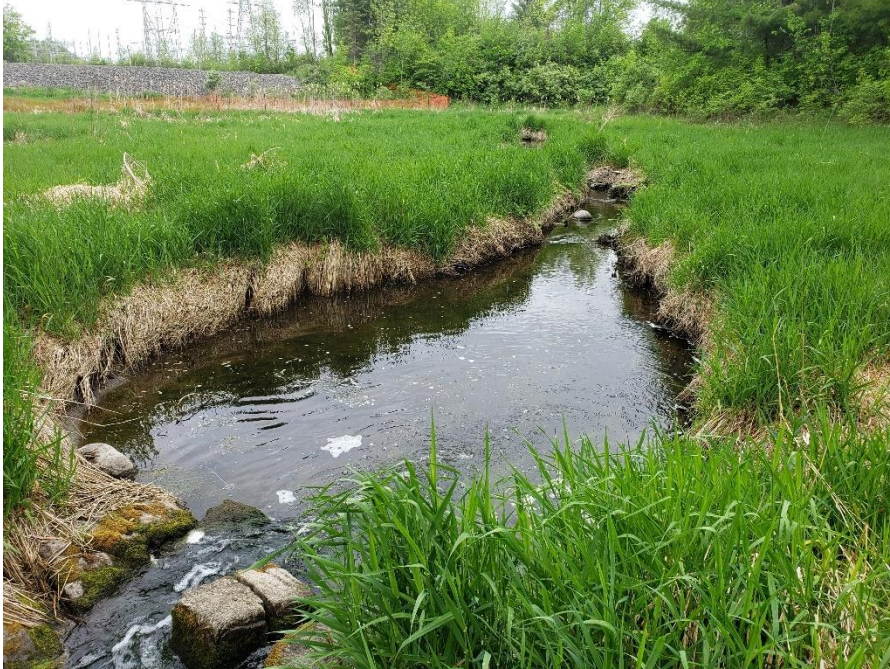
Photo 5
Kizell Drain, KDR-4 – Kanata, Ontario

The downstream extent of the bedrock outcrop is a shallow waterfall or knickpoint, and a wide and relatively shallow scour pool. Downstream of the scour pool, the channel conveys flows through a grassy meadow.

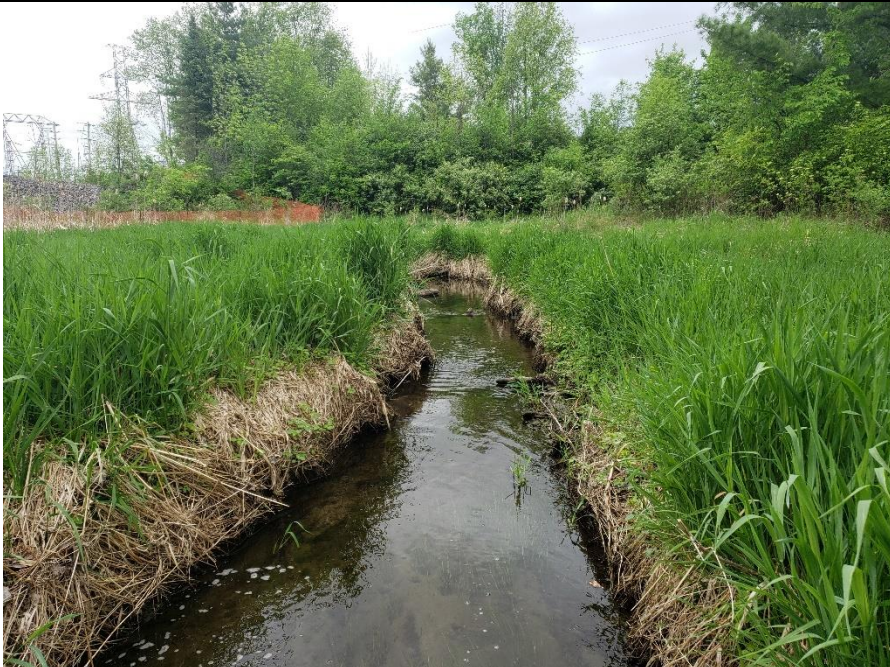
Photo 6
Kizell Drain, KDR-4 – Kanata, Ontario

In this section of KDR-4 where the riparian area has been subjected to less disturbance than adjacent reaches of the Kizell Drain, the banks are generally steep and composed of a loamy clay.

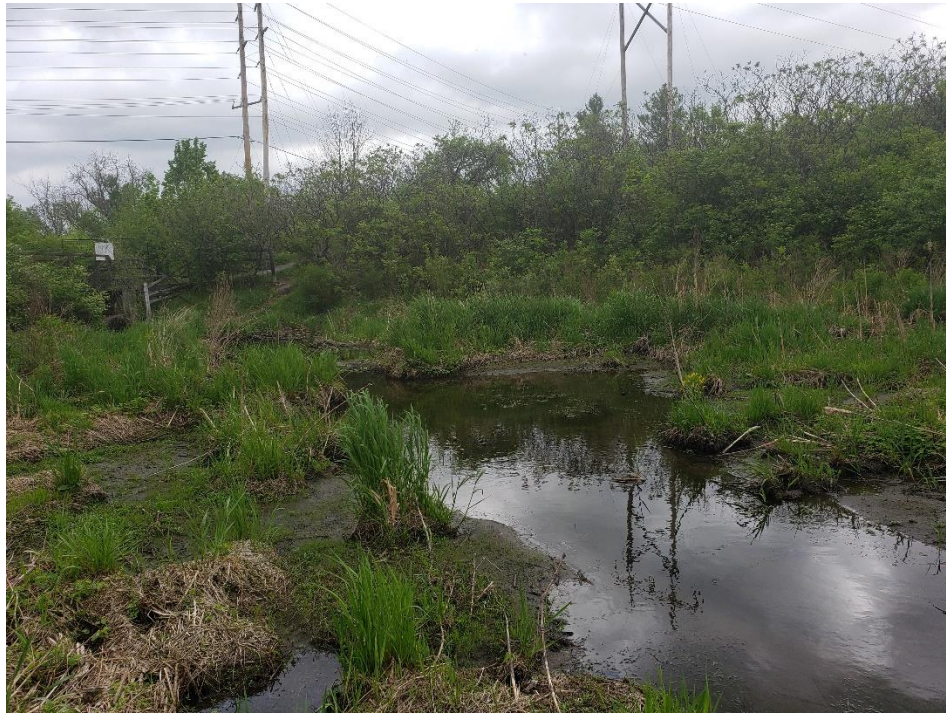
Photo 7
Kizell Drain, KDR-4 – Kanata, Ontario

At the downstream extent of the natural riparian area, the channel is backwatered by exposed bedrock creating a depositional area with a soft, unconsolidated sandy silt overlying cohesive clay on the channel bed.

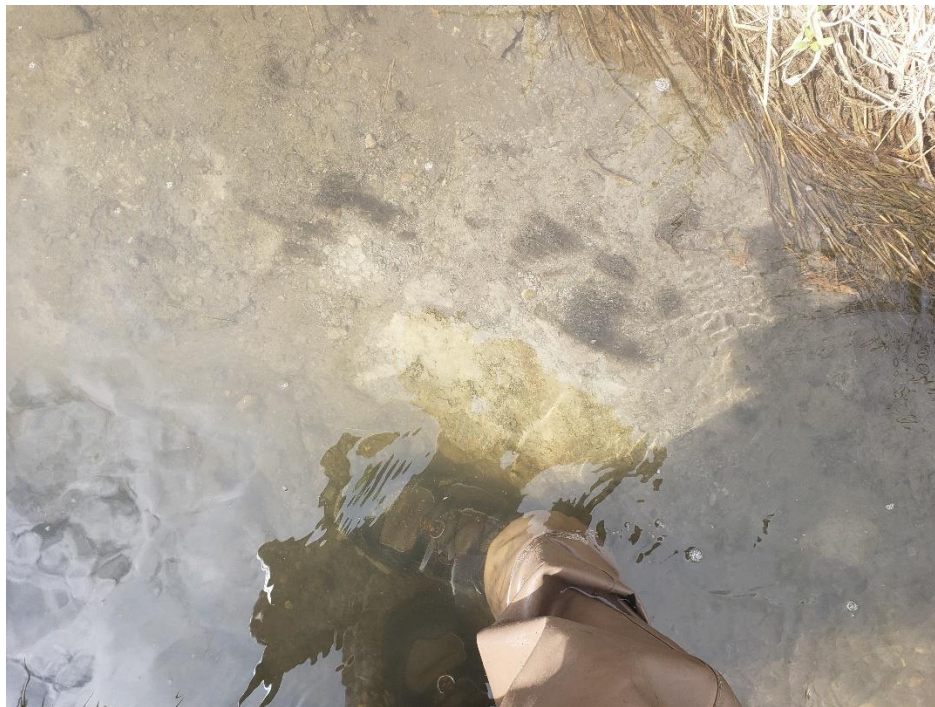
Photo 8
Kizell Drain, KDR-4 – Kanata, Ontario

Exposed compact grey clay was frequently observed along the bed of the channel.

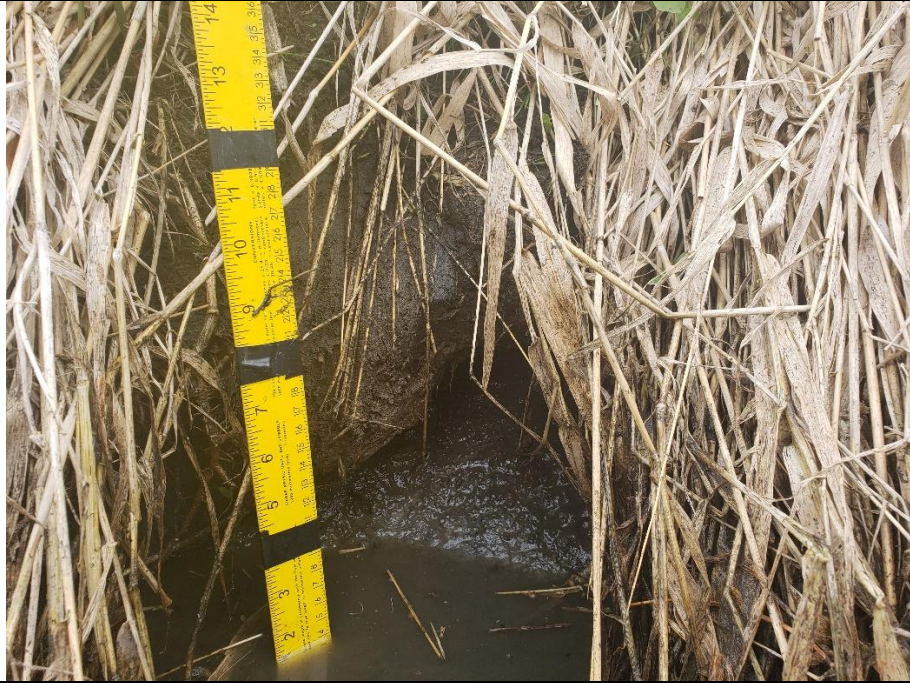
Photo 9
Kizell Drain, KDR-4 – Kanata, Ontario

Below the dense grass rooting structure, both banks through the natural riparian area of KDR-4 are composed of a loamy clay.

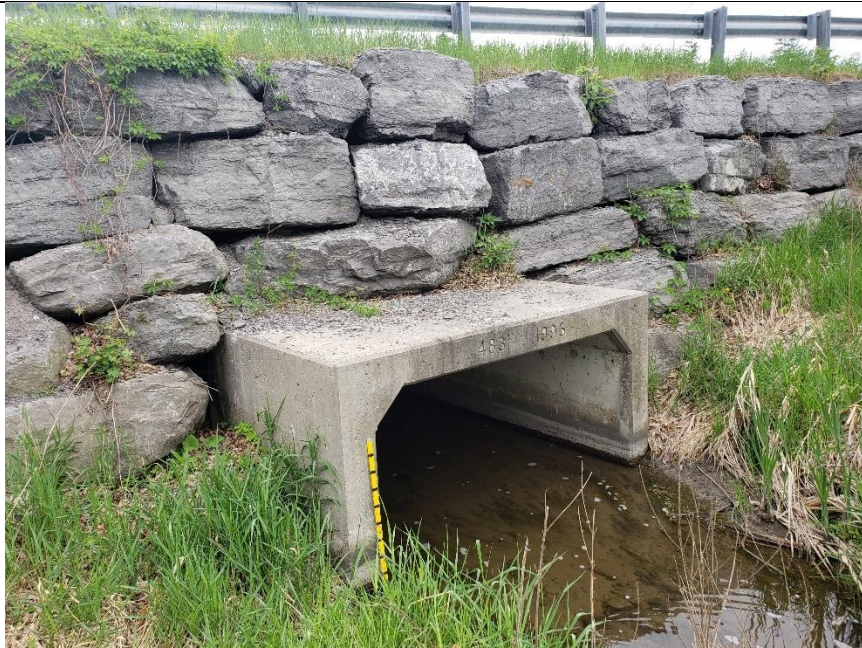
Photo 10
Kizell Drain, KDR-3 – Kanata, Ontario

Culvert marking the upstream extent of AECOM detailed reach, KDR-3. This reach was also partially backwatered in May, 2020 at the time of the rapid assessment when these photographs were taken.

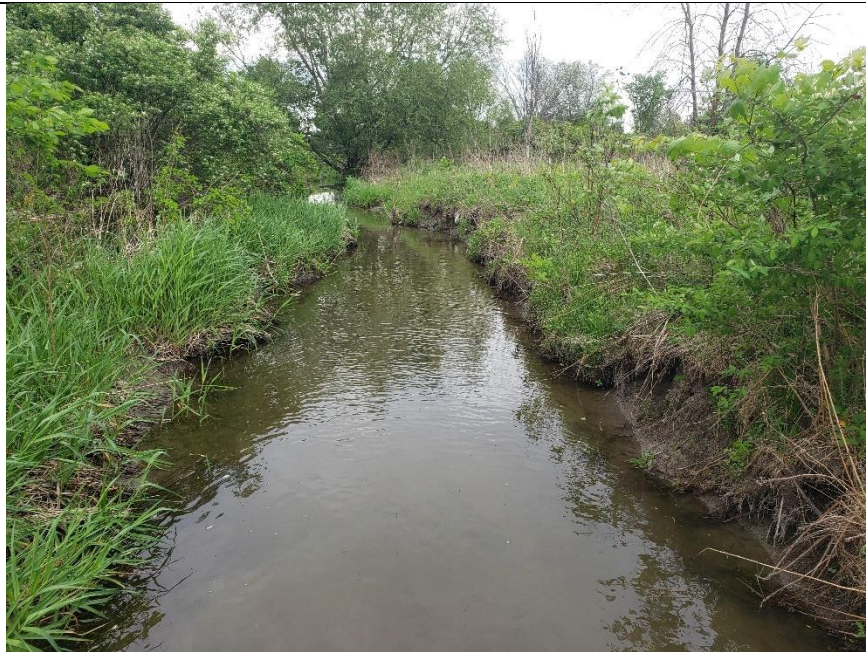
Photo 12

Similar to KDR-4, the banks were steep with undercutting below the rooting system.

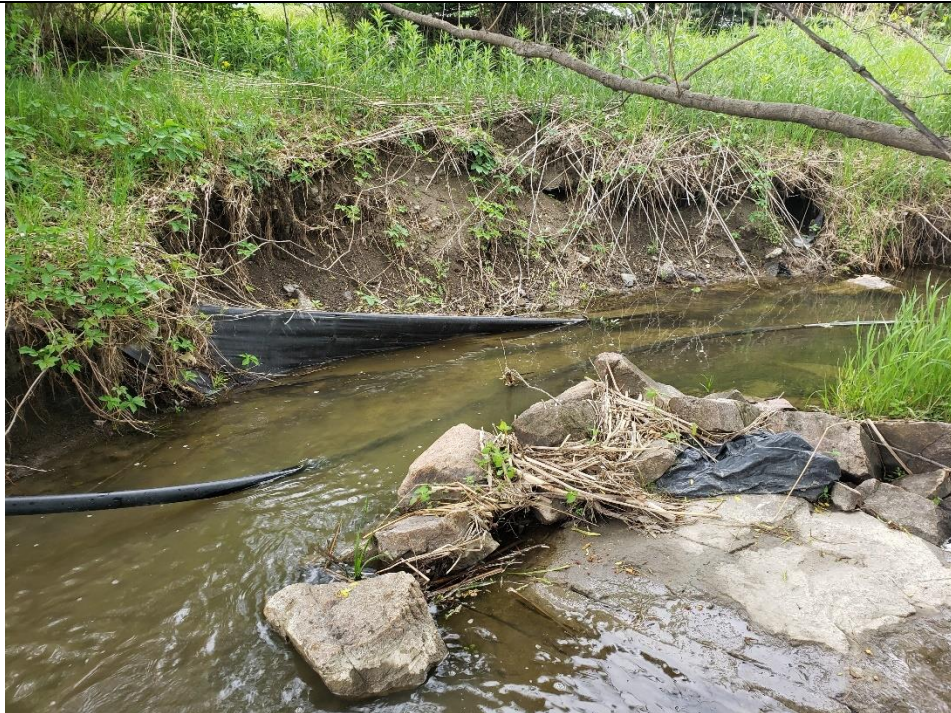
Photo 13
Kizell Drain, KDR-3 – Kanata, Ontario

Exposed filter cloth and bank erosion adjacent to exposed bedrock along the right bank. At this location, it is assumed that the presence of bedrock increases channel energy to the left bank.

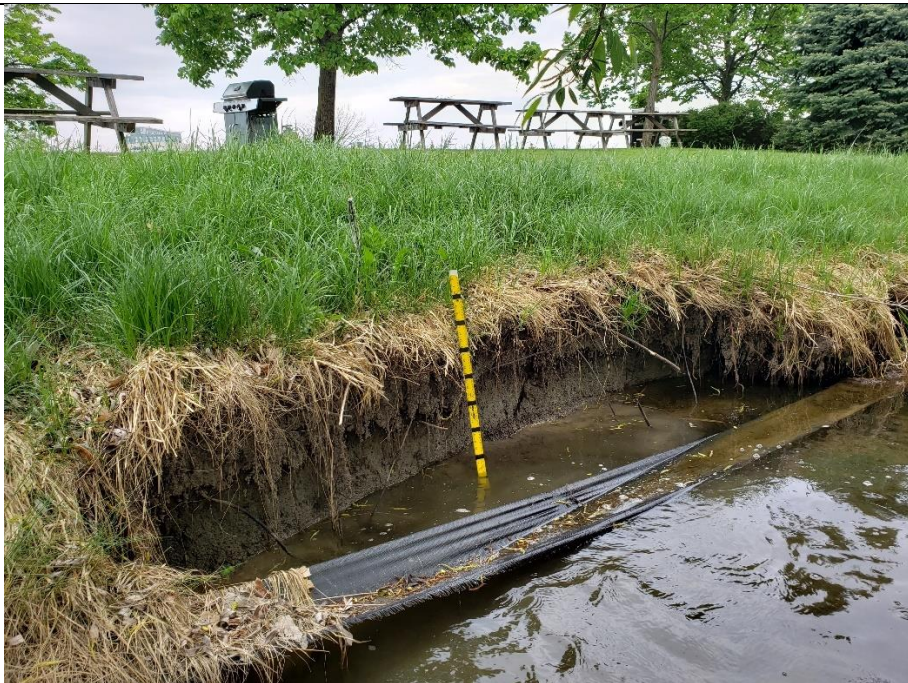
Photo 14
Kizell Drain, KDR-3 – Kanata, Ontario

In this instance of bank erosion, the riparian vegetation has been cut and maintained. The lack of riparian vegetation and rooting structure is assumed to have resulted in the increased erosion.

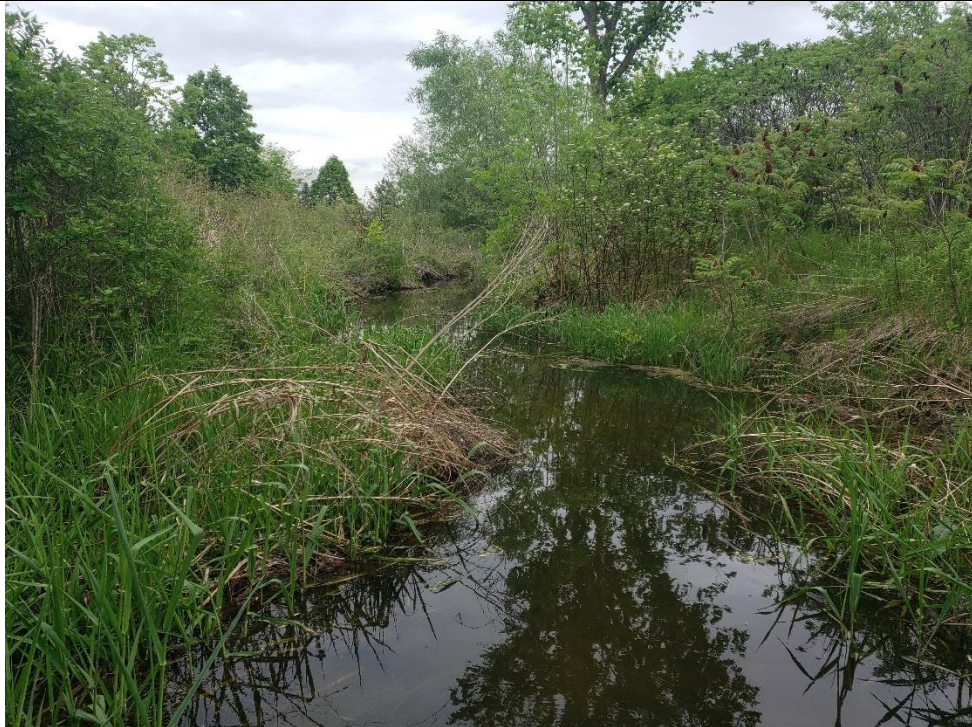
Photo 15

Downstream of channel disturbances, the channel is significantly backwatered by a beaver dam, limiting the ability to make observations of erosion. The channel was mostly depositional in this backwatered area.

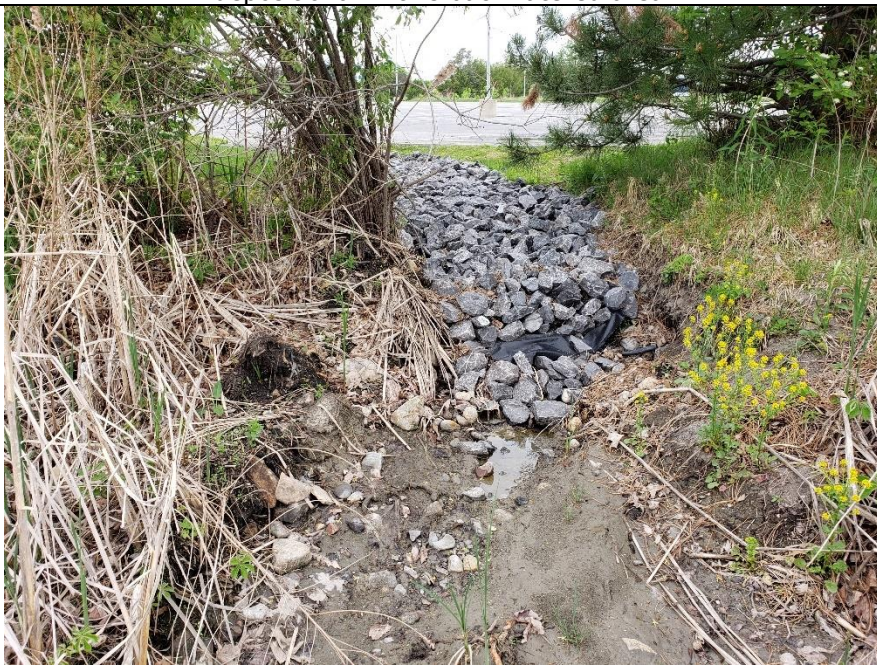
Photo 16

Example of direct parking lot drainage into the riparian zone/channel.

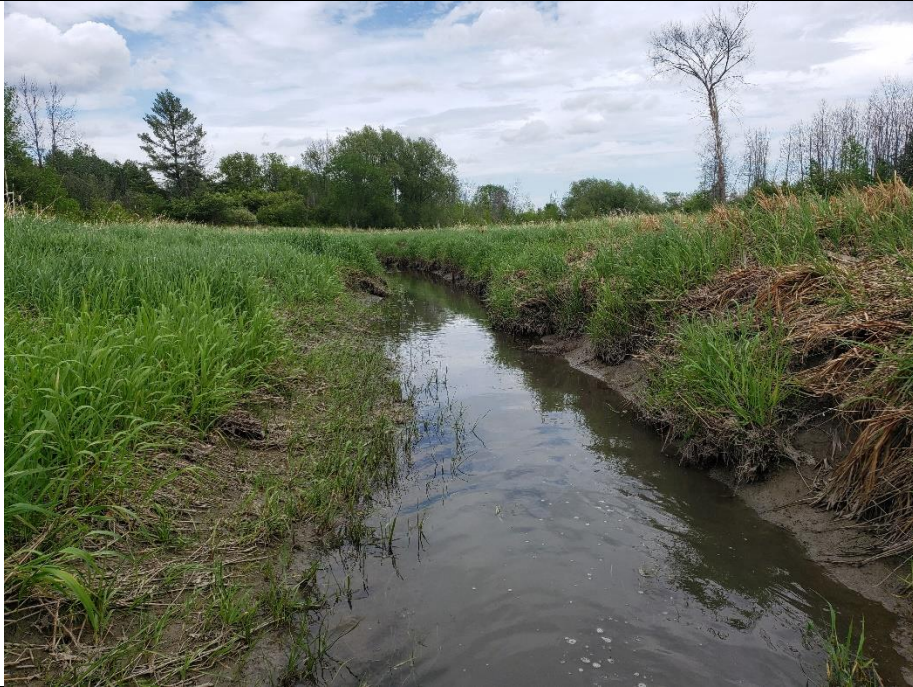
Photo 23
Kizell Drain, KDR-1 – Kanata, Ontario

Through KDR-1, there is evidence of lateral migration. In this photograph (looking downstream), deposition of sandy silts were observed along the left bank and slumping was observed along the right bank.

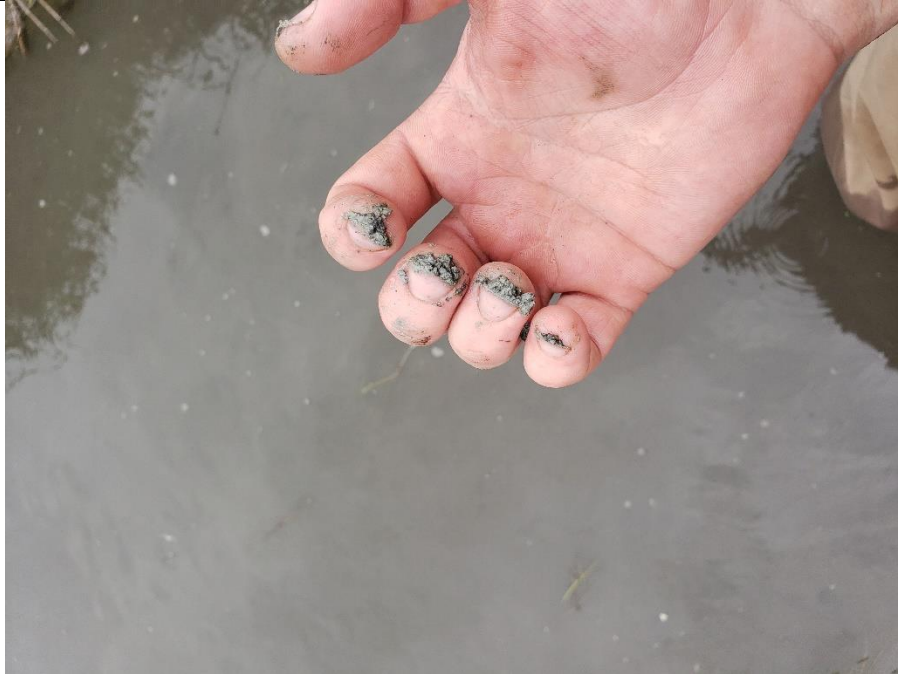
Photo 24
Kizell Drain, KDR-1 – Kanata, Ontario

Through the majority of the reach, the bed was composed of highly compact grey clay which could only be disturbed by scratching at the bed.
