August 28, 2020

RE: TREE CONSERVATION REPORT FOR 178-200 ISABELLA STREET, OTTAWA

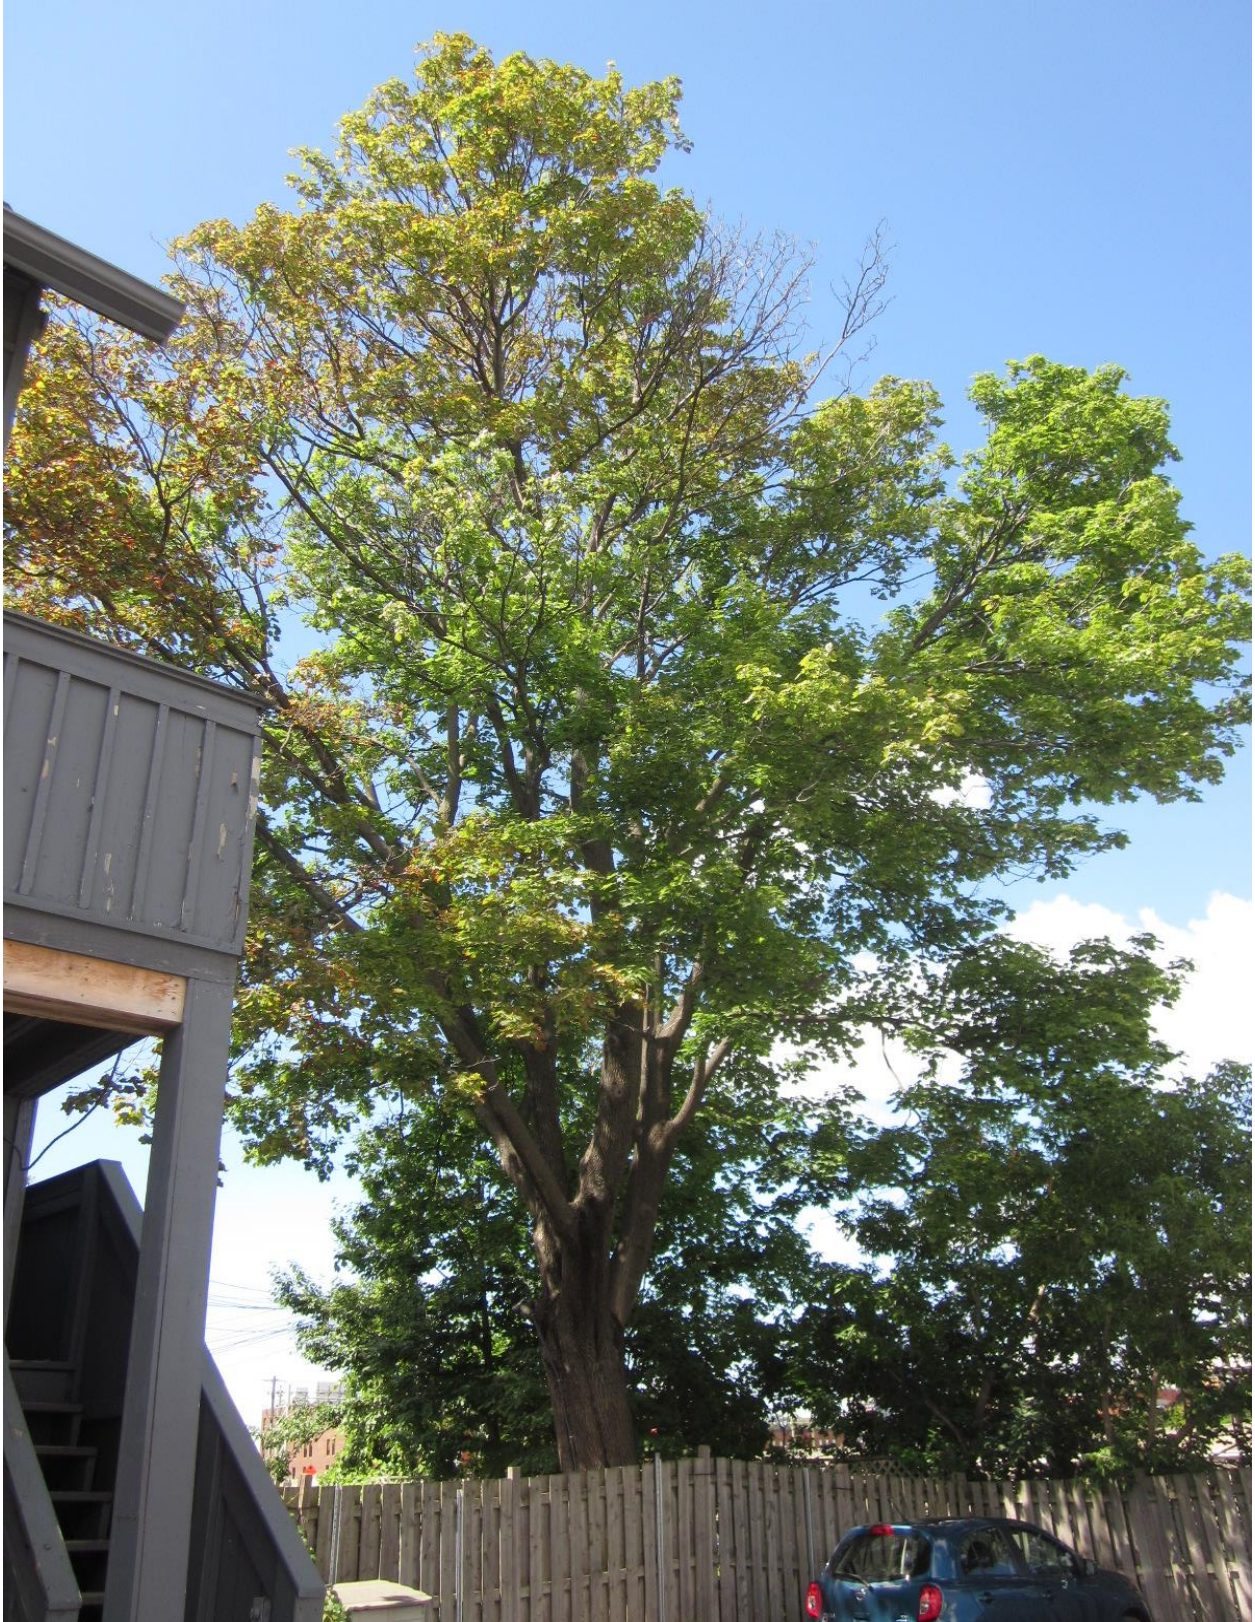
Picture 1. Tree #2 – Norway maple on neighbouring private property

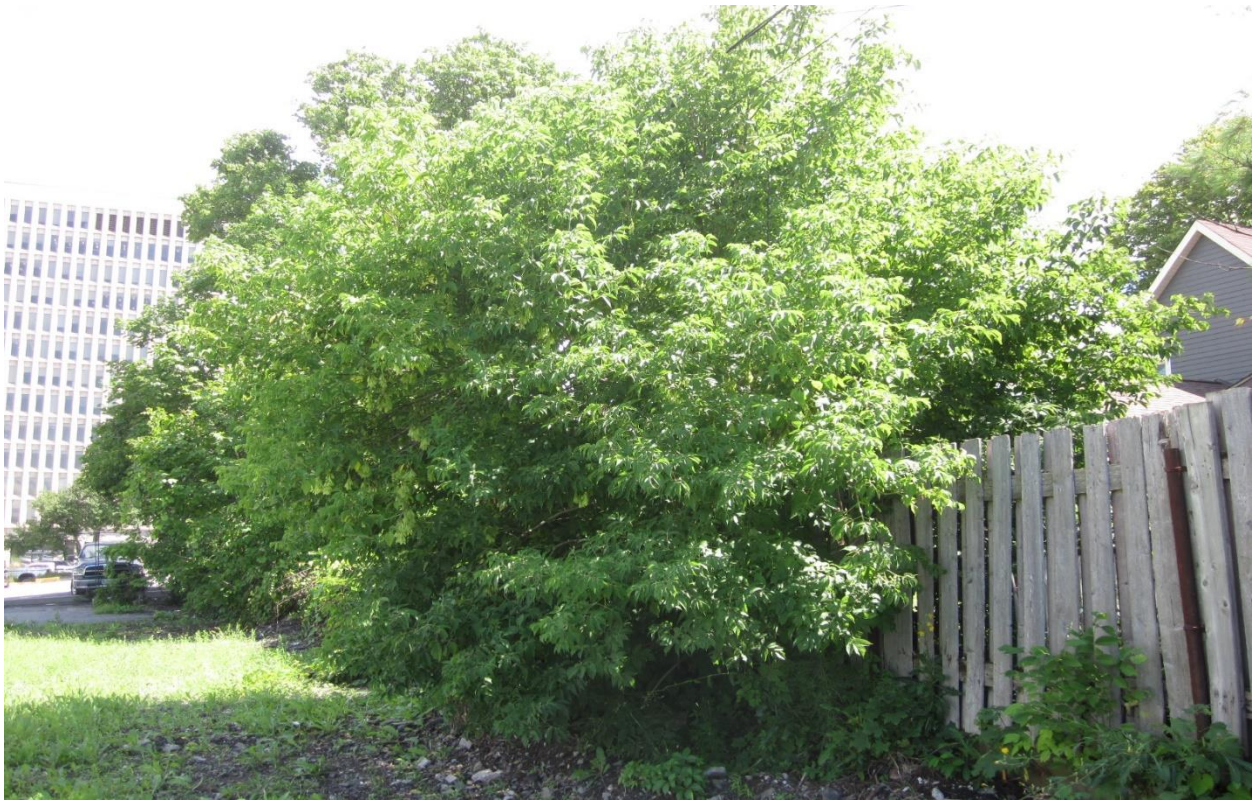
8	Norway maple	Poor	<10	Private	Immature; multi-stemmed – coppicing stump; broad crown; invasive species; to be removed (conflicts with construction)
9	Manitoba maple	Poor	13 avg.	Shared	Maturing; tri-stemmed – coppicing stump; broad crown; growing through fence; naturalized species; to be removed (conflicts with construction)
10	Silver maple (<i>Acer saccharinum</i>)	Fair	+/- 90 (at 1m)	Neighbour	Mature; co-dominant stems at 1.5m with strong union; broad, thin crown with dieback at margins; native species; to be preserved and protected
11	White elm (<i>Ulmus americana</i>)	Dead	All 60+	Neighbour	Three dead mature trees (likely due to Dutch elm disease (<i>Ophiostoma ulmi/novo-ulmi</i>)); all hazardous (and so should be removed)
12	Manitoba maple	Poor	<10	Shared	Immature; six-stemmed – coppicing stump; broad crown; naturalized species; to be removed (conflicts with construction)
13	Manitoba maple	Fair	14, 18 & 18	Shared	Maturing; located atop retaining wall; all divergent due to intolerance to shade; originated from seed; naturalized species; to be removed (conflicts with construction)

Picture 2. Tree #9 – privately owned Manitoba maple

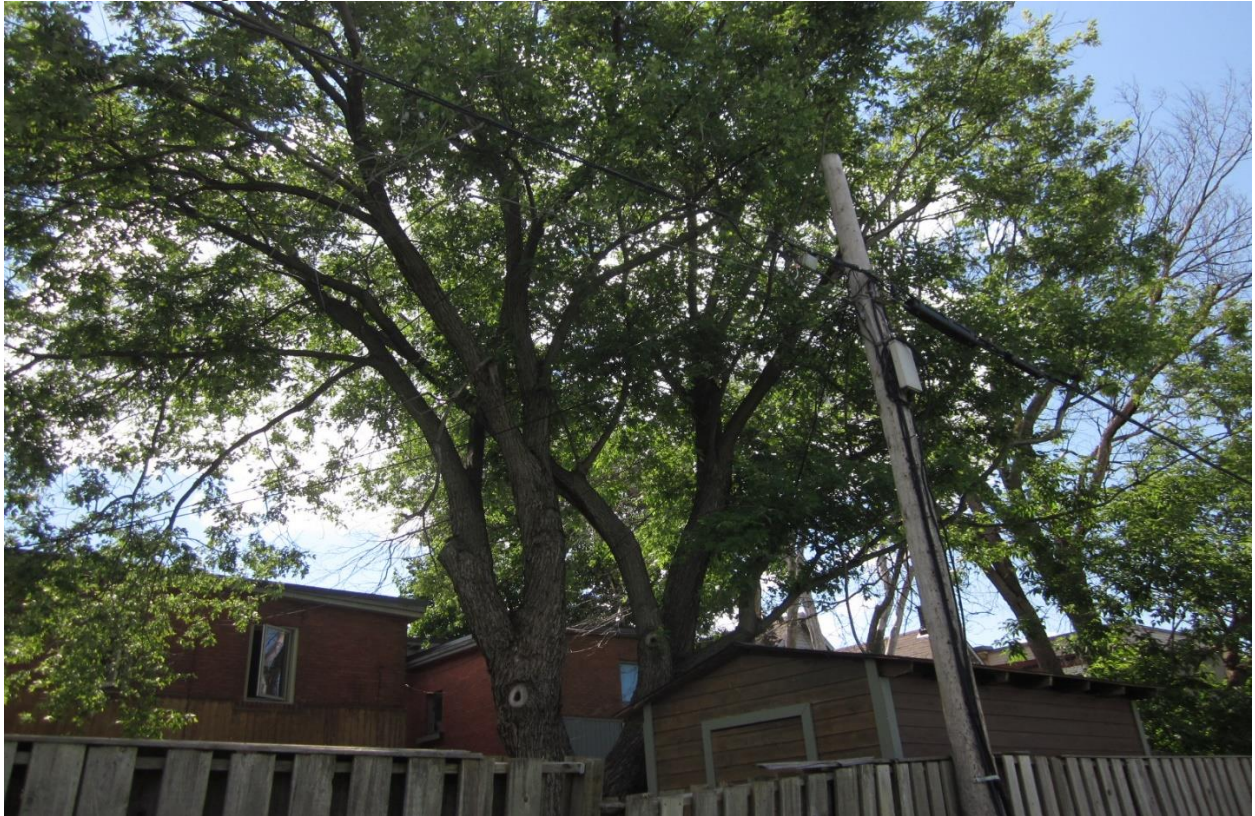
Picture 3. Tree #10 – silver maple on neighbouring private property

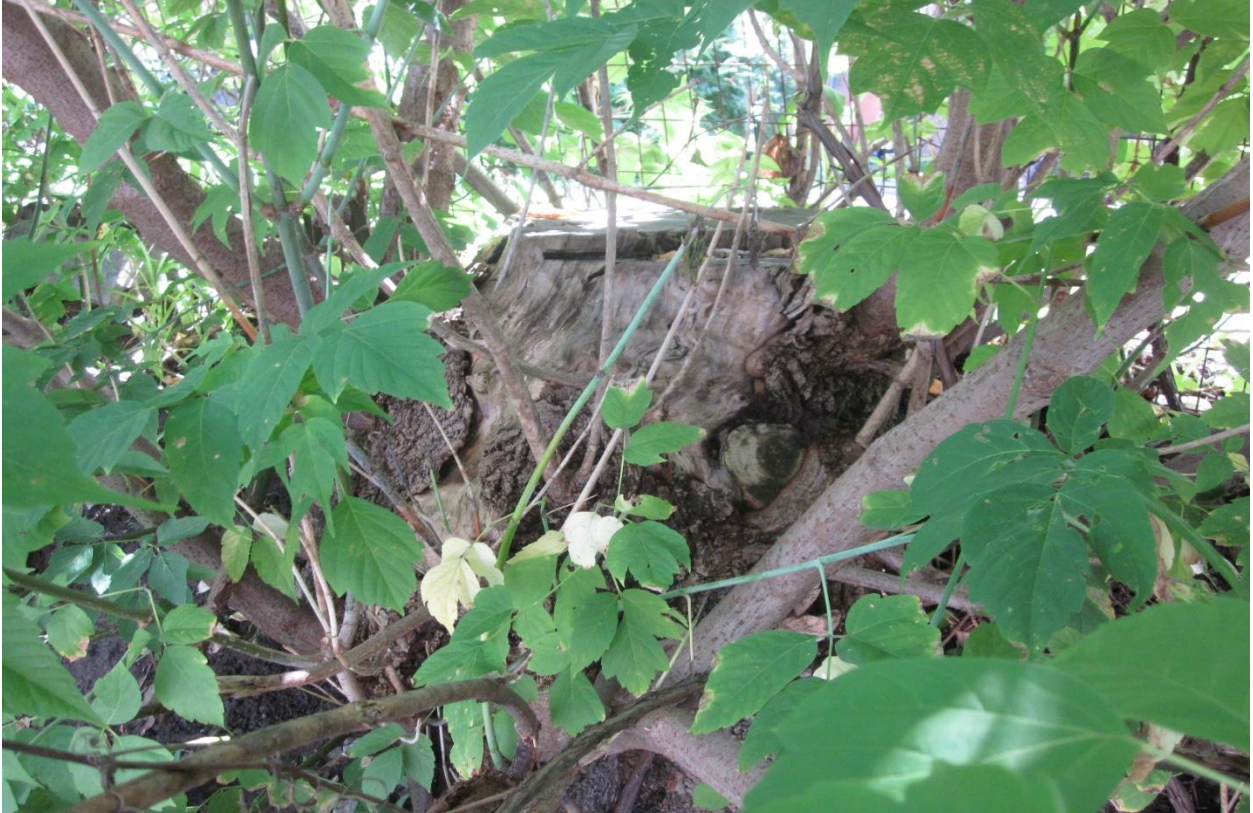
Picture 4. Tree #12 - coppicing stump of shared Manitoba maple

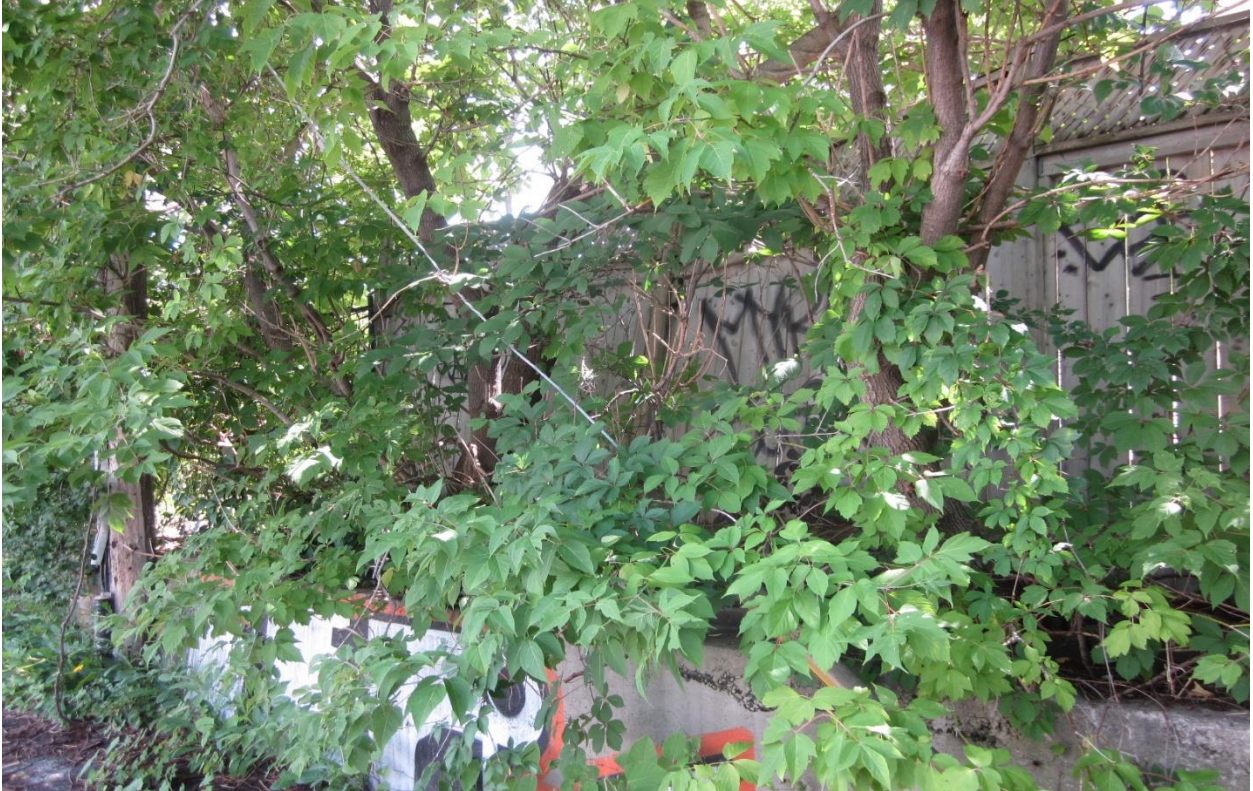
14	Manitoba maple	Good	14	Shared	Maturing; located atop retaining wall; generally upright form; growing into service wires; originated from seed; naturalized species; to be removed (conflicts with construction)

Picture 5. Trees #13 and 14 – neighbouring Manitoba maples atop retaining wall
