Phase I - Environmental Site Assessment

770-774 Bronson Avenue Ottawa, Ontario

April 10, 2020

Report: PE4146-01

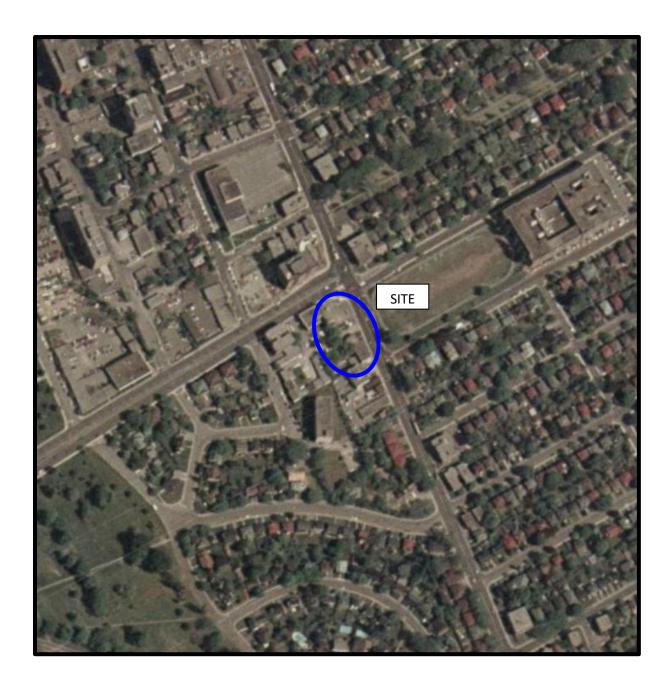
AERIAL PHOTOGRAPH 1976

- 1976 (City of Ottawa website) No significant changes can be seen on the subject or neighbouring properties since the previous photo.
- 1991 (City of Ottawa website) No significant changes can be seen on the subject or neighbouring properties since the previous photo.

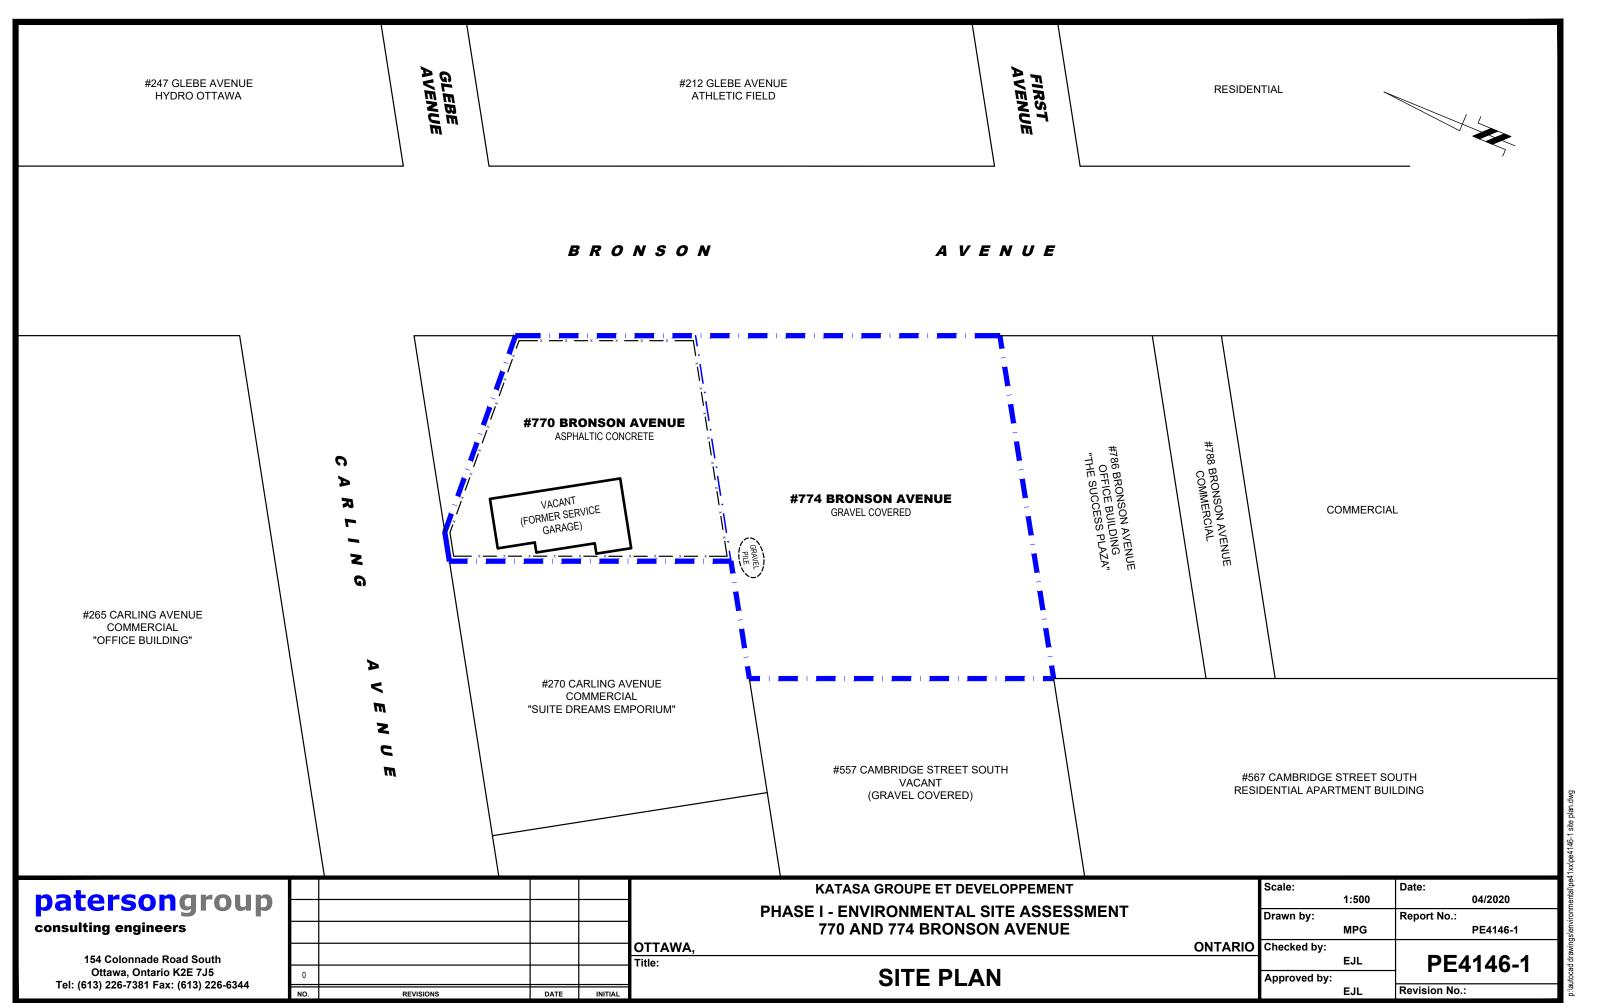
DRAWING: PE4146-1 – SITE PLAN

- □ North Carling Avenue followed by an office building.
- □ South Commercial property.
- East Bronson Avenue followed by an athletic field.
- □ West Commercial property and vacant land.

The current uses of the adjacent properties were not considered to pose an environmental concern to the subject site. Current land use adjacent to the subject site is illustrated on Drawing PE4146-1 – Site Plan in the Appendix.
