LAURIER & SWEETLAND Ottawa, Ontario

SEWER CCTV INSPECTION REPORT

Report ID
108465ST1

Completion Date
October 13, 2021

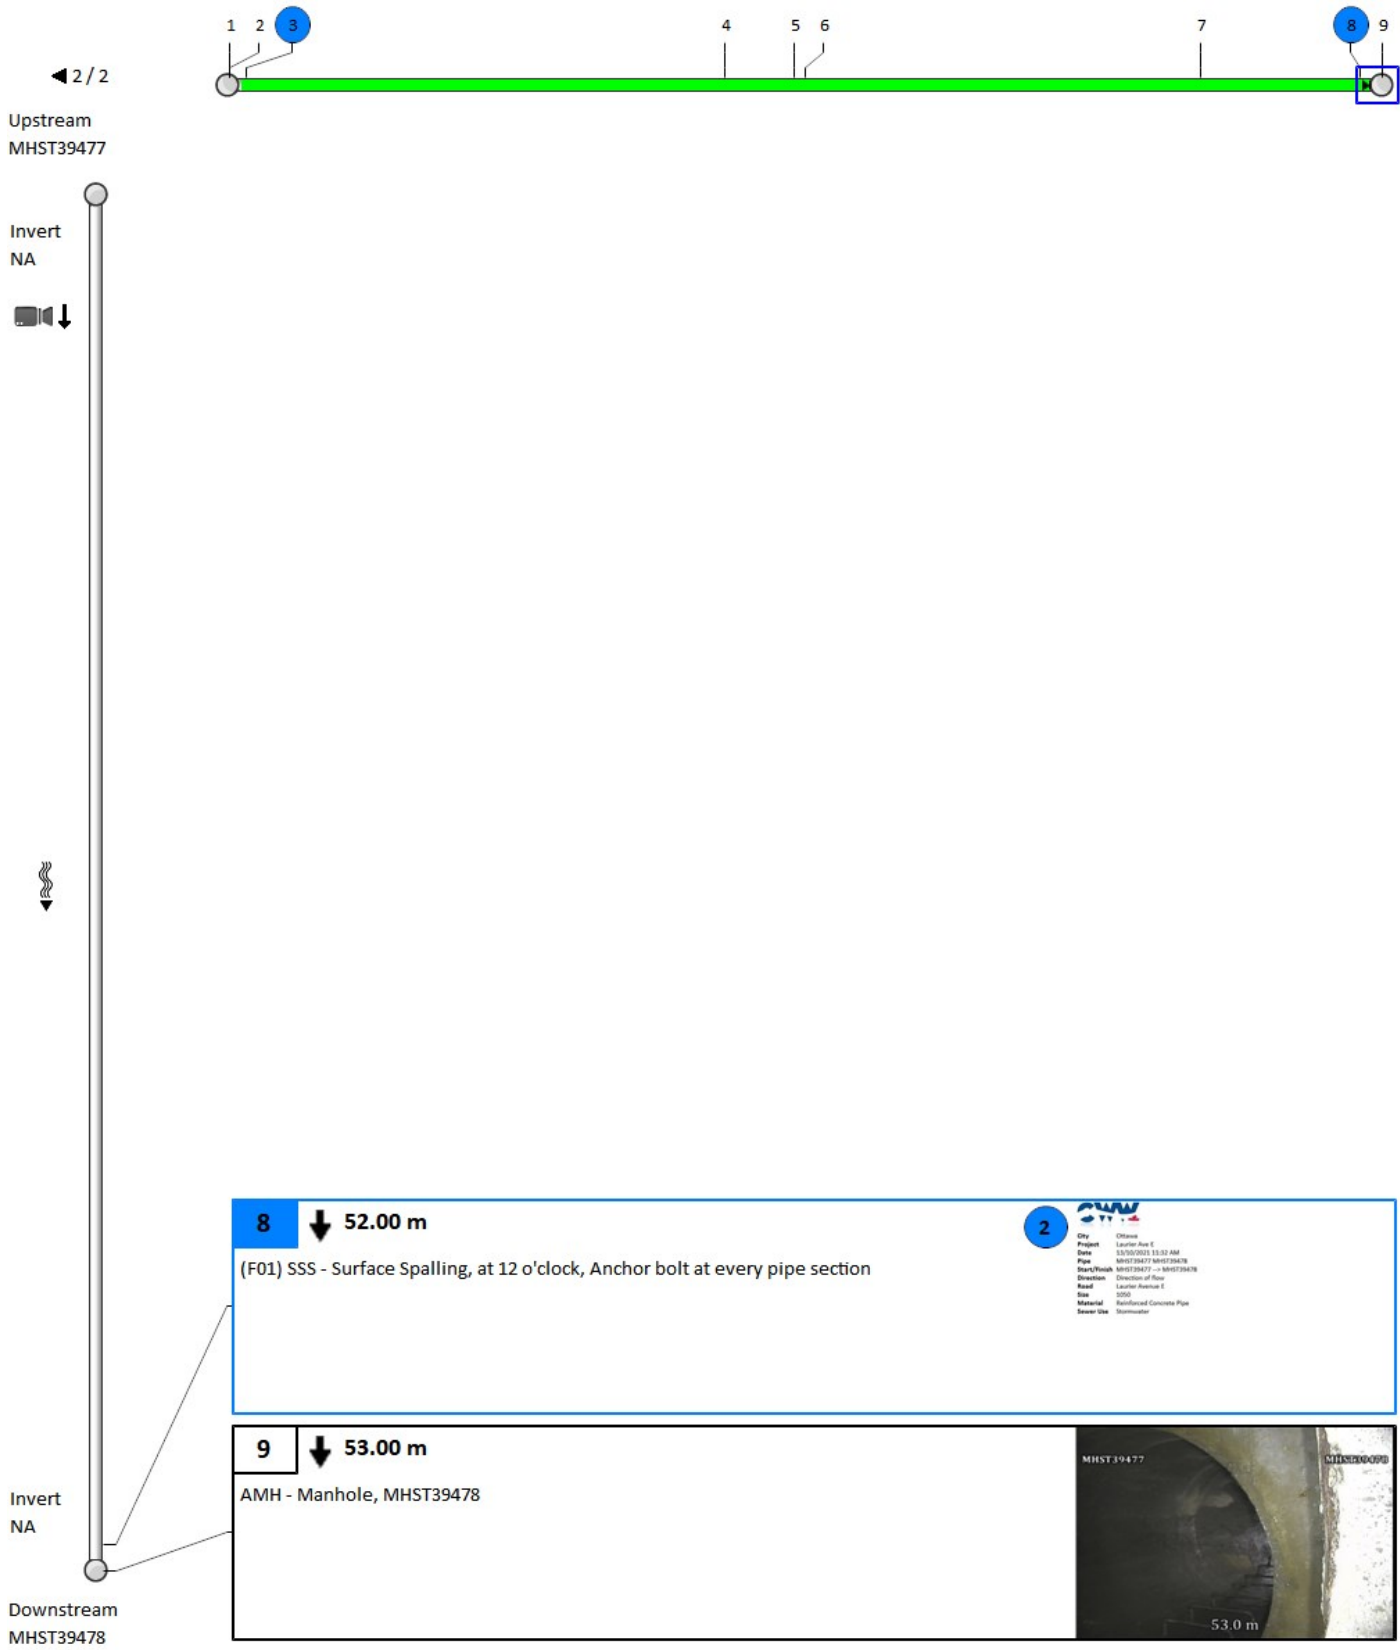
8 ↓ 52.00 m

(F01) SSS - Surface Spalling, at 12 o'clock, Anchor bolt at every pipe section
