LAURIER & SWEETLAND Ottawa, Ontario

SEWER CCTV INSPECTION REPORT

Report ID
108465SA1

Completion Date
October 13, 2021

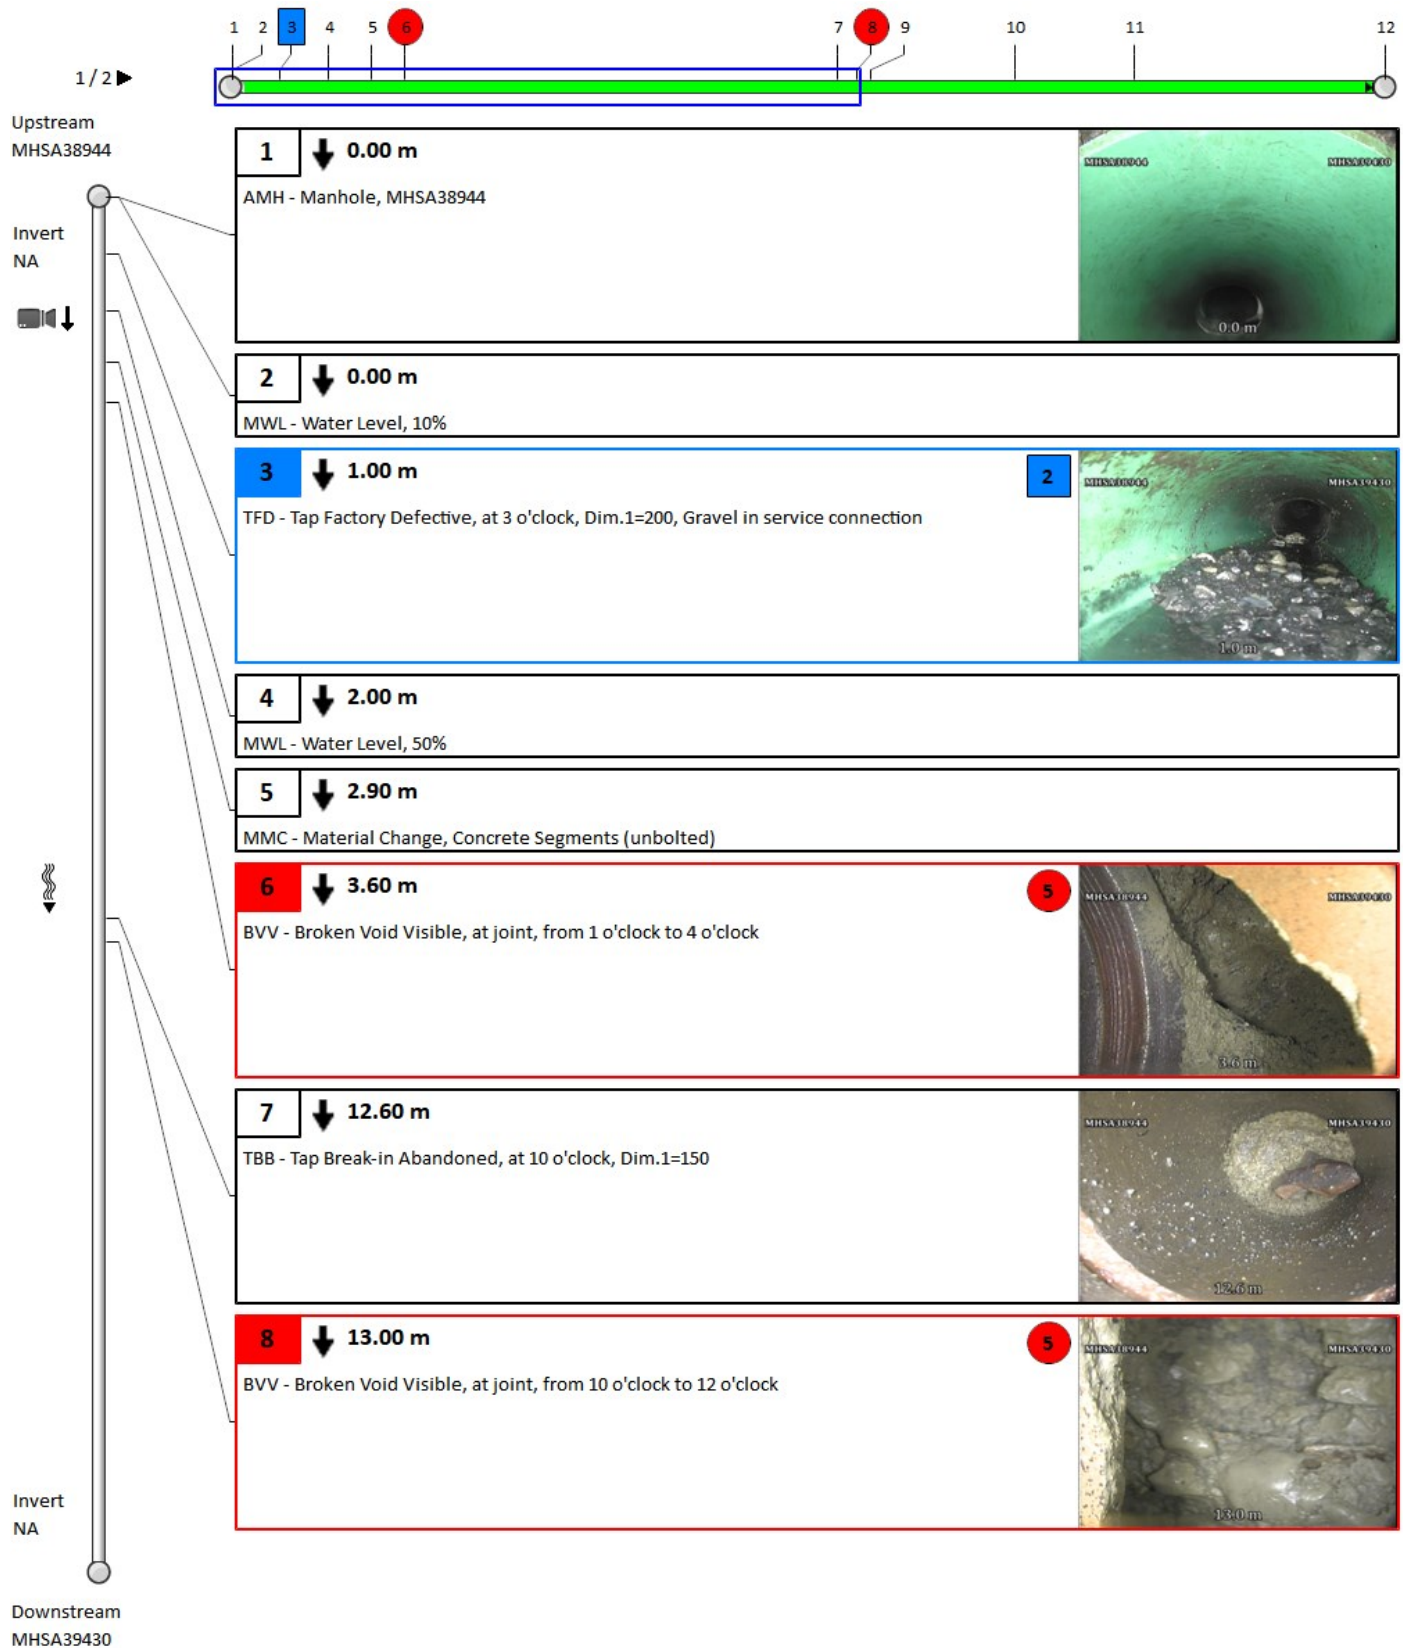
Pipe: MHSA38944 MHSA39430	Direction of inspection: MHSA38944 --> MHSA39430
Direction of flow: MHSA38944 --> MHSA39430	Direction: Direction of flow

Peak: 5	Peak: 2	Peak: 5
Quick rating: 5200	Quick rating: 2100	Quick rating: 5221
Score: 10	Score: 2	Score: 12
Index: 5	Index: 2	Index: 4

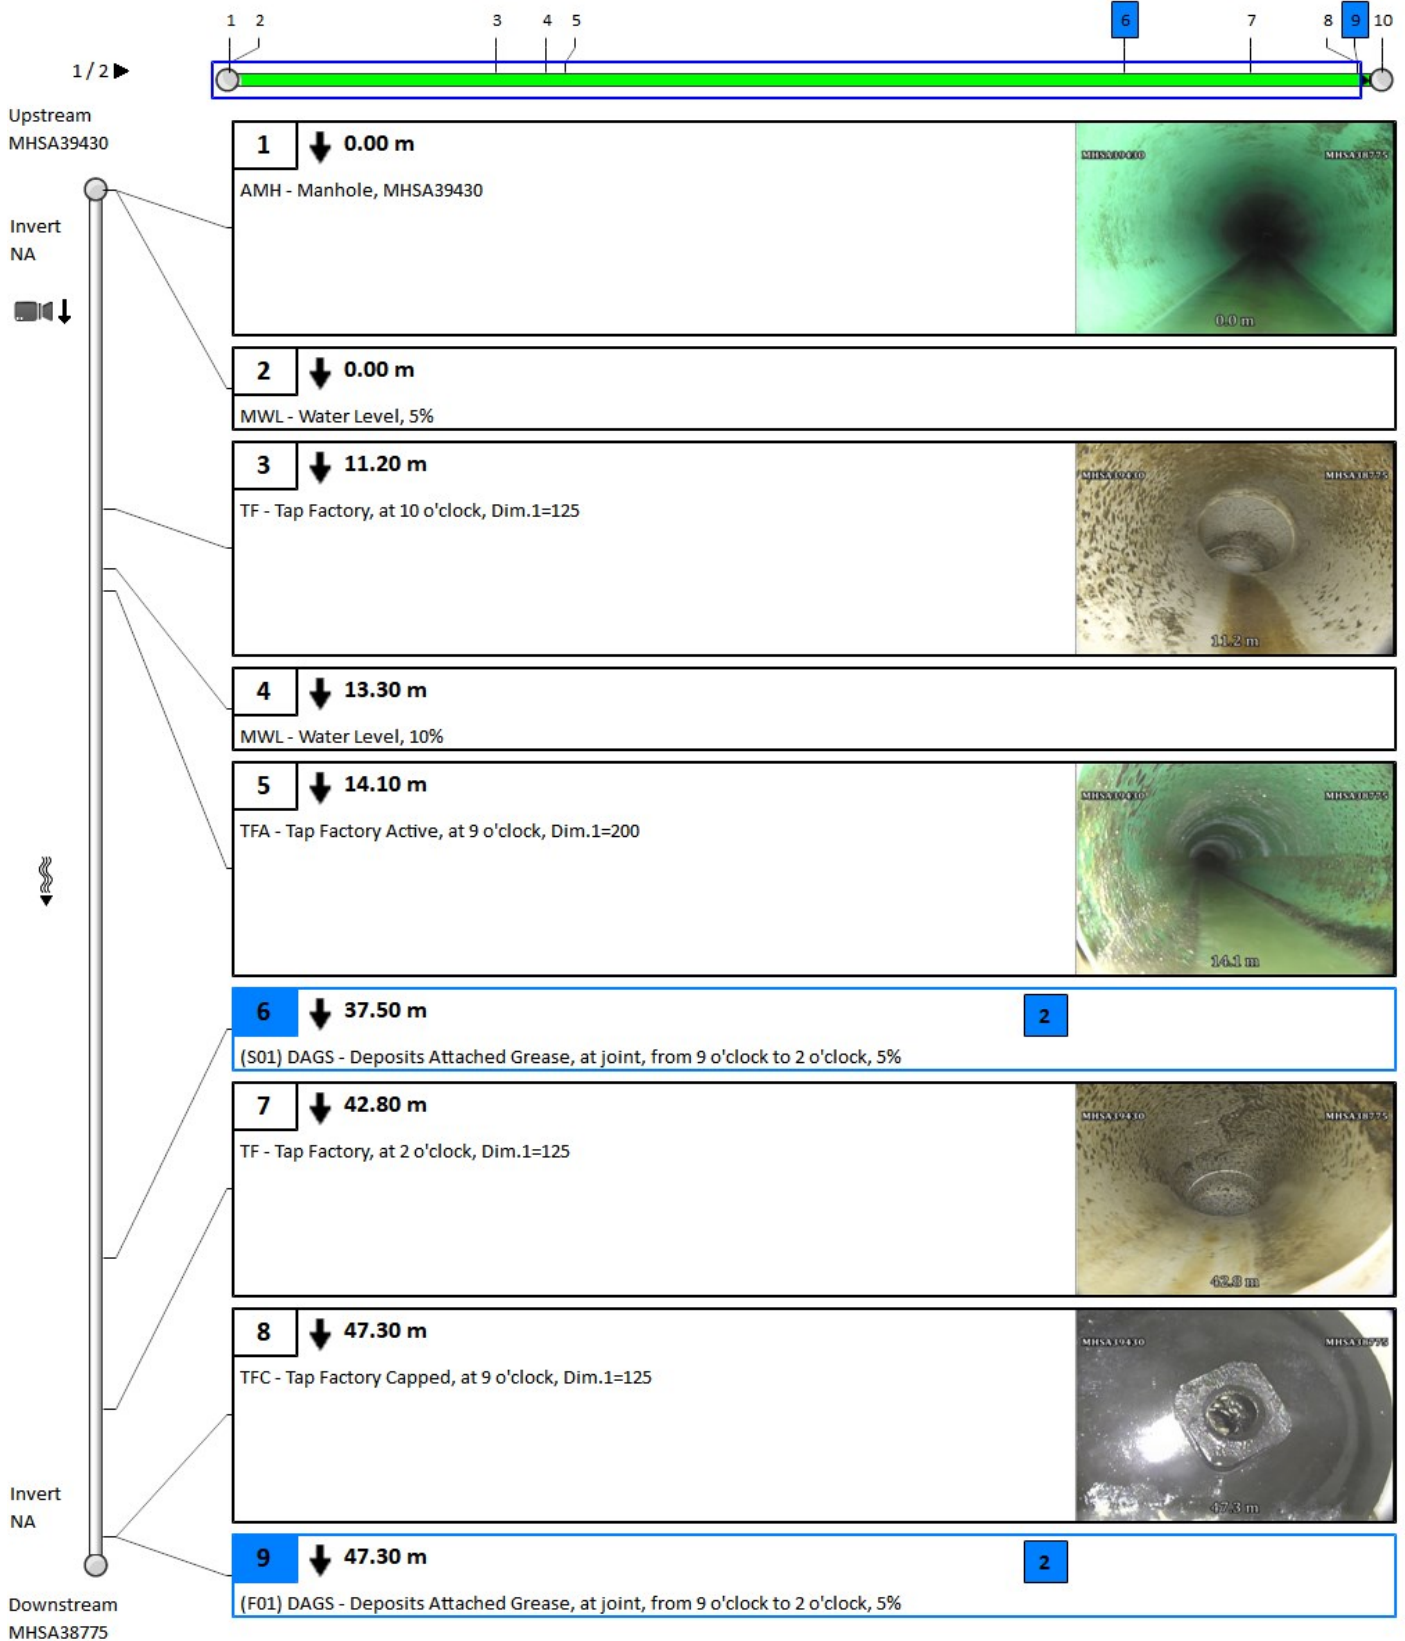
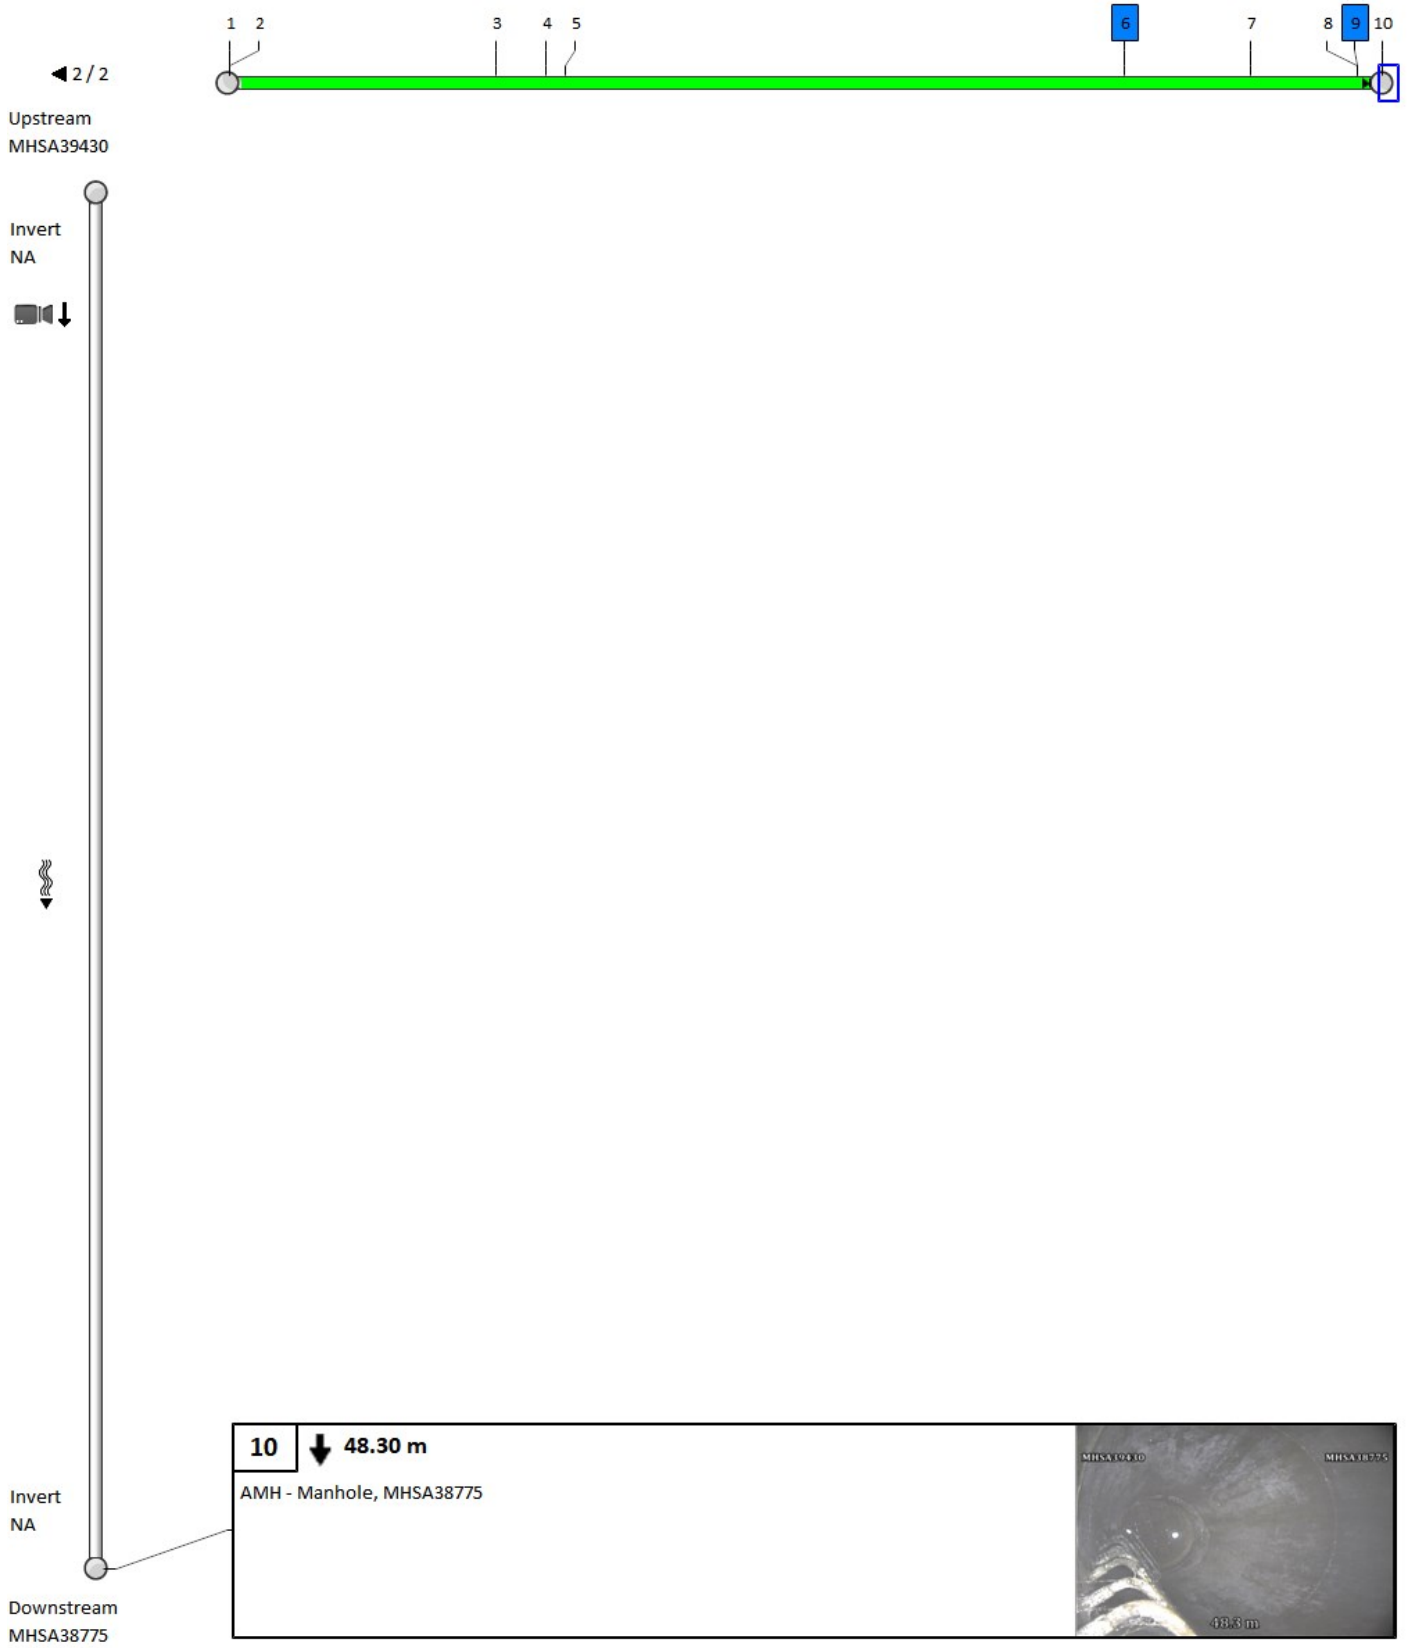
Pipe: MHSA39430 MHSA38775	Direction of inspection: MHSA39430 --> MHSA38775
Direction of flow: MHSA39430 --> MHSA38775	Direction: Direction of flow

Peak: 0	Peak: 2	Peak: 2
Quick rating: 0000	Quick rating: 2600	Quick rating: 2600
Score: 0	Score: 12	Score: 12
Index: 0	Index: 2	Index: 2
