CONSERVATION PLAN 359 KENT STREET, 436 & 444 MACLAREN STREET, OTTAWA

March 2023

Application File Number: D02-02-21-0095 [ZBLA] & D01-01- 21-0015 [OPA]

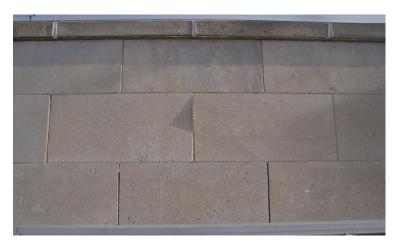
Condition: The limestone cladding is in good condition generally with a few stones at grade level that have been adversely affected by de-icing salts. A number of stones have surface defects or concretions that have not weathered well; however, they are limited in number. A detailed condition assessment of each stone panel will be completed as part of the dismantling process. There are a number of stone panels where the mortar is missing from the joints particularly in the area of the introduced Kent Street entrance providing a general sense of how difficult the removal of the mortar from the units may be during the salvage process.

Figures 7: View of the Niagara limestone cladding above the Kent Street entrance. Note the variations in the material, coursing and the window sill course band the length of units corresponding with the cladding coursing. Mortar is missing from a number of joints. Source: Commonwealth 2023.

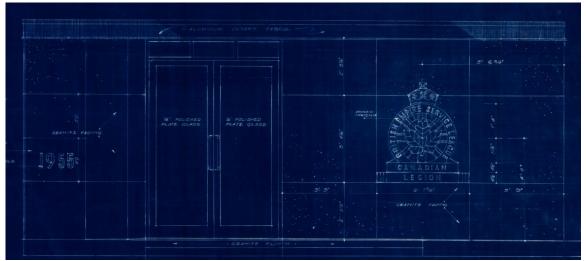
Figures 9: Elevation of the Gilmour Street entrance illustrating the arrangement of the granite cladding. The Royal Canadian Legion crest was removed in 2009 and the original granite panels removed and new material inserted possibly due to the poor condition of the material. Note the two radius cut granite panels to the left of the door and the panel arrangement to the right of the door. Source: 1955 Drawing Set A5

Condition: De-icing slats have had a major impact on the lower three stones set at floor level. The surfaces are disaggregated and crumble to the touch. The memorial stone with an incised date and inscription is in better condition although it is not clear when the inscription was incised.

Preservation of the six intact polished granite cladding panels to the left of the entrance door including the memorial stone, and the installation of three new polished granite panels to match the material in form, finish and colour.

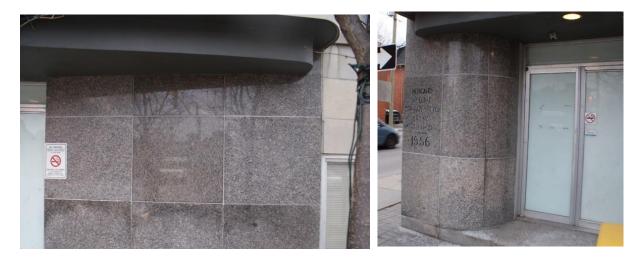
Figures 10 & 11: (6 -left) View of the introduced polished granite panels to the right of the Gilmour Street entrance. (7-right) View of the original polished granite panels. Source: Commonwealth 2023

Restoration: Reinstate new polished granite cladding to match the original material and panel configuration modified in width to accommodate an increased exit width to the right of the door where the original material was removed in 2009.

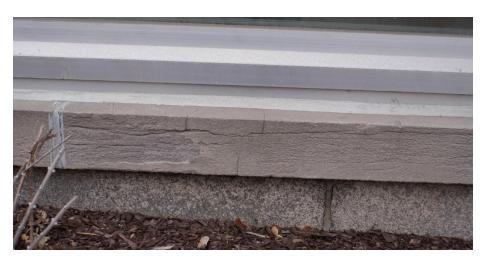
Condition: The limestone windowsills are relatively porous along cleavage planes, susceptible to de-icing salts, and freeze-thaw cycling to varying degrees dependent upon material defects within individual stones. Stones vary in quality as is evident on all elevations where sound stones are interspersed with poorer quality material that has failed. Typical failure patterns include delamination along cleavage planes after the surface has weathered and at the exposed surfaces where the material pops during freeze thaw cycling. Approximately 30% of the sill stones will need to be replaced, and further loss is expected during the dismantling, storage and reinstallation processes; however, between the four façades there should be enough good quality sill stones to complete the Gilmour and Kent street window sill courses.

Figure 13: View of a deteriorated limestone windowsill and the granite plinth course below. The cleavage planes within the limestone sills are evident where the sawn surface has weathered. The cleavages planes follow the layers of deposition of the sedimentary rock. Source: Commonwealth 2022.

Rehabilitation – The limestone sills will continue to weather and deteriorate over time. The limestone is not the highest quality material. Install new pre-cast concrete sills that are tinted to match the dimension, form and colour of the existing material. Replacing them all is the client's preference.

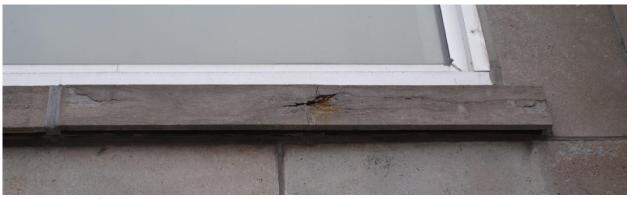
Figure 14: View of a deteriorated limestone windowsill. The cleavage planes within the limestone sills are evident where the sawn surface. The cleavages planes follow the layers of deposition of the sedimentary rock. Source: Commonwealth 2022.

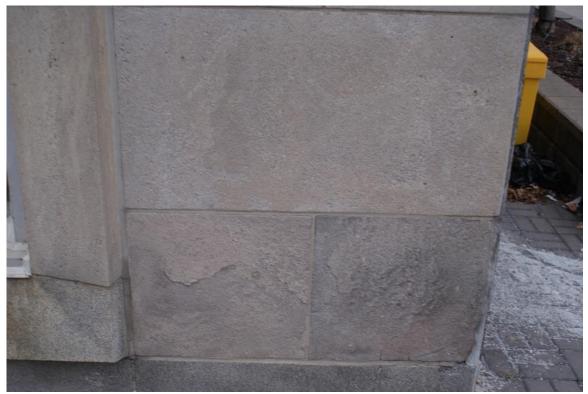
Condition: The limestone window surrounds on the multi-storey windows on Kent and Gilmour are generally in good condition. There is some deterioration of the surface due to de-icing salts where the units are in proximity to grade, some material defects, and rust staining of the material. The condition of the individual units will be assessed and noted during the dismantling phase.

Figure 15: Detail view at the base of the wall at the south-west corner. The surface of the two Niagara limestone panels at the base of the wall are scaling due to de-icing salts. The granite plinth course is evident at the bottom of the photo. The Niagara limestone window surround is the vertical element to the left and a granite window sill/surround below. Source: Commonwealth 2022.

Preservation of the limestone window surrounds and reinstallation in the Kent and Gilmour Street façades.

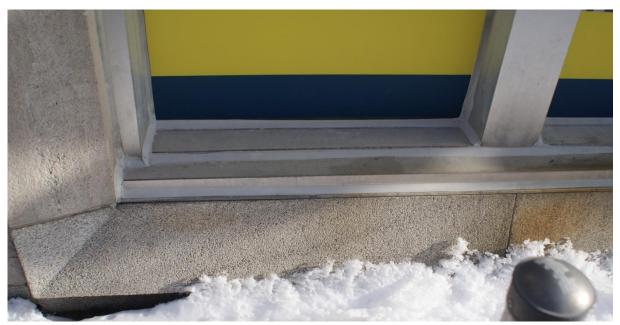
Figure 16: Detail view of the base of the Kent Street window. The horizontal units at the base of the window are formed of the same material as the granite plinth course. The vertical stone to the left is a limestone unit. Note the close match in colour and surface texture. Source: Commonwealth 2023

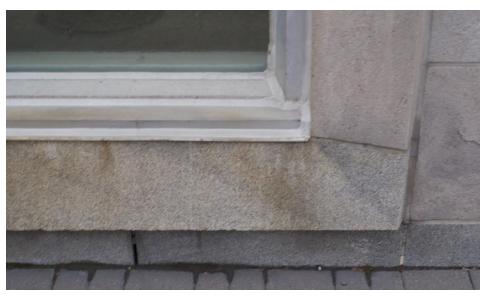
Condition: The granite sill on the Kent Street window is in good condition. The condition of the granite plinth course buried below grade has not been determined.

Figure 18: Detail of the granite plinth course and windowsill granite surround at the base of the three-storey Kent Street window. The colour of the granite sill is very close to the limestone cladding and window surrounds. Source: Commonwealth 2022.

Preservation of the intact granite sill and plinth course panels and reinstallation in the Kent and Gilmour Street façades forming an upstand wall supporting curtain wall glazing. The condition of the material buried below grade has not been determined.

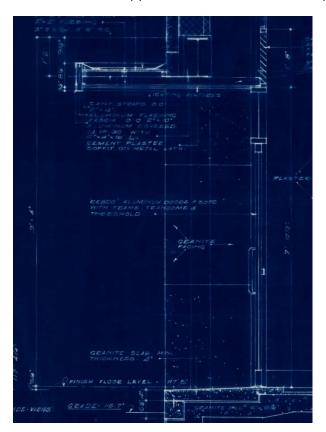
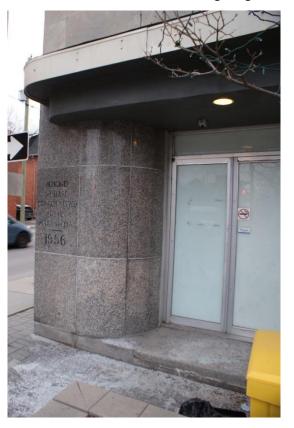
Condition: The canopy has been modified with a dropped modern enclosure with recessed lighting.

Figures 19 & 20: Detail section of the Gilmour Street Entrance illustrating the form and materials and the relationship to the entrance doors. Existing view of the canopy illustrating alterations to the canopy and entrance doors. Source: Original 1955 Drawing Set A5 & Commonwealth 2022.

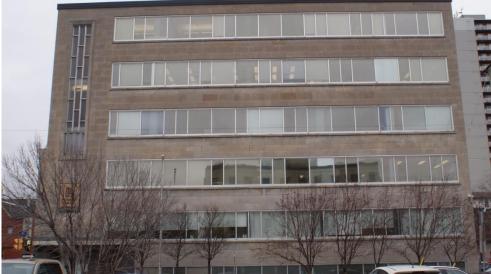
Figure 23: View of the

windows on the Gilmour Street façade. All of the original windows have been replaced with the exception of the three-storey window above the Gilmour Street entrance. Source: Commonwealth 2022.

Rehabilitation – The windows are being replaced with a modern aluminum thermal unit. The horizontal and vertical arrangement of the original sash should be maintained in the new units. The horizontal division at the midpoint of the height of the units is an important feature adding to the horizontal sweep of the façades a character defining feature of the International Style.

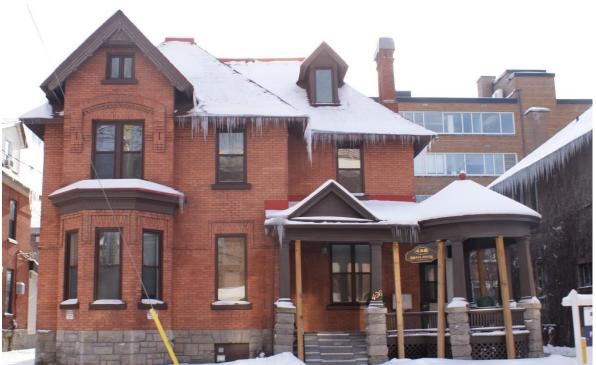
The building at 436 MacLaren is in good condition overall with the exception of the one-storey porch. The coursed limestone pillars supporting the deck structure need to be dismantled and rebuilt with a new foundation. The deck structure which is supported on the masonry piers will also need some attention.

Figure 25: View of 436 MacLaren Street. The masonry piers supporting the porch have settled due to inadequate foundation depth. A detailed assessment of the condition of the porch is required. Guidelines from the CHCDP provide guidance for the conservation approach to the materials and assemblies. Source: Commonwealth 2023.

- d) Owners are encouraged to engage a heritage professional with experience in historic porch restoration when considering porch work.
- e) Where a porch or balcony is badly deteriorated, it should be conserved, not replaced. Where components are beyond reasonable repair, new components should match the originals in terms of design and detail, with the same materials, style and size, as closely as possible.
- g) Any changes to railing heights are required to meet the standards of the Ontario Building Code (OBC). As part of the Building Permit process, owners should discuss options under Part 11 of the OBC that would allow for the retention of the existing railings with heritage staff and a Building Official.
- i) Masonry piers that support historic porches should be conserved. Repairs should be made in kind.

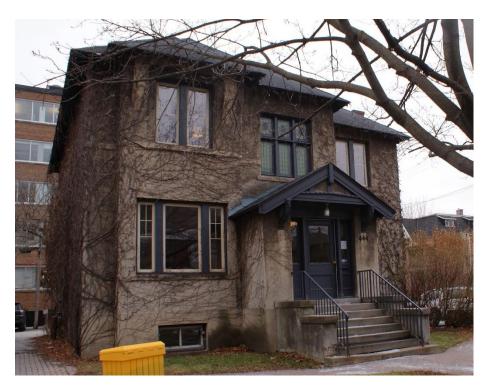
The building at 444 MacLaren is covered in vines that should be removed. The guidelines contained in the 2022 Centretown Heritage Conservation District Plan (CHCDP) are provided to guide the conservation work.

Figure 26: View of 444
MacLaren Street. The
stuccoed exterior wall is
covered in vines that should
be removed before they
have an adverse impact on
the stucco finishes. Source:
Commonwealth 2022

1. Conserve, maintain and repair historic masonry, stucco, and wood exterior cladding.

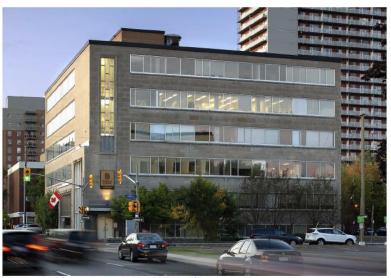
Figure 2 - Current condition, 2022, of Legion House
