February 7, 2023

File: 64913.01 – R03

**Re: Slope Stability Assessment
5497 Manotick Main Street
Manotick (Ottawa), Ontario**

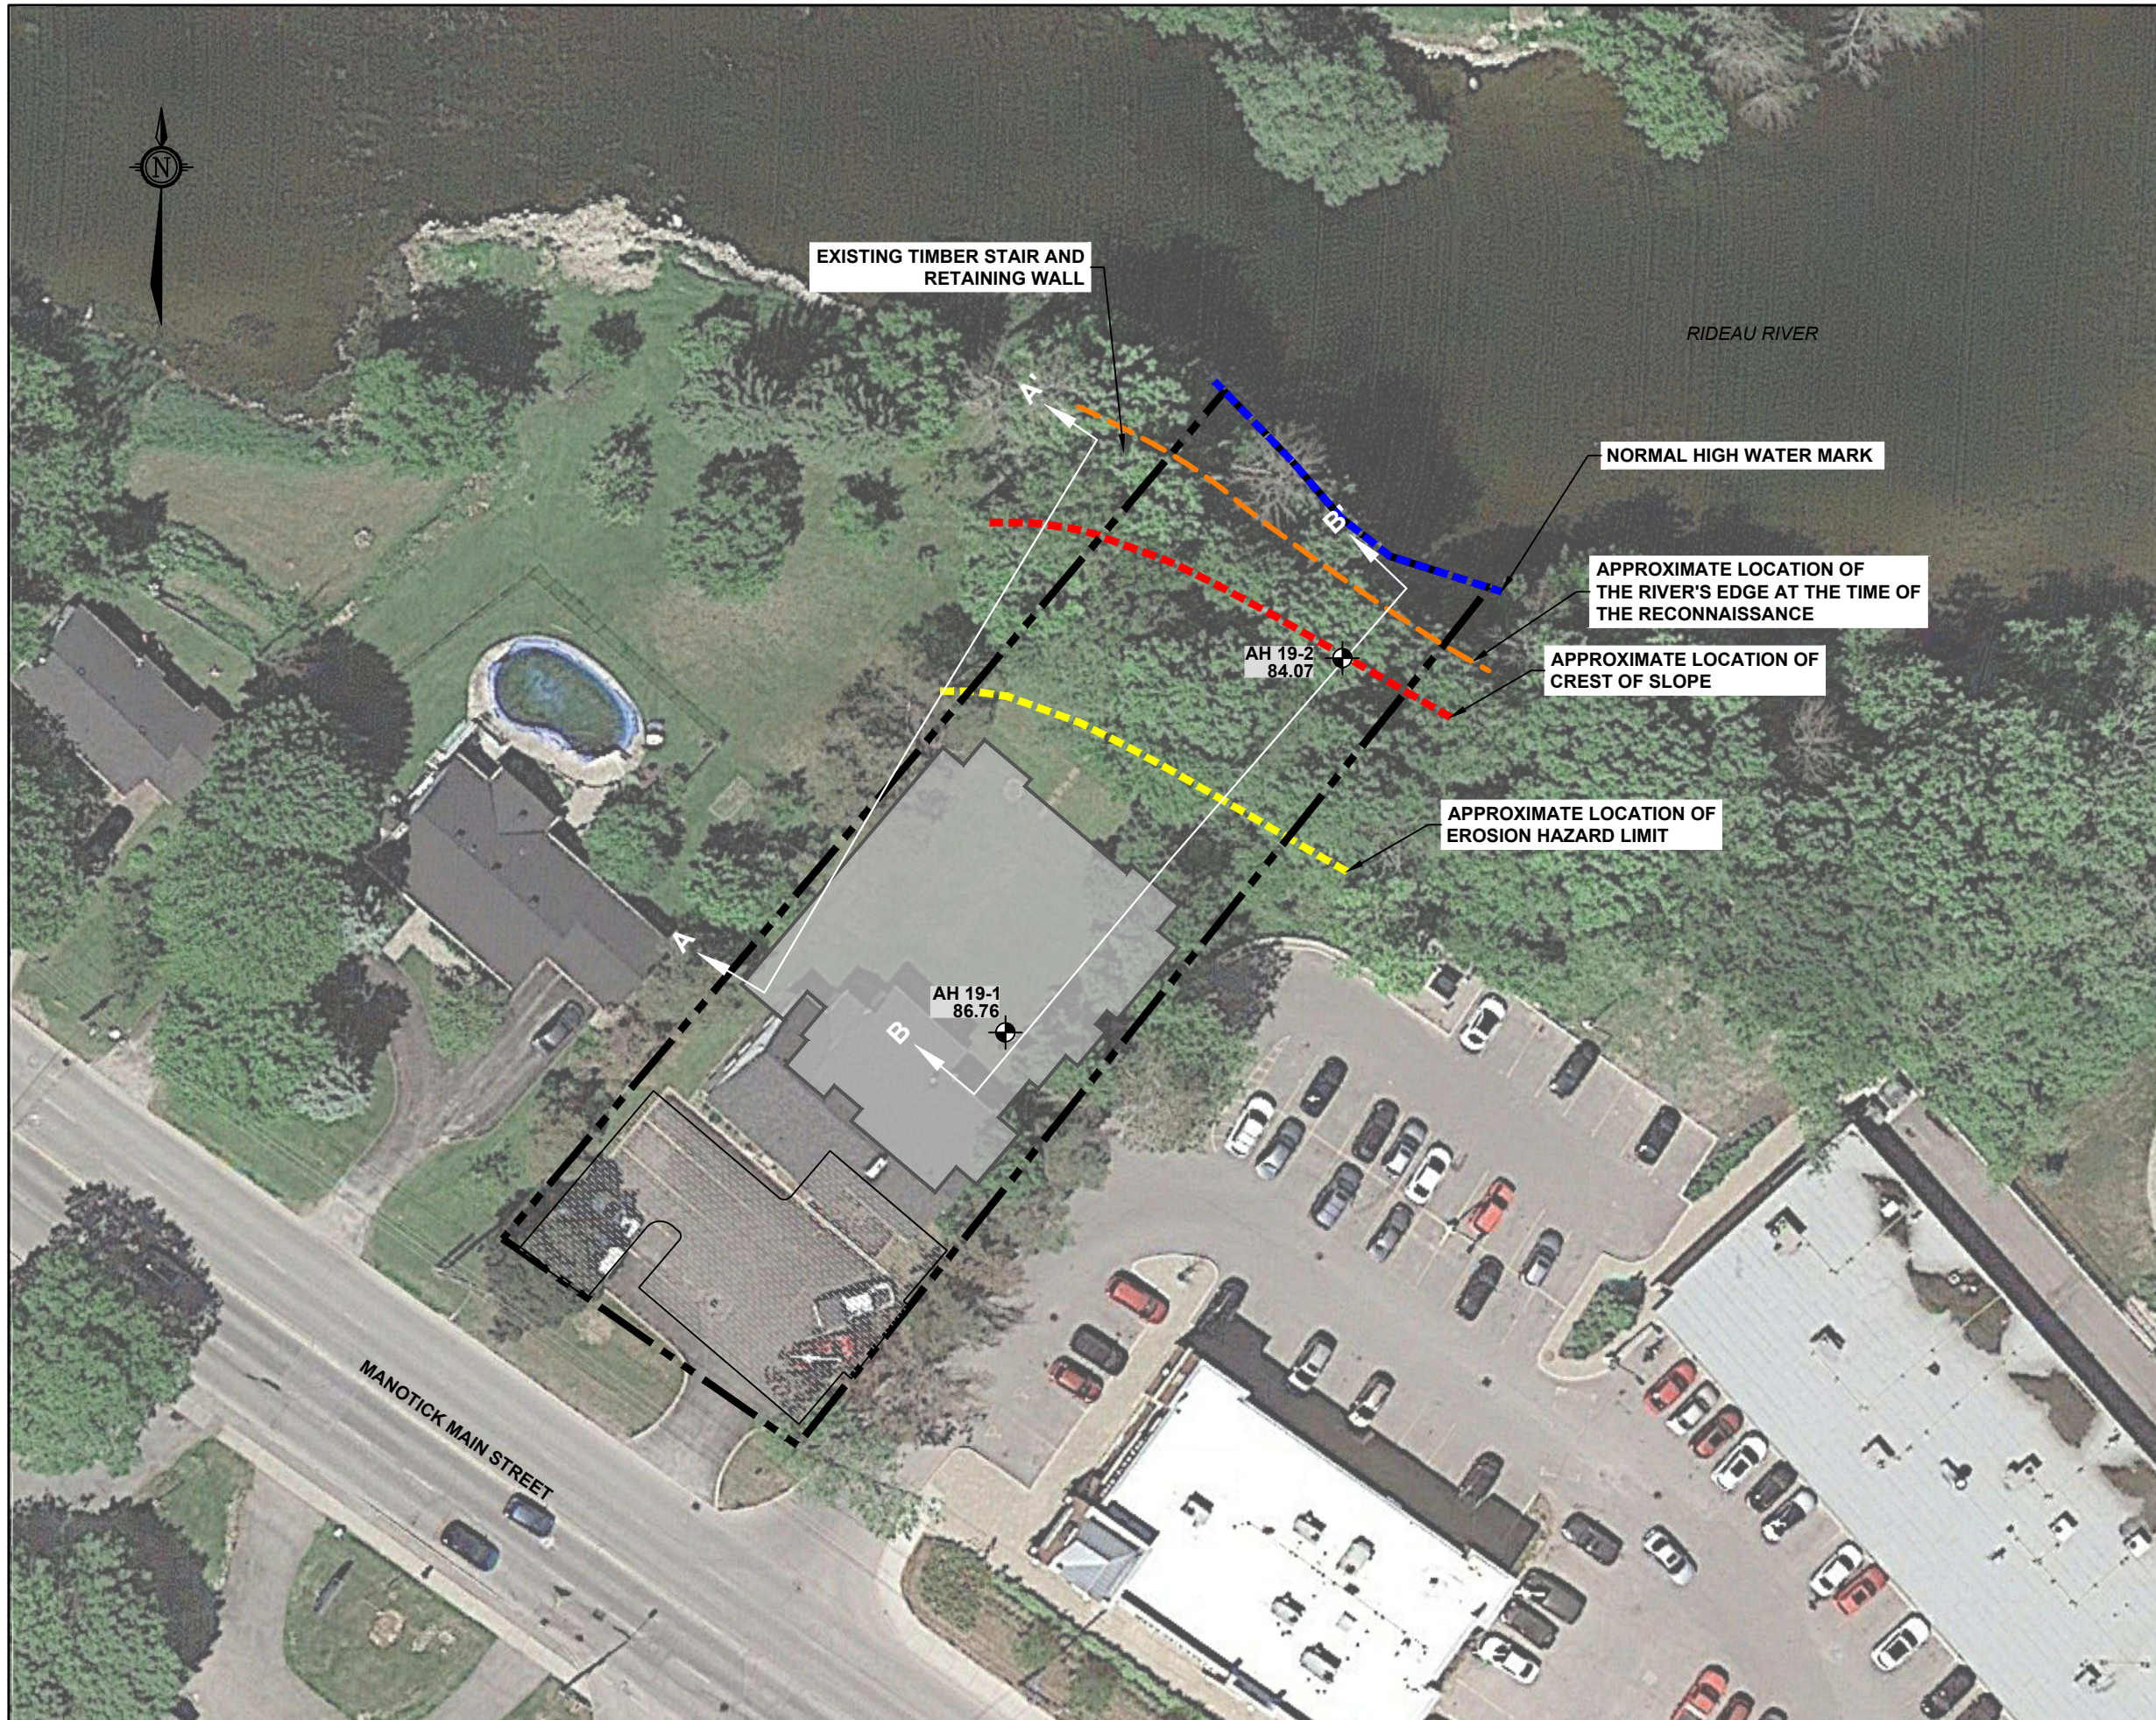
Client		OLIGO GROUP	Project	64913.01
Location		5497 MANOTICK MAIN STREET MANOTICK, ON		
Drwn by	Chkd by	SITE PLAN		
S.L.	D.C.			
Date	FEBRUARY, 2023	Rev.	2	FIGURE 1

It is noted that at the time of the site reconnaissance the Rideau River was experiencing high water levels and based on a review of aerial photographs, the river's edge had advanced up the toe of the slope. The approximate location of the river's edge at the time of the site reconnaissance is shown on Figure 1. Also shown on Figure 1 are the main components of the proposed development based on the Site Plan prepared by P2 concepts dated May 2022 (which was not available to GEMTEC at the time of initial submission of this letter).

The proposed position of the Erosion Hazard Limit is shown on Figure 1, as well as an estimate of the location of the crest of slope line. The location of the crest of slope was not readily identifiable on site during GEMTEC's site visit due to the relatively shallow slopes (refer to the site photographs in Appendix B). A top of slope line is identified on P2 concepts Site Plan south of the existing retaining wall which may be used for reference.

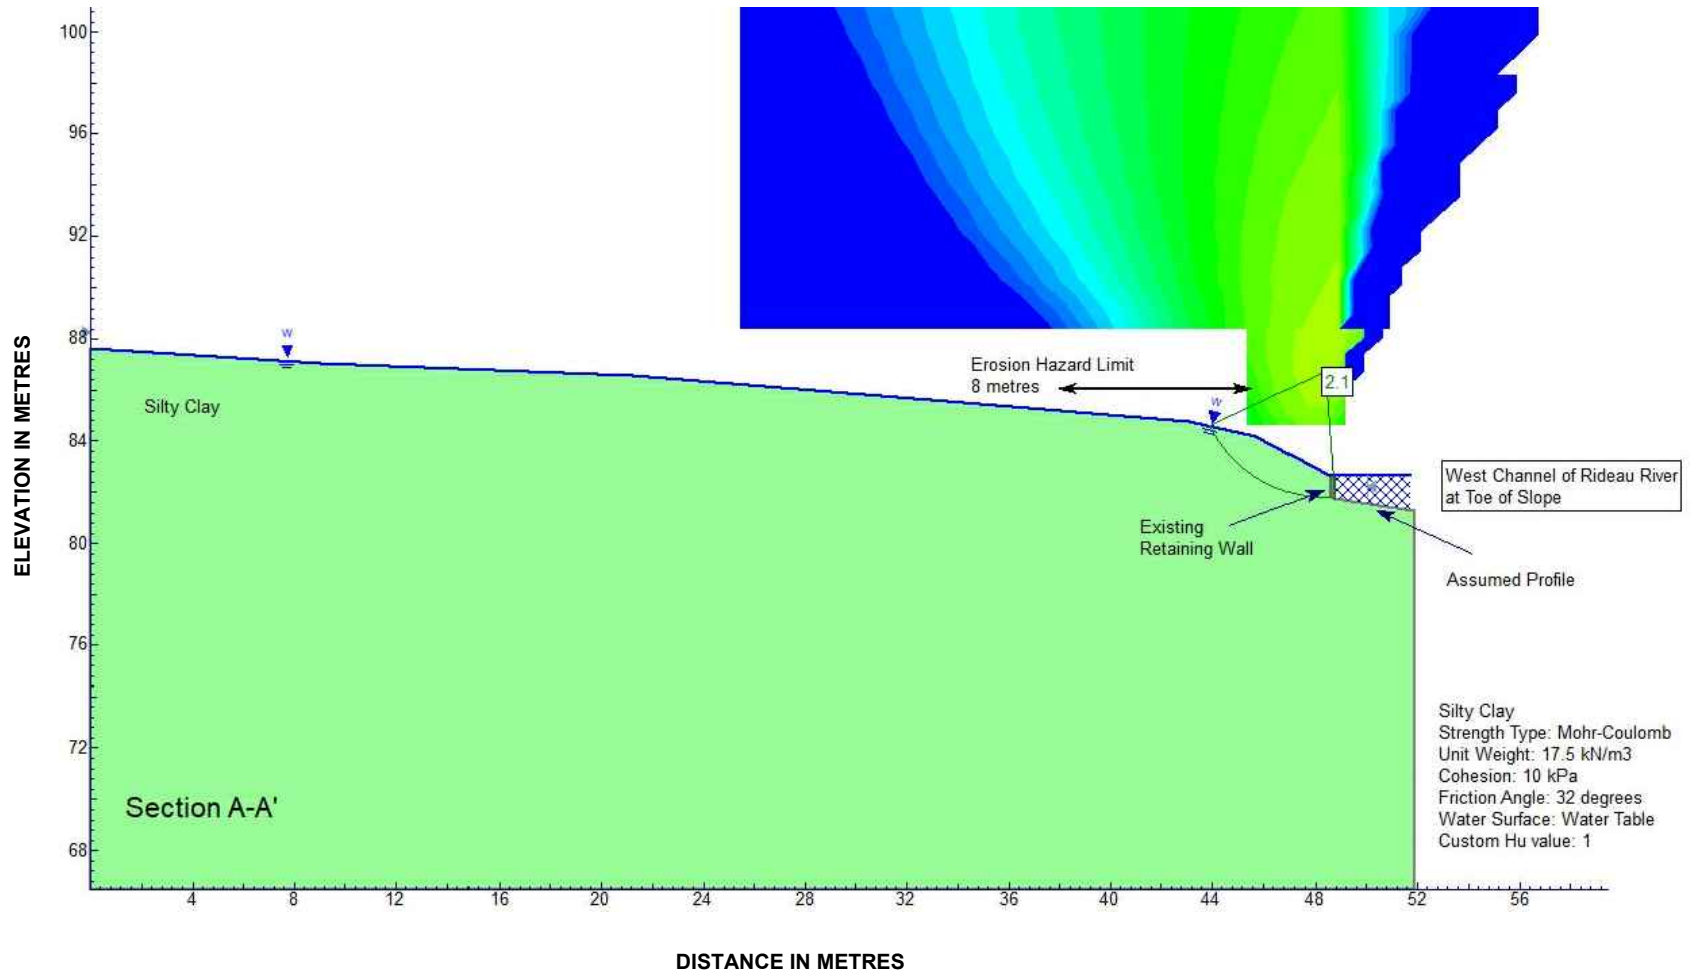
FIGURE A1

The slope stability analyses indicate that the existing slope, in its current configuration, has a factor of safety against overall rotational failure of about 2.1 and 3.1 for Sections A-A' and B-B', respectively. Based on the slope stability analyses, the factors of safety against overall rotational failure for static loading conditions are considered to indicate adequate long-term stability. The results of the stability analyses are provided on Figures A1 and A2 in Attachment A.

than 1.5 (refer to Figures A1 and A2 in Attachment A). Therefore, the Stable Slope Allowance described in the MNR procedures is not required.

Therefore, the Erosion Hazard Limit for the slope at this site is located about 14 metres from the crest of the existing slopes at Sections A-A' and B-B' (refer to Figures A1 and A2). It may be possible to reduce the Toe Erosion Allowance if an additional site visit is carried out when the water levels have receded in order to confirm the state of erosion along the slope toe at the base of the existing retaining wall. However, this may not be warranted, should the proposed development not be impacted by the proposed (conservatively estimated) Erosion Hazard Limit.

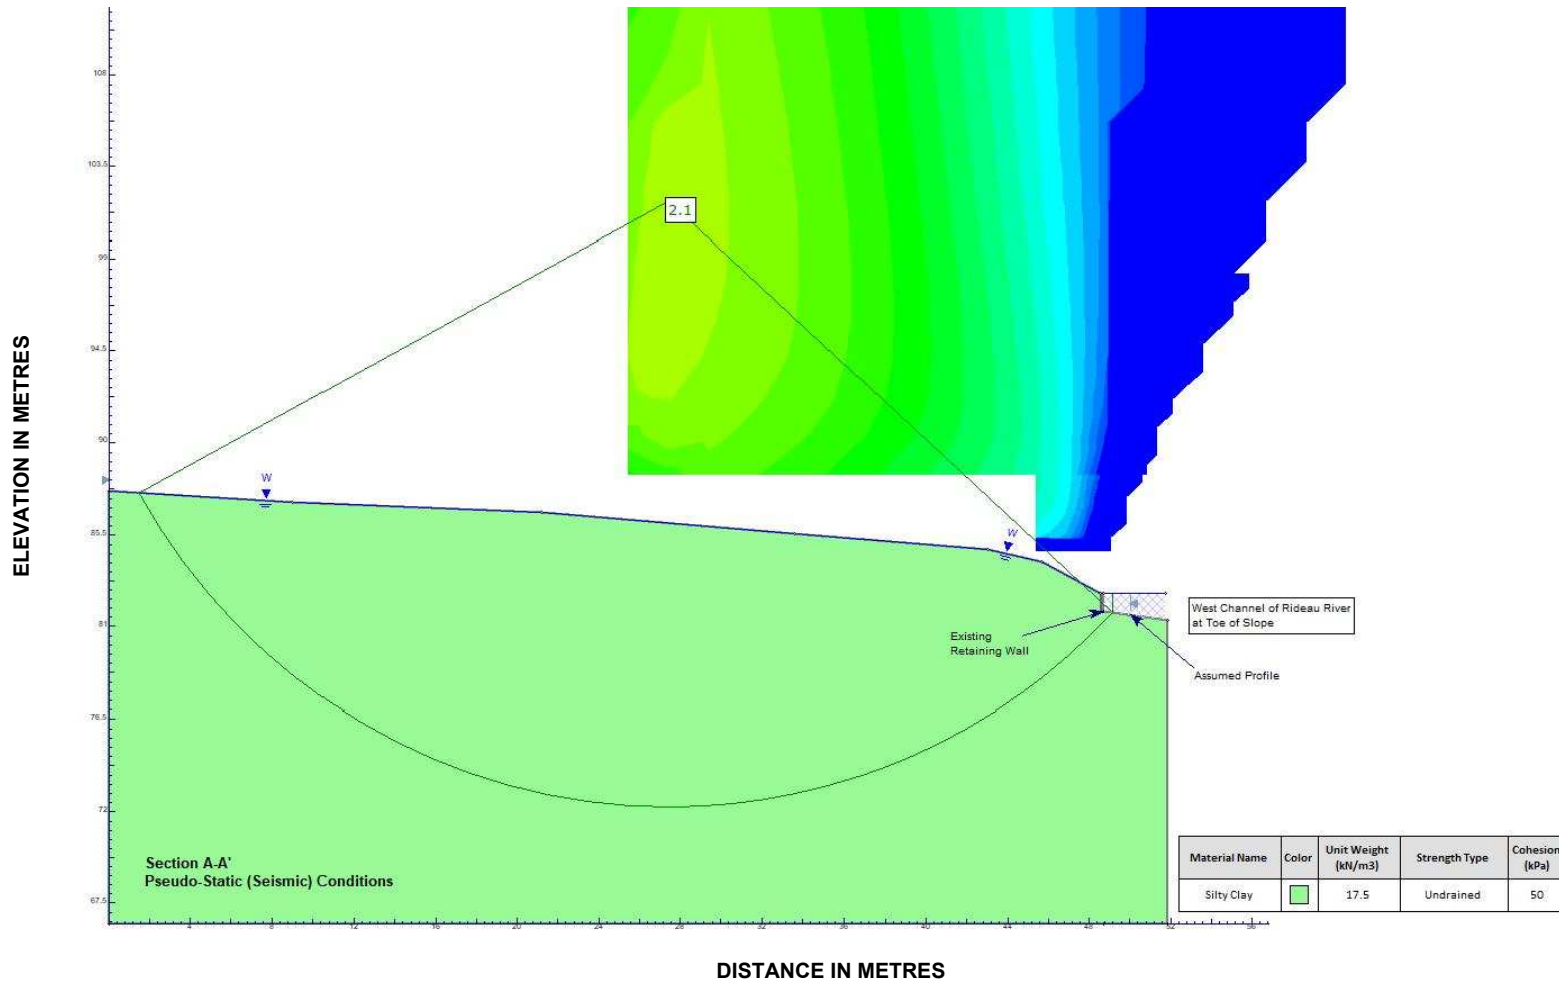
FIGURE A3

The slopes at Sections A-A' and B-B' were analysed for pseudo-static (seismic) conditions using the undrained silty clay strength parameters. A seismic coefficient of 0.14 was used in the pseudo-static analyses (i.e., half of the Peak Ground Acceleration for Ottawa (Barrhaven) according to the Ontario Building Code 2015). The slope stability analyses indicate that the existing slopes, in their current configurations, have a factor of safety against failure of greater than 1.1 for pseudo-static (seismic) conditions, which is considered acceptable. The results of the pseudo-static stability analyses are provided on Figures A3 and A4 in Attachment A.

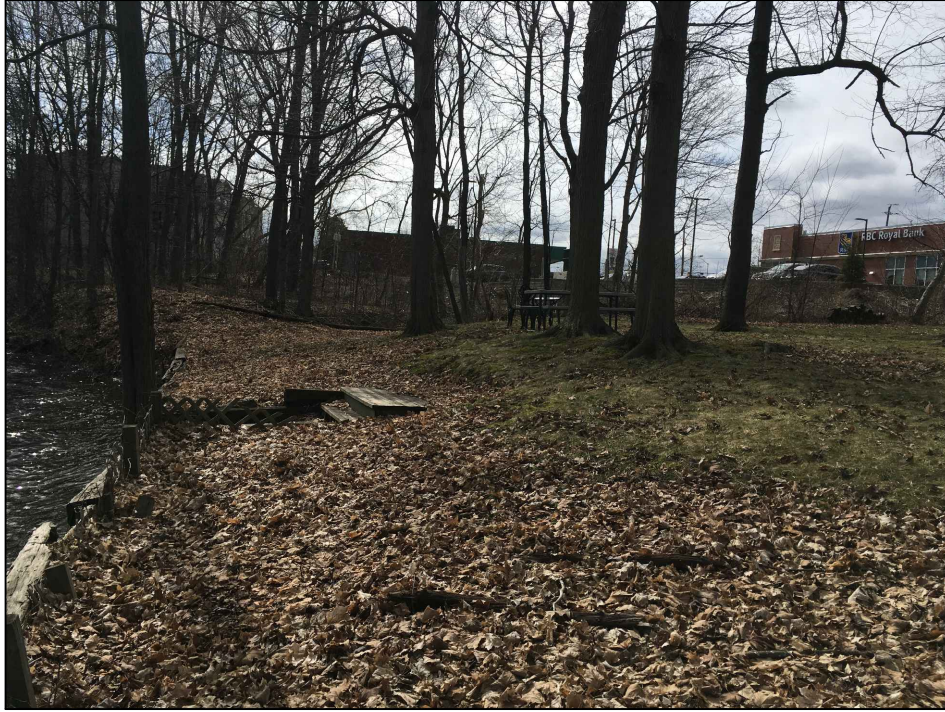
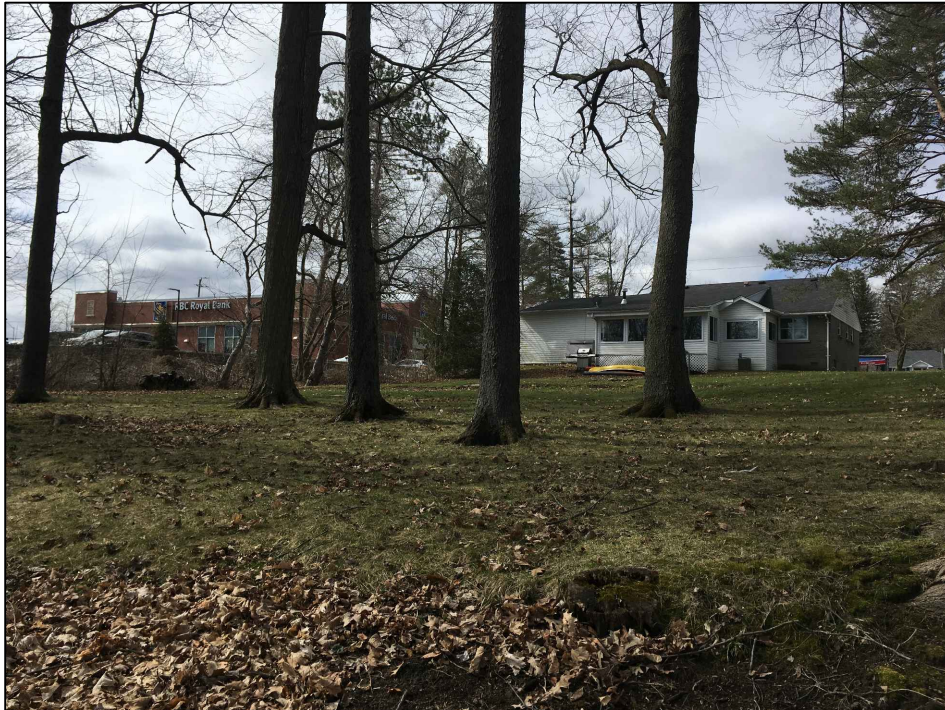
FIGURE B1

- The slopes at the property are relatively flat and are vegetated with grass and large trees.
- An existing timber retaining wall is located at the toe of the slope.
- The river's edge was located at the retaining wall at the time of the site reconnaissance and, as a result, the conditions at the toe of the retaining wall could not be observed.
- Based on visual observations, the height of the retaining wall appears to be less than 1 metre.
- No signs of active erosion or instability were observed at the subject site (i.e., tension cracks, rotational failures, etc.) at the time of the site reconnaissance.

GEMTEC recommends that the existing vegetation and trees along the slope be maintained, to ensure the stability of the slope is not affected.
