March 24, 2021

File: 64913.01 – R01

**Re: Slope Stability Assessment
5497 Manotick Main Street
Manotick (Ottawa), Ontario**

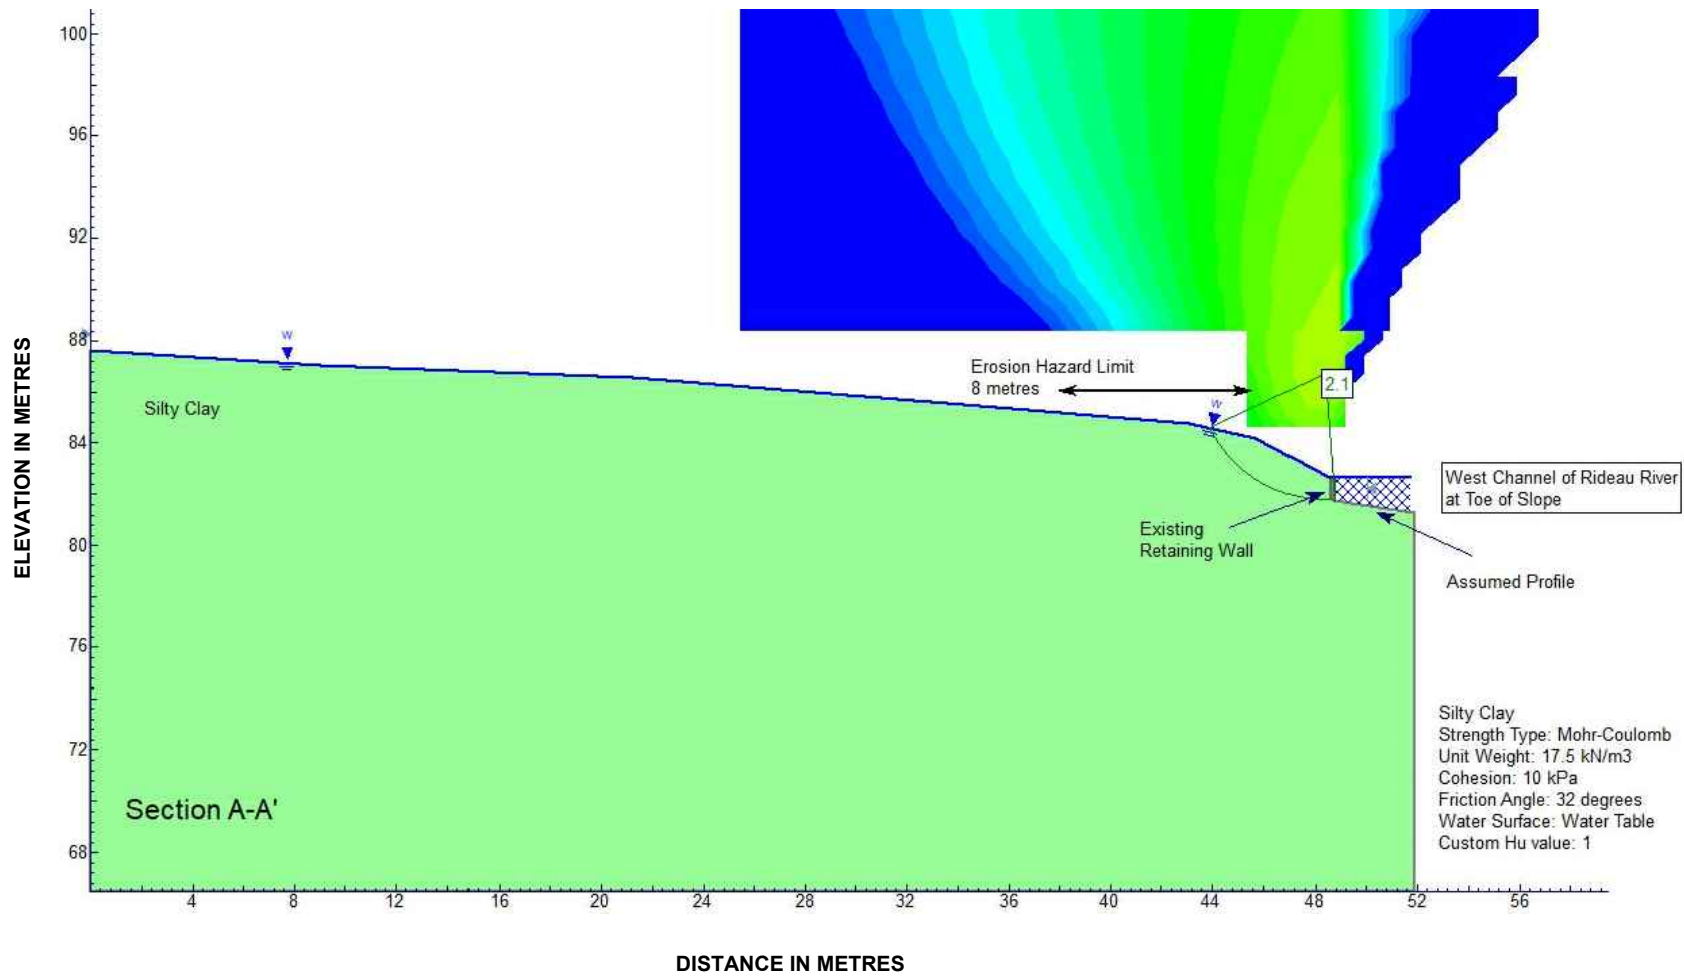
FIGURE A1

The slope stability analyses indicate that the existing slope, in its current configuration, has a factor of safety against overall rotational failure of about 2.1 and 3.1 for Sections A-A' and B-B', respectively. Based on the slope stability analyses, the factors of safety against overall rotational failure for static loading conditions are considered to indicate adequate long term stability. The results of the stability analyses are provided on Figures A1 and A2 in Attachment A.

- The Stable Slope Allowance, as described in the MNR procedures, is the area where a factor of safety of less than 1.5 against overall rotational failure is calculated. The slope stability analyses indicate that the slope has a factor of safety against failure of greater than 1.5 (refer to Figures A1 and A2 in Attachment A). Therefore, the Stable Slope Allowance described in the MNR procedures is not required.

Therefore, the Erosion Hazard Limit for the slope at this site is located about 8 metres from the crest of the existing slopes at Sections A-A' and B-B' (refer to figures A1 and A2). It may be possible to reduce the Toe Erosion Allowance if an additional site visit is carried out when the water levels have receded in order to confirm the state of erosion along the slope toe at the base of the existing retaining wall.

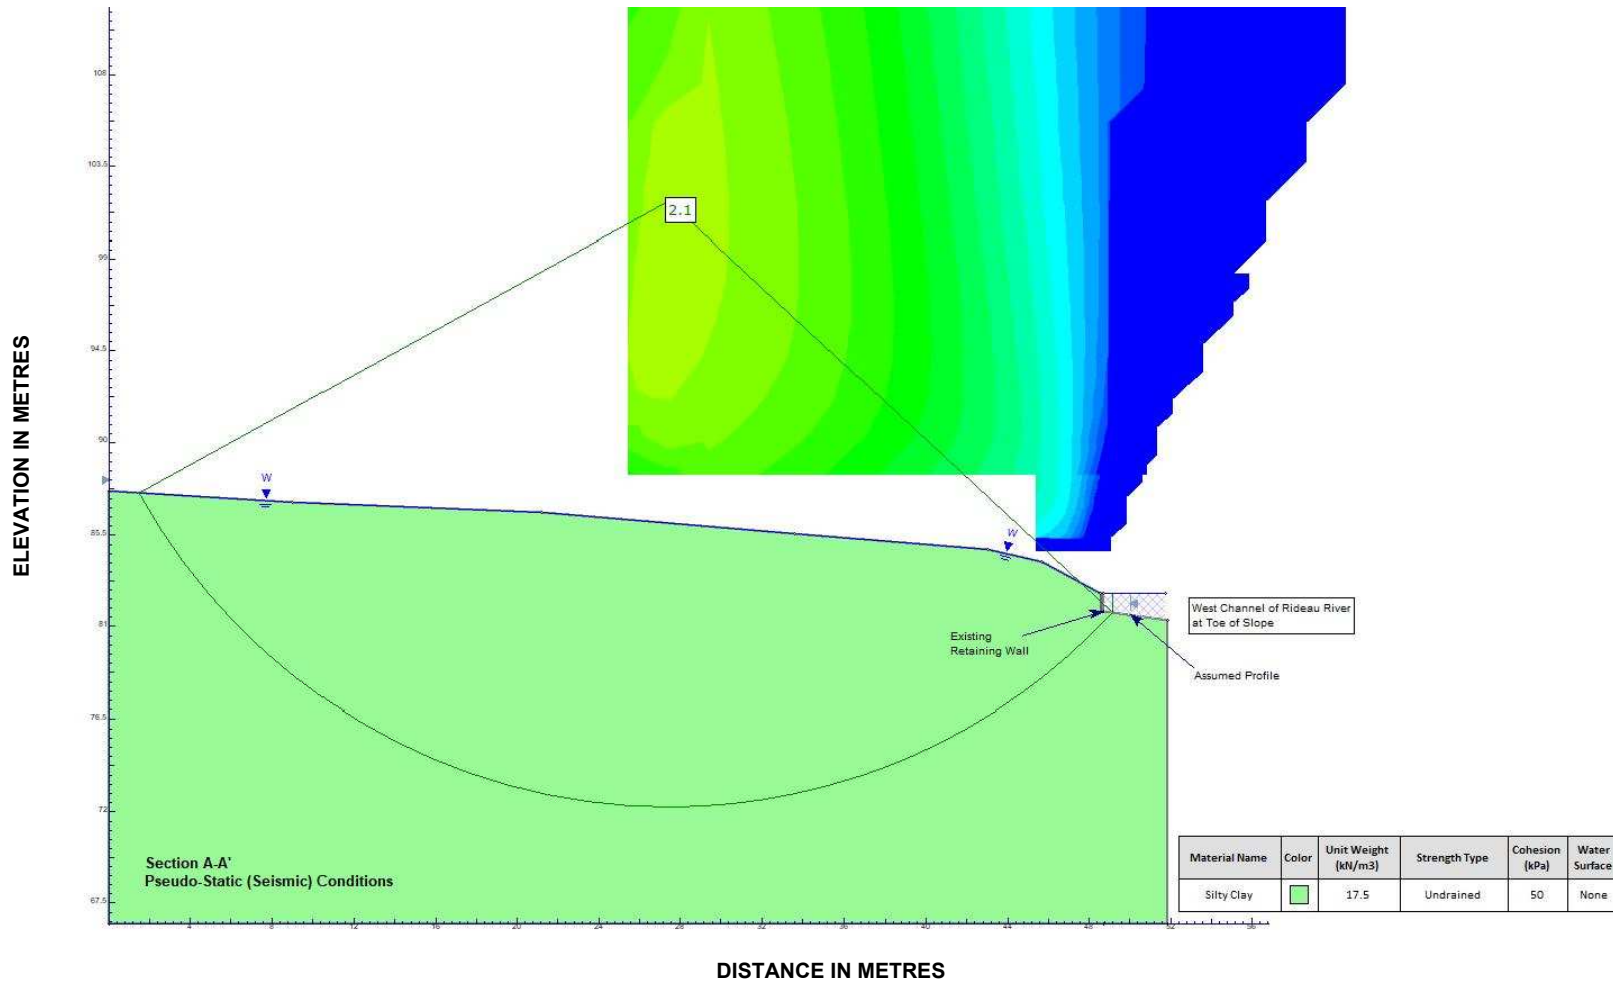
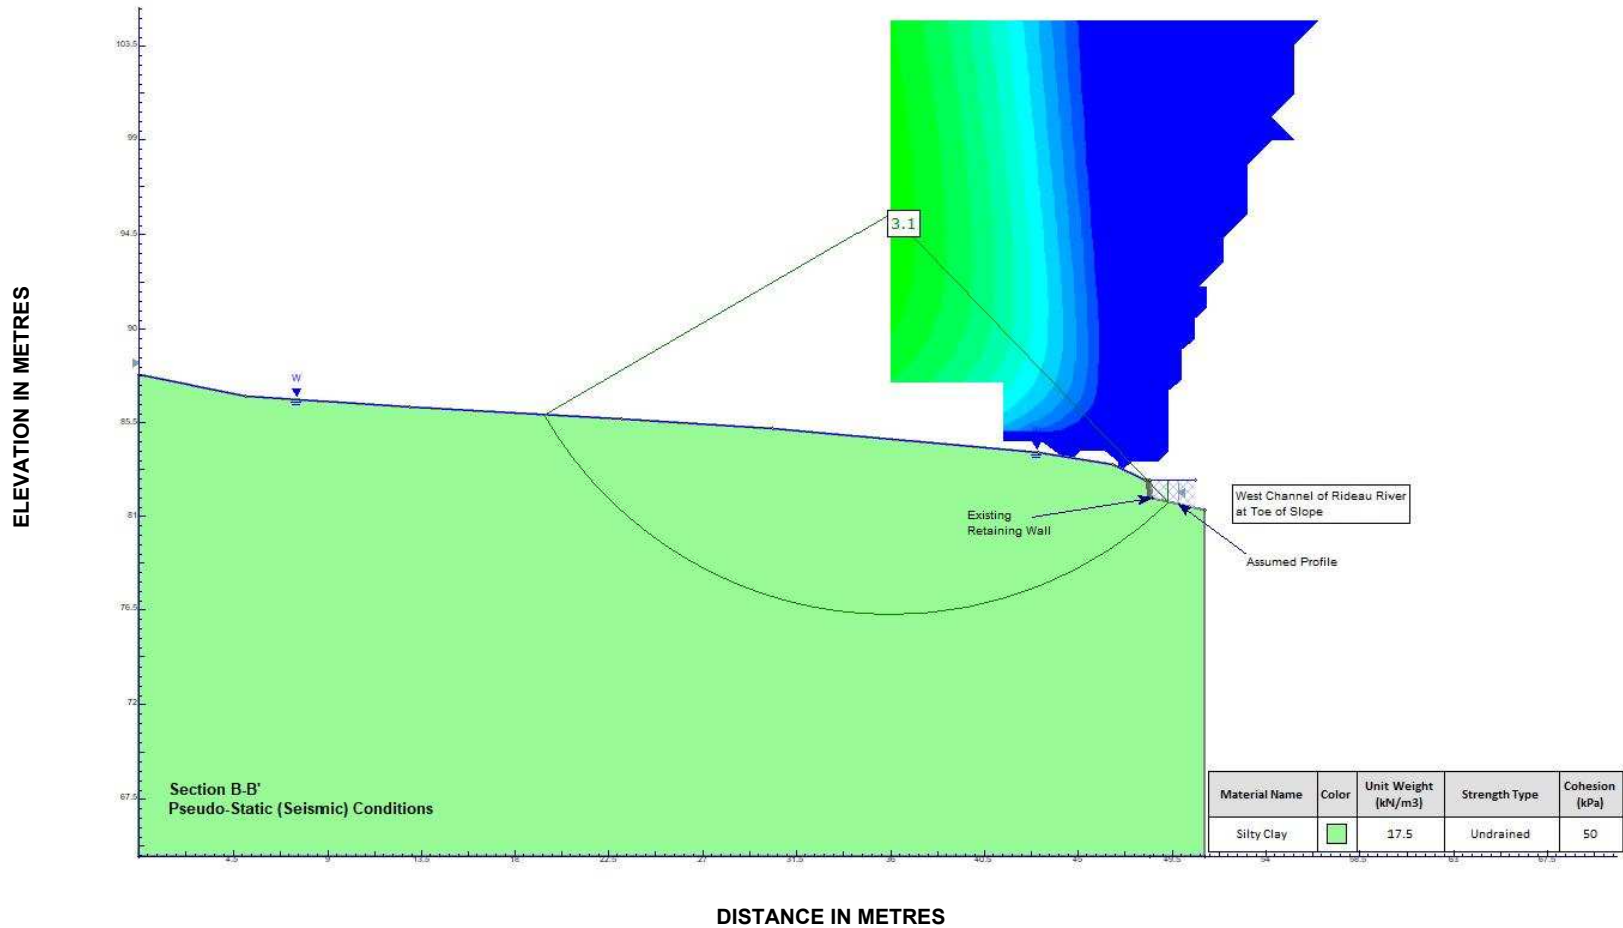
The slopes at Sections A-A' and B-B' were analysed for pseudo-static (seismic) conditions using the undrained silty clay strength parameters. A seismic coefficient of 0.14 was used in the pseudo-static analyses (i.e., half of the Peak Ground Acceleration for Ottawa (Barrhaven) according to the Ontario Building Code 2015). The slope stability analyses indicate that the existing slopes, in their current configurations, have a factor of safety against failure of greater than 1.1 for pseudo-static (seismic) conditions, which is considered acceptable. The results of the pseudo-static stability analyses are provided on Figures A3 and A4 in Attachment A.

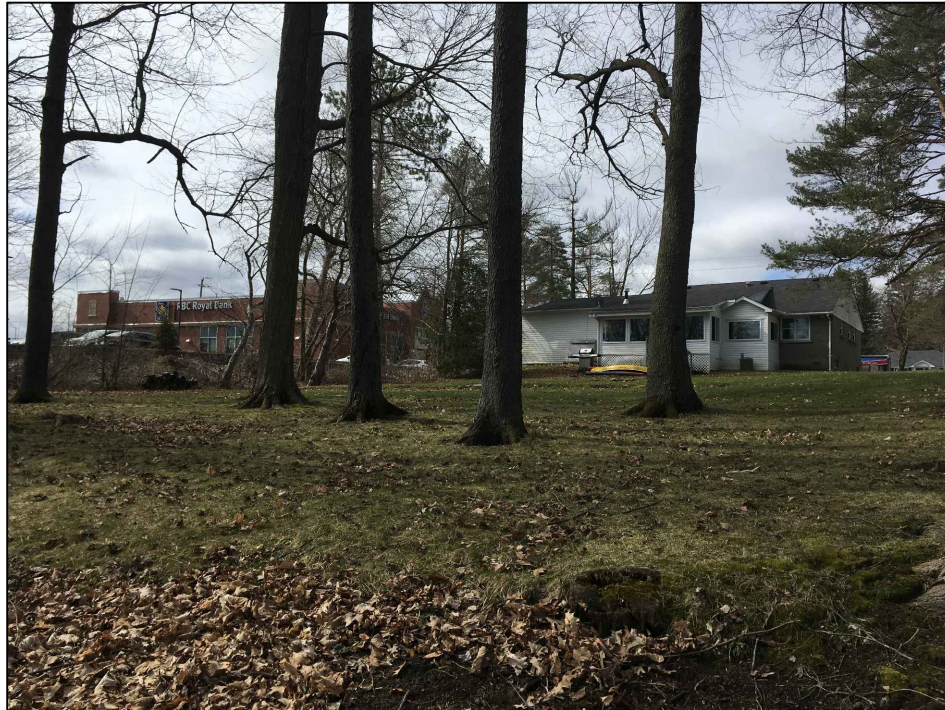
FIGURE B1

- The slopes at the property are relatively flat and are vegetated with grass and large trees.
- An existing timber retaining wall is located at the toe of the slope.
- The river's edge was located at the retaining wall at the time of the site reconnaissance and, as a result, the conditions at the toe of the retaining wall could not be observed.
- Based on visual observations, the height of the retaining wall appears to be less than 1 metre.
- No signs of active erosion or instability were observed at the subject site (i.e., tension cracks, rotational failures, etc.) at the time of the site reconnaissance.

GEMTEC recommends that the existing vegetation and trees along the slope be maintained, to ensure the stability of the slope is not affected.
