TREE CONSERVATION REPORT

6001-6005 Renaud Road

Tree Conservation Report submitted as Partial
Requirements for a Site Plan Control Application, June
12, 2023

Date of Report: June 12, 2023

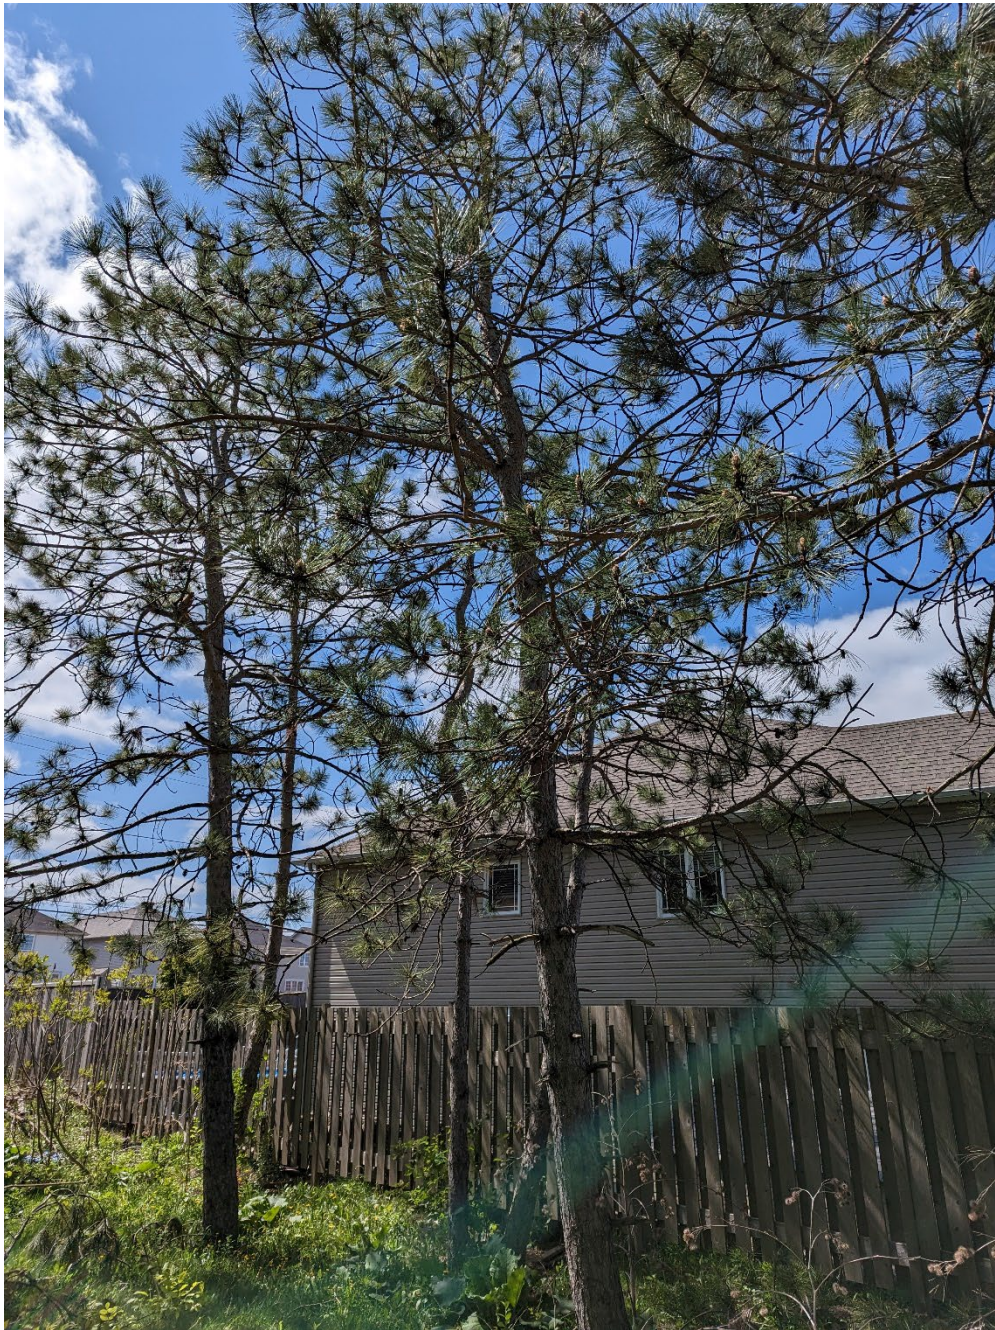
Figure 2 - (Left to Right) Trees 9-13

Trees 9-20 are established red pines. **Tree 20** conflicts with the proposed driveway, but most of the remaining trees can likely be effectively preserved. **Tree 16** is only approximately 1.5m away from the proposed building, and therefore it is expected that the excavation would need to come very close to the trunk. It is for this reason that removal is recommended of Tree 16. For the remainder of the trees in this group (i.e. **Trees 9-15, 17-19**), fencing is to be erected as described below and excavation for the adjacent building should be reduced as much as possible to reduce impact to these trees.

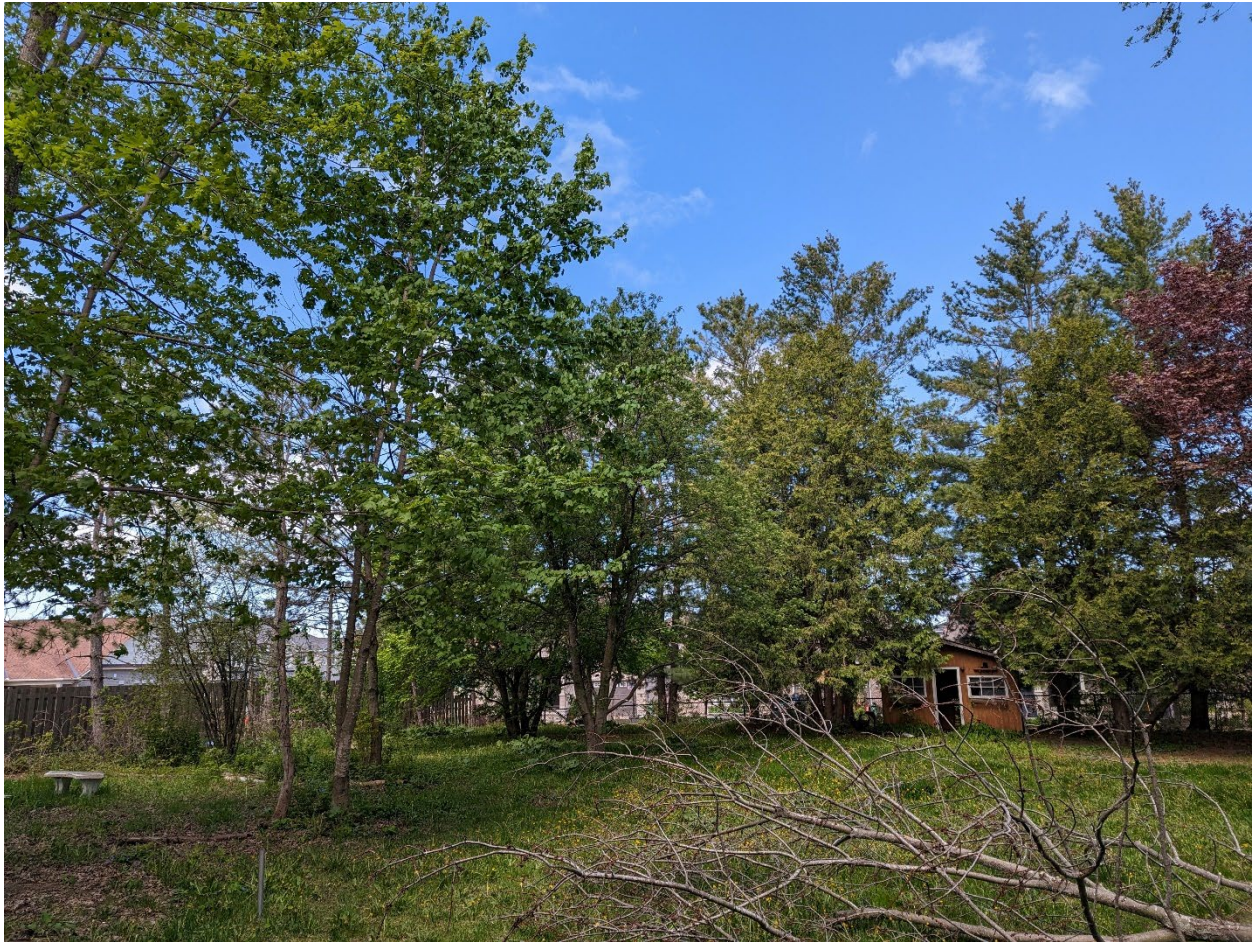
Figure 3 - Western corner of the property (Ziegler is behind the fence in the background)

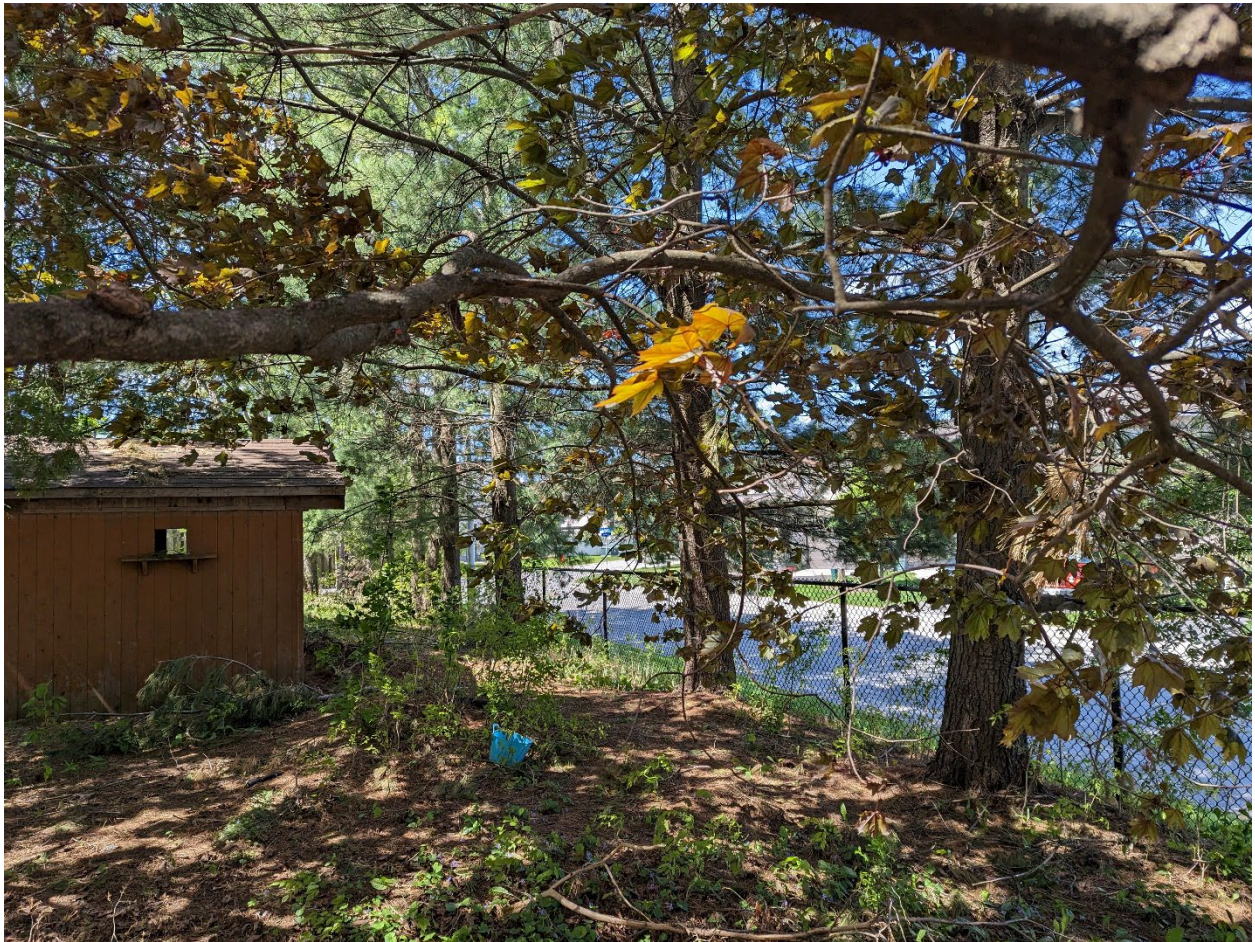
Figure 4 - White pines along the north property line

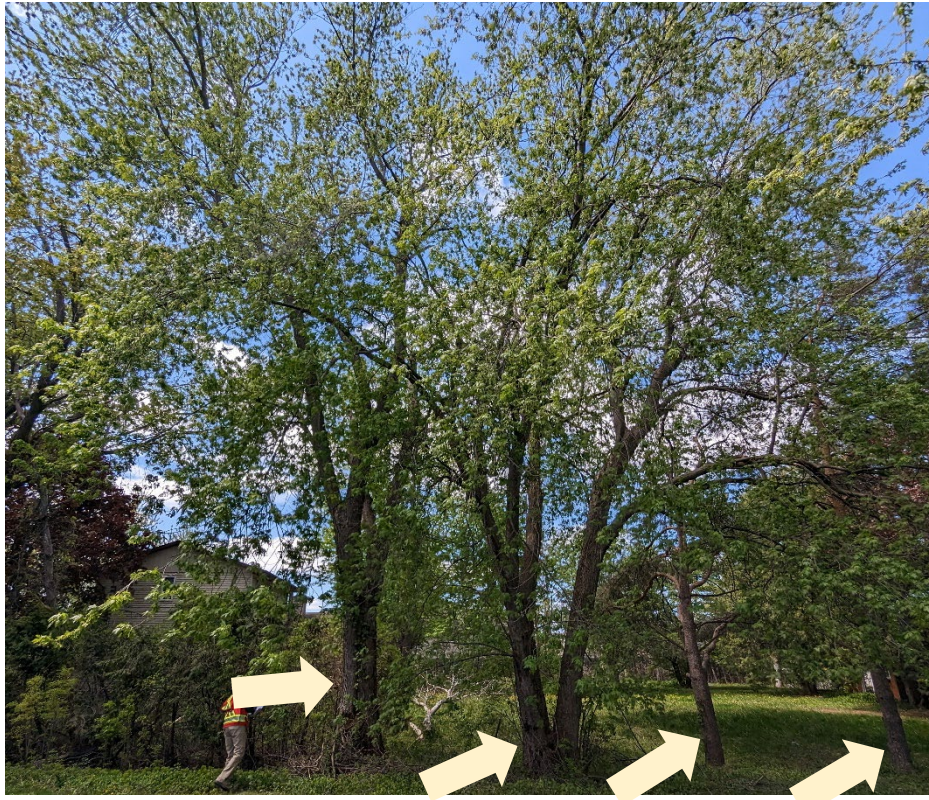
Figure 7 - (Left to Right) Trees 40-43

Initially, options were explored to retain some of the trees at the centre of the property such as 40 and 41, but due to sensitive marine clay soils on the site and the City of Ottawa Tree Planting in Sensitive Marine Clay Soils (2017 Guidelines), these large trees are not retainable.

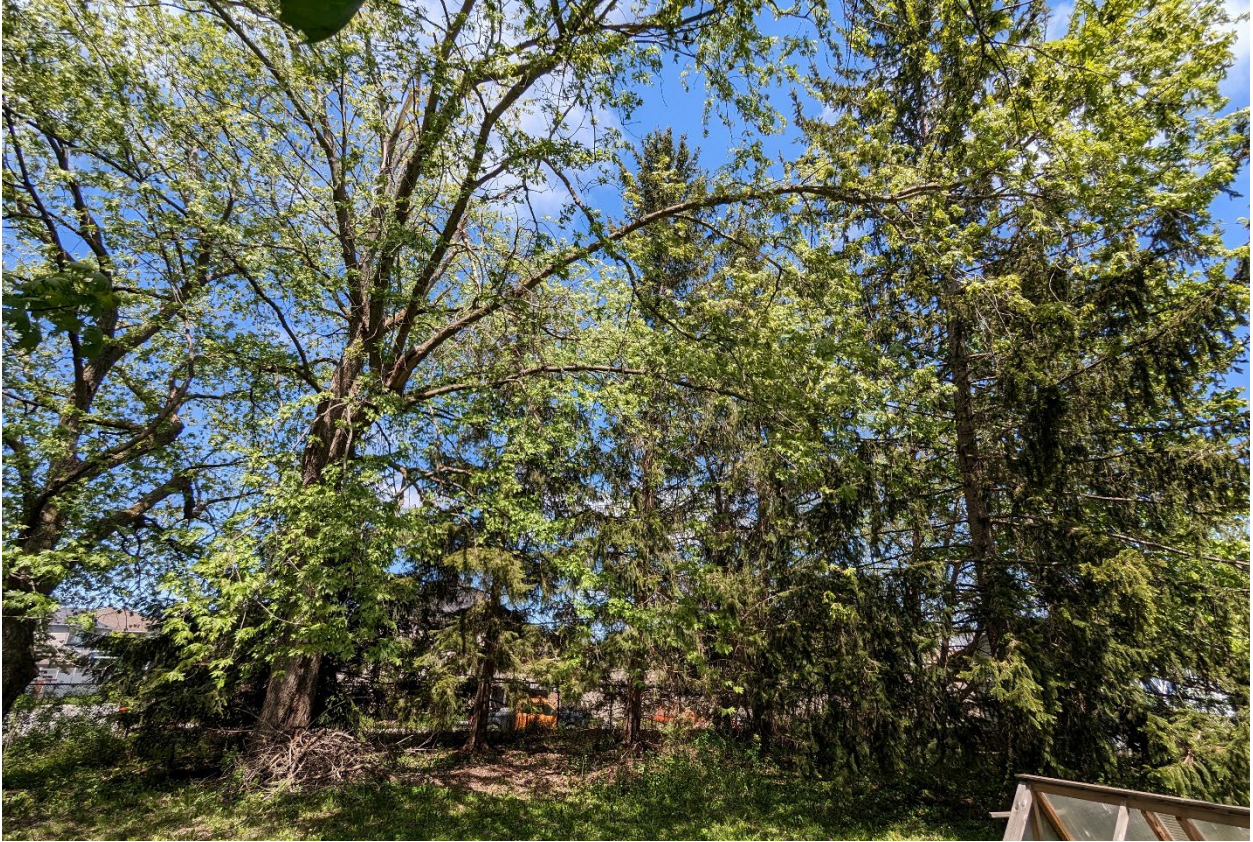
Figure 8 - Northwestern corner of the property

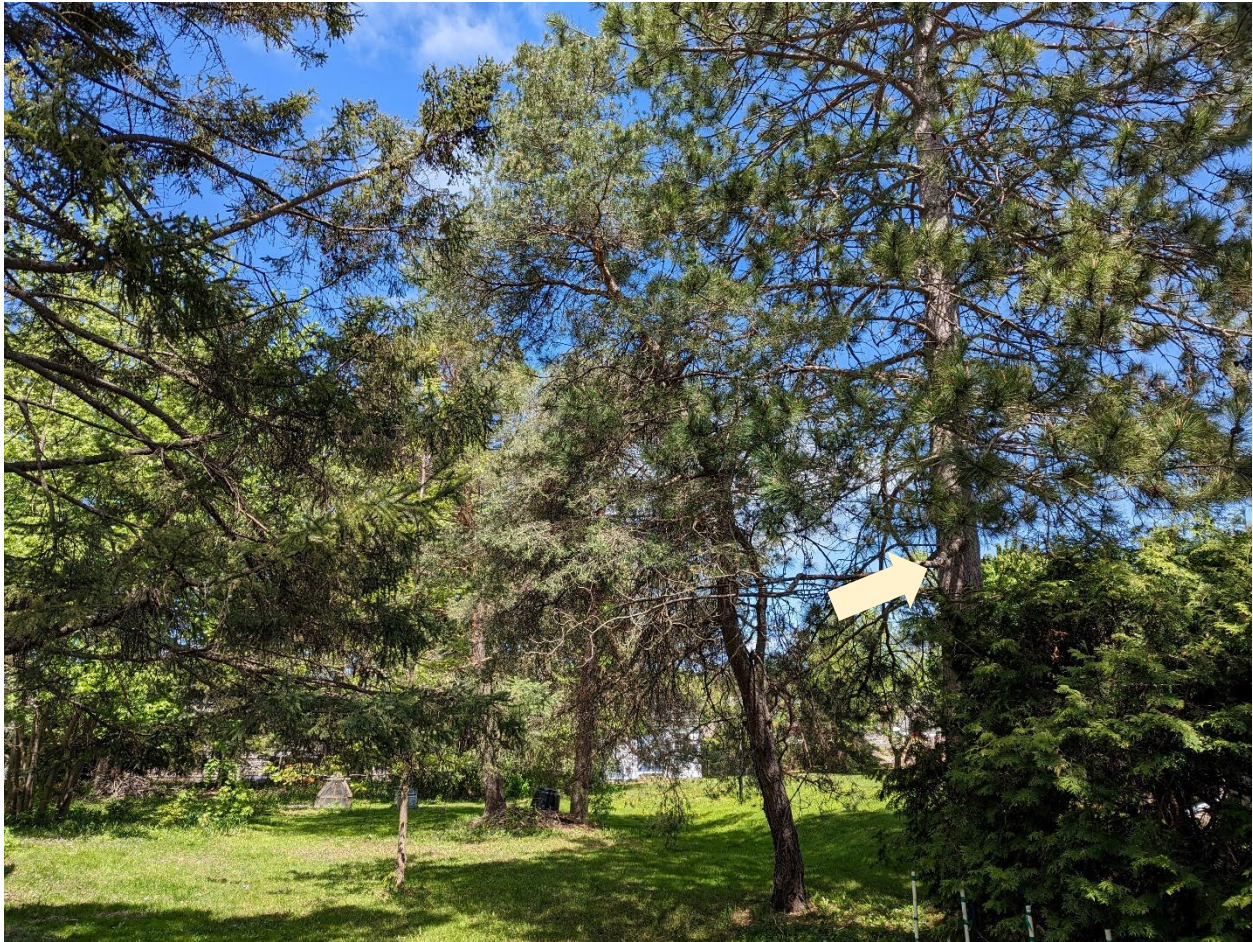
Figure 9 - Looking along the western property line. Tree 66 indicated with arrow

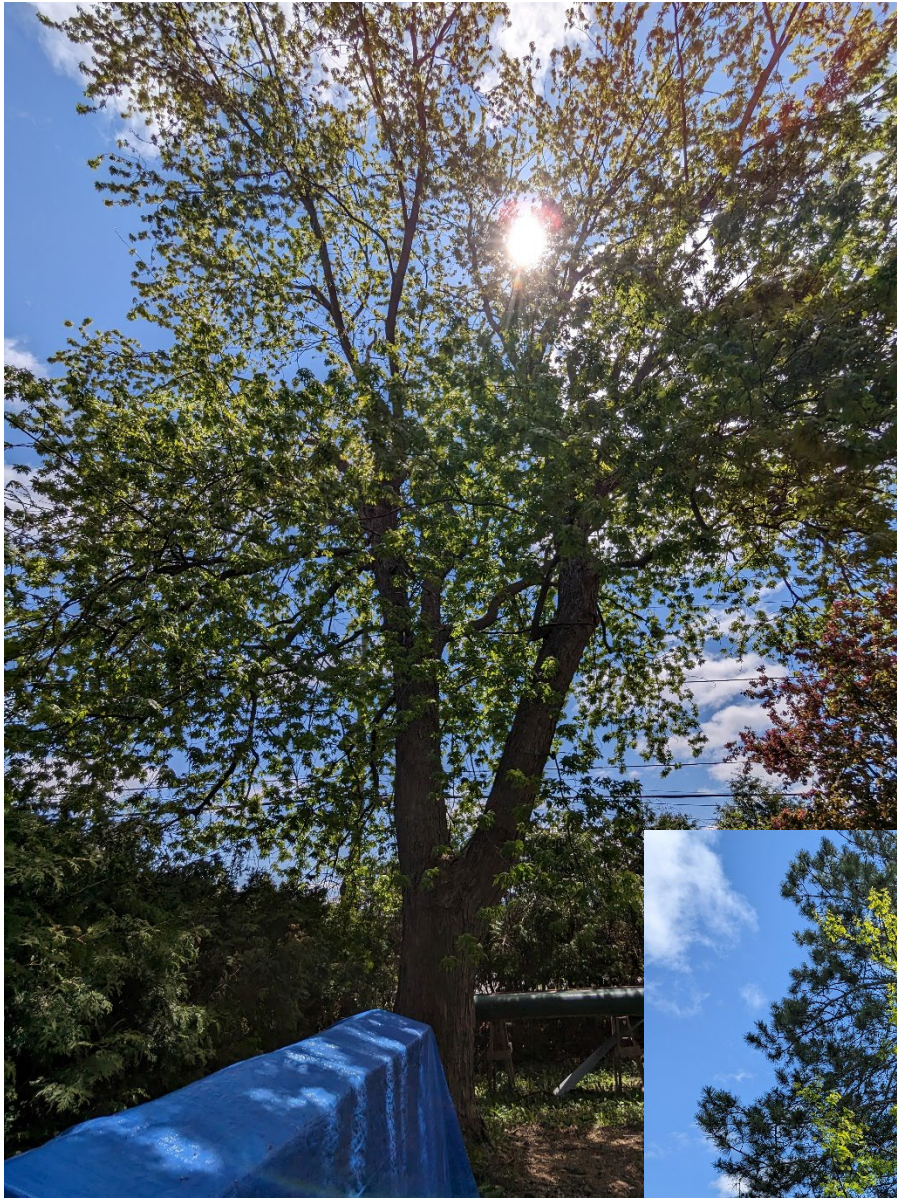
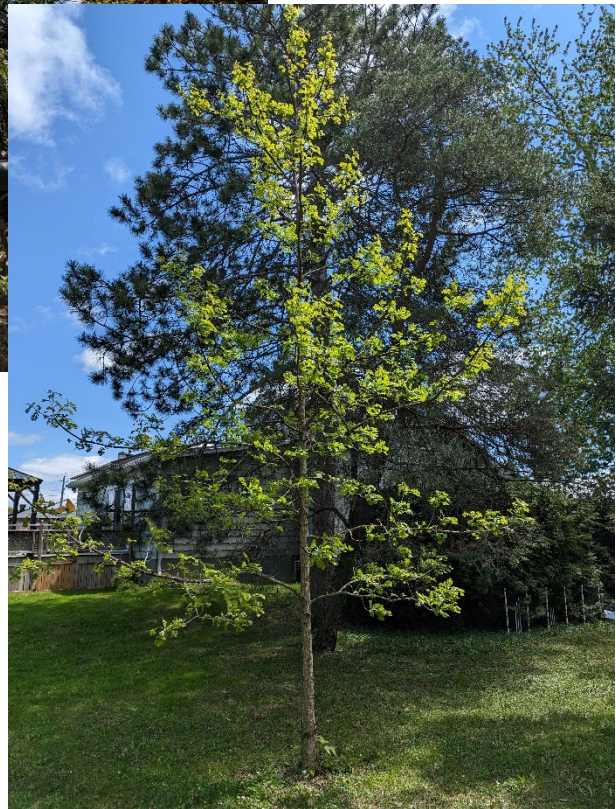
Figure 10 - (Above) Tree 68 (Right) Tree 64

<i>resinosa</i>)				
67	White spruce (<i>Picea glauca</i>)	31	S.p.	Fair/Poor: significant dieback in crown	Remove
68	Silver maple (<i>A.</i> <i>saccharinum</i>)	91	S.p.	Good	Remove

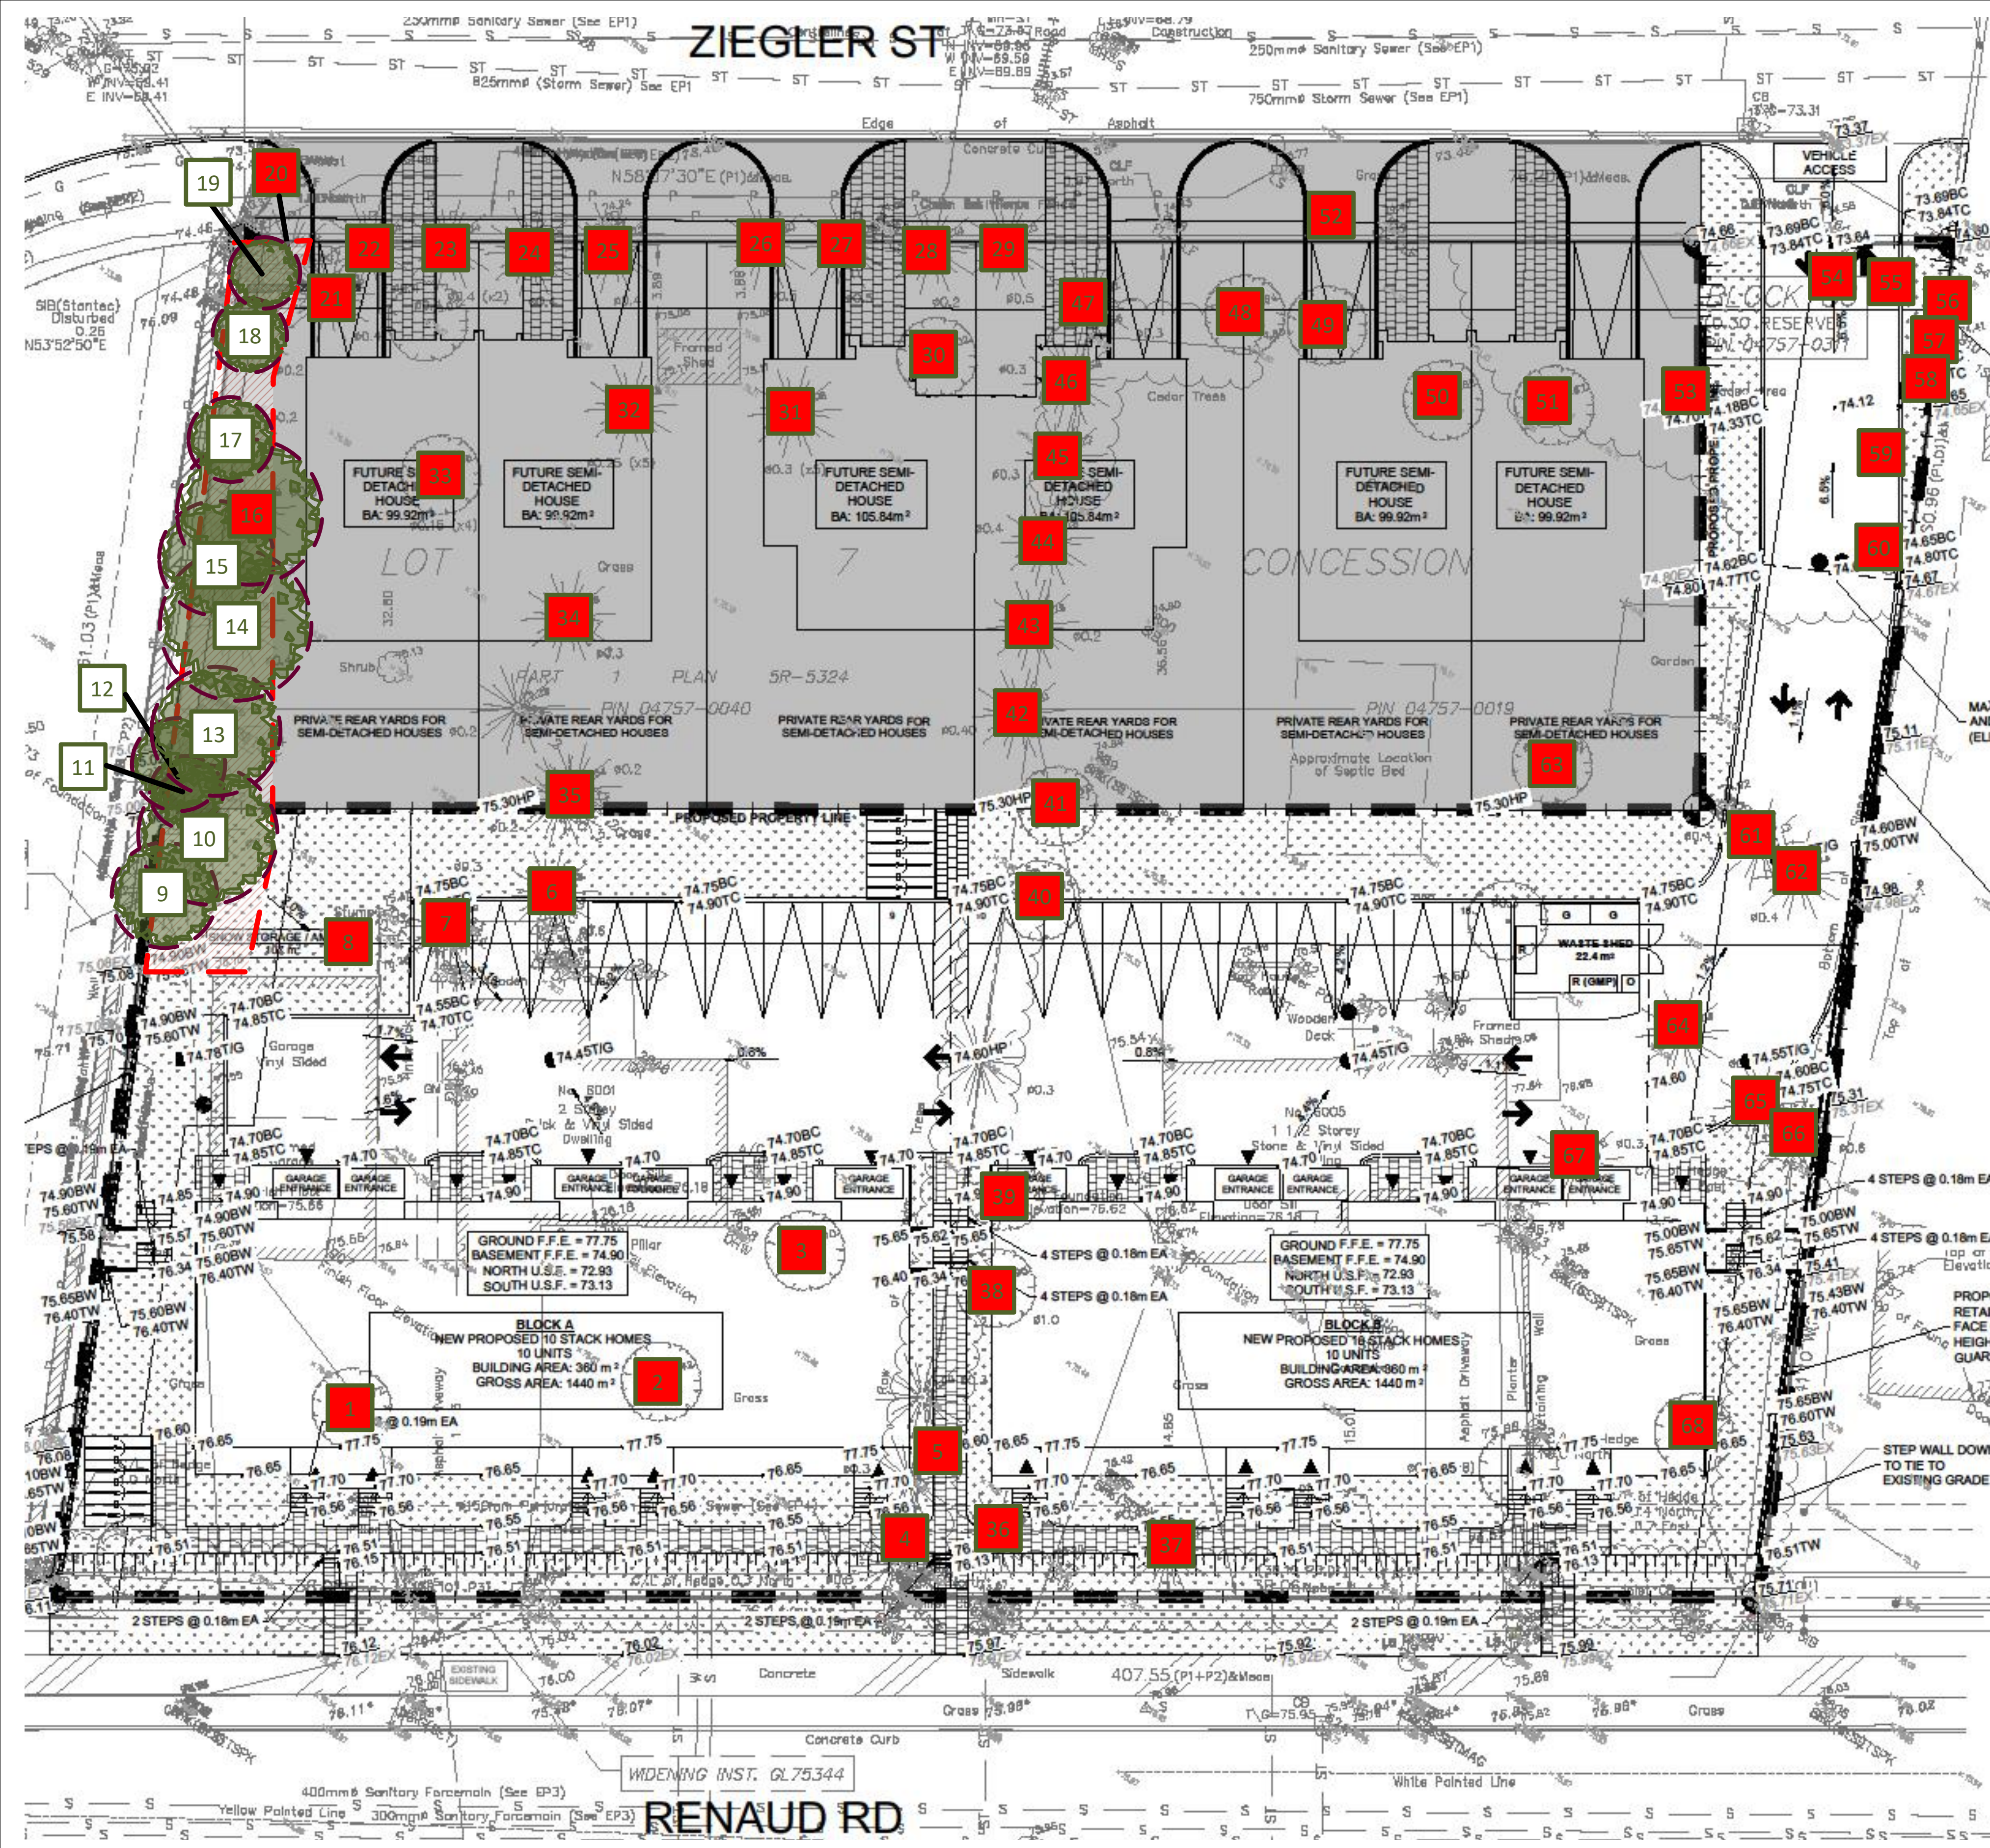
Tree#	Species	DBH (cm)	Condition
1	Silver maple (<i>Acer saccharinum</i>)	80	Fair: epicormic shoots
2	Crabapple (<i>Malus spp.</i>)	31	Fair/Good: mechanical injury on trunk; sapsucker holes
3	Norway maple (<i>Acer platanoides</i>)	38	Good/Fair: possible canker on trunk
4*	Scot's pine (<i>Pinus sylvestris</i>)	29	Fair/Good: shaded by Tree 38
4*	Scot's pine (<i>Pinus sylvestris</i>)	21	Fair: suppressed
6	Silver maple (<i>A. saccharinum</i>)	12, 14, 56	Good/Fair: codominant stems; sprouts from trunk becoming stems
7	Eastern white cedar (<i>Thuja occidentalis</i>)	29	Fair
8*	Silver maple (<i>A. saccharinum</i>)	23	Good/Fair: codominant stems; slight lean
9	Red pine (<i>Pinus resinosa</i>)	21	Fair: thin crown
10	Red pine (<i>P. resinosa</i>)	28	Fair: thin crown
11	Red pine (<i>P. resinosa</i>)	15	Fair: thin crown
12	Red pine (<i>P. resinosa</i>)	19	Poor: thin crown; lean
13	Red pine (<i>P. resinosa</i>)	26	Fair: thin crown

14	Red pine (<i>P. resinosa</i>)	31	Fair: forked leader
15	Red pine (<i>P. resinosa</i>)	24	Fair
16	Red pine (<i>P. resinosa</i>)	30	Fair
17	Red pine (<i>P. resinosa</i>)	17	Fair
18	Red pine (<i>P. resinosa</i>)	13	Fair: thin crown; lean
19	Red pine (<i>P. resinosa</i>)	14	Fair: suppressed
20	Red pine (<i>P. resinosa</i>)	19	Fair
21	White pine (<i>Pinus strobus</i>)	37	Good
22	White pine (<i>P. strobus</i>)	36	Good/Fair: crooks
23	White pine (<i>P. strobus</i>)	31, 33	Fair: codominant stems; included bark
24	White pine (<i>P. strobus</i>)	33	Good
25	White pine (<i>P. strobus</i>)	42	Good
26	White pine (<i>P. strobus</i>)	45	Good
27	White pine (<i>P. strobus</i>)	42	Good
28	White pine (<i>P. strobus</i>)	24	Fair: suppressed
29	White pine (<i>P. strobus</i>)	22, 40, 23, 45	Fair: 4 stems divide at 1.2m
30	Norway maple (<i>A. platanoides</i>)	44	Poor: canker on trunk and in crown; lean
31	Eastern white cedar (<i>Thuja occidentalis</i>)	29, 11, 16	Fair: tridominant stems; heavy lean on smaller stem

32	Eastern white cedar (<i>T. occidentalis</i>)	6 stems 9-26cm	Good/Fair
33	Tree lilac (<i>Syringa reticulata</i>)	15, 7, 13, 19, 17	Good/Fair
34	Mountain ash (<i>Sorbus spp.</i>)	21, 24	Fair: wound on trunk; sapsucker holes
35	Norway maple (<i>A. platanoides</i>)	12, 14	Fair: poor union – included bark
36	Scot's pine (<i>P. sylvestris</i>)	24, 20	Poor: LCR <15%
37	Sugar maple (<i>Acer saccharum</i>)	55	Fair: central leader is dead – has been replaced by side branches
38	Silver maple (<i>A. saccharinum</i>)	110	Fair: codominant stems with very large bulge at union; broken branches
39	Silver maple (<i>A. saccharinum</i>)	91	Fair/Good: tridominant stems; cavities with decay (one >1/4 diameter, one <1/8)
40	Silver maple (<i>A. saccharinum</i>)	83	Fair: large limb broken and hanging; decay at base where large stem was removed
41	Silver maple (<i>A. saccharinum</i>)	27, 57, 60	Fair: three stems – smallest fusing with largest; small cavity at base

42	Scot's pine (<i>P. sylvestris</i>)	35	Fair: suppressed
43	Scot's pine (<i>P. sylvestris</i>)	32	Fair/Poor: thin crown
44	Scot's pine (<i>P. sylvestris</i>)	35	Fair/Good
45	Red pine (<i>P. resinosa</i>)	33	Good/Fair: slight lean with possible girdling root
46	Scot's pine (<i>P. sylvestris</i>)	25	Good
47*	Scot's pine (<i>P. sylvestris</i>)	23	Fair: suppressed
48	Scot's pine (<i>P. sylvestris</i>)	33	Fair: crooks
49	Scot's pine (<i>P. sylvestris</i>)	37	Fair: sapsucker
50	Silver maple (<i>A. saccharinum</i>)	67, 84	Fair/Poor: large crack with cavity at main union
51	Silver maple (<i>A. saccharinum</i>)	94	Fair/Good: decay in large wound in crown
52	Trembling aspen (<i>P. tremuloides</i>)	7 stems 8-14cm	Fair: growing on fence
53	Norway spruce (<i>Picea abies</i>)	5 trees avg. 40cm	Good
54	Silver maple (<i>A. saccharinum</i>)	57	Fair: heavy lean into subject property
55	Manitoba maple (<i>A. negundo</i>)	15	Fair: lean

56	Manitoba maple (<i>A. negundo</i>)	18	Fair: lean
57	Manitoba maple (<i>A. negundo</i>)	27	Fair: lean
58	Manitoba maple (<i>A. negundo</i>)	20	Fair: lean
59	Scot's pine (<i>P. sylvestris</i>)	22, 30	Fair: sapsucker
60	Basswood (<i>Tilia americana</i>)	52	Fair: hollow trunk with sprouts
61	Scot's pine (<i>P. sylvestris</i>)	42	Fair/Good
62	Scot's pine (<i>P. sylvestris</i>)	33	Fair
63	Silver maple (<i>A. saccharinum</i>)	8 stems 6-23cm	Fair: growing as clump
64	Bur oak (<i>Quercus macrocarpa</i>)	9	Good
65	Scot's pine (<i>P. sylvestris</i>)	26	Fair: lean and crooks
66	Red pine (<i>P. resinosa</i>)	49	Good
67	White spruce (<i>Picea glauca</i>)	31	Fair/Poor: significant dieback in crown
68	Silver maple (<i>A. saccharinum</i>)	91	Good

Prior to any site works, protective fencing should be installed around the TPA as indicated on Map and maintained until all construction on site has been completed as per the City of Ottawa Tree Protection Specifications (March 2021). **Failure to install and maintain the indicated fencing may result in fines from the City.**

The tree protection fencing must be 1.2 m in height and constructed of a rigid or framed material (e.g. modulus – steel, plywood hoarding, or snow fence on a 2"X4" wood frame) with posts 2.4 m apart such that the fence location cannot be altered. All supports must be placed outside of the CRZ and installation must minimize damage to existing roots.

- Place a layer of 6-12 inches (15 to 30 cm) of woodchip mulch to the area
- Apply 3/4 (2 cm) inch plywood, or road mats over a 4+ inch (10 cm) thick layer of the wood chip mulch
- Apply 4-6 inches (10 to 15 cm) of gravel over a taut, staked, geotextile fabric
