Arborist Report

DATE: 2022-09-01

Object: Tree Health Assessment and Proposed Tree Protection Plan at Queenswood United Church (360 Kennedy Lane E, Ottawa, Ontario)

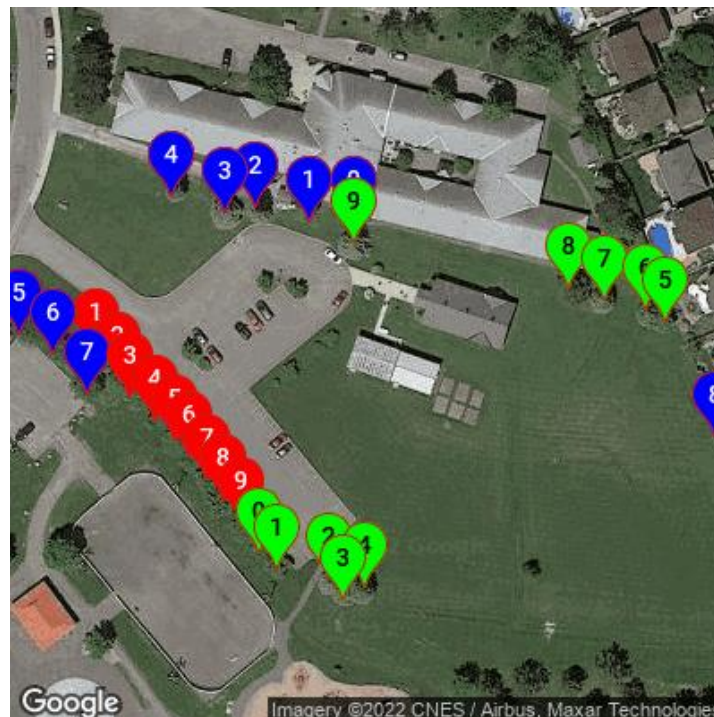
A total of 28 trees were assessed on the property. The Amur Maples have multiple co-dominant stems, each one having a varying diameter at breast height of 5 to 20 centimeters. For the purpose of this assessment, their DBH was measured at the lowest point before codominance begins and each stem was measured at 1.3 meters from the ground. This was also the case for Colorado Blue Spruce #19. All other trees were measured at 1.3 meters from the ground.

- : 1-9
- : 10-19
- : 20-29
