Landslide Hazard Assessment

Proposed Residential Development

Old Montreal Road
Ottawa, Ontario

Report PG5201-2 Revision 5 dated December 20, 2024

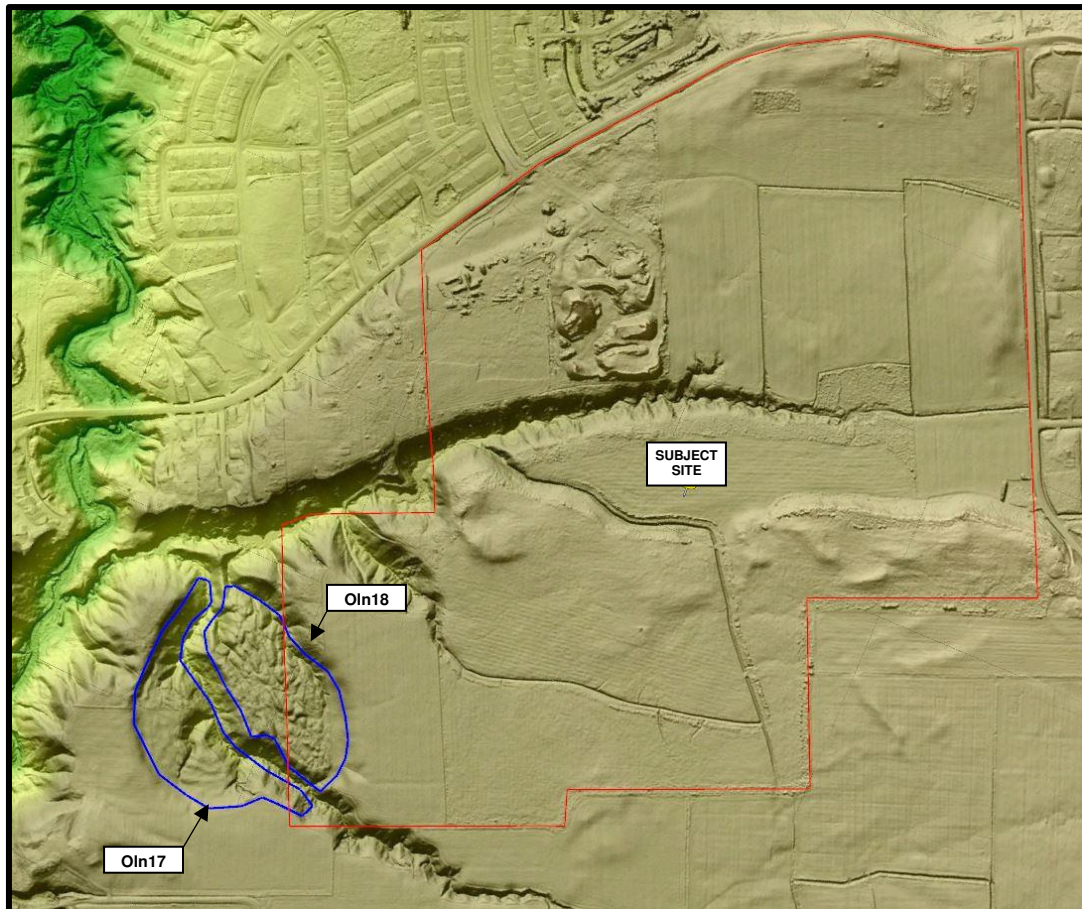
Figure 2 – LiDAR Image of Subject Site and closest landslide and slope failure.

Further to the above-noted large-scale landslides that have occurred within the vicinity of the subject site, recent small-scale and localized slumps have formed in recent years in response to active erosion and sheet drainage. Given the high concentration of local small- and large-scale landslides throughout the area and within the subject site, it is considered appropriate to increase the baseline probability for landslides to occur throughout the subject site by a factor of 2 in Section 4.3 – Hazard Assessment of this report.

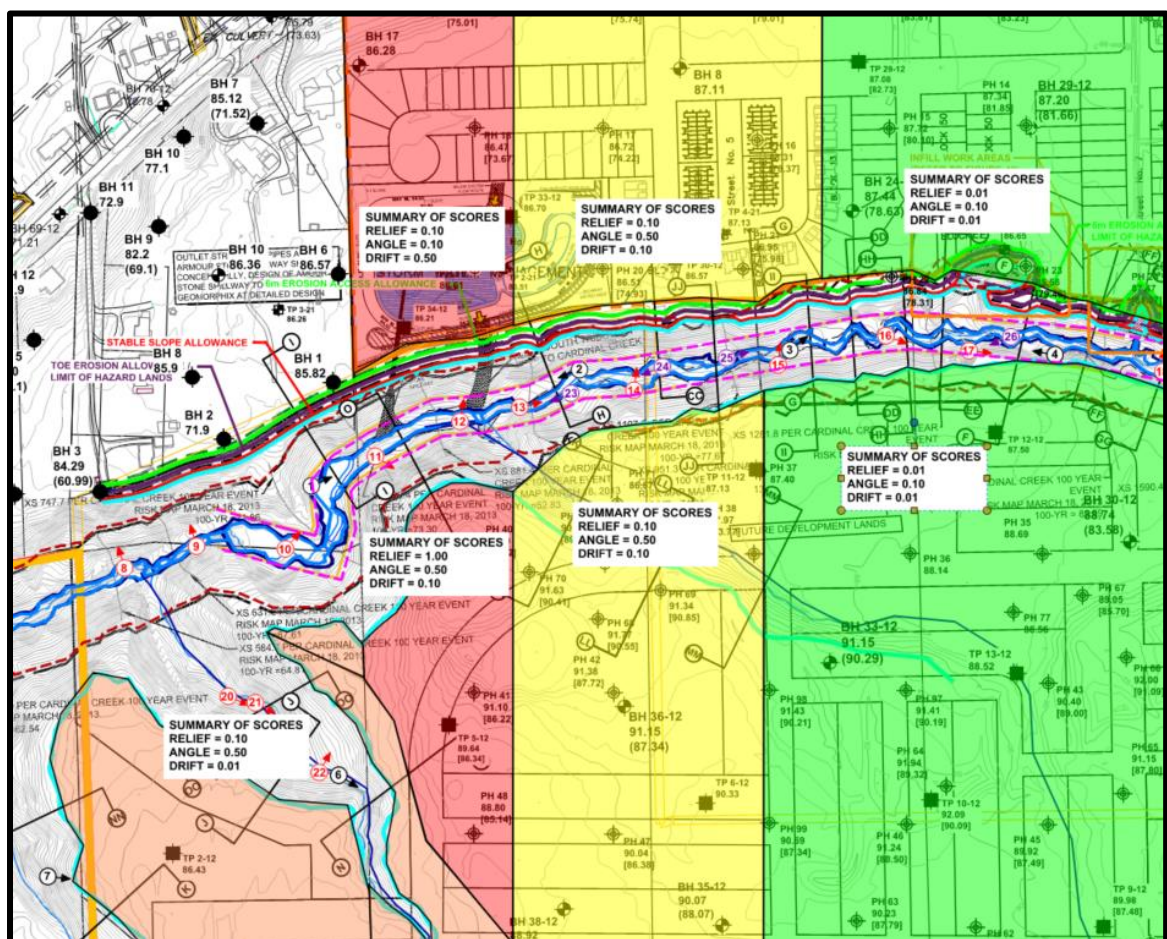
Figure 4 - Summary of Drift Thickness, Surface Relief and Slope Angle Weight Factors

Based on this, the probability for a landslide to occur throughout a portion of the subject site would be the cumulative site-specific probability which has been adjusted for the drift thickness, topographic relief and slope angle weight factors for that portion of the subject site. The probability for the north and south portions of the subject tributary are provided below

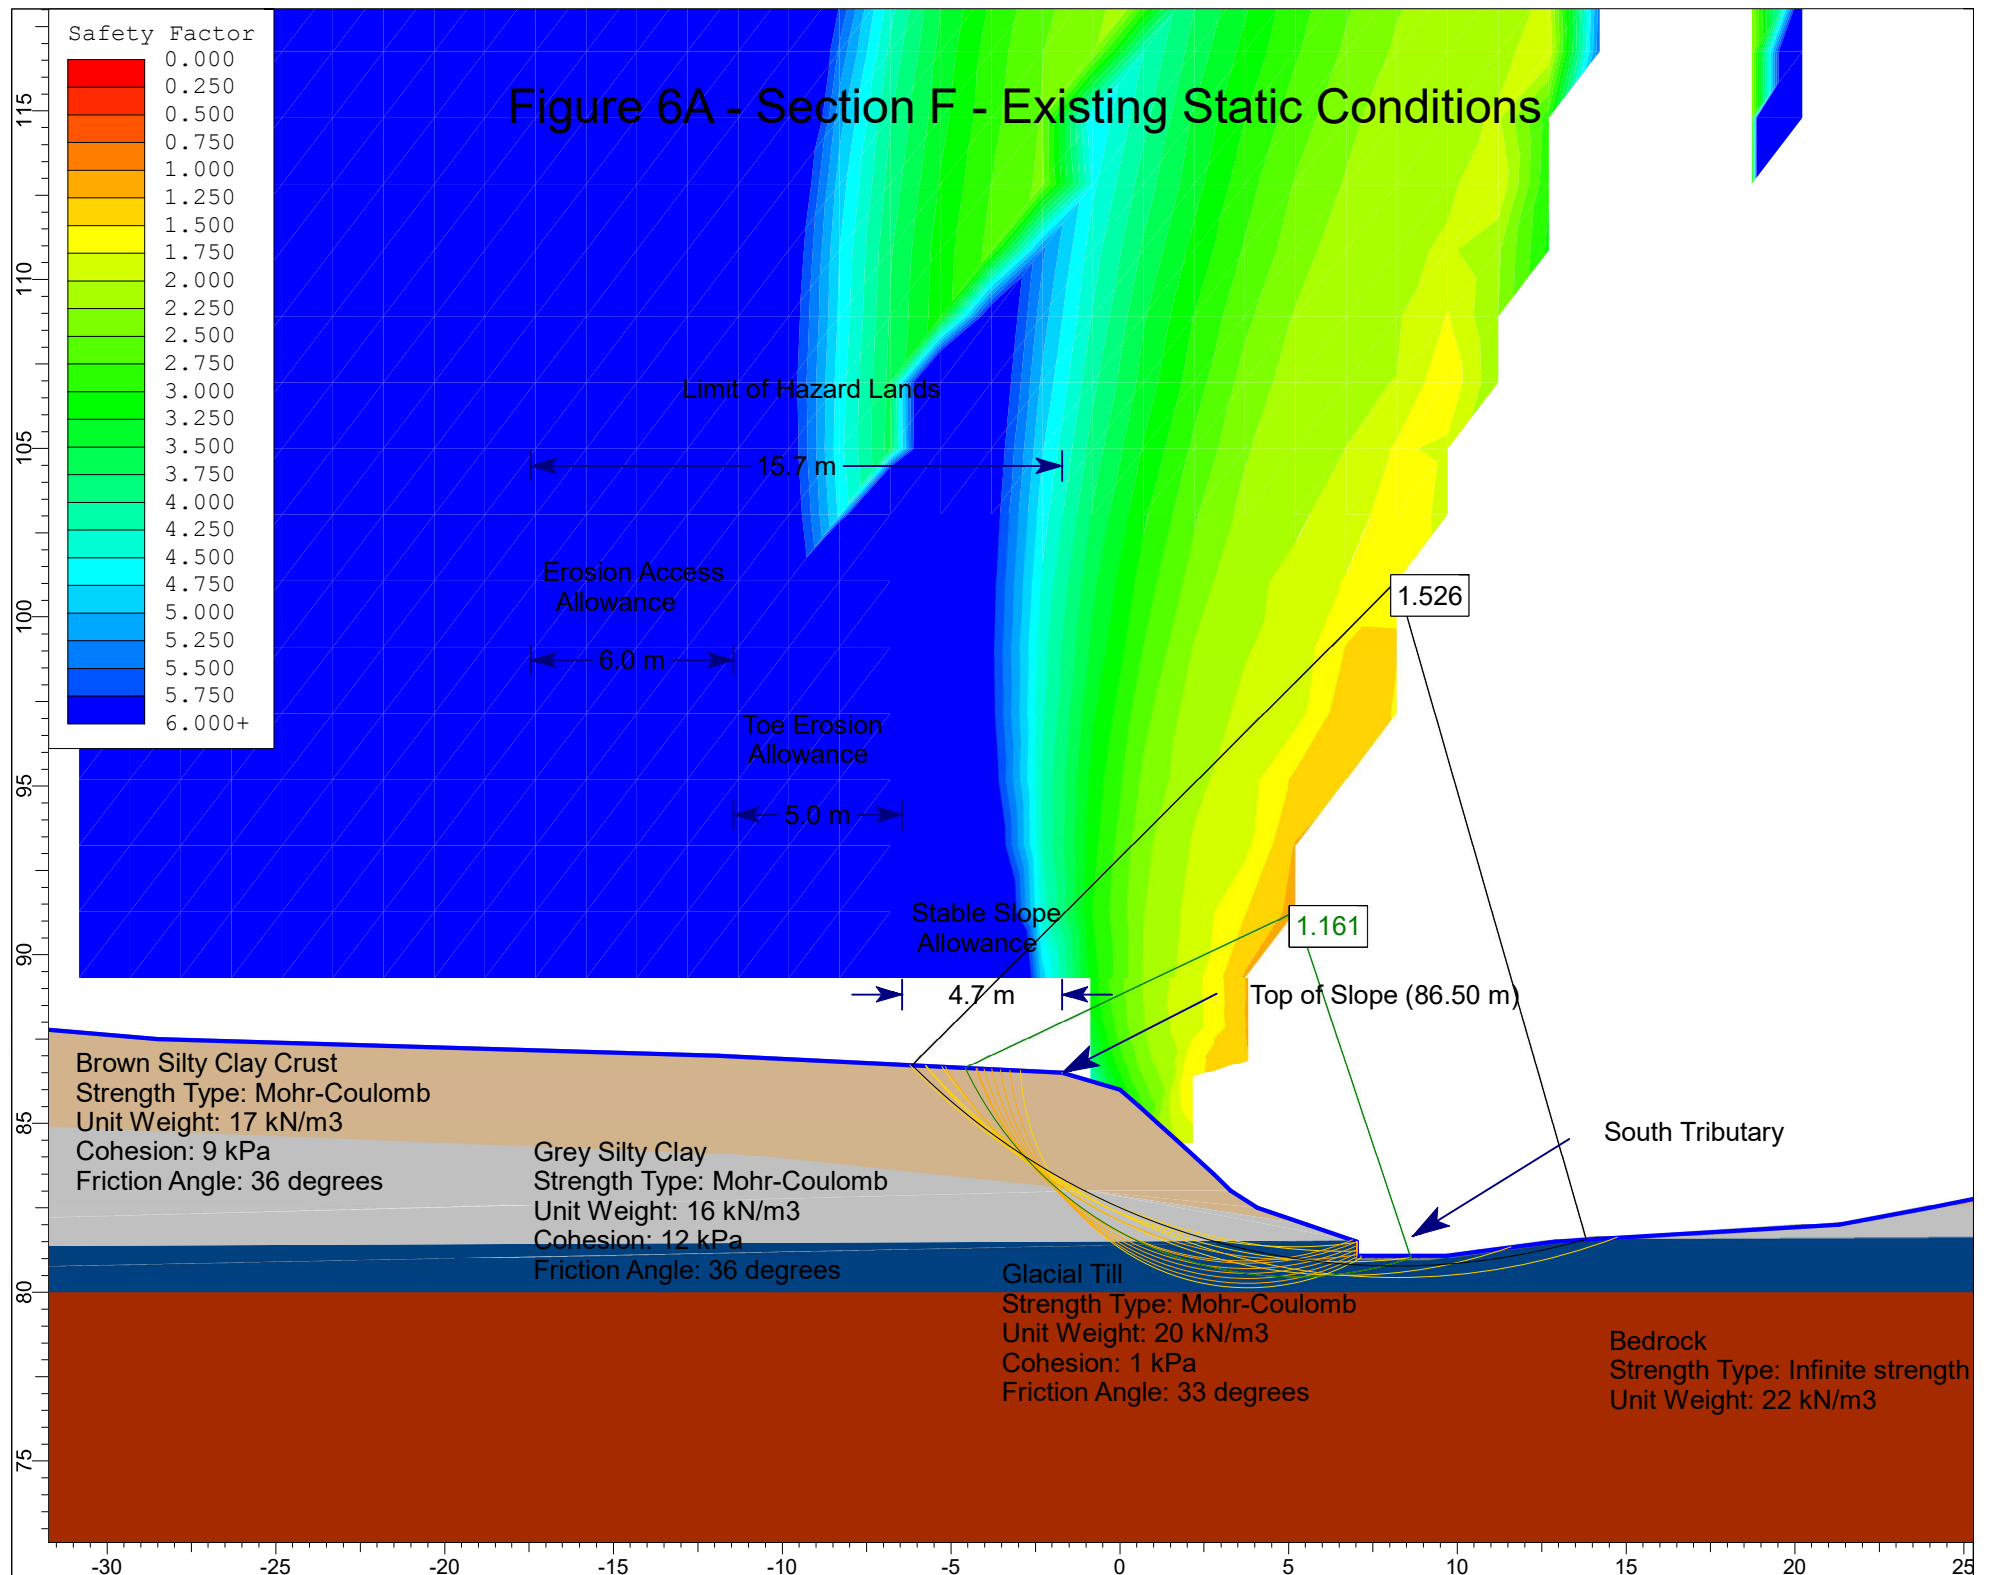
Figure 6A - Section F - Existing Static Conditions

The results for the existing static slope conditions at the slope stability sections are presented in Appendix 2. The slope stability factors of safety were found to be greater than 1.5 at all sections analyzed, except for Sections F and JJ, which require a 4.7 and 17 m setback, respectively from top of slope to obtain a factor of safety greater than 1.5.
