**re: Slope Stability Assessment of Existing Slope Failure**  
**Existing Residential Dwelling**  
**1320 Grand-Chêne Court – Ottawa, Ontario**  
**to: Tamarack Homes – Mr. Mike Green – [mike.green@taggart.ca](mailto:mike.green@taggart.ca)**  
**to: HP Urban Inc. - Mr. Peter Hume - [peter.hume@hpurban.ca](mailto:peter.hume@hpurban.ca)**  
**to: DSEL - Mr. Braden Kaminski - [Bkaminski@dsel.ca](mailto:Bkaminski@dsel.ca)**  
**date: November 13, 2023**  
**file: PG5201-MEMO.03**

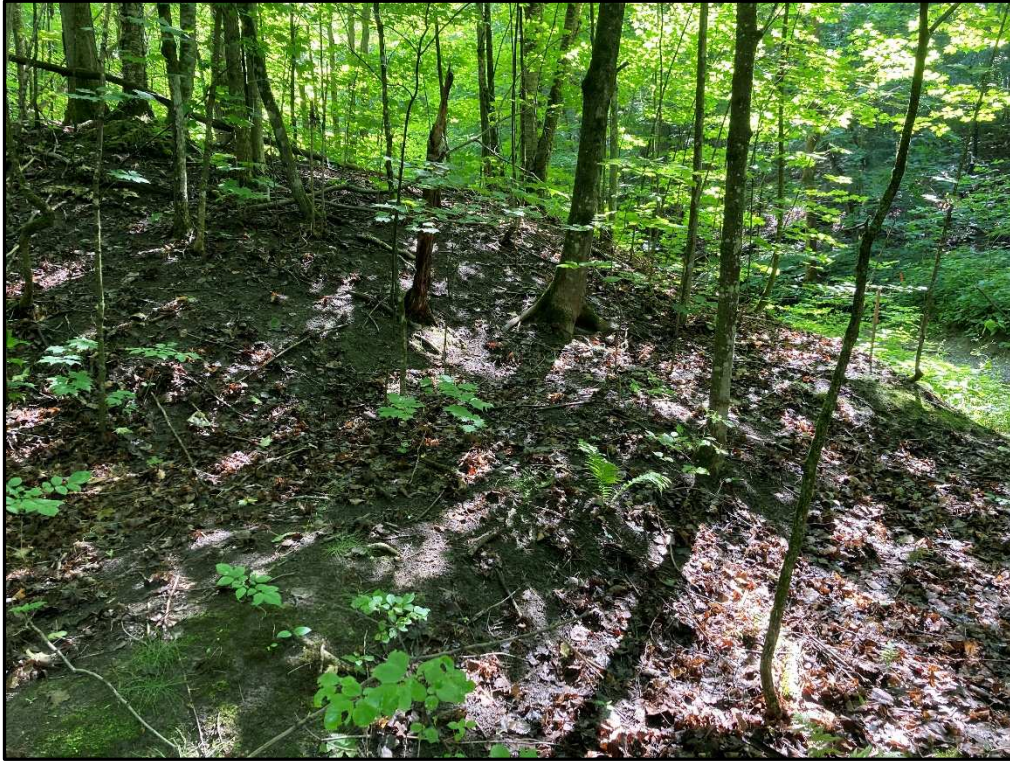
**Photo 3:** Photograph along the slope face, facing northeast. The photograph depicts the presence of mature vegetation. The face of slope can be observed to consist of brown silty clay.

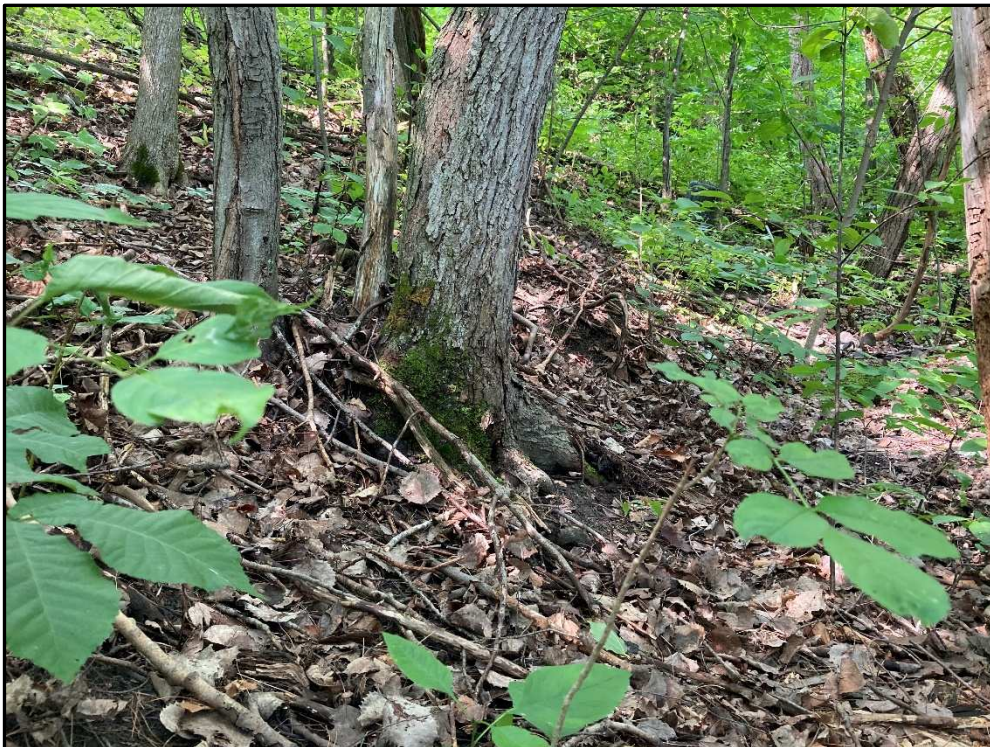
**Photo 4:** Photograph of the face of slope indicating the presence of mature vegetation. The face of slope is observed to consist mostly of brown silty clay.
