# **Geotechnical Investigation**

## **Proposed Residential Development**

4386 Rideau Valley Drive  
Ottawa, Ontario

Report PG5828-1 Revision 4 dated April 4, 2024

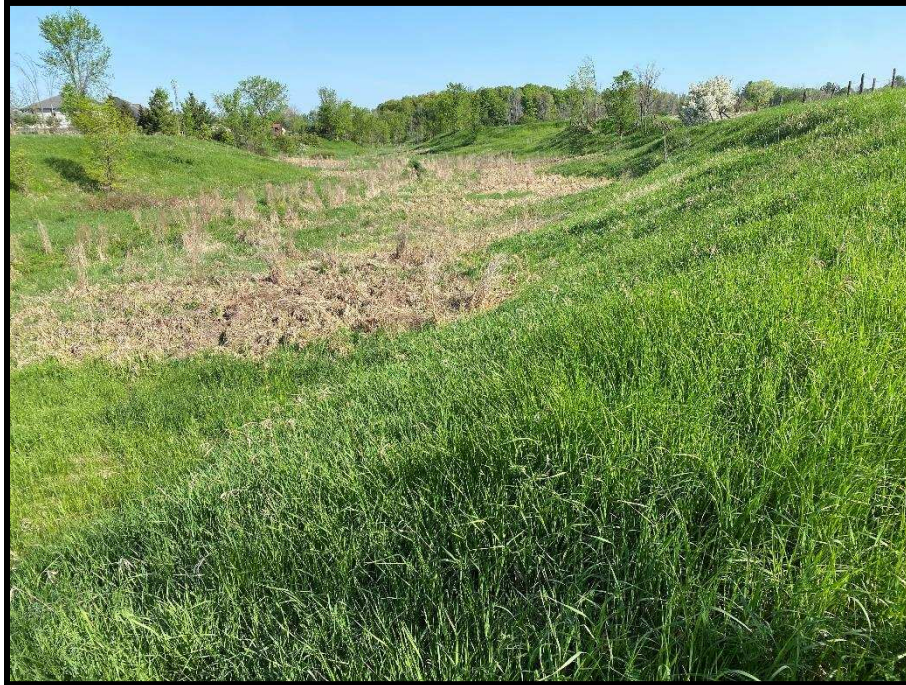
Photo 1: Area located at the bottom of the slope along the south-west portion of the subject site. Area is well vegetated and sloped gradually towards the valley floor.

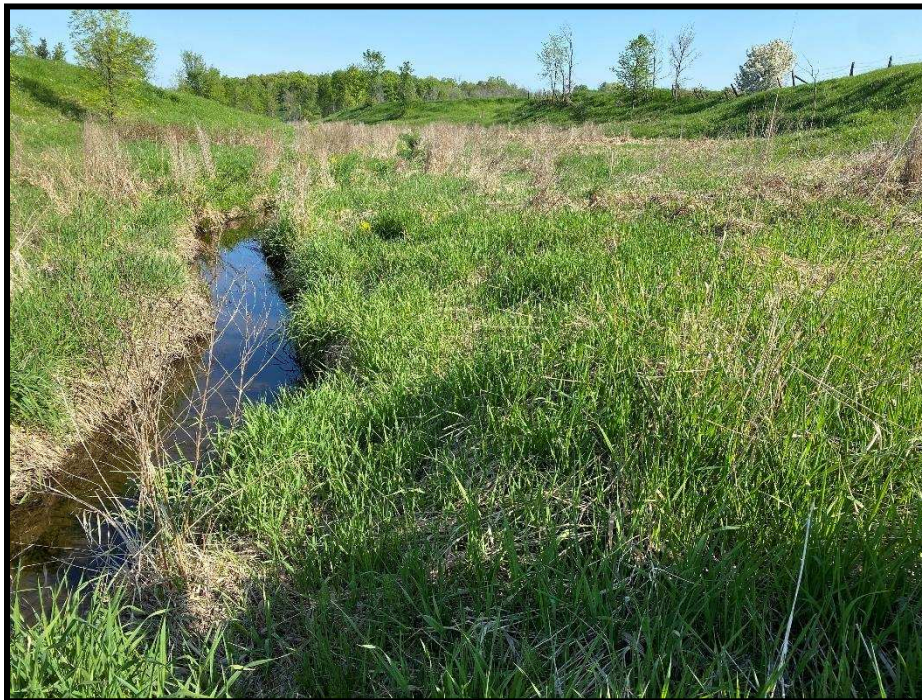
Photo 2: Area along creek tributary and south-west portion of the subject site. Area appeared to be well vegetated and did not appear to be eroded at the time of site visit. Water throughout creek tributary appeared to be flowing very slowly and/or ponding.

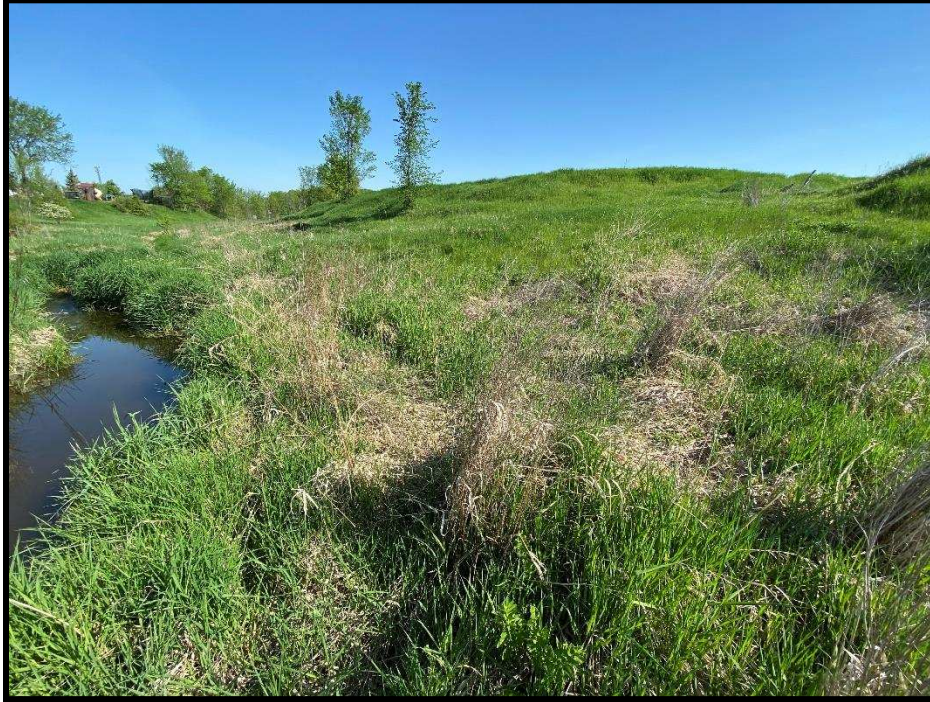
Photo 3: Area along creek tributary and south-west portion of the subject site. Area appeared to be well vegetated and did not appear to be eroded at the time of site visit. Gradual slope observed from subject site to the valley floor.

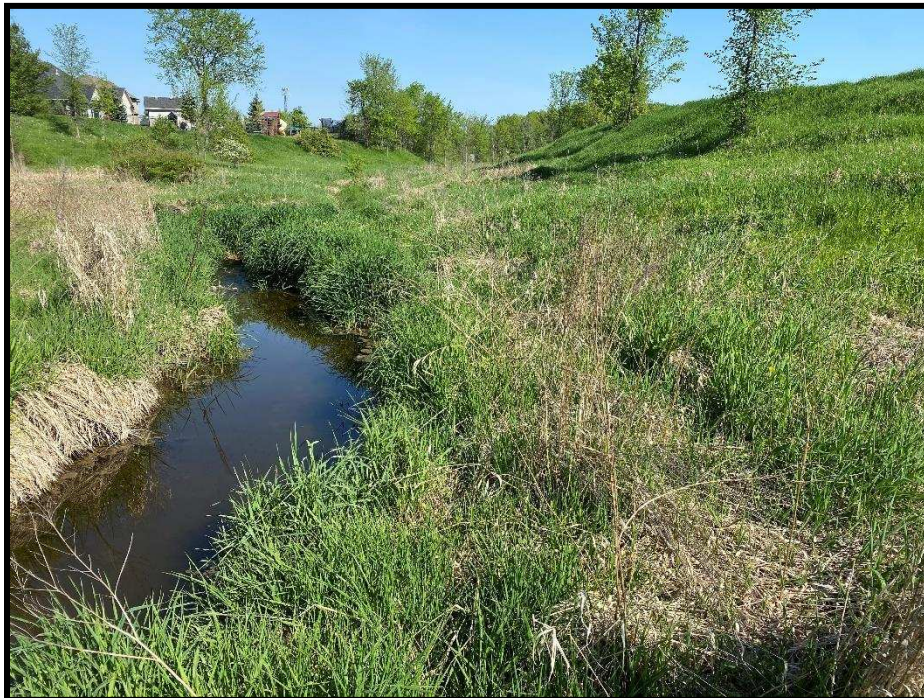
Photo 4: Area along creek tributary and south-west portion of the subject site. Area appeared to be well vegetated and did not appear to be eroded at the time of site visit. Water throughout creek tributary appeared to be flowing very slowly and/or ponding.

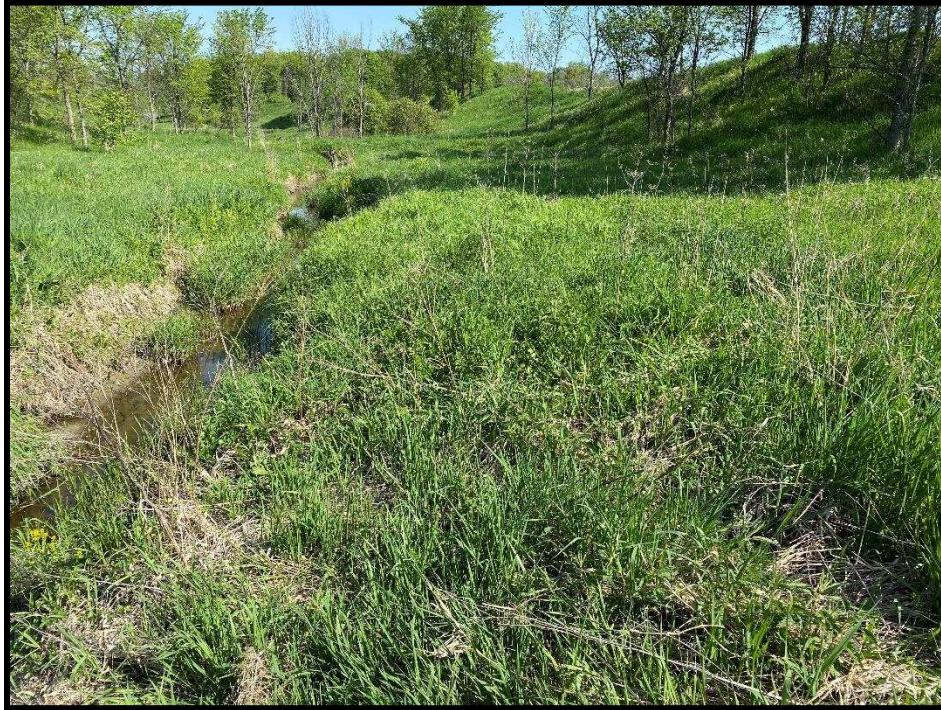
Photo 5: Area along creek tributary and south-west portion of the subject site. Area appeared to be well vegetated and did not appear to be eroded at the time of site visit. Water throughout creek tributary appeared to be flowing very slowly and/or ponding.

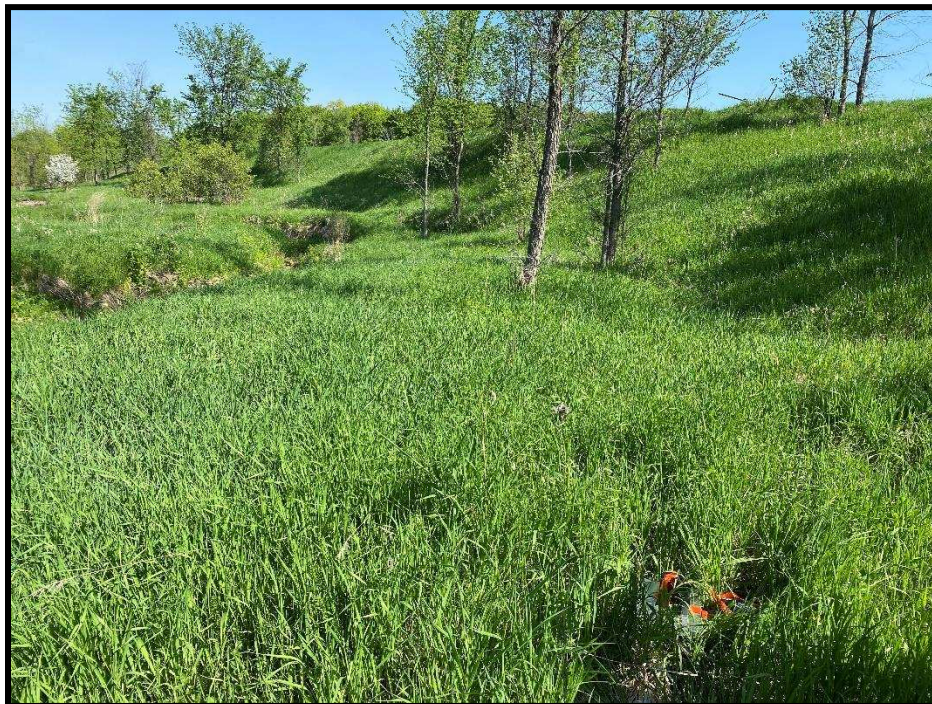
Photo 6: Area along creek tributary and west portion of the subject site. Area appeared to be well vegetated and did not appear to be eroded at the time of site visit. Gradual slope observed from subject site to the valley floor.

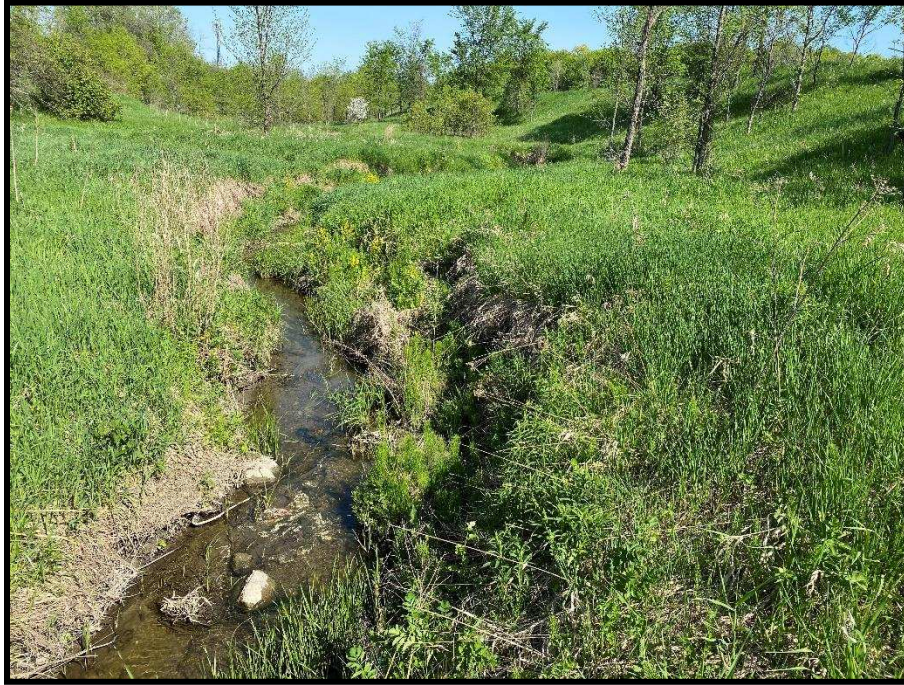
Photo 7: Area along creek tributary and west portion of the subject site. Area appeared to be well vegetated with a slightly steeper bank along the tributary at the time of site visit. Gradual slope observed from subject site to the valley floor. Active erosion was not observed.

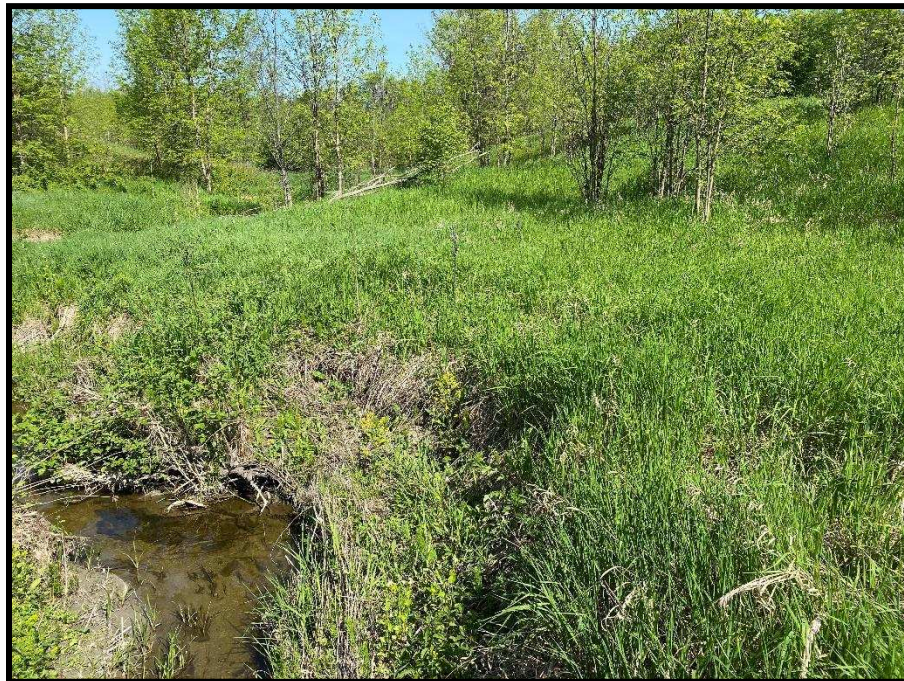
Photo 8: Area along creek tributary and west portion of the subject site. Area appeared to be well vegetated with a slightly steeper bank along the tributary at the time of site visit. Gradual slope observed from subject site to the valley floor. Active erosion was not observed.

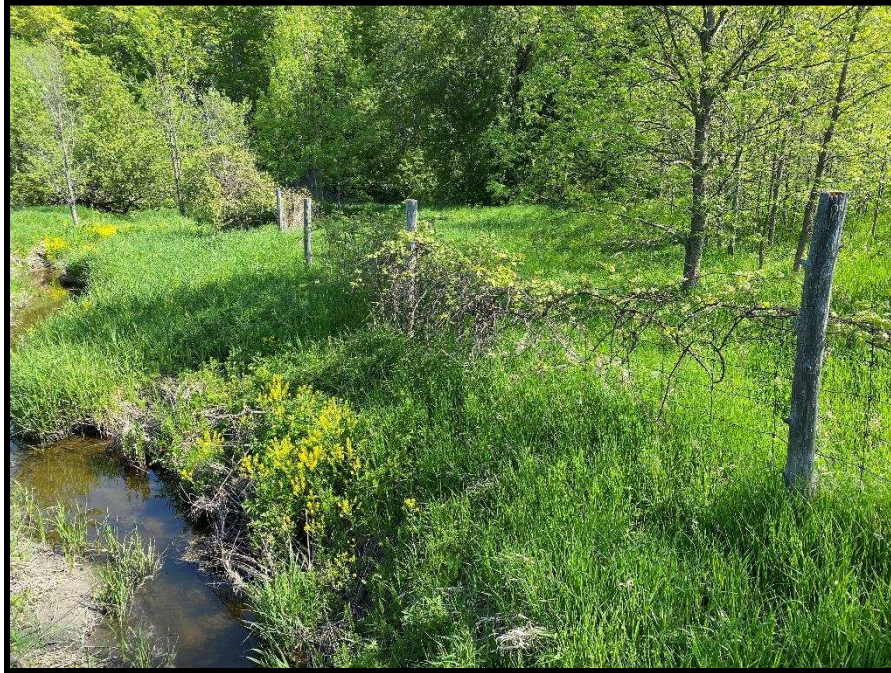
Photo 9: Area along creek tributary and north-west portion of the subject site. Area appeared to be well vegetated with a gentle flow throughout the tributary at the time of site visit. Gradual slope observed from subject site to the valley floor.

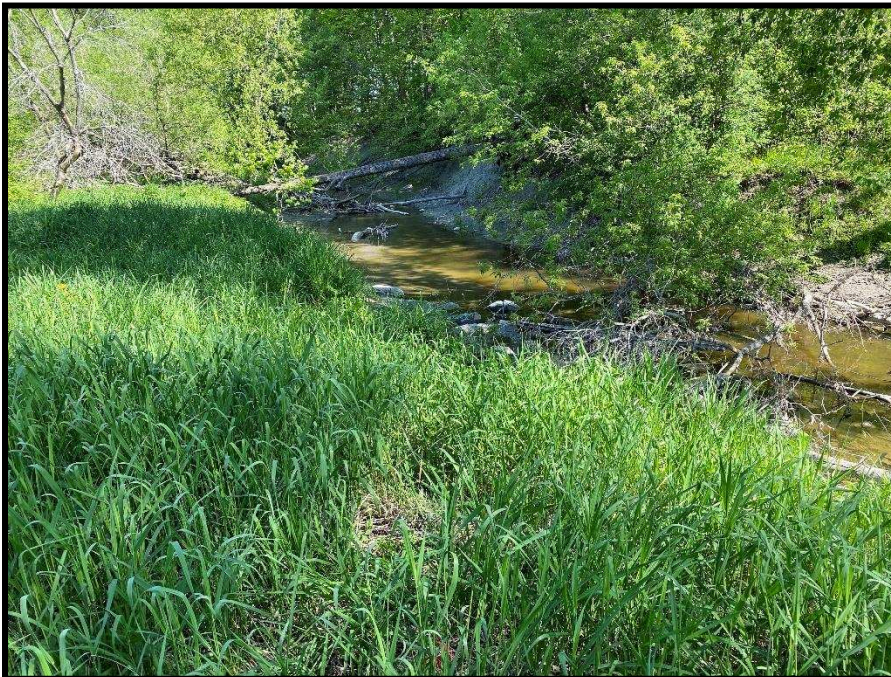
Photo 10: Area of intersection of tributary along west portion of subject site and Ruisseau Mud Creek. Area of Ruisseau Mud Creek appeared to have banks exposed to streams flow. Mature trees noted to have previously fallen across creek alignment. Some over-steepening of banks also observed at the time of site visit.

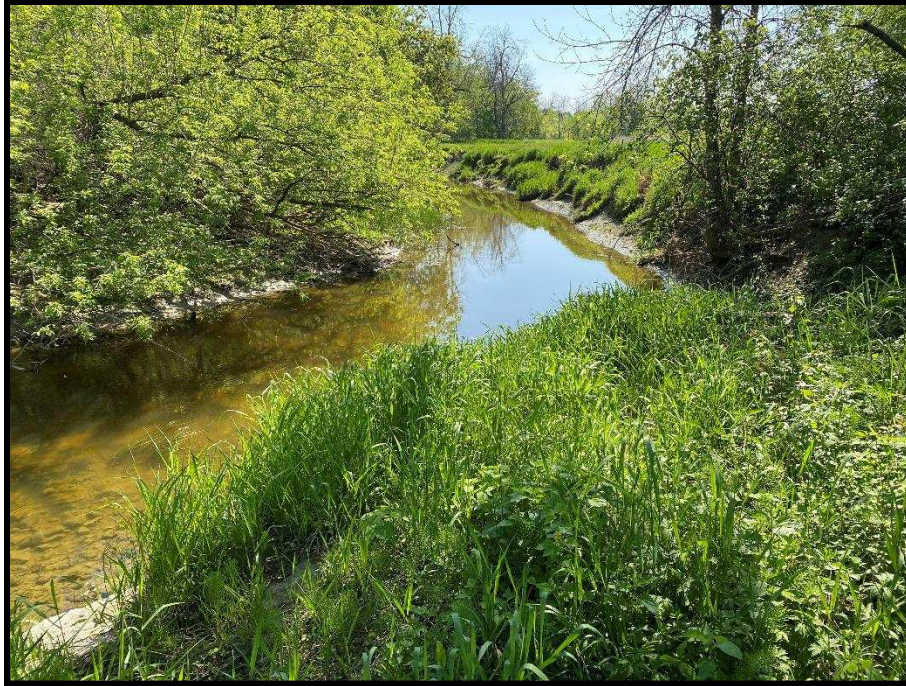
Photo 11: Area of Ruisseau Mud Creek along north-west portion of subject site. Area appeared to have banks exposed to streams flow and lack of well rooted vegetation along bank. Some oversteepening of banks also observed. Creek appeared to be flowing very slowly at the time of site visit.

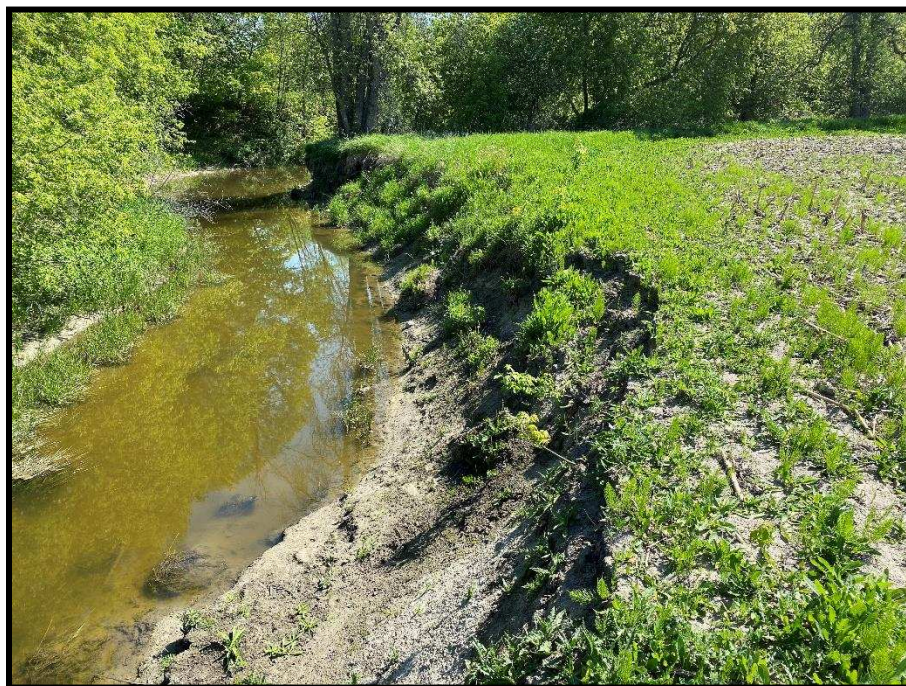
Photo 12: Area of Ruisseau Mud Creek along north-west portion of subject site. Area appeared to have banks exposed to streams flow and along with slumping and oversteepening of banks at the time of our site visit.

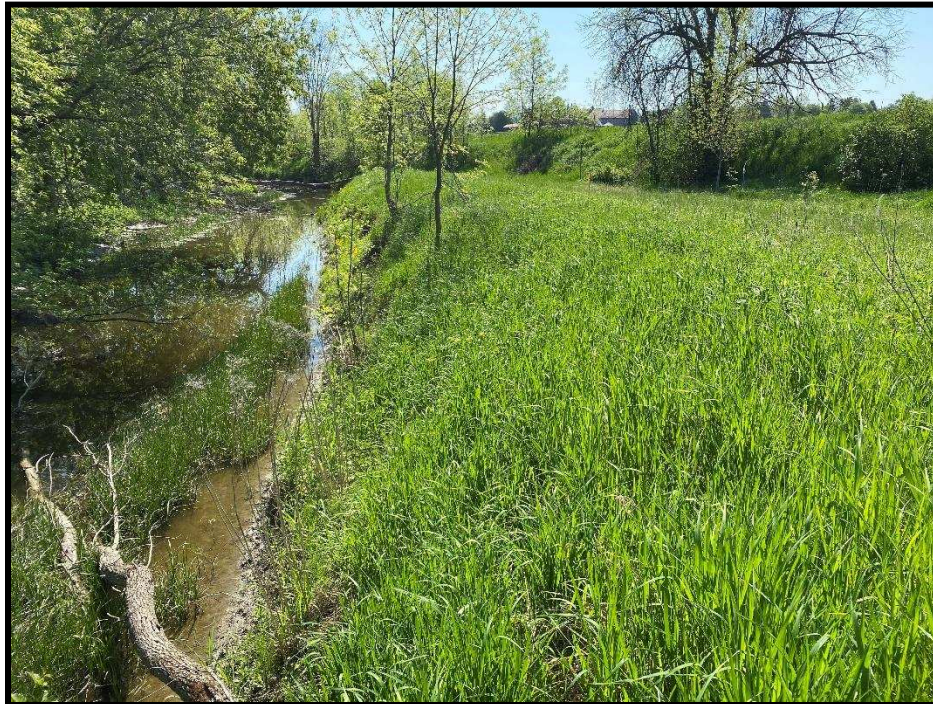
Photo 13: Area of Ruisseau Mud Creek along north-west portion of subject site. Area of valley floor appeared to have well rooted vegetation with relatively steep banks along creek. No active erosion observed along photographed portion of creek at the time of site visit.

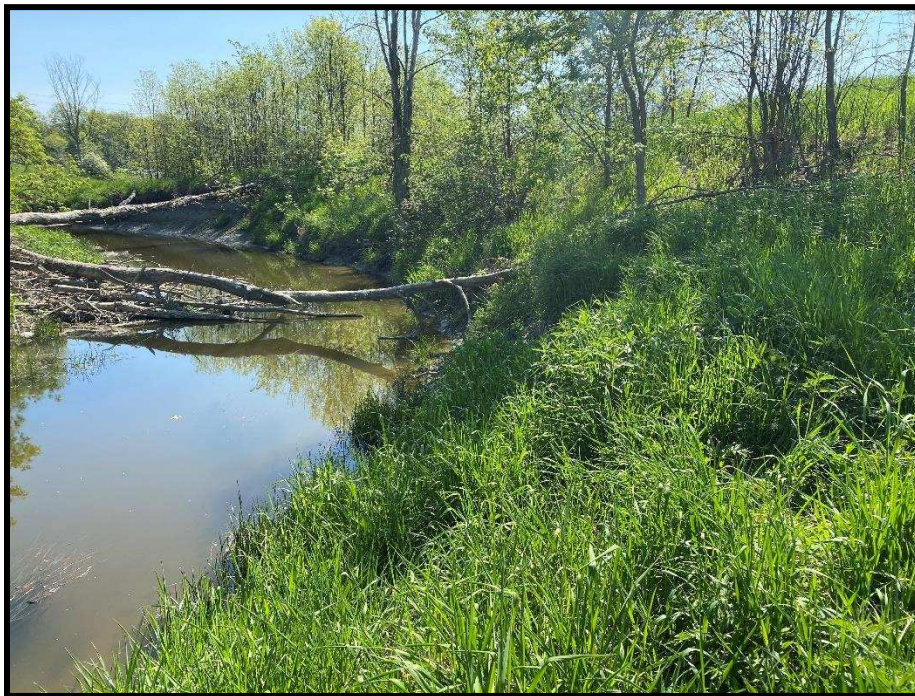
Photo 14: Area of Ruisseau Mud Creek along north-west portion of subject site. Area of valley floor appeared to have well rooted vegetation with relatively steep banks along creek. Some active erosion and fallen trees observed along photographed portion of creek.

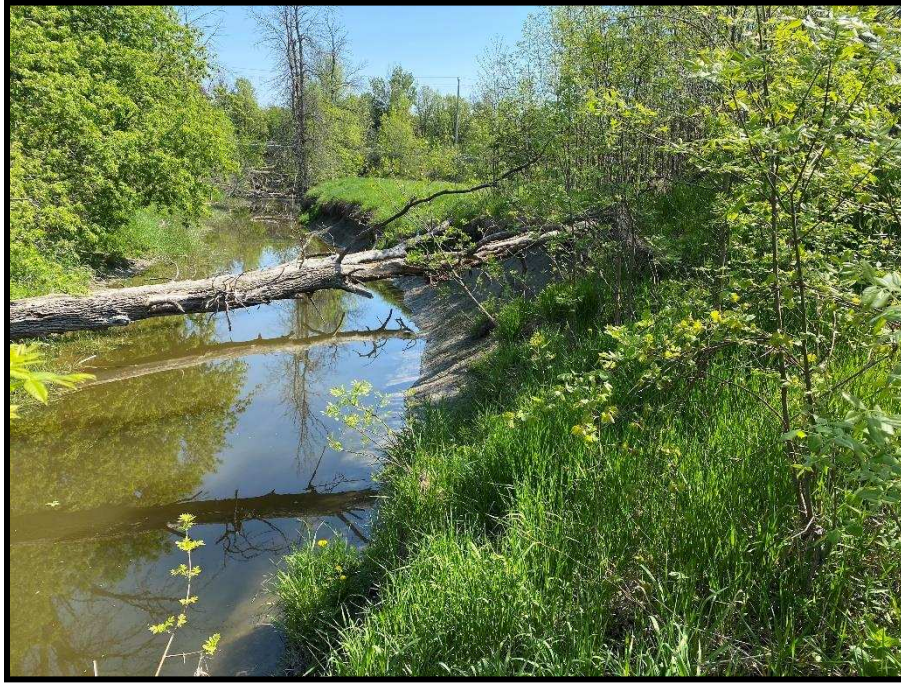
Photo 15: Area of Ruisseau Mud Creek along northern portion of subject site. Photographed area appeared to have banks exposed to streams flow along with slumping and undercutting of banks at the time of our site visit.

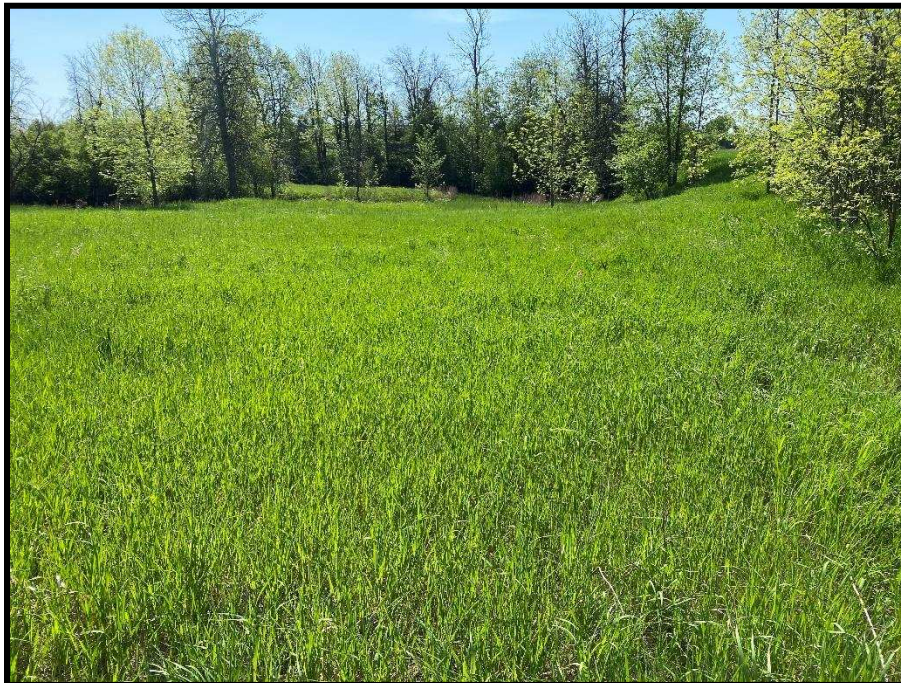
Photo 16: Area of Ruisseau Mud Creek valley floor along north-east portion of subject site. Photographed area appeared to contain well rooted vegetation and mature trees.

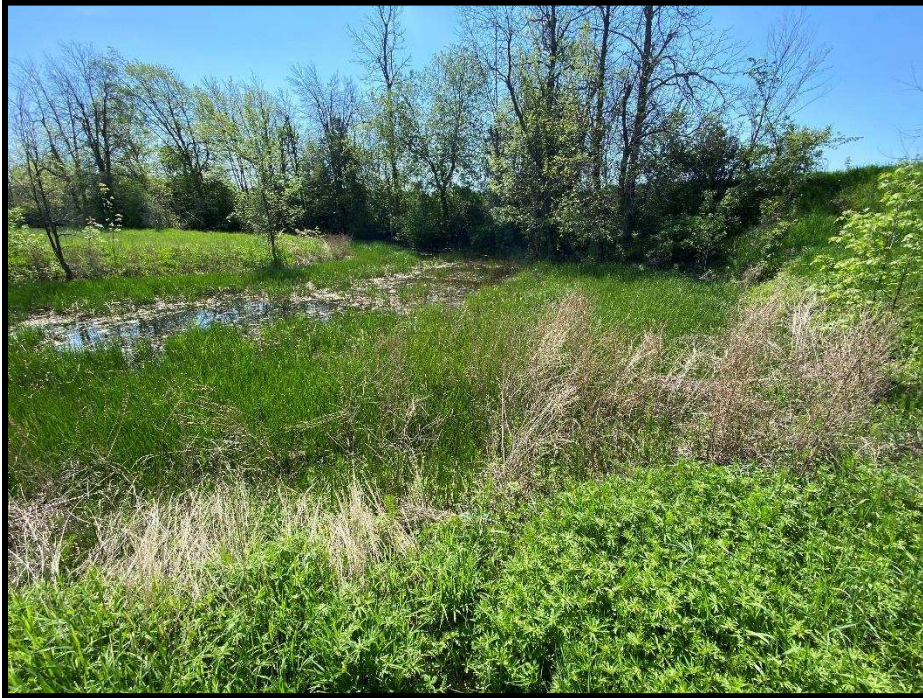
Photo 17: Area of Ruisseau Mud Creek valley floor along north-east portion of subject site. Photographed area appeared to contain well rooted vegetation and mature trees. No erosion observed along toe of slope at time of site visit.

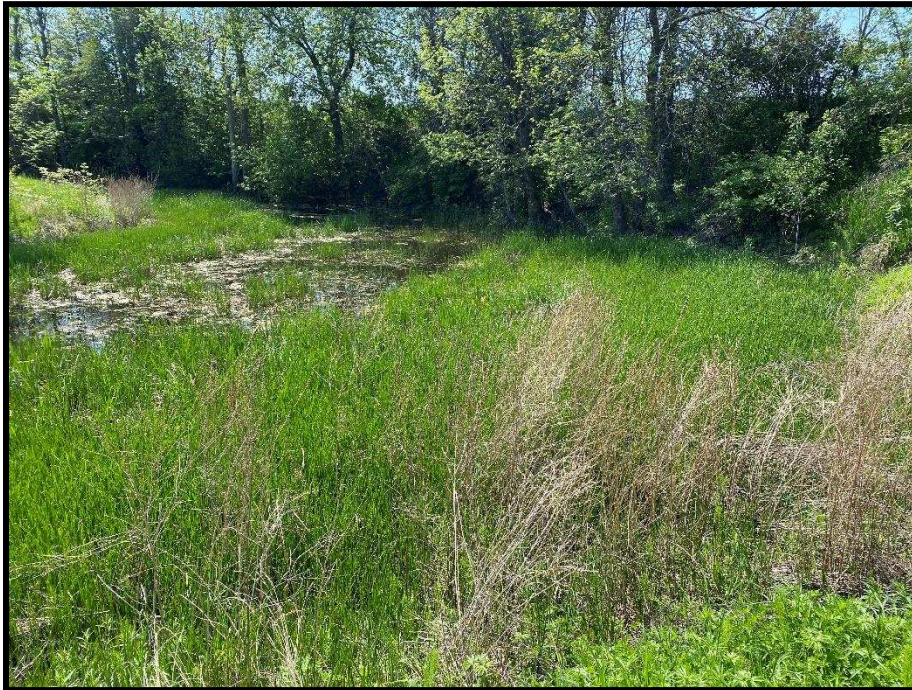
Photo 17b: Close-up of Photo 17 - Area of Ruisseau Mud Creek valley floor along north-east portion of subject site. Photographed area appeared to contain well rooted vegetation and mature trees. No erosion observed along toe of slope at time of site visit.

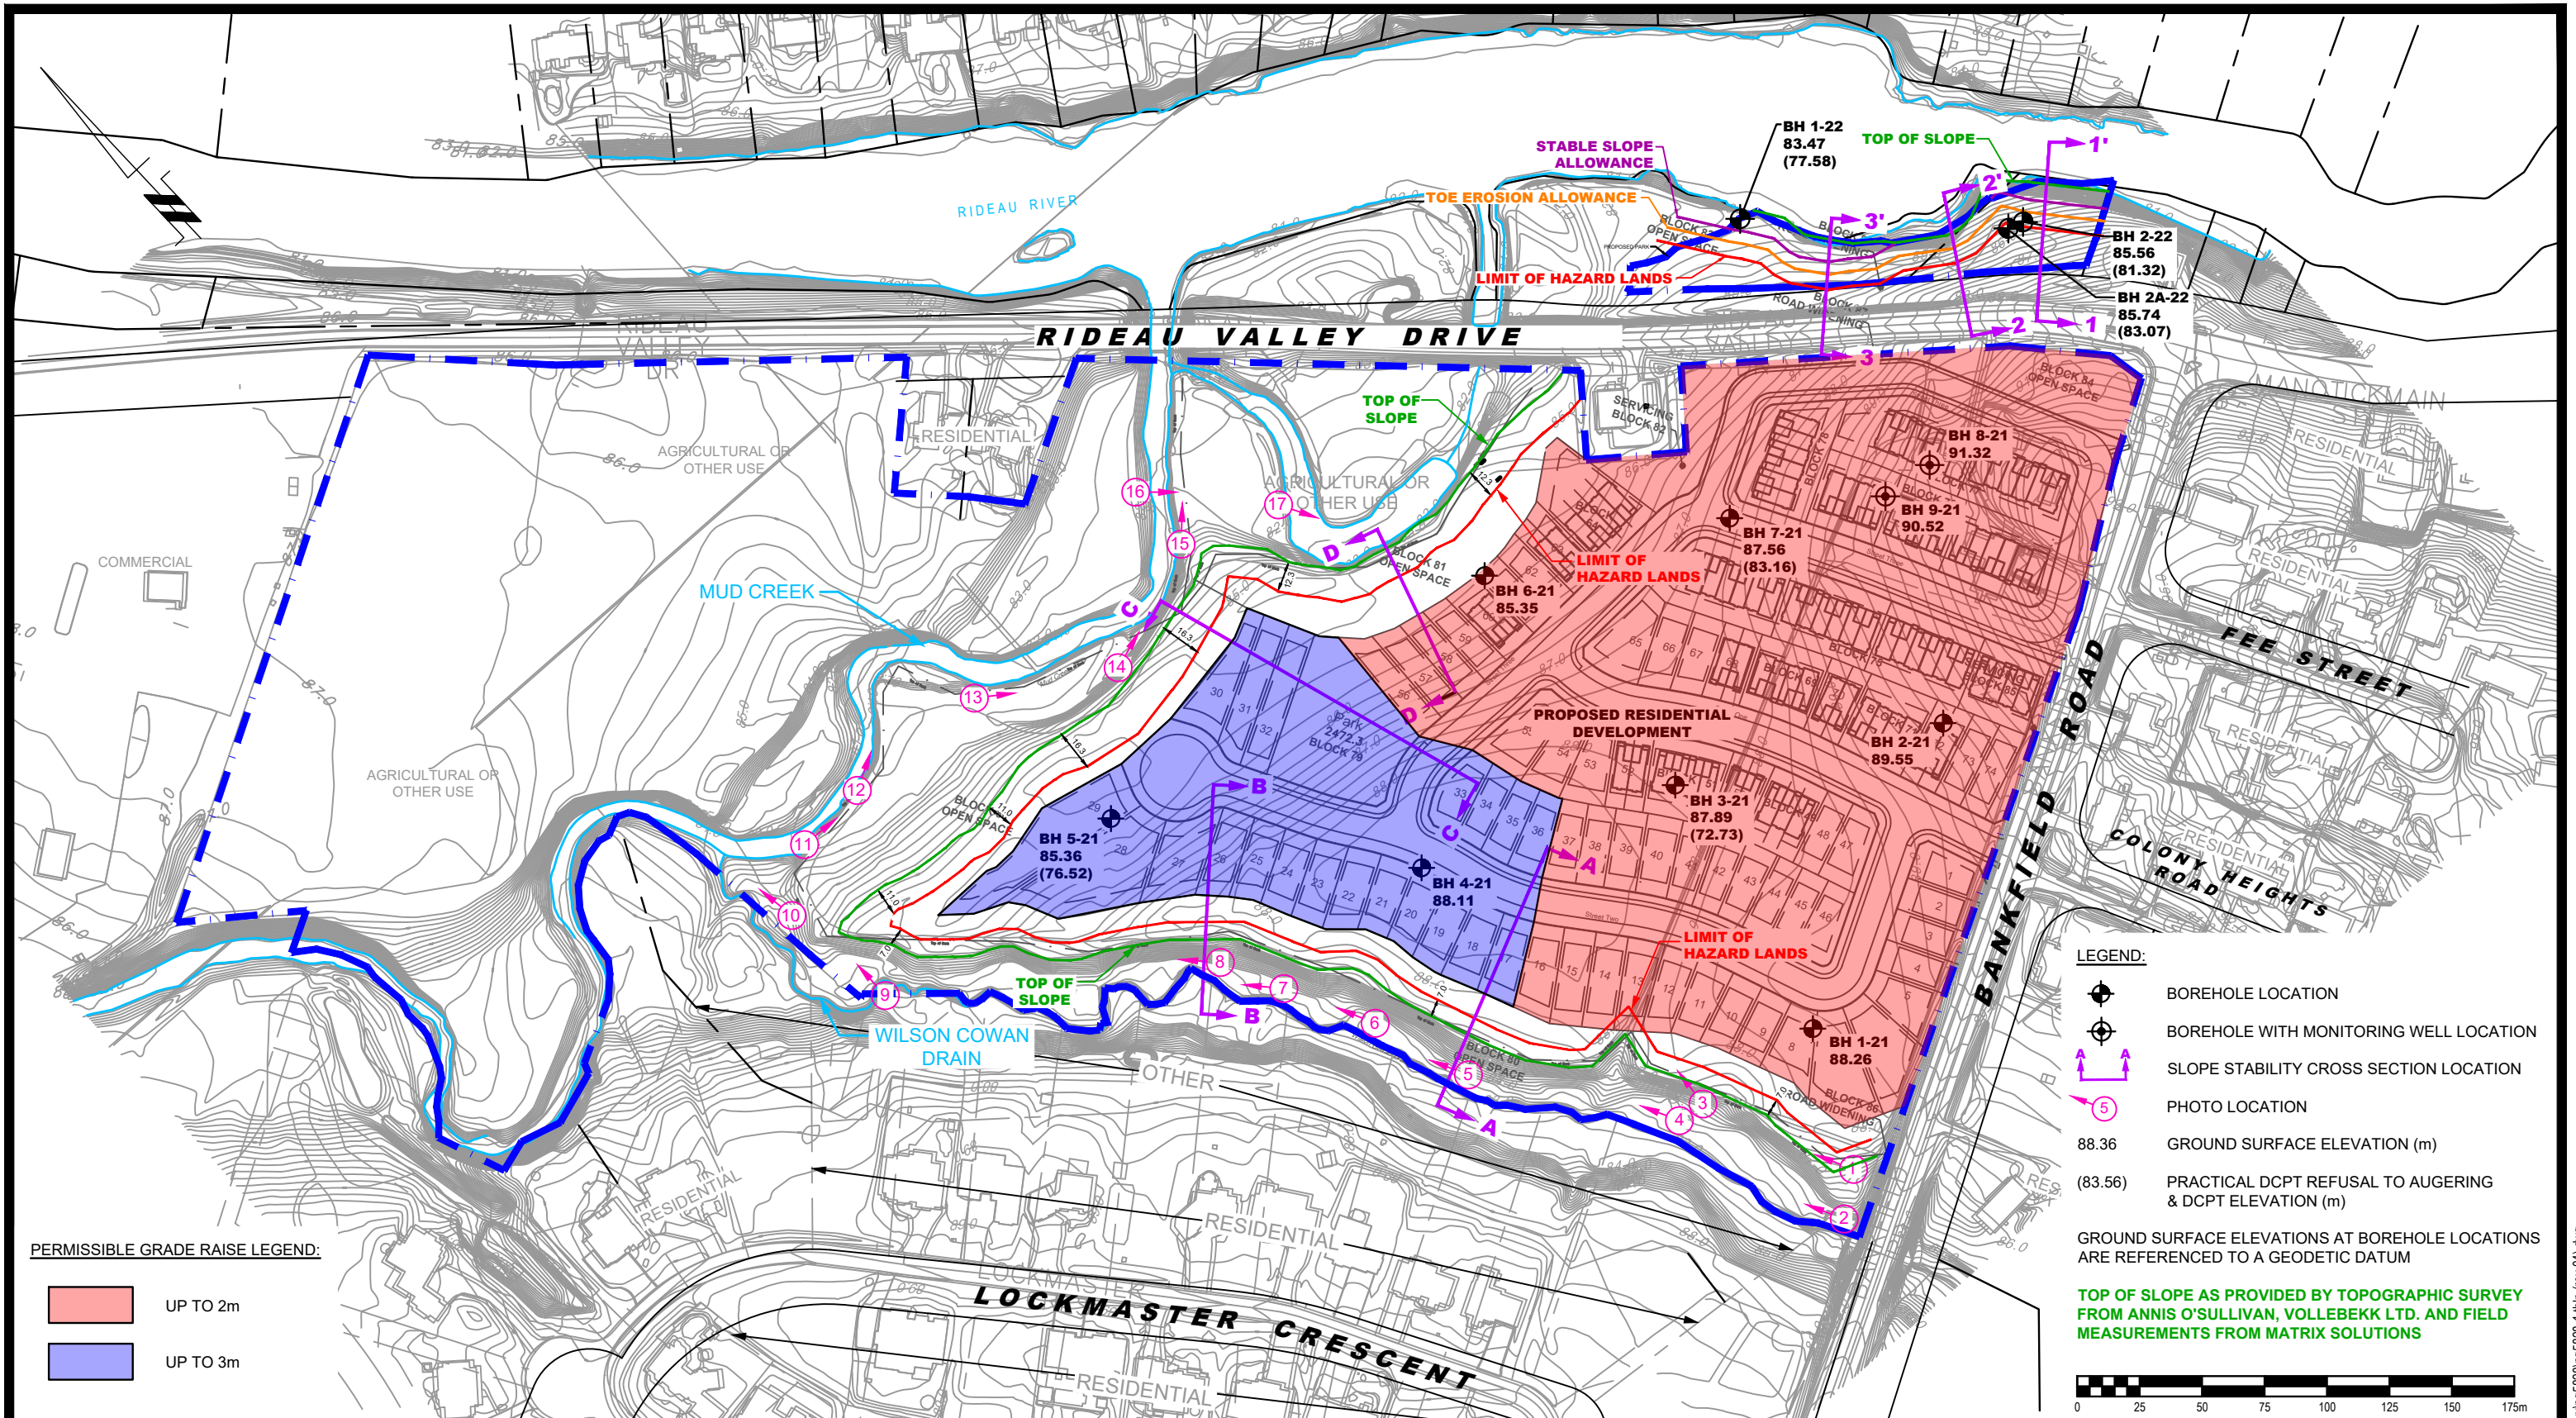
DRAWING PG5828-3 – PERMISSIBLE GRADE RAISE PLAN

Due to the presence of the silty clay deposit, permissible grade raise restrictions are recommended for all structures placed on a silty clay bearing medium. The recommended grade raise restrictions are shown on Drawing PG5828-3 – Permissible Grade Raise Plan included in Appendix 2. A post-development groundwater lowering of 0.5 m was considered in our permissible grade raise calculations.

If greater permissible grade raises are required, preloading with or without a surcharge, lightweight fill, and/or other measures should be investigated to reduce the risks of unacceptable long-term post construction total and differential settlements of the soils surrounding the buildings. However, it should be noted that lightweight fill is not permitted under the ROWs.
