Geotechnical Investigation

Proposed Residential Development

4386 Rideau Valley Drive
Ottawa, Ontario

Report PG5828-1 Revision 2 dated October 14, 2022

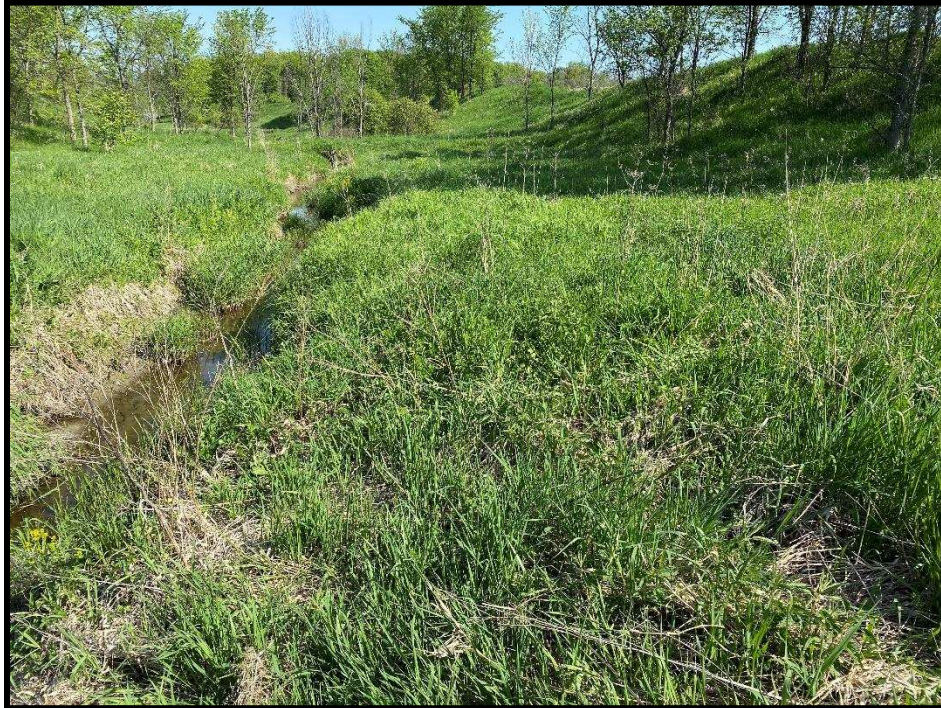
Photo 5: Area along creek tributary and south-west portion of the subject site. Area appeared to be well vegetated and did not appear to be eroded at the time of site visit. Water throughout creek tributary appeared to be flowing very slowly and/or ponding.

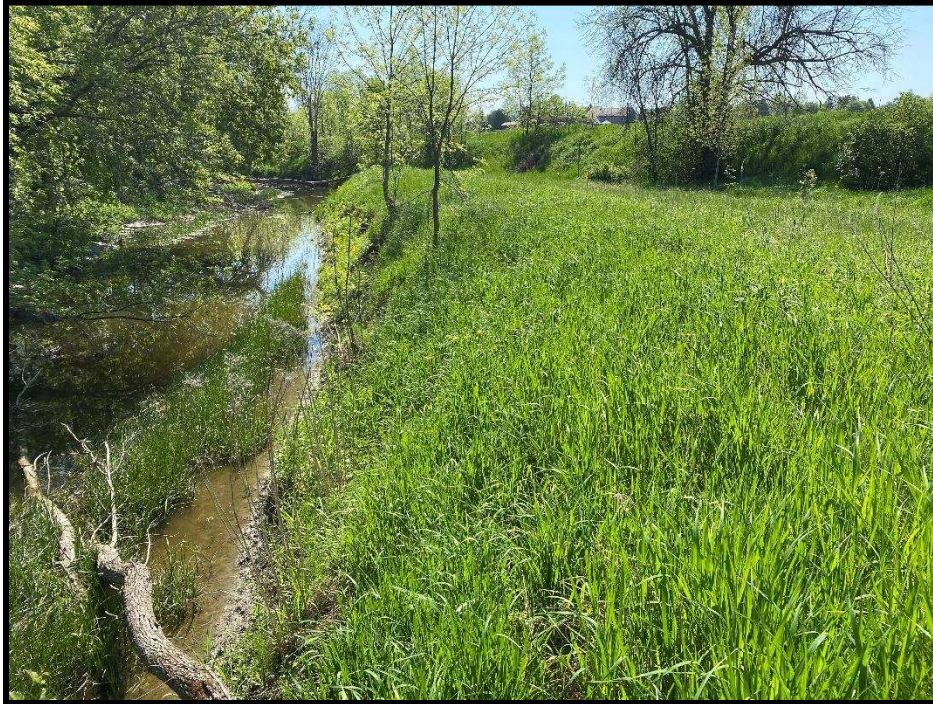
Photo 13: Area of Ruisseau Mud Creek along north-west portion of subject site. Area of valley floor appeared to have well rooted vegetation with relatively steep banks along creek. No active erosion observed along photographed portion of creek at the time of site visit.

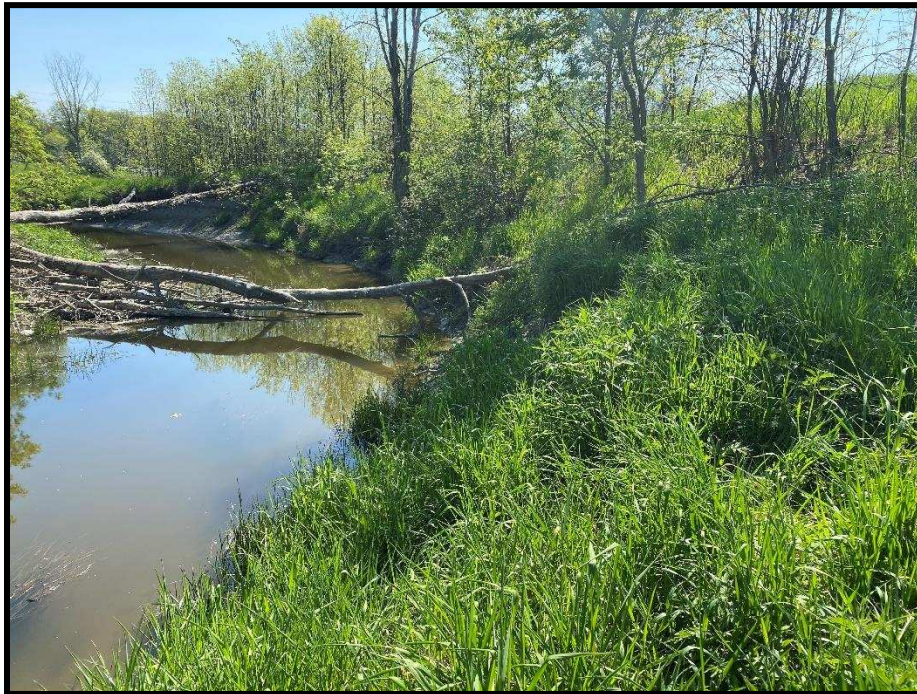
Photo 14: Area of Ruisseau Mud Creek along north-west portion of subject site. Area of valley floor appeared to have well rooted vegetation with relatively steep banks along creek. Some active erosion and fallen trees observed along photographed portion of creek.

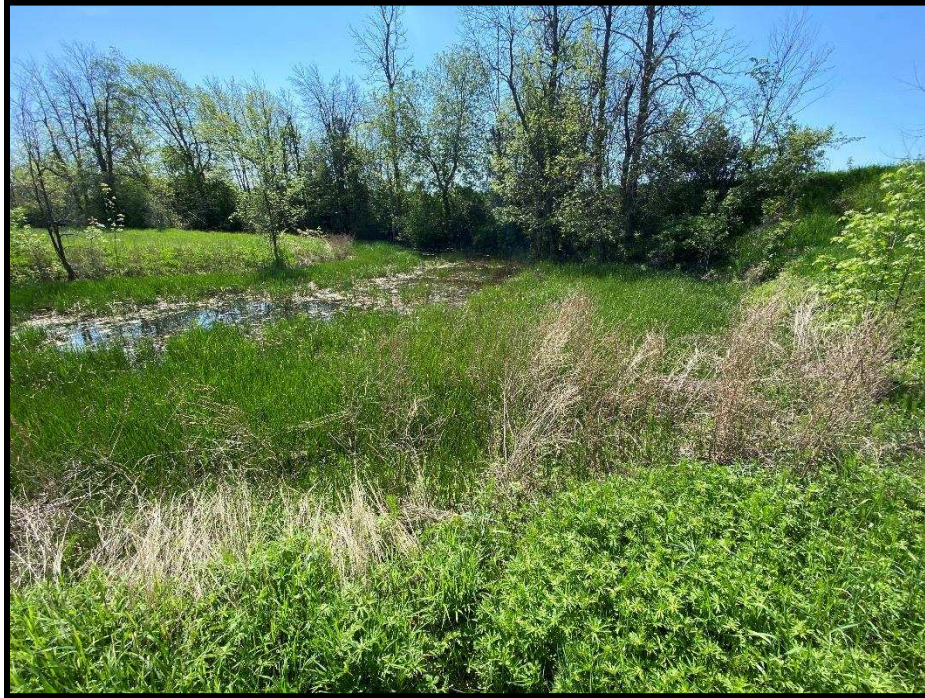
Photo 17: Area of Ruisseau Mud Creek valley floor along north-east portion of subject site. Photographed area appeared to contain well rooted vegetation and mature trees. No erosion observed along toe of slope at time of site visit.

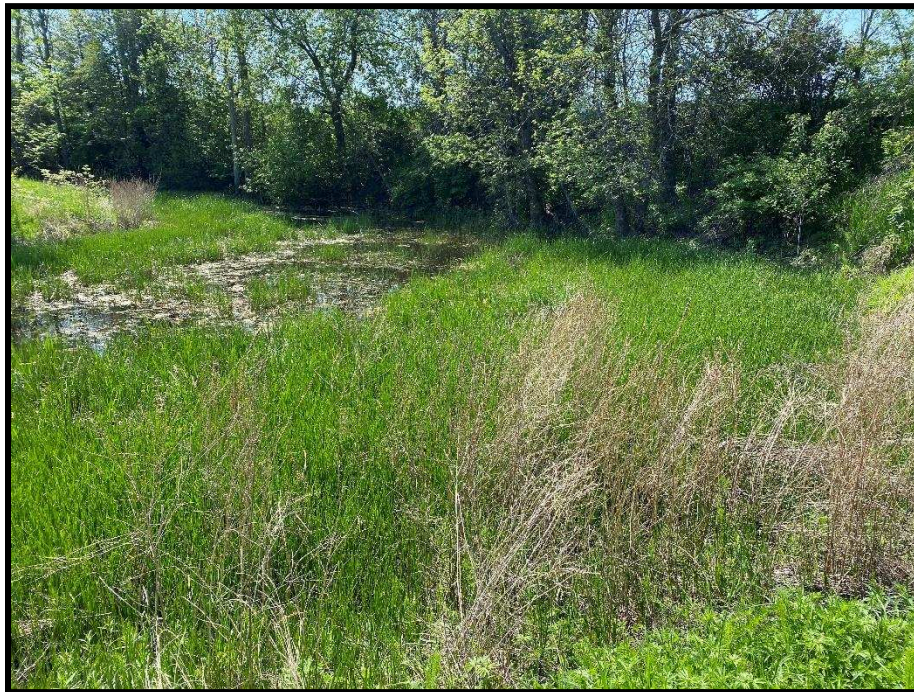
Photo 17b: Close-up of Photo 17 - Area of Ruisseau Mud Creek valley floor along north-east portion of subject site. Photographed area appeared to contain well rooted vegetation and mature trees. No erosion observed along toe of slope at time of site visit.
