ADDENDUM #1

211-231 BANK STREET CONSERVATION PLAN

Applications D02-02-22-0127 / D07-12-22-0188 and plan number 18910

August 2024

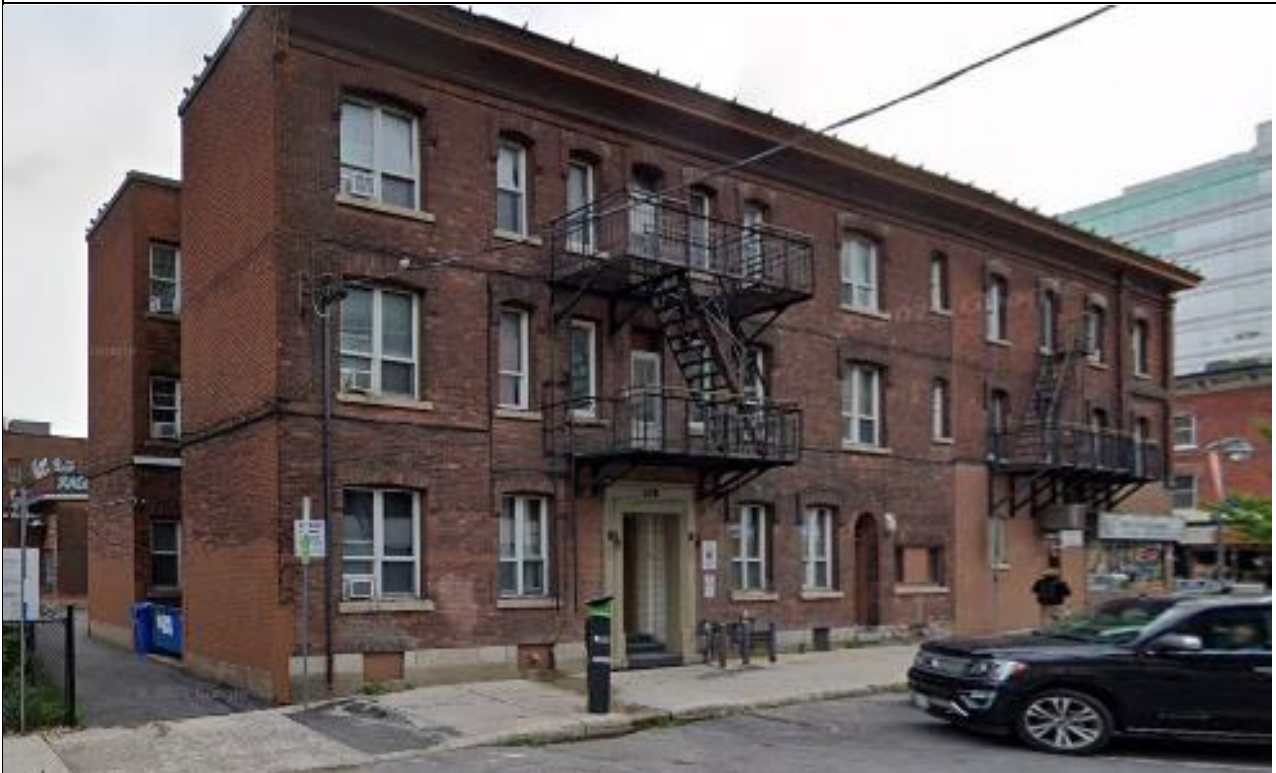
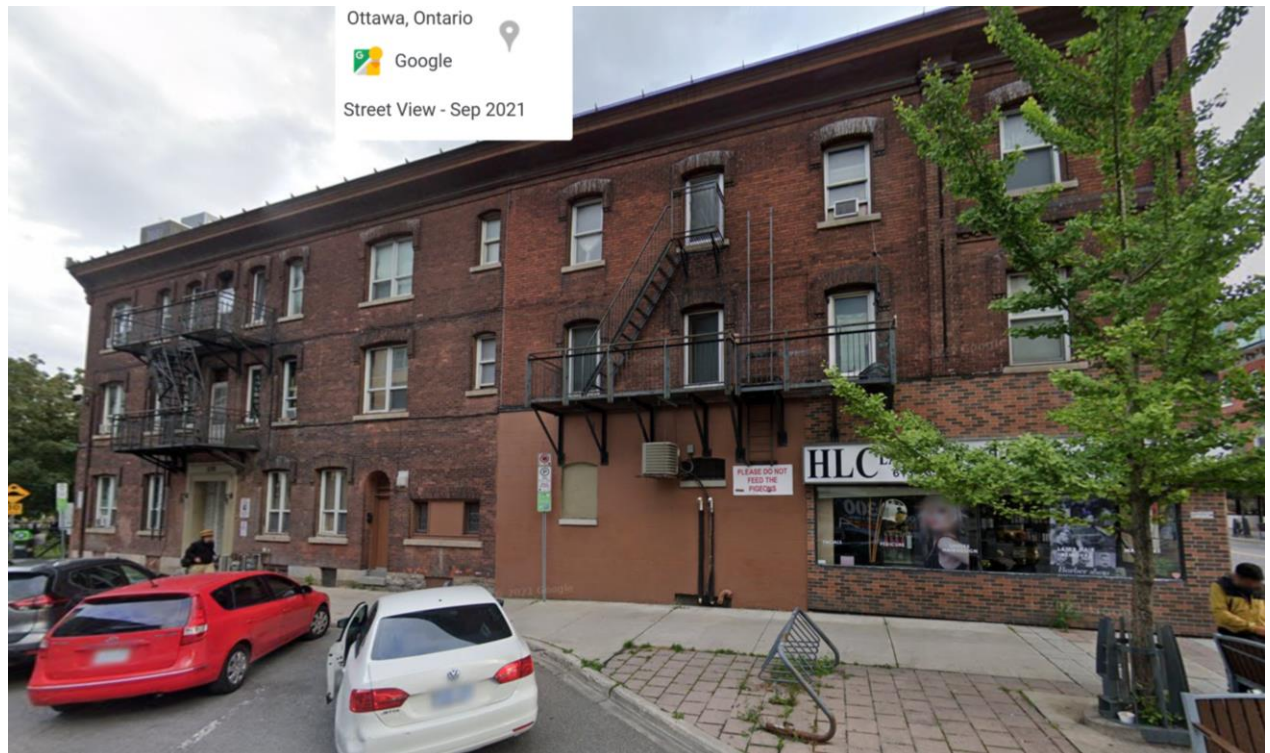
Figure 4 :& 5 views of the north elevation

The building's footprint and upper storeys have not changed since the Nepean addition c.1922. The upper floors continue as residential apartments. The building appears to be in fair to good condition requiring cleaning and repointing of masonry, some repairs to the metal cornice, and the renewal of windows. The ground floor commercial storefronts have been completely altered, with original features lost. The existing frontage replaced with a variegated brick infill, the shopfront's glazed transoms and large commercial glazing removed along with the ground floor cornice.

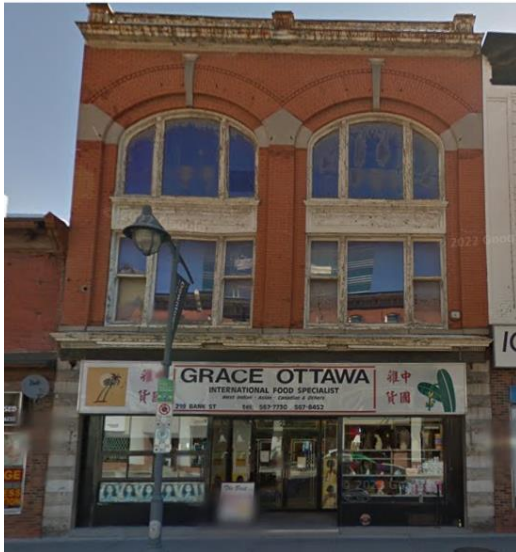
219 -221 BANK STREET

The building's footprint has not been altered. The upper floors show signs of deterioration and lack of maintenance. The retail on the ground floor consists of aluminum and tile storefront with a recessed entrance flanked by the original stone piers.

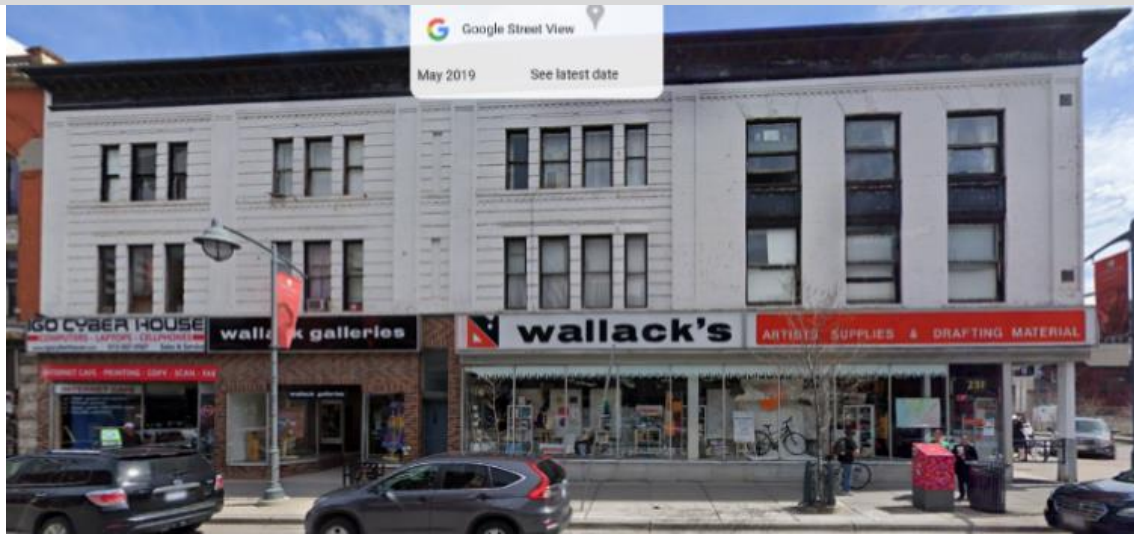
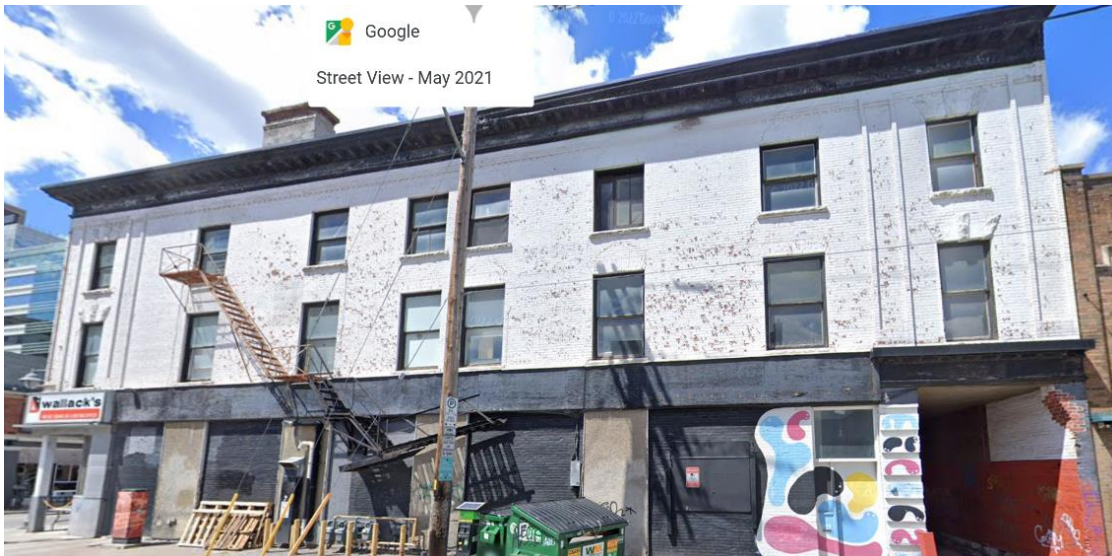
223 -225 - 227 229 & 231 BANK STREET

The façade of the Wallack's Building has been painted. In the detailed view the spalling of the paint is extensive suggesting that the removal of paint will not be too difficult. The extent of damage to the brick needs to be assessed. Along the face there is step cracking of the brick below third floor windows. There is some bulging in places. The pilasters at either end of the facade will have to be replaced at the street level. The large black panels at grade were originally windows that have been boarded over.
