# Fluvial Geomorphology and Erosion Hazard Assessment

**1086 Antochi Lane  
Manotick, Ontario**

June 22, 2023  
PN23057

Project Number: PN23057  
Status: Final  
Version: 1.0  
First Submission Date: June 22, 2023

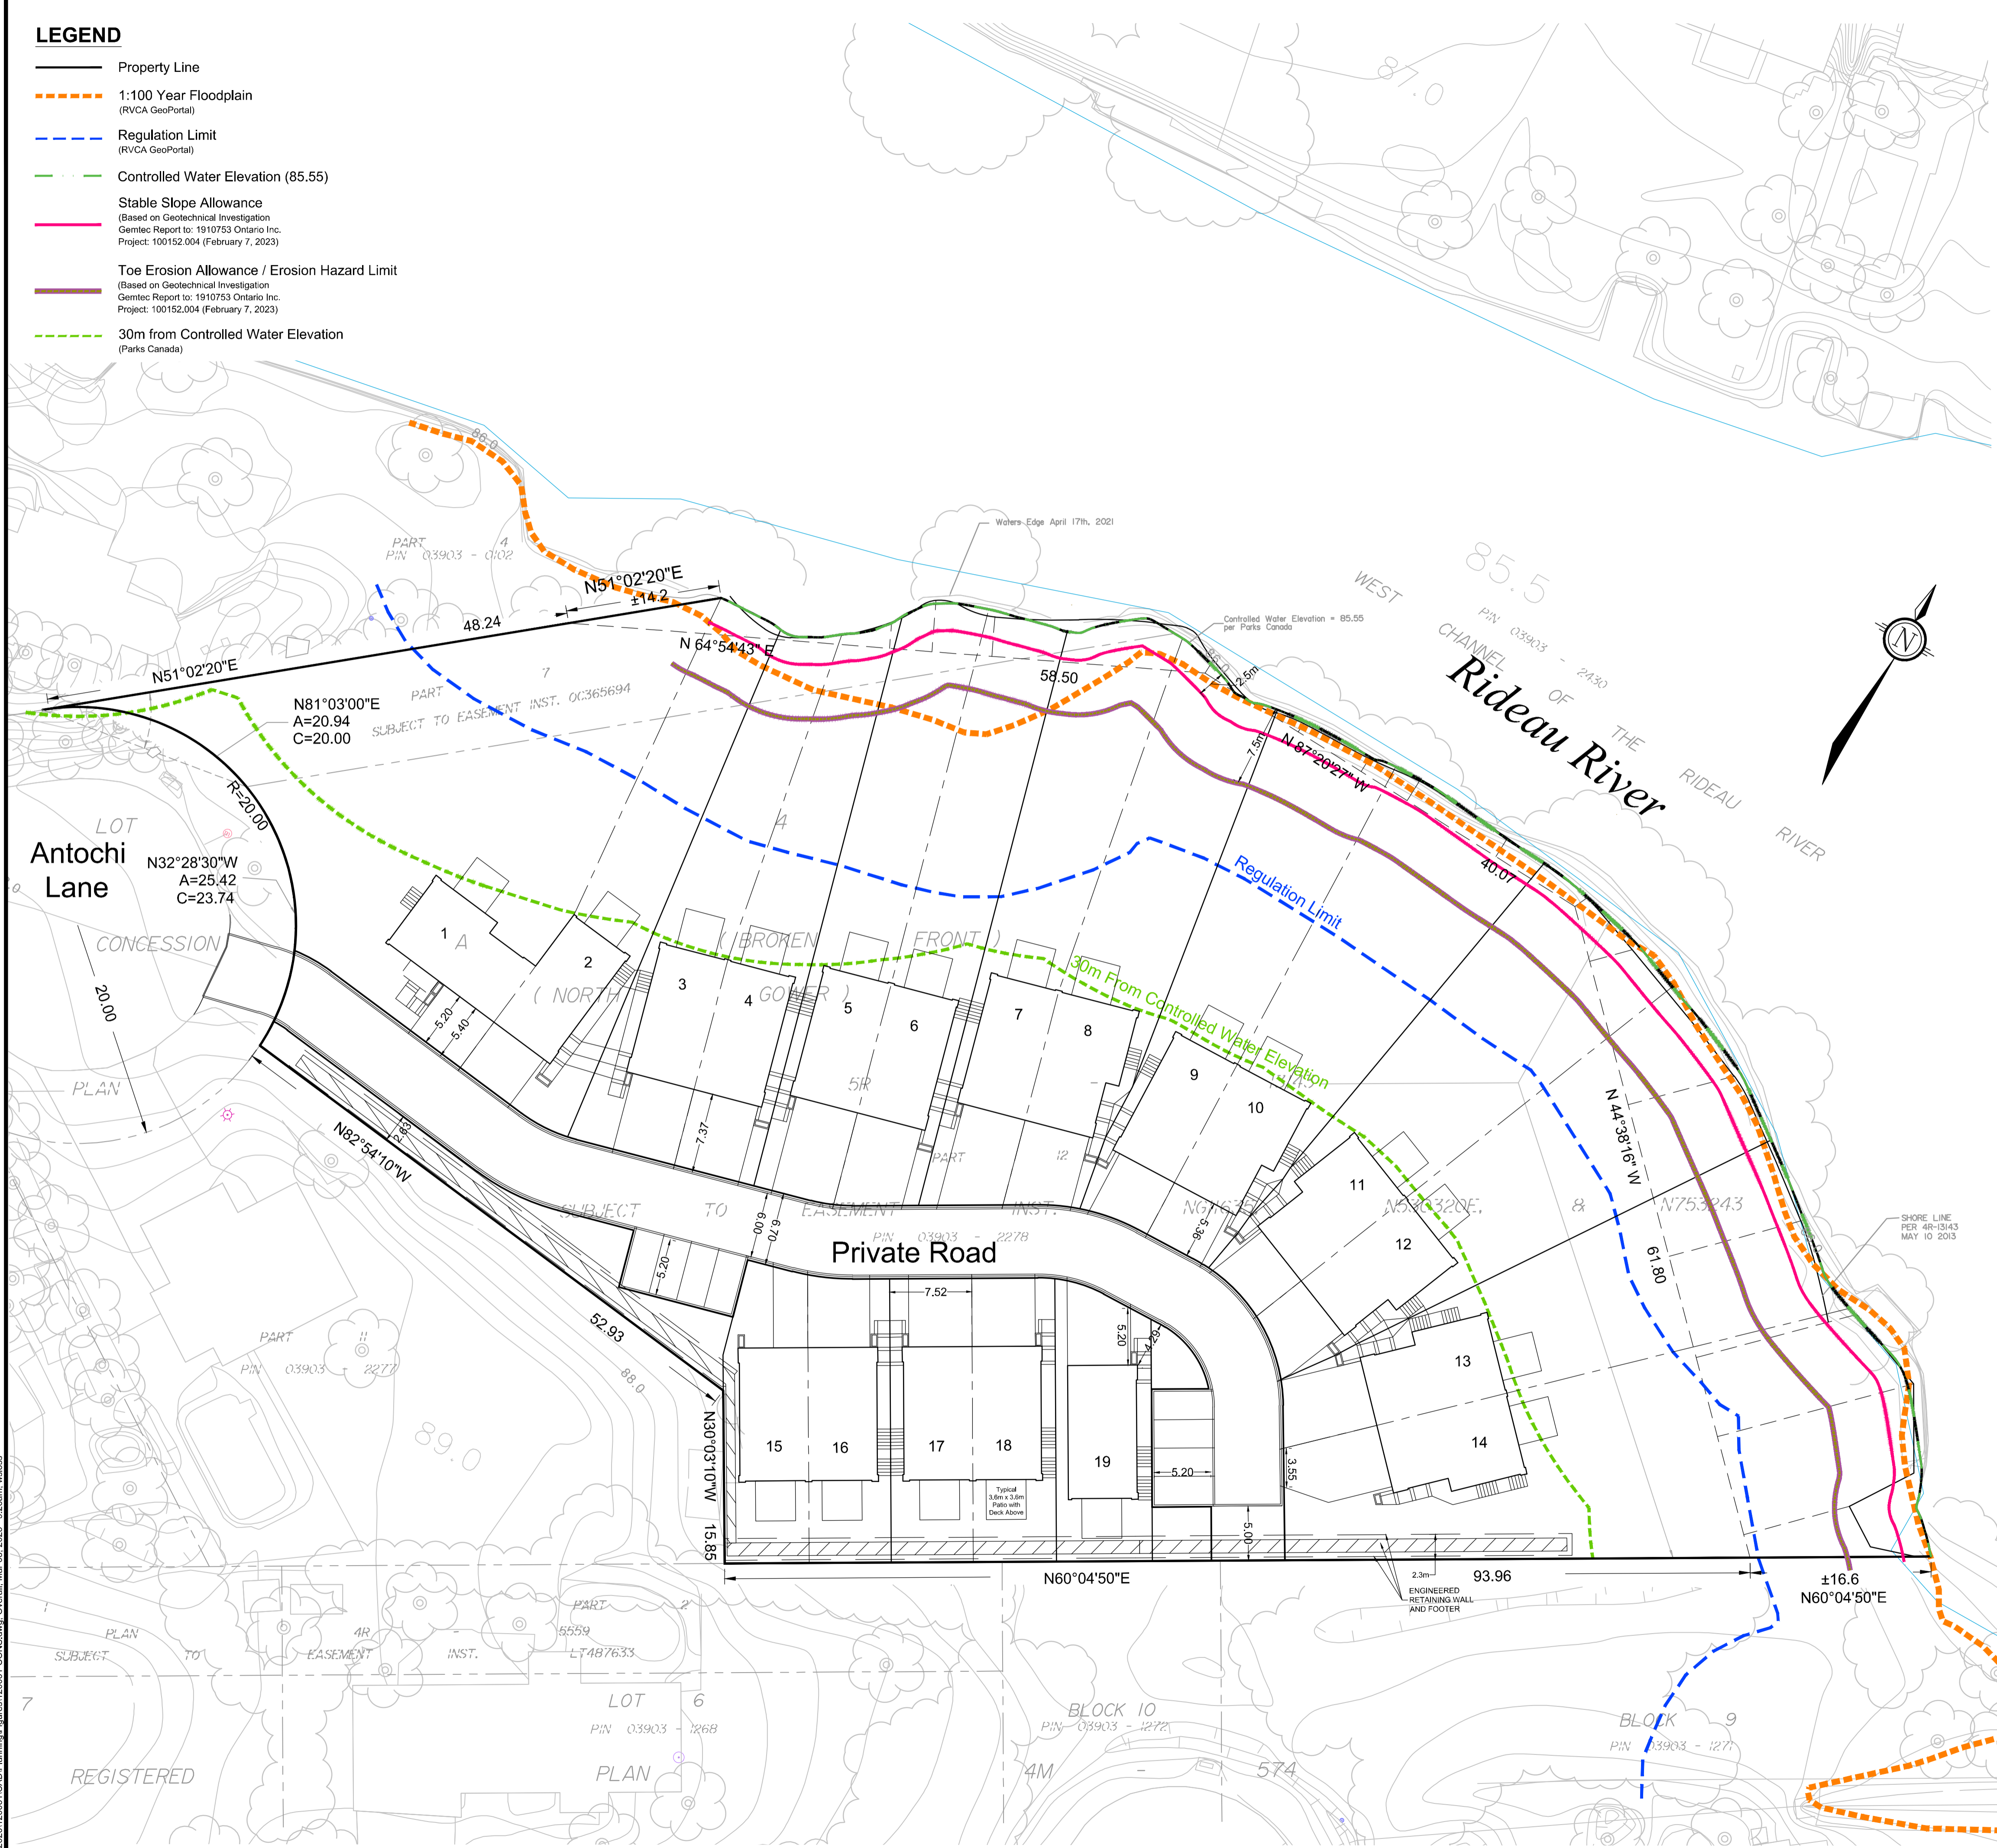
# CONSTRAINTS PLAN

Novatech prepared a plan that illustrates constraints to development (refer to Drawing No. 120061-CONS in **Appendix B**). As demonstrated in the plan, the proposed development respects the erosion hazard limit delineated by GEMTEC Consulting Engineers and Scientists Limited (2023). The 30 m setback from the controlled water elevation is the governing constraint to the development as currently proposed.

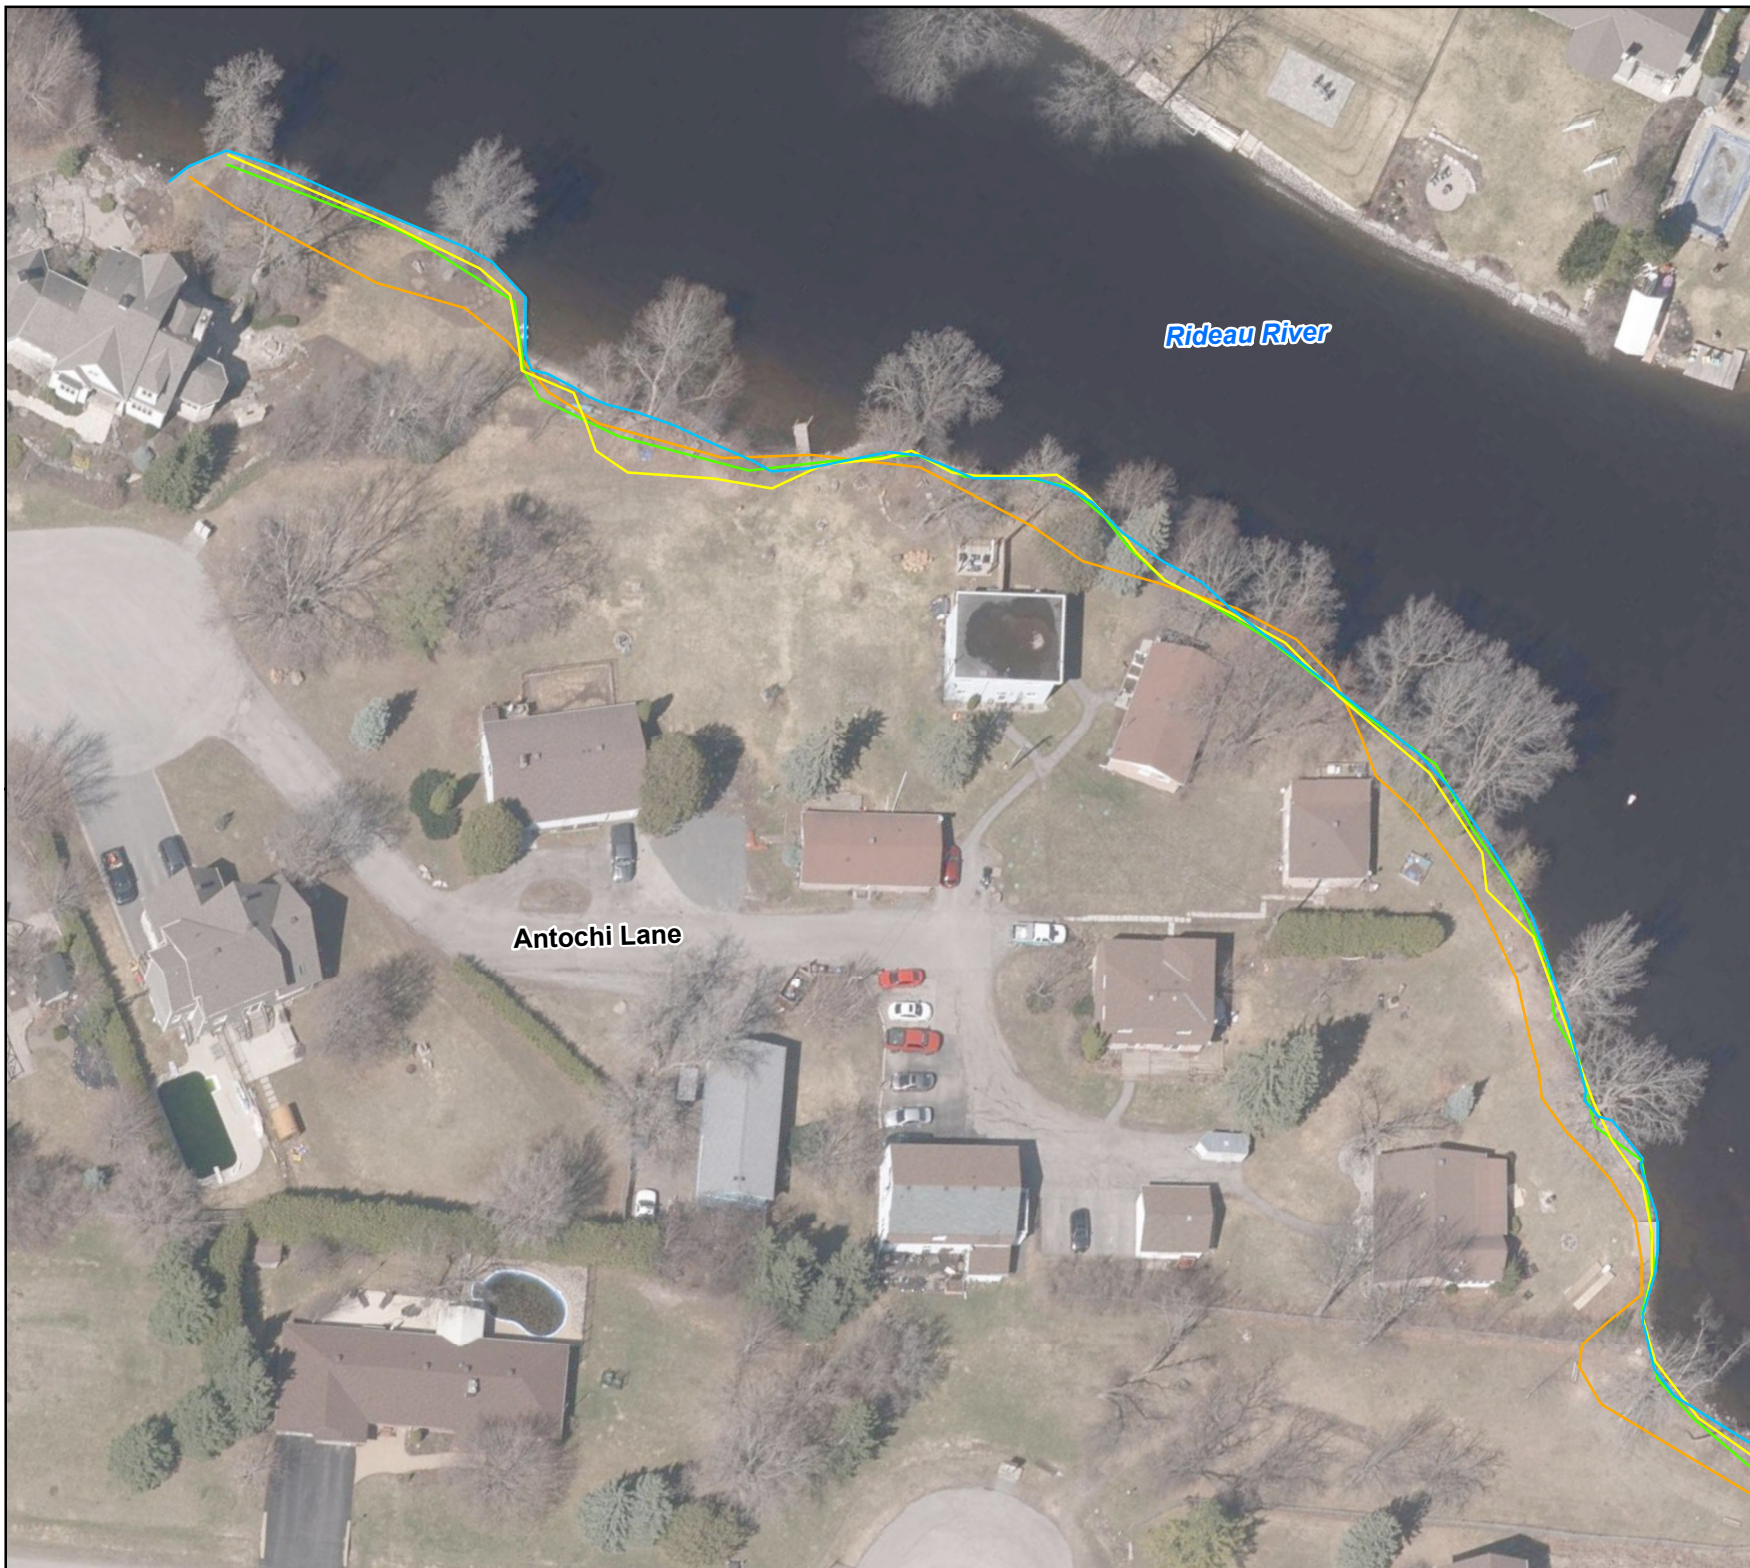
### **Historical Channel Position**

Further to the qualitative overall assessment above, the channel bank along the property was digitized using GEO Ottawa imagery for the years 1976, 2002, 2011 and 2021, encompassing 45 years of record. Although a 1954 aerial image is available from the University of Toronto, the shoreline was not digitized due to the resolution of the image and georeferencing considerations (i.e., inadequate control points). As shown in **Appendix D**, the channel bank appears to have been modified/infilled when 1976 and 2002 channel bank positions are compared, but has remained relatively stable over the period examined.

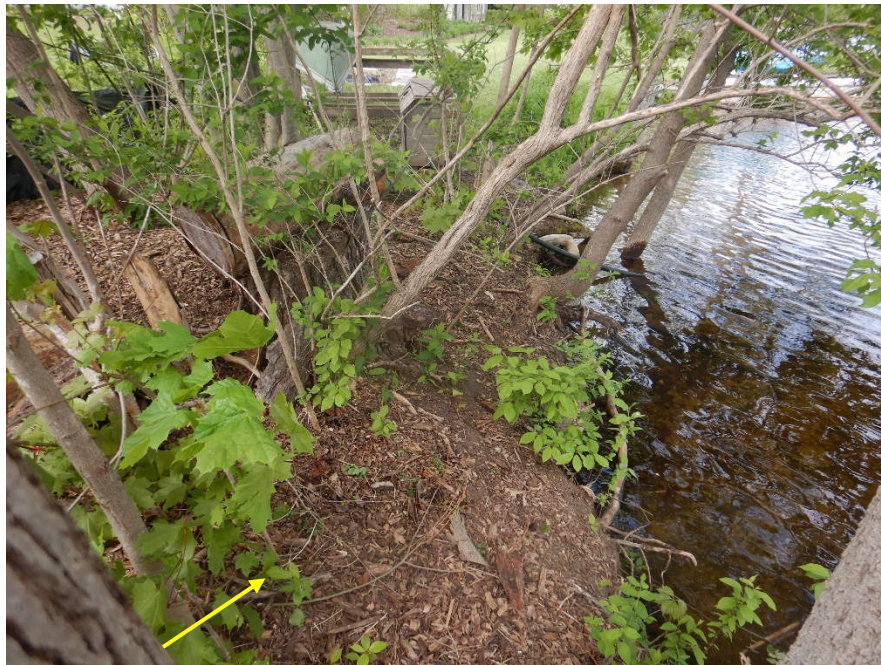
Photo 1  
Rideau River  
1086 Antochi Lane, Manotrick

Photograph taken at the downstream extent of the subject lands. Bank was unaltered along an approximately 5 m section.

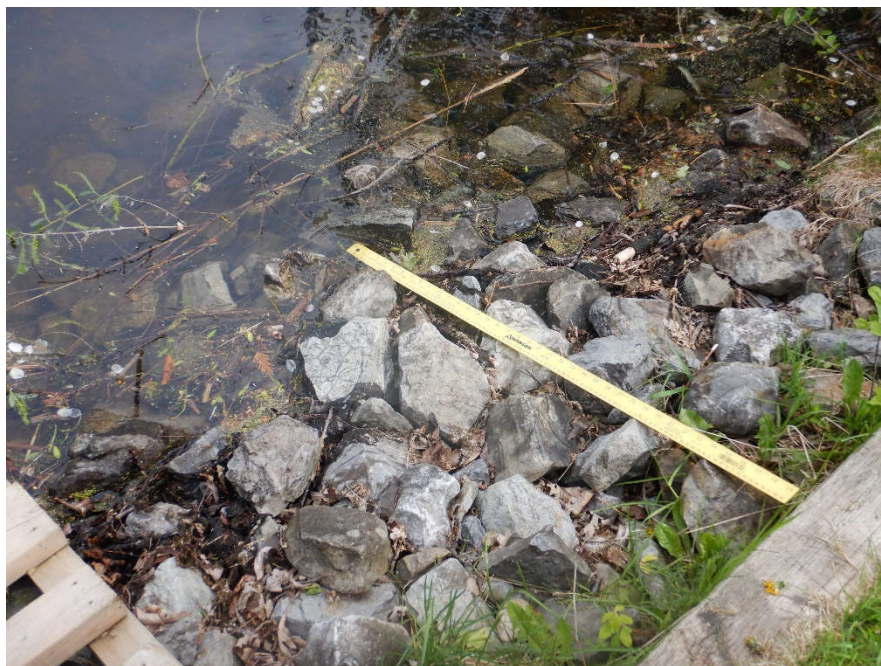
Photo 2  
Rideau River  
1086 Antochi Lane, Manotrick

Photograph taken at the downstream extent of the subject lands. The remainder of the bank was composed of 10-20 cm rip rap.

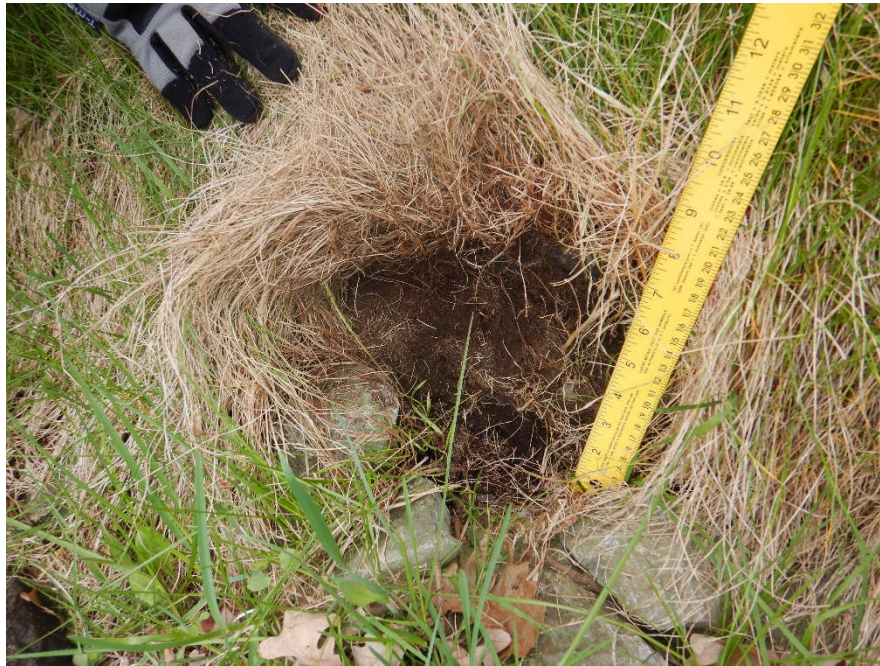
Photo 3  
Rideau River  
1086 Antochi Lane, Manotrick

Erosion blanket observed at several locations along the bank under the rip rap.

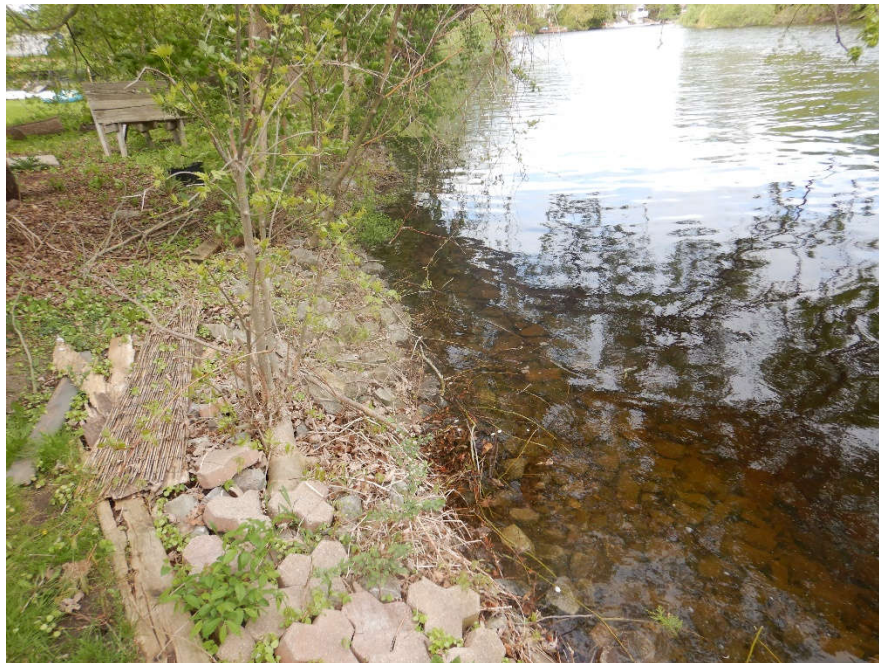
Photo 4  
Rideau River  
1086 Antochi Lane, Manotrick

Photograph taken facing downstream, bank materials extended approximately 1-3 m into the water, and 1-2 m up the channel banks.

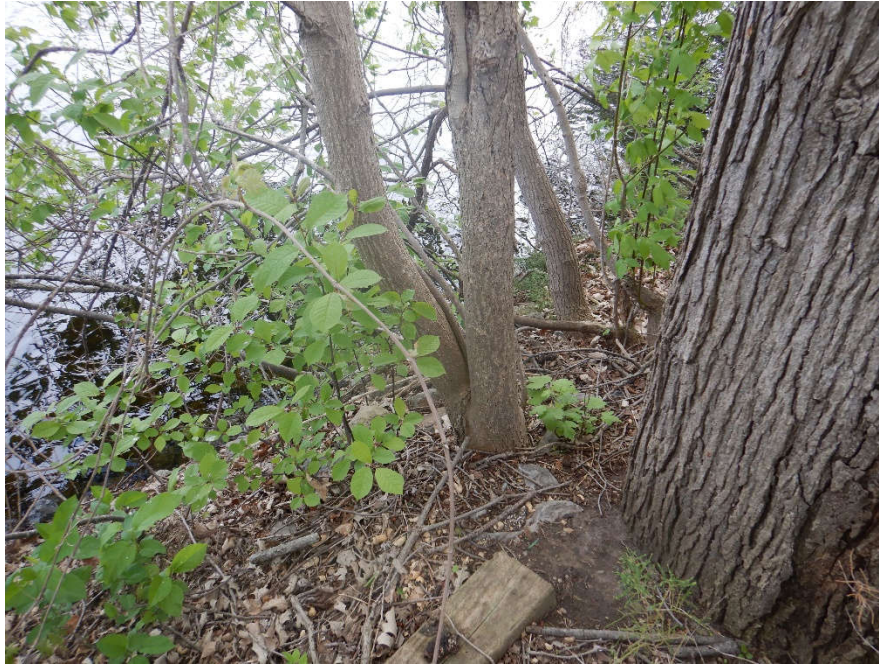
Photo 5  
Rideau River  
1086 Antochi Lane, Manotrick

Between property lines, vegetation extended to the water edge. Mature and immature vegetation was well established along the banks.

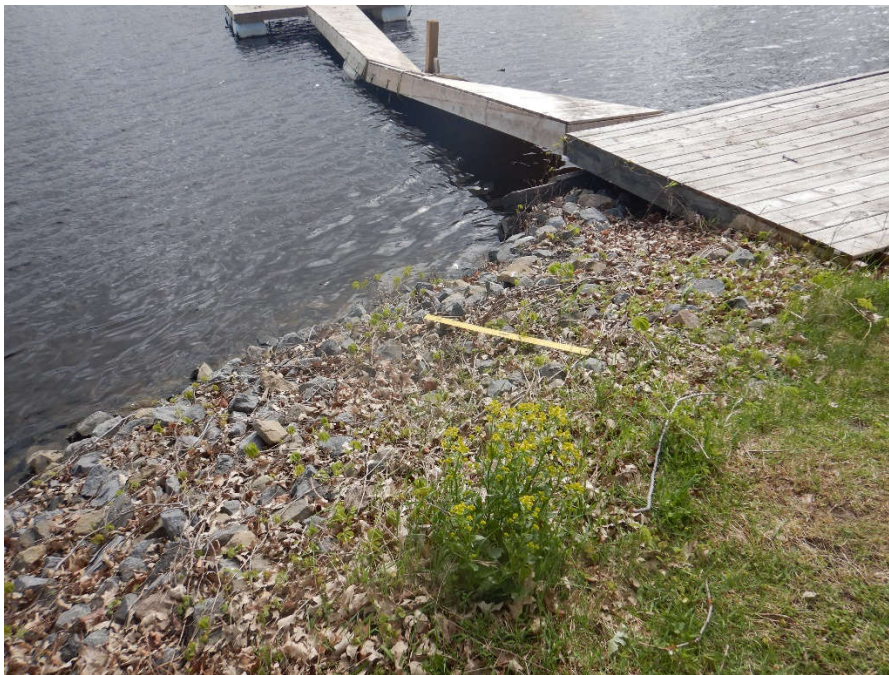
Photo 6  
Rideau River  
1086 Antochi Lane, Manotrick

Photograph taken facing upstream at the upstream extent of the subject lands. A majority of the shoreline was composed of rip rap. Private docks were present at the shoreline of most residences.
