1900 and 2000 CITYPARK DRIVE TREE INVENTORY AND RETENTION REVIEW

1900 & 2000 CITY PARK DRIVE

drawing title
1900 CITY PARK DRIVE EXISTING VEGETATION

drawing title
2000 CITY PARK DRIVE EXISTING VEGETATION

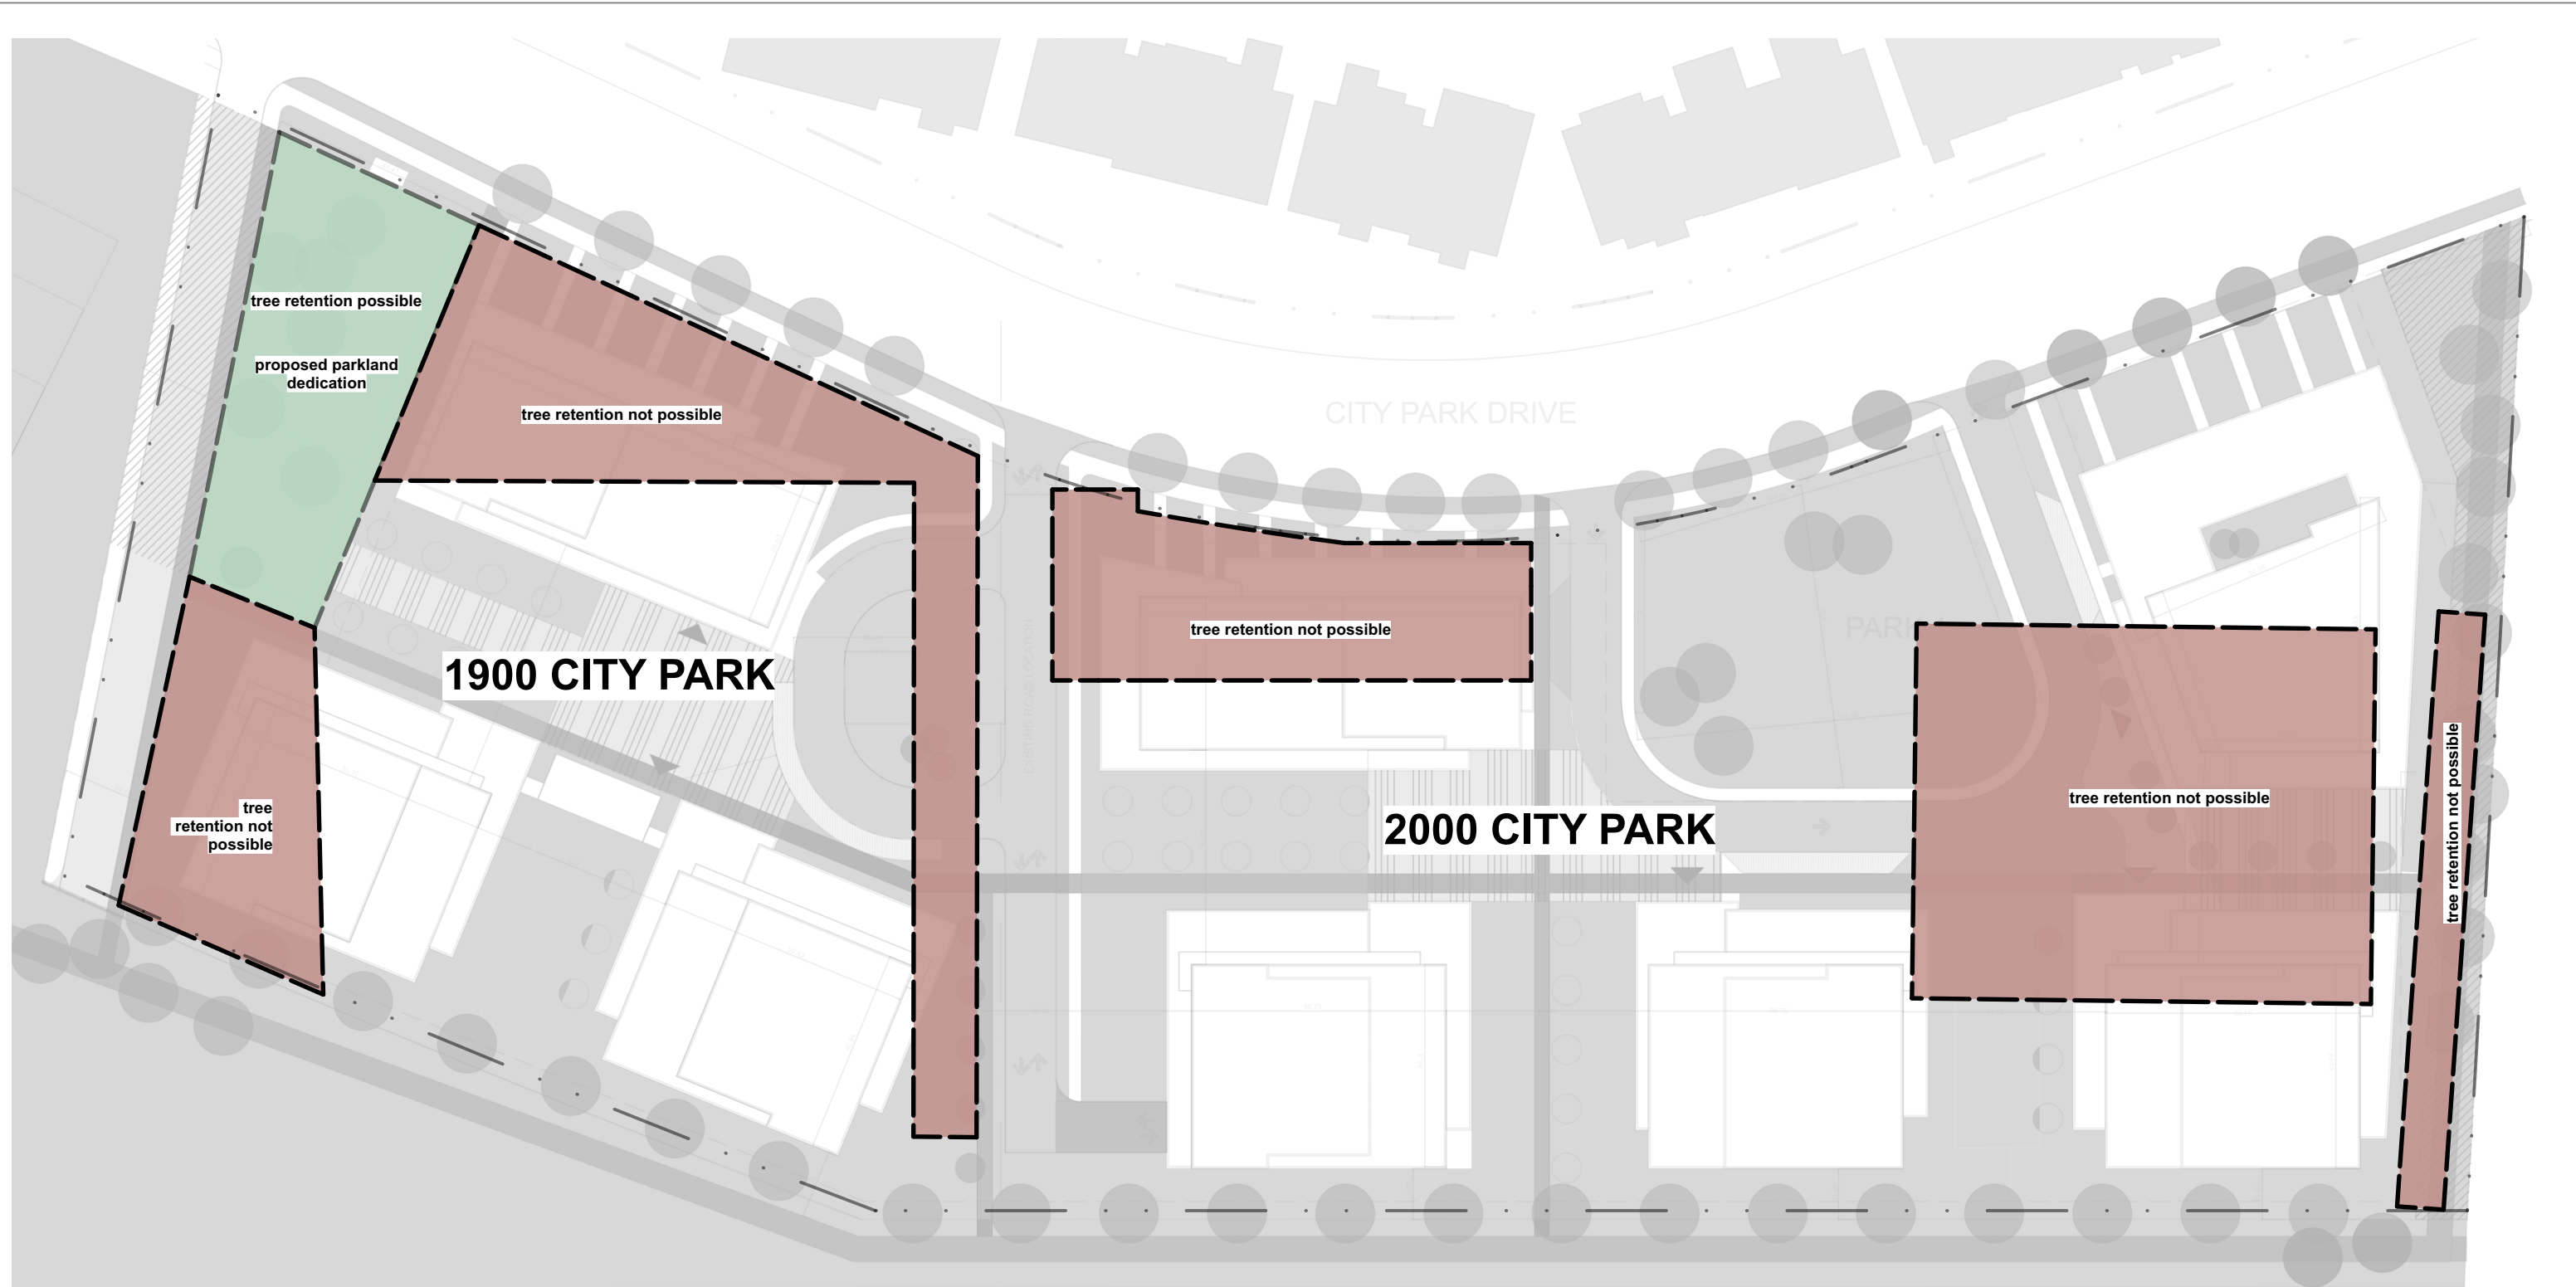
Tree Retention: based on the current schematic site plan, preservation opportunities exist in the north west corner in the r.o.w. adjacent to the proposed entrance drive (trees #36-40, 48 & 49). The remainder of the trees would be removed. A final review of retention possibilities will be undertaken during the site plan control process with a final site plan layout. Refer to attached tree retention areas.

Tree Retention: Preservation opportunities exist in the north west corner (parkland dedication) (trees #8-21), depending on the future use. The remainder of the trees would be removed. A final review of retention possibilities will be undertaken during the site plan control process with a final site plan layout. Refer to attached tree retention areas.

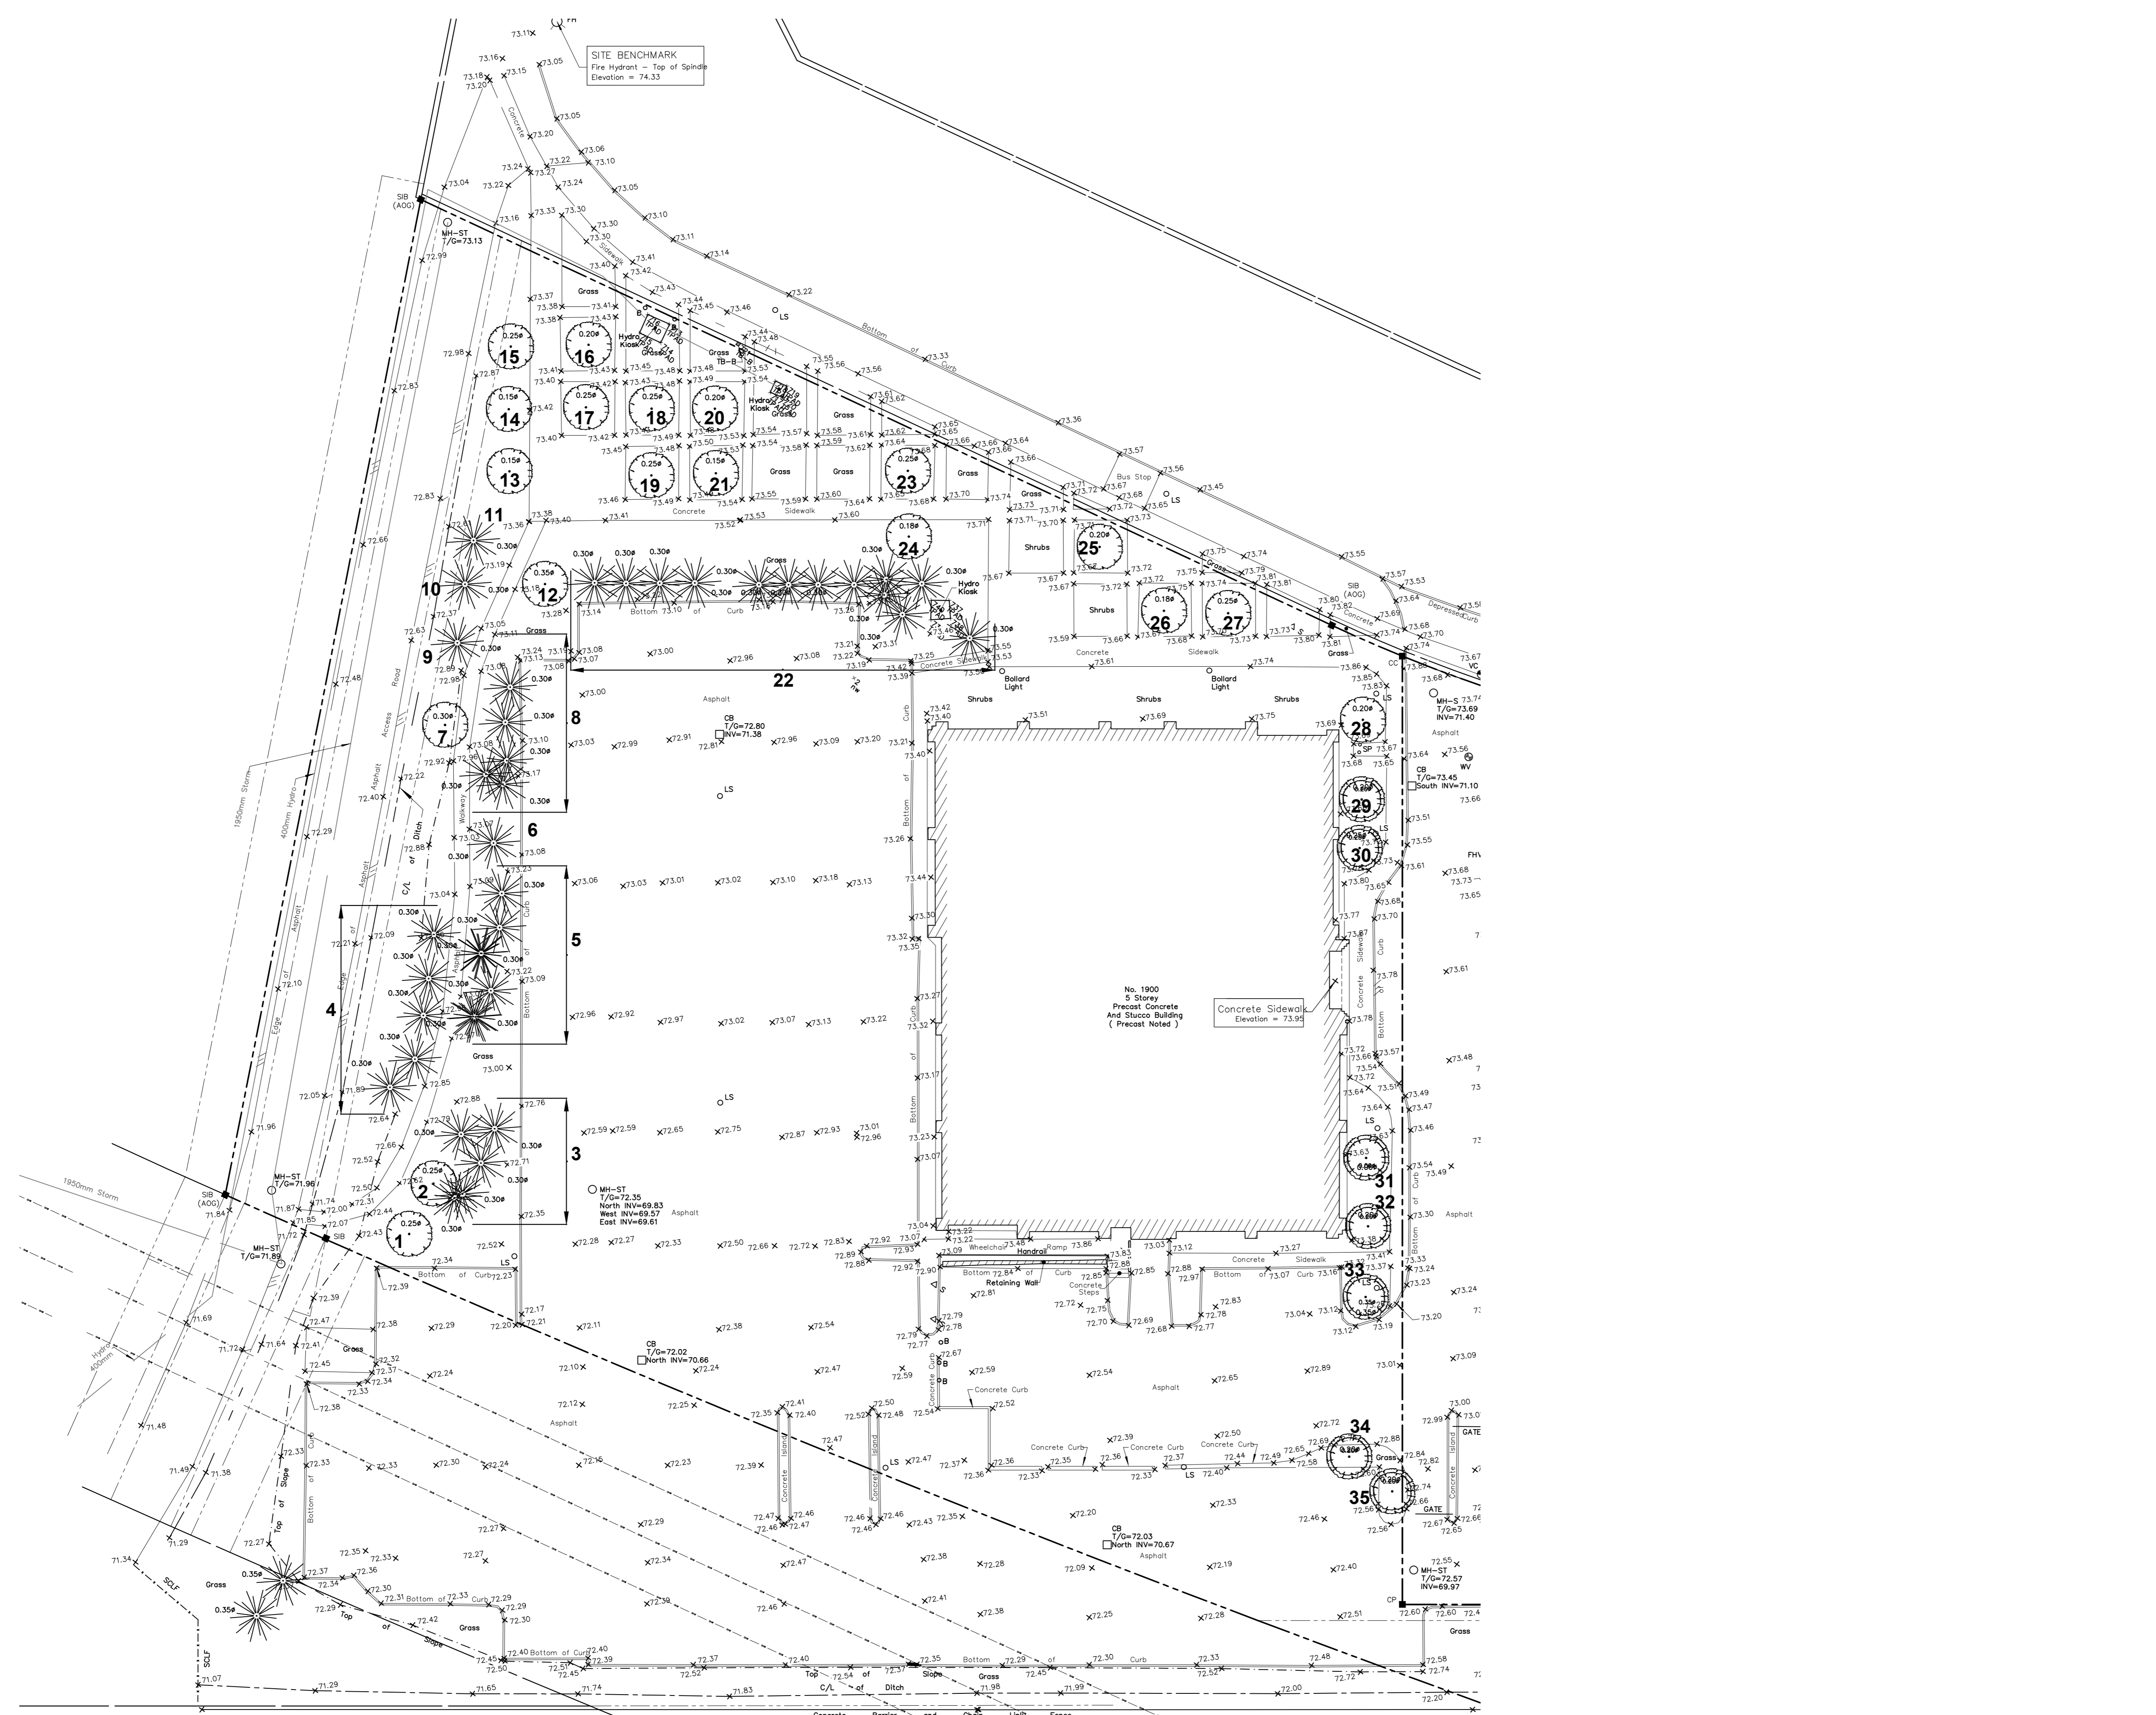
This block consists of an existing 5 storey building, parking and built landscape with semi mature trees. The majority of the species here are Norway Maple, Colorado Spruce and Japanese Tree Lilac, semi-mature to mature size, from poor to good condition, refer to chart.

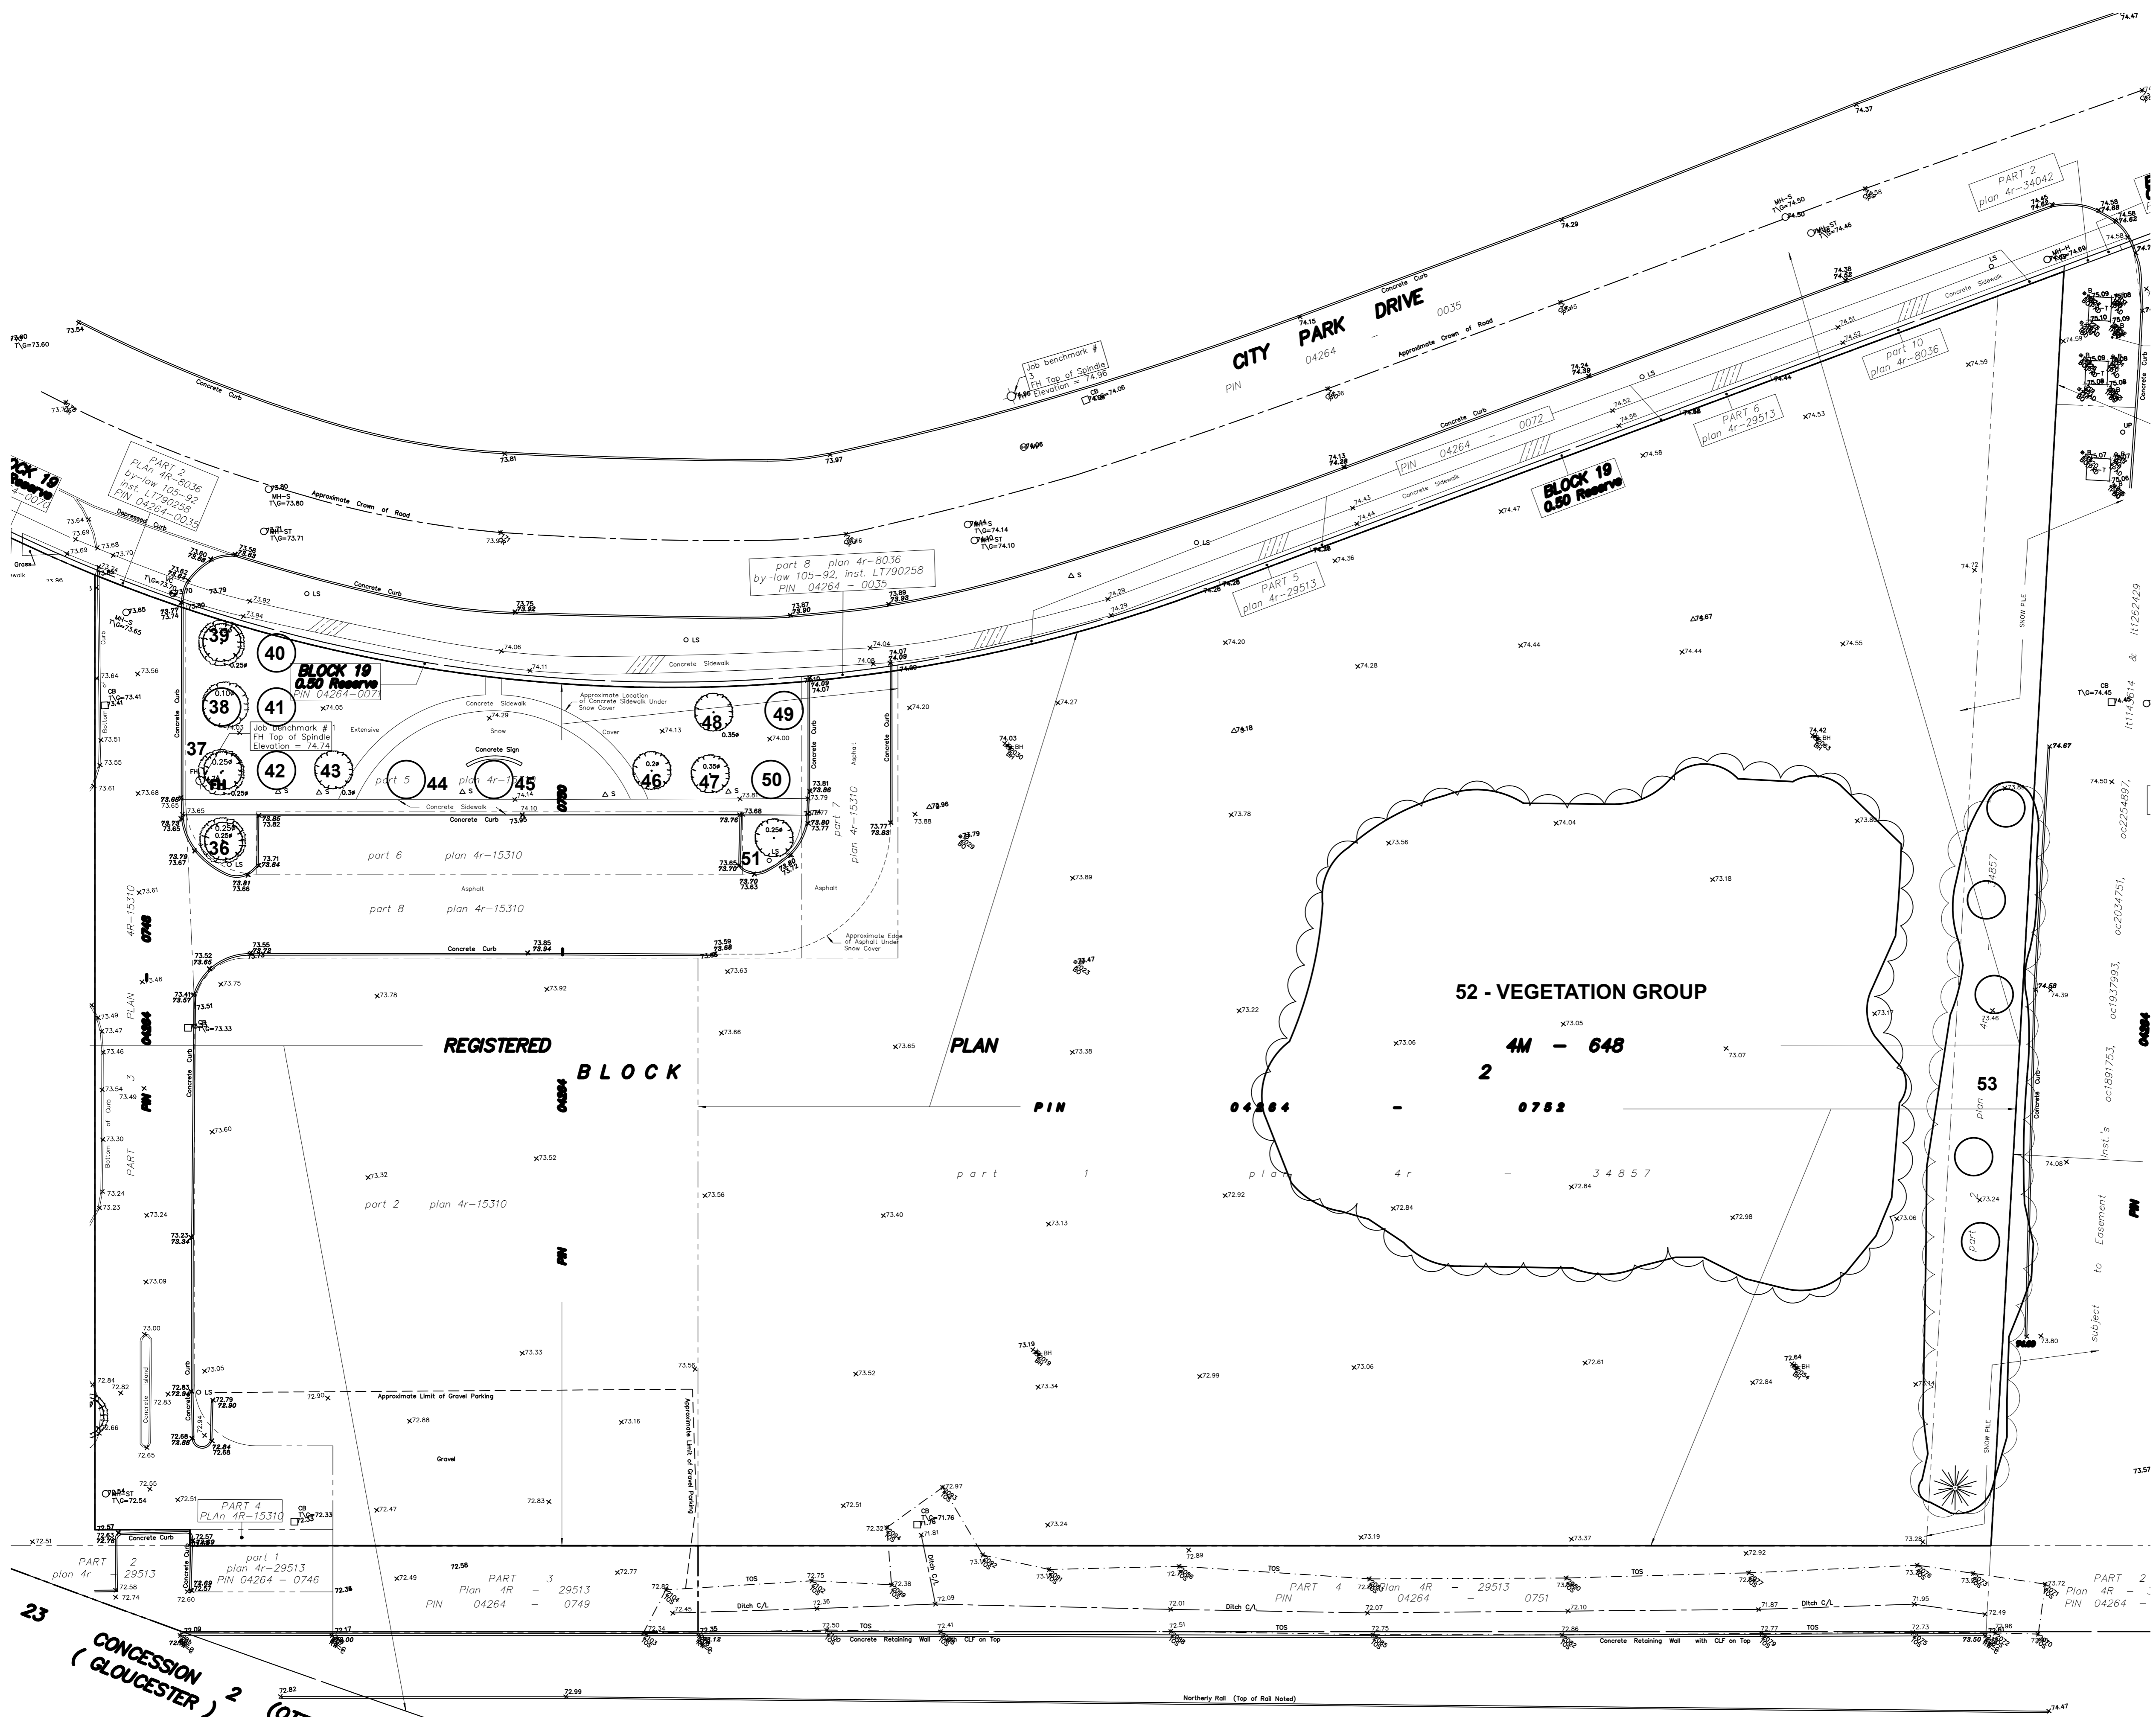
Majority of this block is vacant field. Existing planted trees are located in the north-western portion (young to maturing Norway Maple and Crab Apple) and along the eastern property line (young Norway Maple, Colorado Spruce and White Elm). A naturalized vegetation area is centrally located consisting mainly of young White Elm and Buckthorn. Condition is very poor to good, refer to chart.
