June 6, 2019

Chmiel Architects Inc.
Attention Richard Chmiel
200-109 Bank Street
Ottawa, Ontario, K1P 5N5

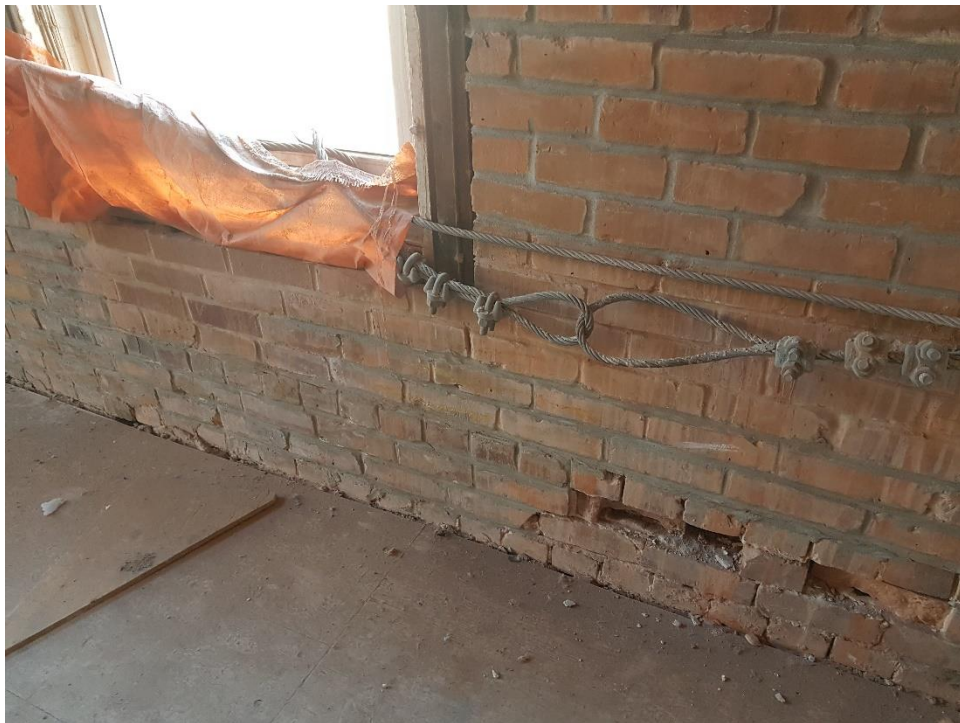
Photograph 10: Area of noted brick deterioration on the interior wythe of second floor, north wall.

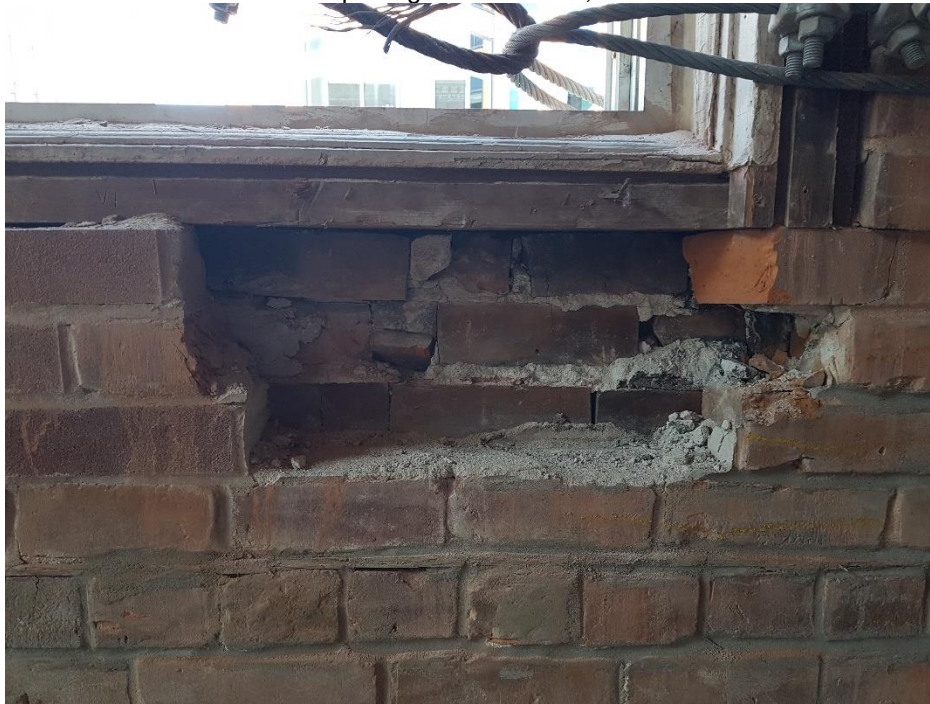
Photograph 12: View of the middle wythe condition. Mortar in poor condition and some cracked bricks.
Opening on north wall, second floor (below window to extract middle wythe).

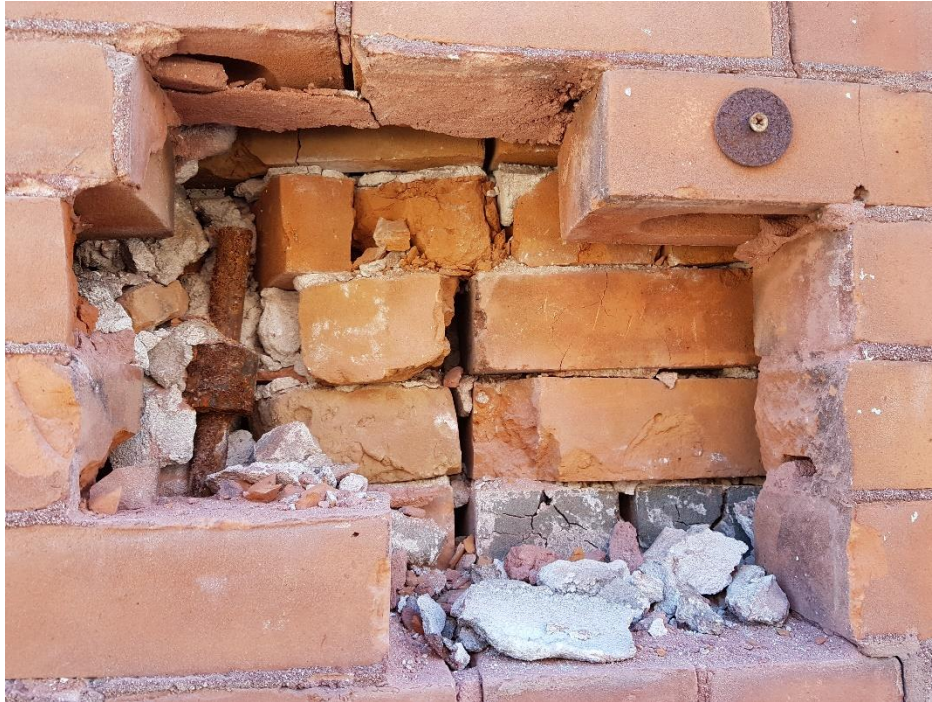
Photograph 13: View of the middle wythe condition. Mortar deteriorated, crack and crushed bricks. Opening on the exterior, ground floor of the north elevation.

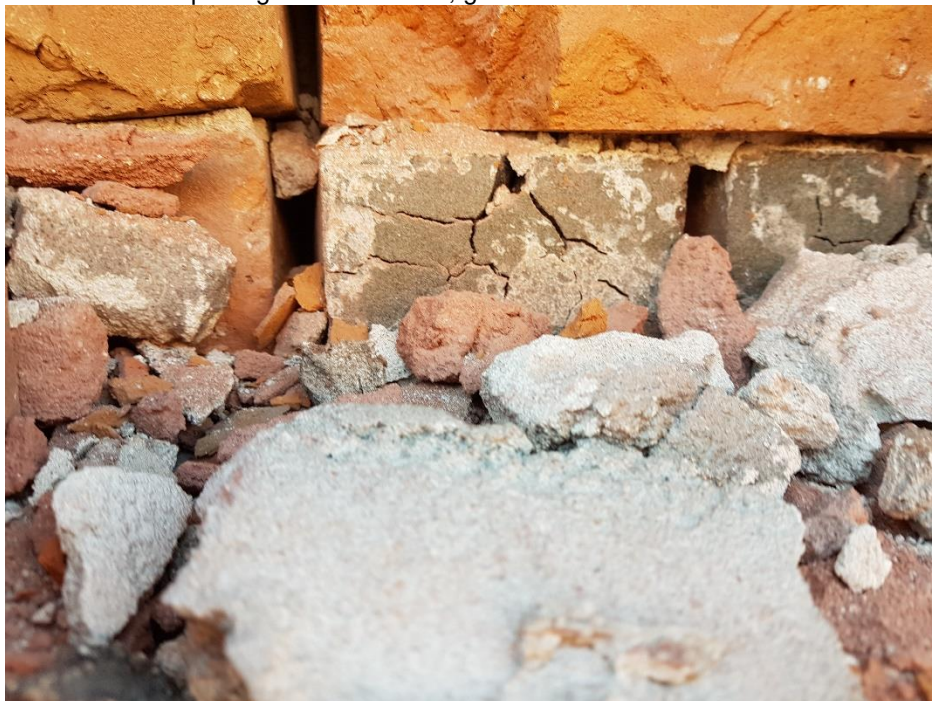
Photograph 14: Close-up view of the middle wythe condition. Mortar deteriorated, crack and crushed bricks. Opening on the exterior, ground floor of the north elevation.
