# 110394936 CANADA INC.

## Tree Conservation Report

2940, 2944, and 2946 Baseline Road

CIMA+ file number: A001384  
May 15, 2023 – Review 001

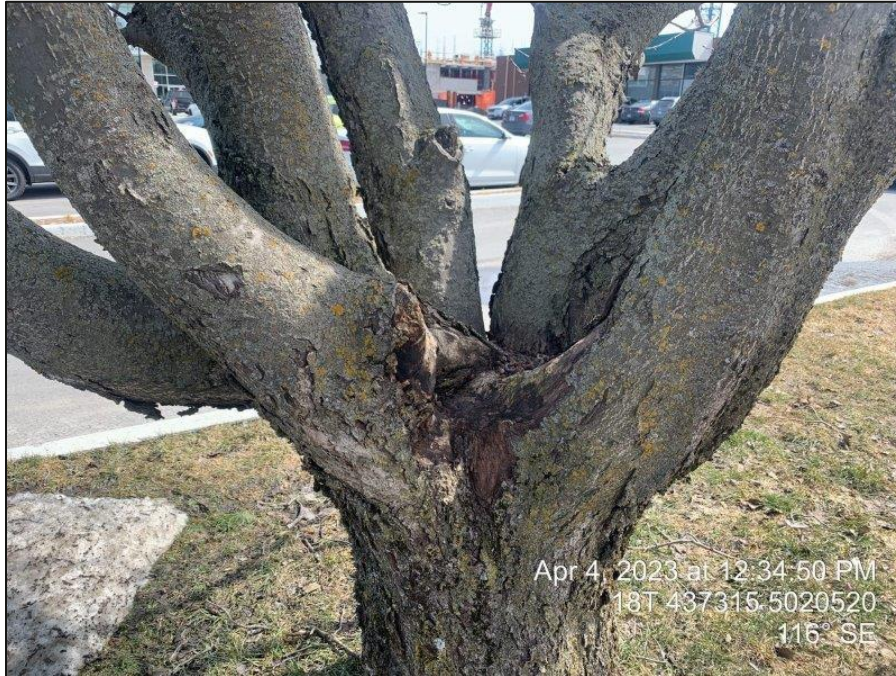
It should be noted that the 18 individual trees proposed for transplant are all newly planted saplings. It should also be noted that the one (1) oakleaf mountain ash (tree #14 - **Appendix A**) was assessed as Fair due to its poor structure and crotch decay. The city has requested this tree be retained. **Photo 1** below displays the deficiencies of this individual.

**Photo 1 : View of crotch decay and poor structure of Tree #14 – Oakleaf Mountain Ash**

14	Oakleaf mountain ash	<i>Sorbus x thuringiaca</i>	1	70	8-11	5	<input checked="" type="checkbox"/>	<input checked="" type="checkbox"/>	<input checked="" type="checkbox"/>	<input checked="" type="checkbox"/>	<input checked="" type="checkbox"/>	<input checked="" type="checkbox"/>	<input checked="" type="checkbox"/>	<input type="checkbox"/>	Fair	Poor structure. Crotch decay.	Private	Retain	7.0
15	Sugar maple	<i>Acer saccharum</i>	1	19	8-11	3	<input checked="" type="checkbox"/>	<input type="checkbox"/>	<input checked="" type="checkbox"/>	<input type="checkbox"/>	<input checked="" type="checkbox"/>	<input type="checkbox"/>	<input checked="" type="checkbox"/>	<input checked="" type="checkbox"/>	Poor	Severe Dieback	City	Retain	1.9
16	Skyline thornless honeylocust	<i>Gleditsia triacanthos 'Skyline'</i>	1	4	4-7	1	<input type="checkbox"/>	<input type="checkbox"/>	<input type="checkbox"/>	<input type="checkbox"/>	<input type="checkbox"/>	<input type="checkbox"/>	<input type="checkbox"/>	<input type="checkbox"/>	Good		Private	Transplant	1
