December 16, 2022  
CO884.00

**Re: Designated Substances Survey  
5650 Manotick Main Street, Ottawa, Ontario**

PHOTOGRAPHIC LOG

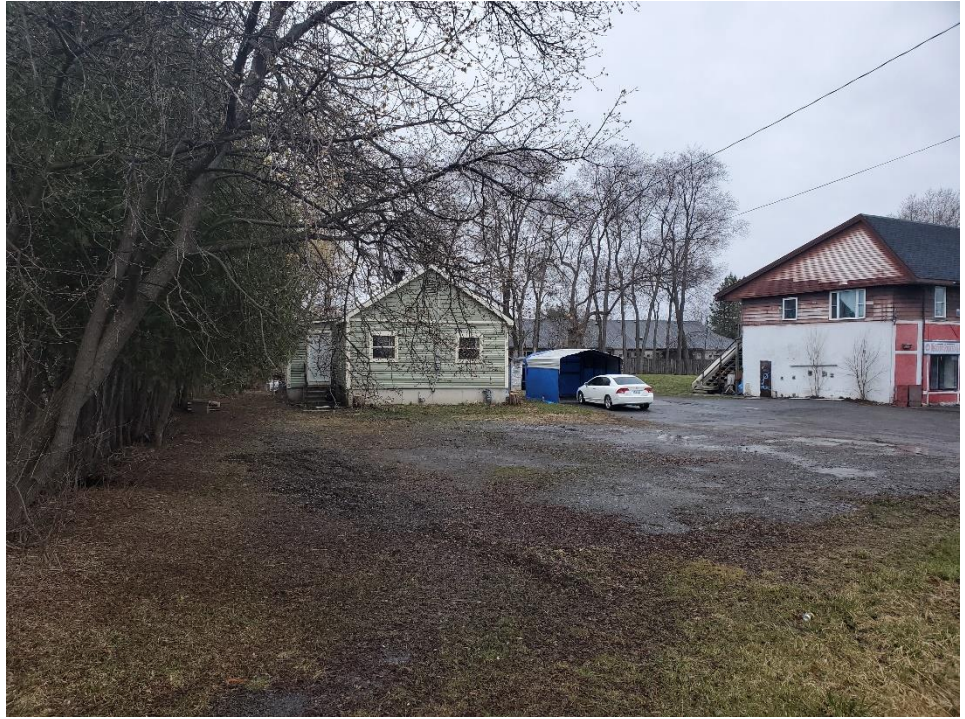
**Photo No:** 1

A view of Site from the Manotick Main Street.

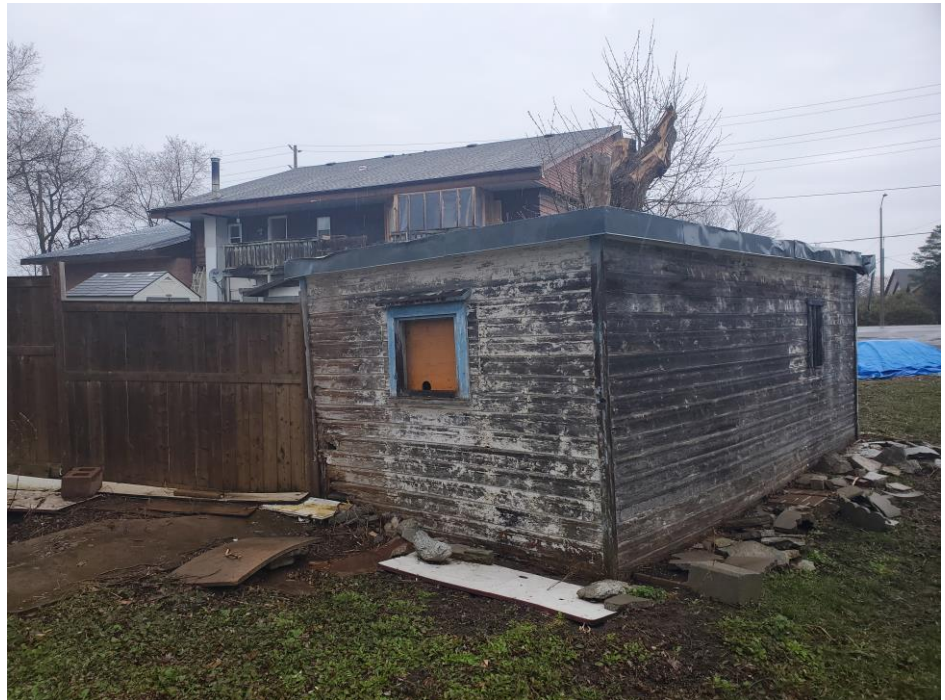
**Photo No:** 2

- the white paint (P-1) located on the exterior of the shed in the backyard.

View of white shed located in the backyard of the property. Paint sample P-1 was collected from the Shed.

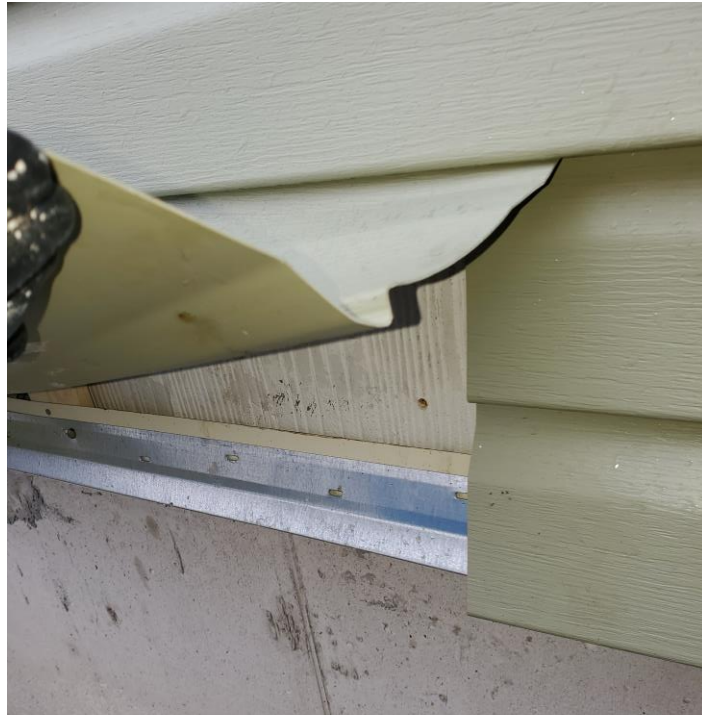
Photo No: 3

- Grey transite board located underneath the aluminum siding on the exterior of the dwelling (sample ACM-5A, non-friable, 20% Chrysotile asbestos, good condition). The entire area of the transite board could not be determined but it may represent an area of approximately 160 m<sup>2</sup>.

View of the transite cement board located underneath the tin siding. ACM-5 was collected from the white transite board.

If any demolition, alteration or repair work that may result in disturbing ACM or potential ACM areas, a qualified asbestos abatement contractor should be retained for asbestos removal prior to undertaking the work. O. Reg. 278/05 defines three types of asbestos removal operations, which require different levels of protection, isolation and decontamination. Type 1 operations involve the lowest level of risk and include the removal of non-friable materials where the material is not damaged, or can be wetted and cut without power tools. Type 3 operations involve the highest level of risk, including removal of most types of friable materials, and require full enclosure of the area and construction of a decontamination area for workers and equipment, among other things.

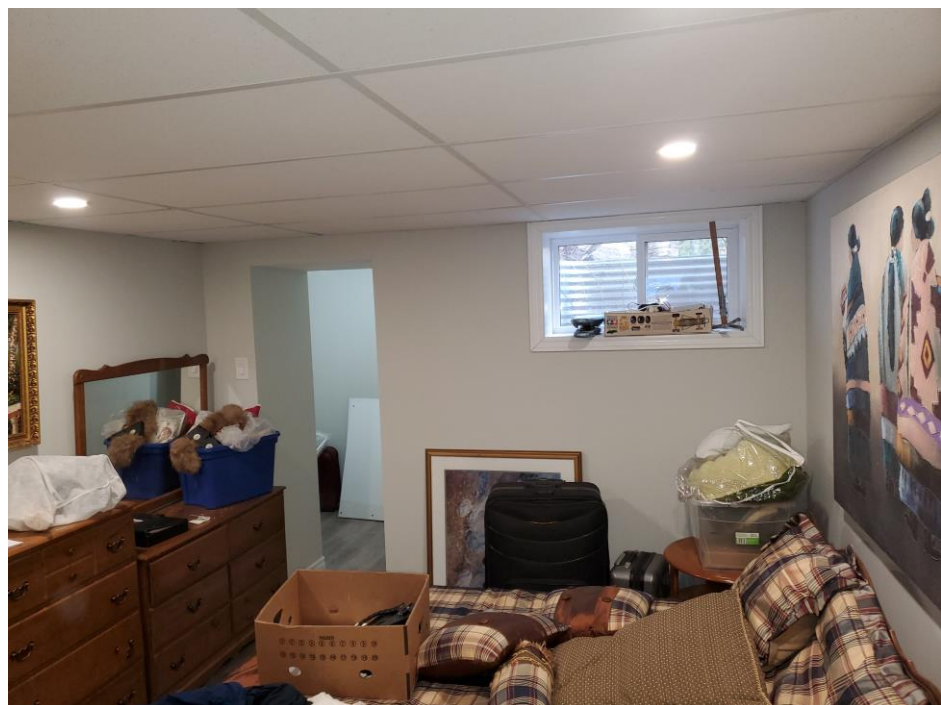
Photo No: 4

View of the finished portion of the basement.

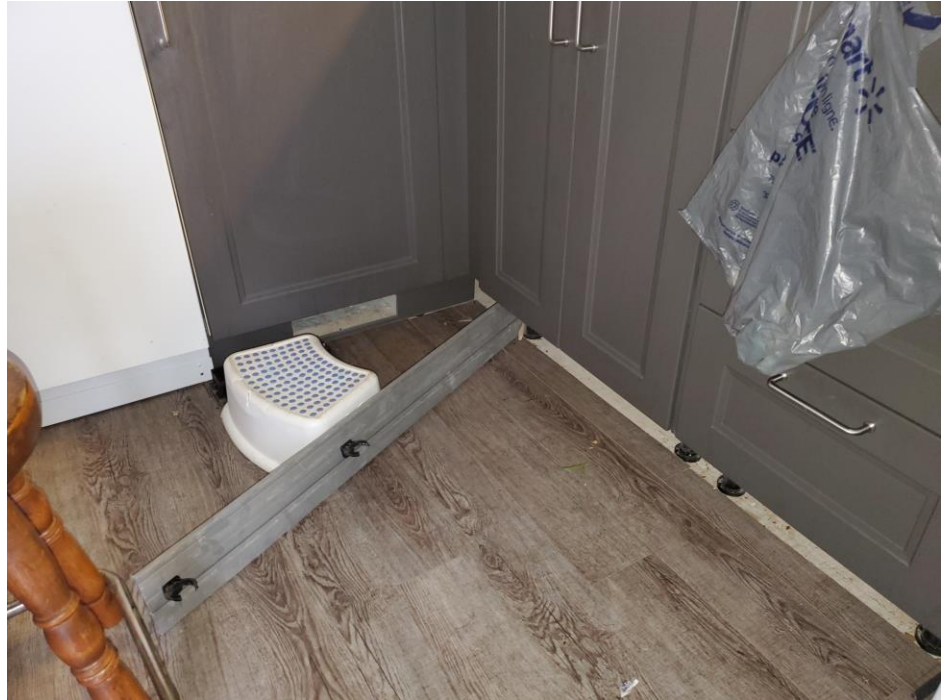
**Photo No:** 5

A view of the flooring located throughout the main floor of the house. It did not appear that any flooring was located underneath the engineered laminate flooring.

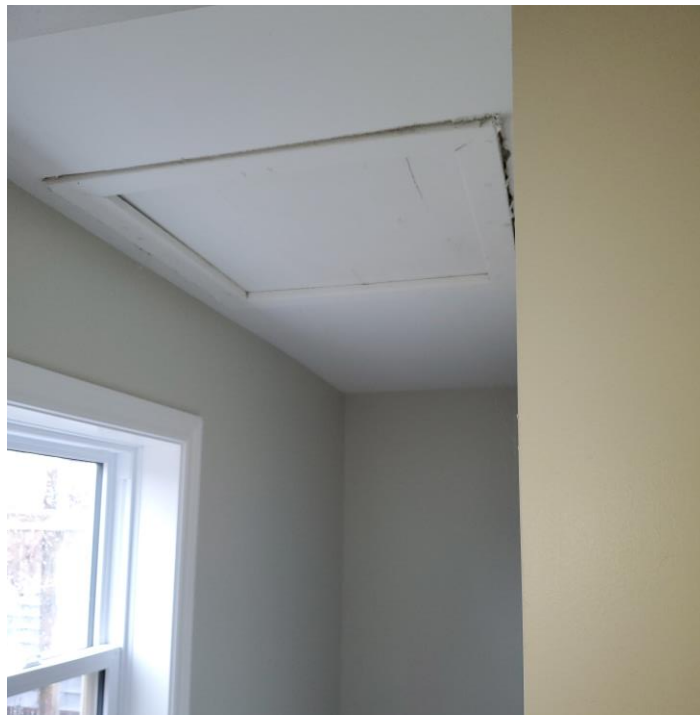
**Photo No:** 6

- Due to the location of the hatch providing access to the attic was located in a stairwell, it was not accessible due to safety reasons.
- Samples of the roofing material were not able to be collected. Based on the fact that the roofing shingles appeared to be new they are not expected to be a concern.

A view attic hatch in the stairwell of the residence.

All other samples are considered to be non-ACM. It should be noted that the attic of the building was not inspected and should be inspected before the demolition of the building to identify any potential ACM.

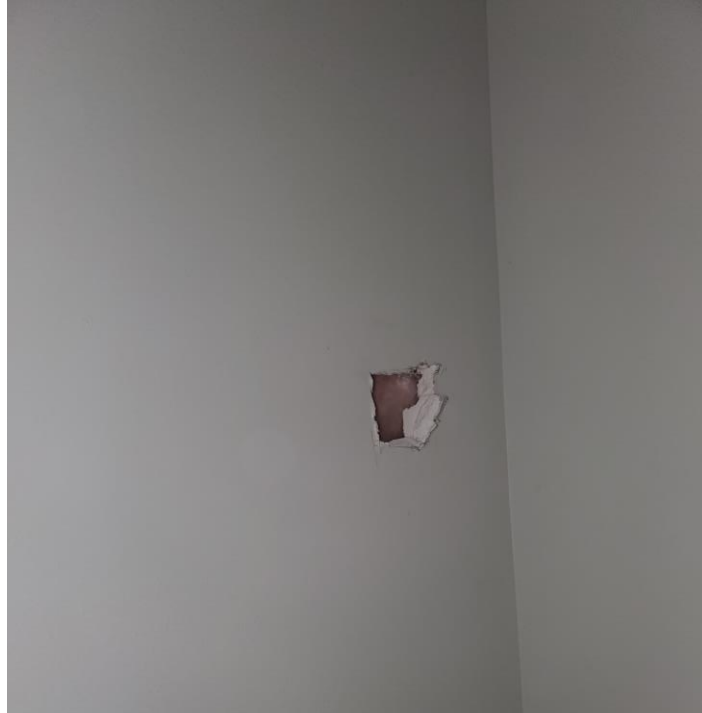
**Photo No:** 7

A view of a hole through the drywall to check the insulation on the upper floor of the residence.

Pink fiberglass insulation was observed on the upper floor. This is not considered asbestos containing.

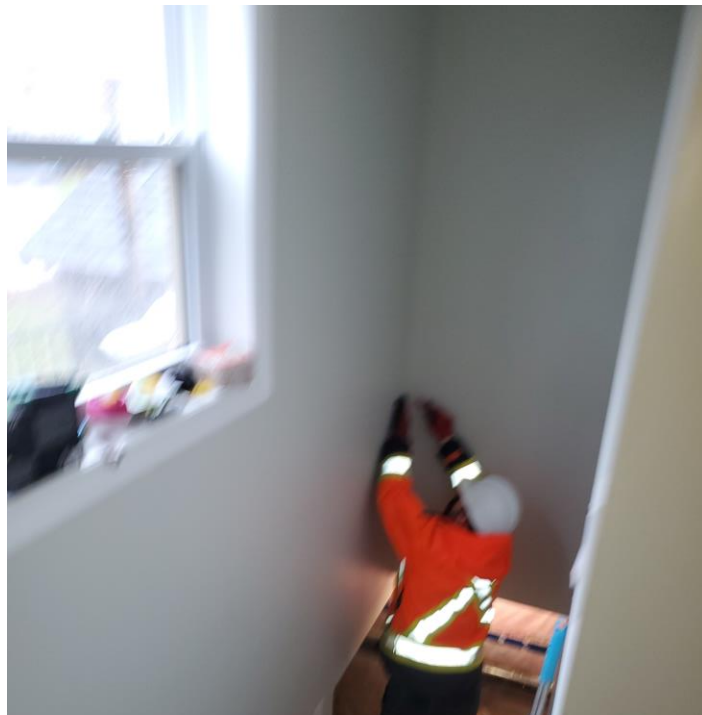
**Photo No:** 8

A view of the collection of a drywall joint compound sample.
