Project Name: Proposed Development, 1158 Old Second Line Road, Ottawa, ON
Project Number: OTT-00245054-A0
Subject: Site Condition Assessment, 1158 Old Second Line Road, Ottawa, Ontario

Site Conditions

*Theberge Homes
Site Condition Assessment
1158 Old Second Line Road, Ottawa, Ontario
EXP Project Number: OTT-00245054-A0
April 21, 2023*

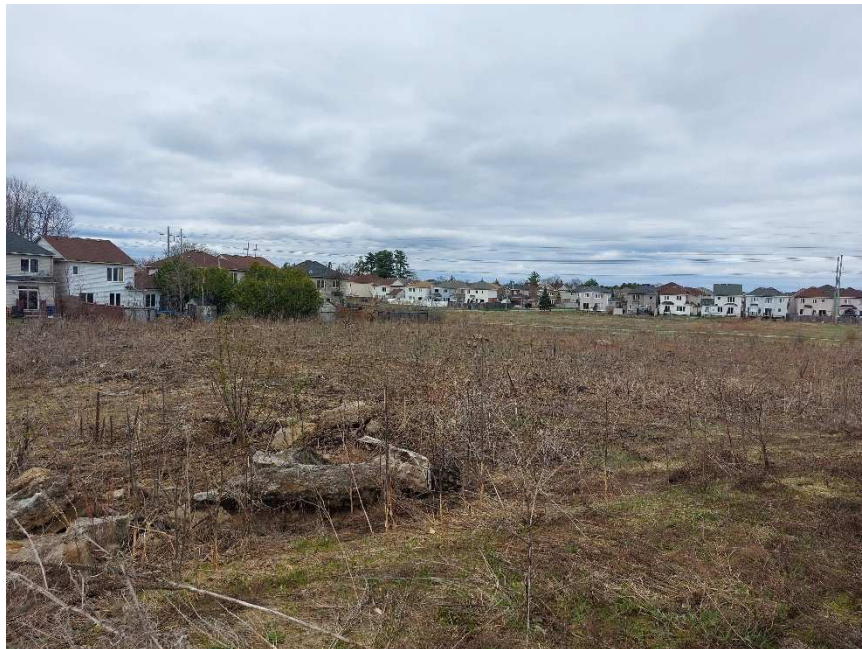
Photograph No. 2

View of the north half of the site looking northeast.

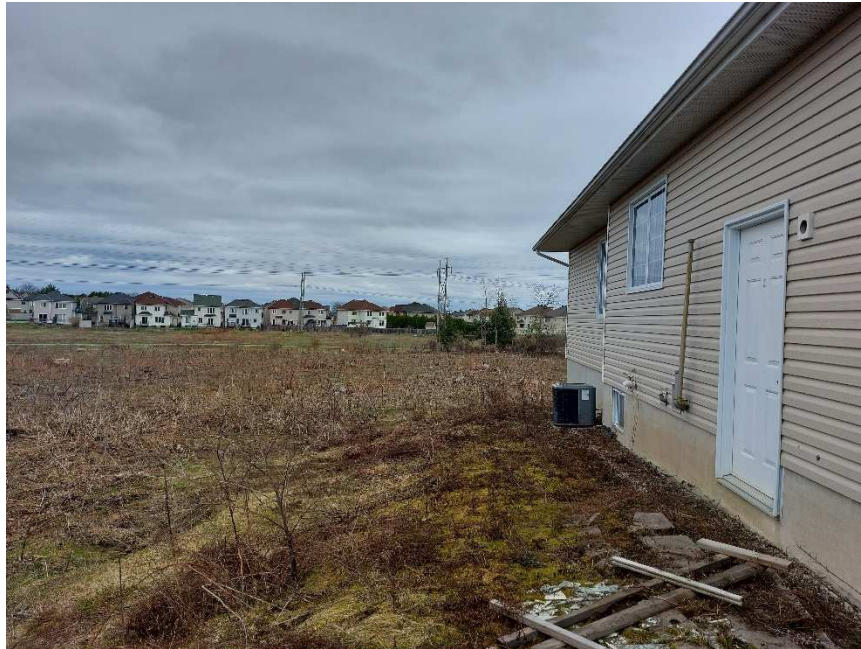
Photograph No. 3

View of the north side of the building and the northeast part of the site looking east.

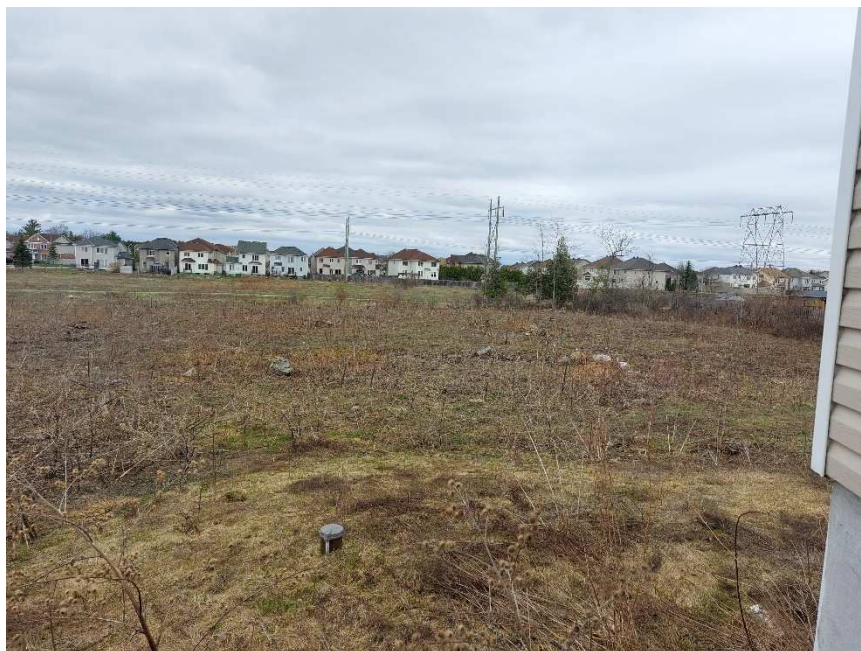
Photograph No. 4

View of the southeast part of the site looking east.

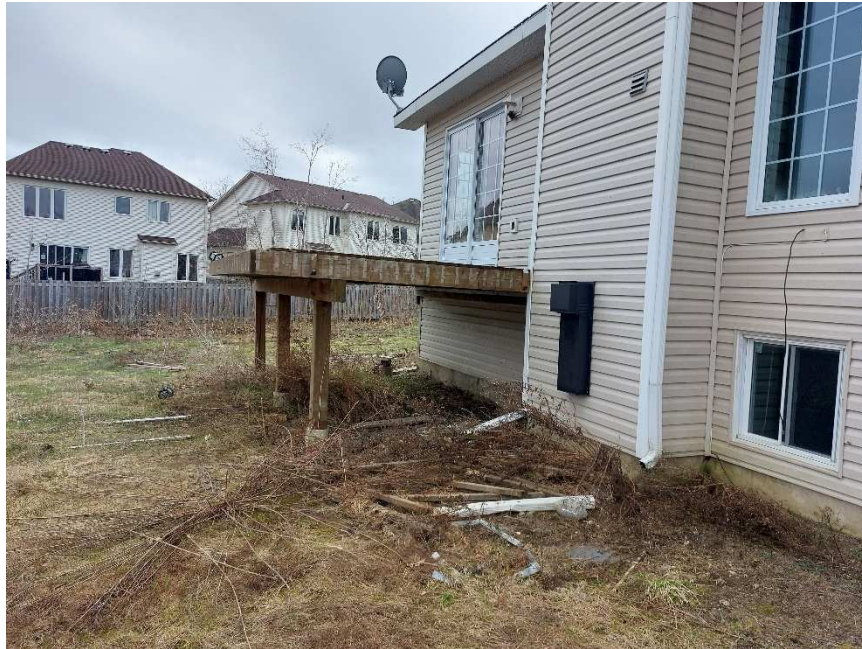
Photograph No. 5

View of the east side of the building.

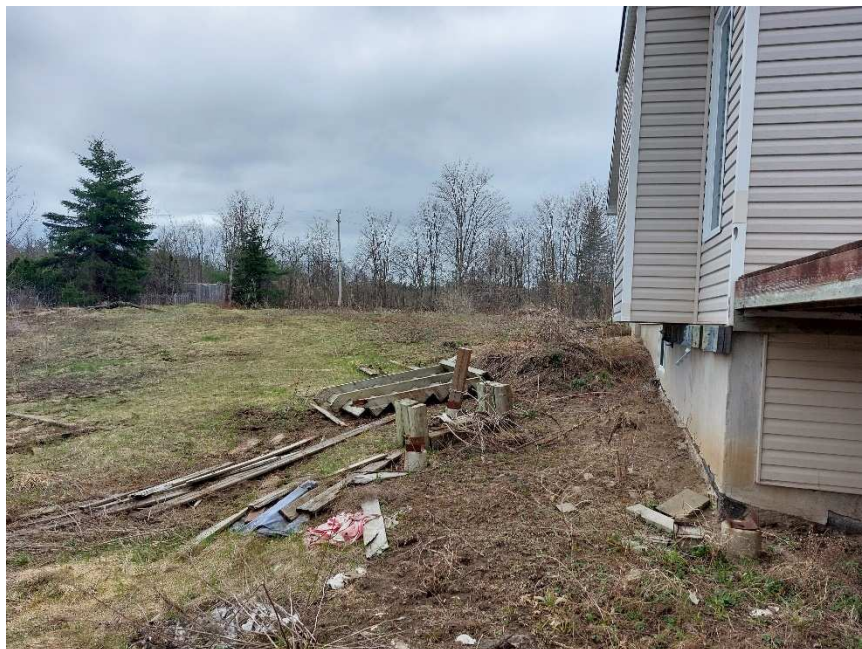
Photograph No. 6

View of the south side of the building and property

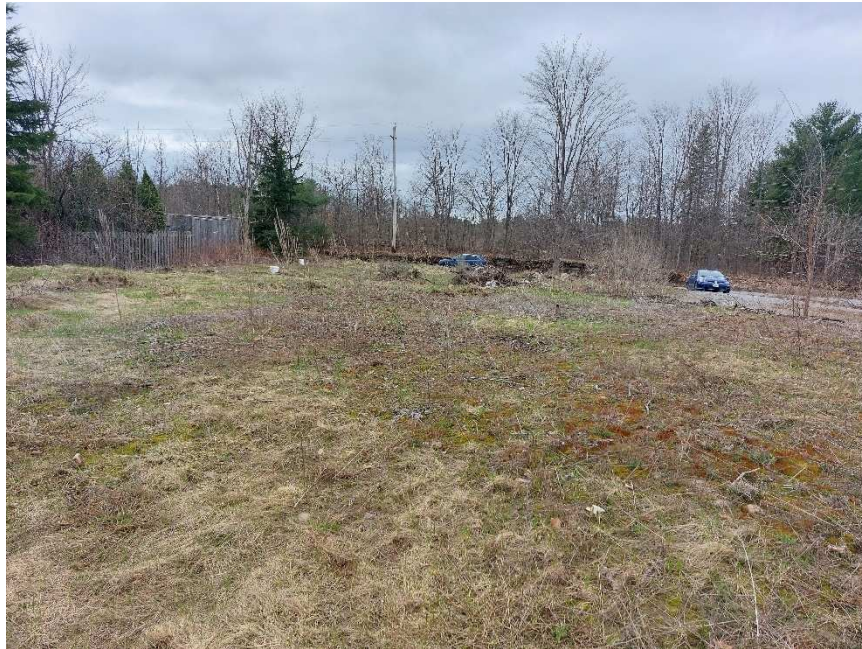
Photograph No. 7

View of the southwest part of the property.

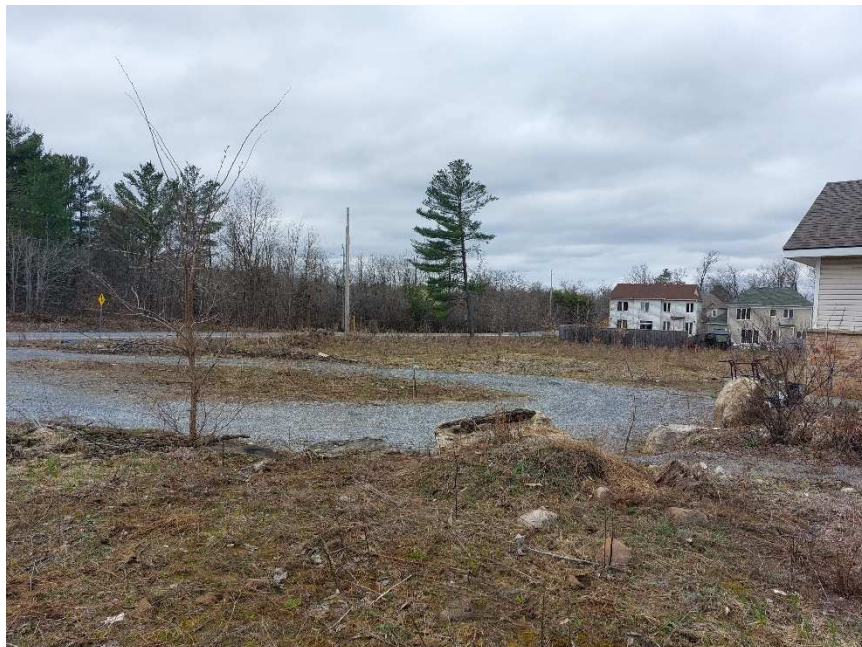
Photograph No. 8

View of the northwest part of the property.
