April 21, 2023

**Project Name:** Proposed Development, 1158 Old Second Line Road, Ottawa, ON  
**Project Number:** OTT-00245054-A0  
**Subject:** **Site Condition Assessment, 1158 Old Second Line Road, Ottawa, Ontario**

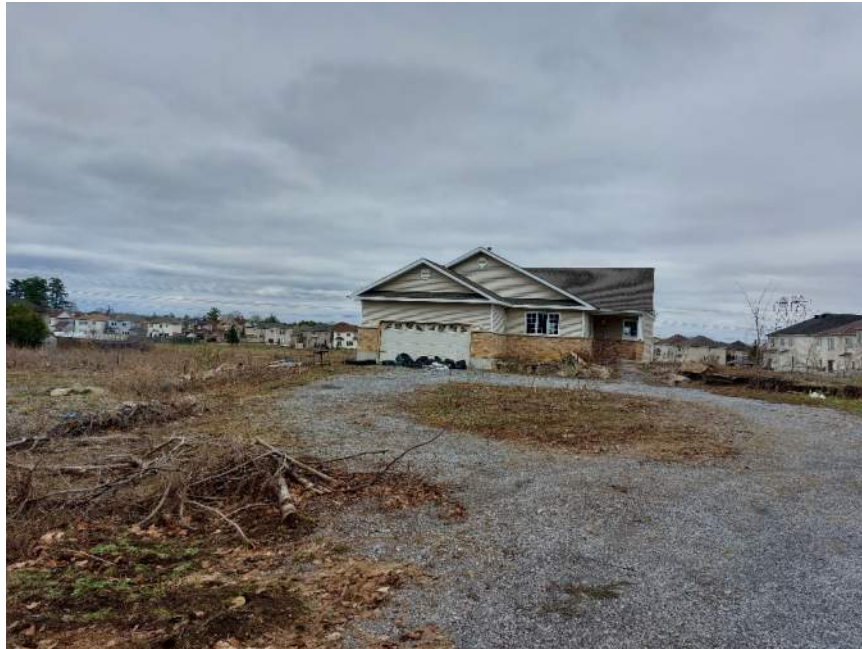
**Photograph No. 1**

View of the Site looking east.

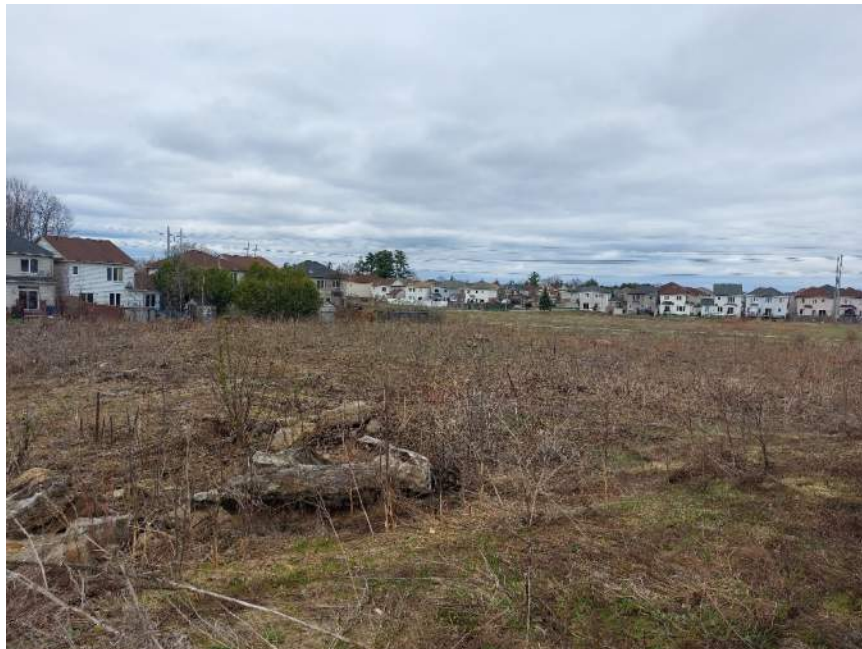
**Photograph No. 2**

View of the north half of the site looking northeast.

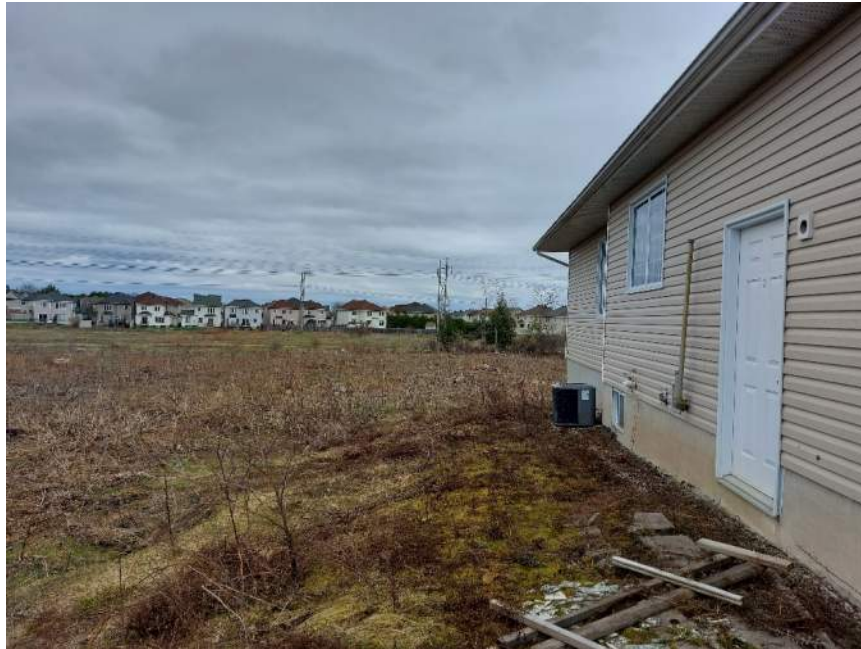
**Photograph No. 3**

View of the north side of the building and the northeast part of the site looking east.

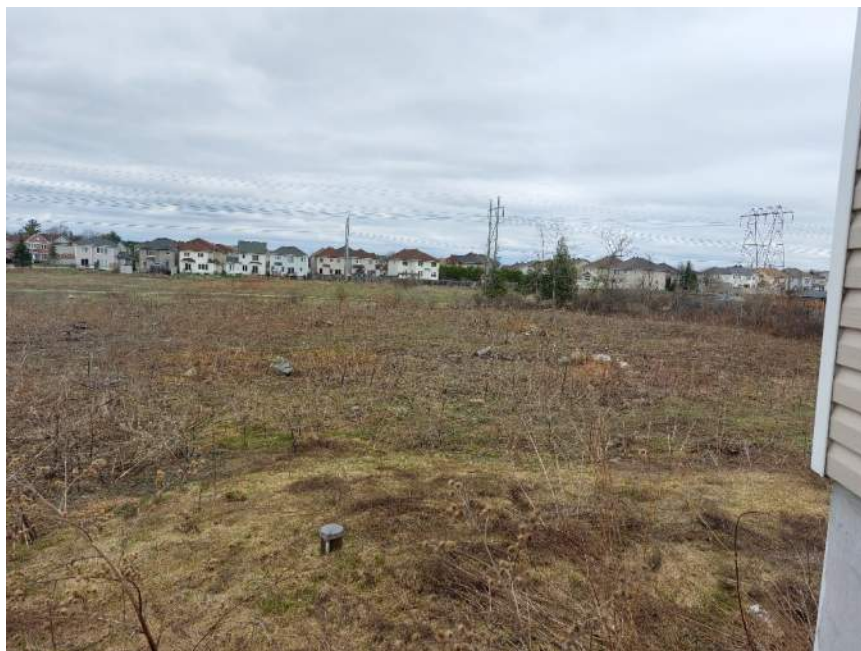
**Photograph No. 4**

View of the southeast part of the site looking east.

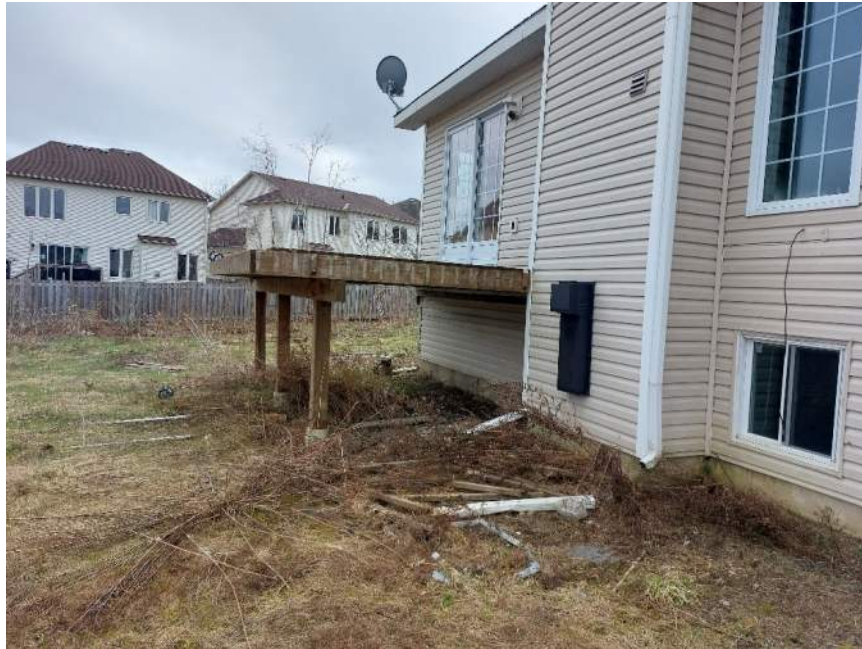
**Photograph No. 5**

View of the east side of the building.

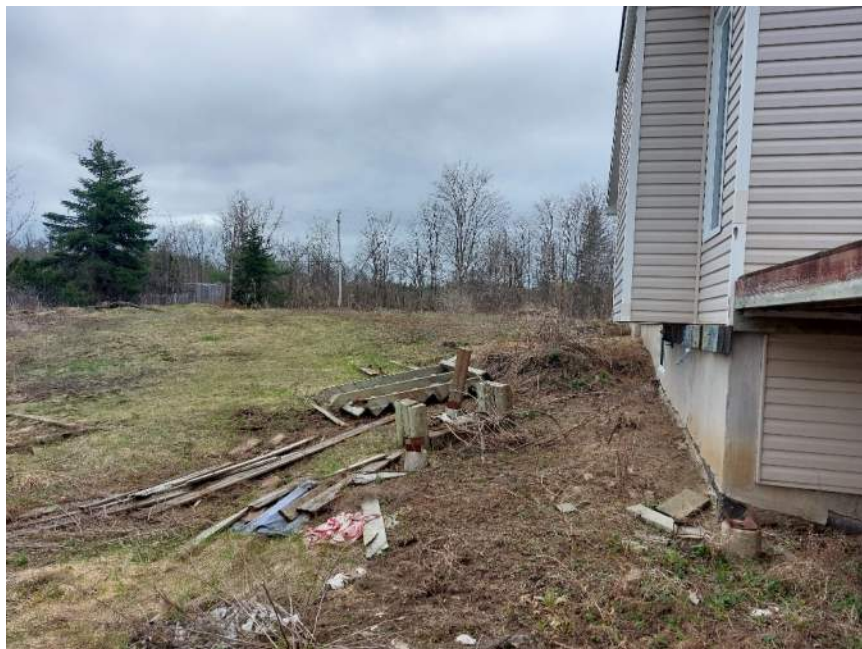
**Photograph No. 6**

View of the south side of the building and property

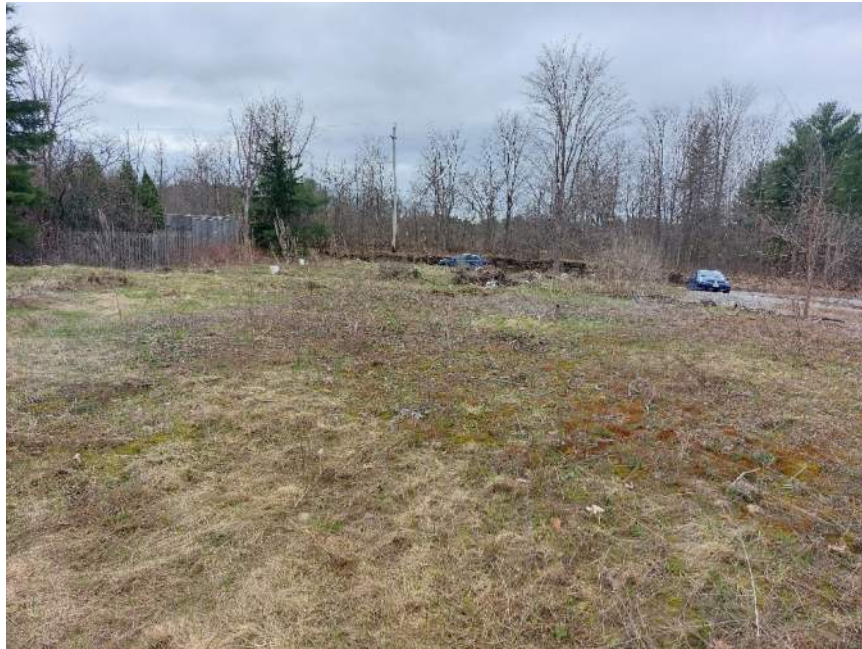
**Photograph No. 7**

View of the southwest part of the property.

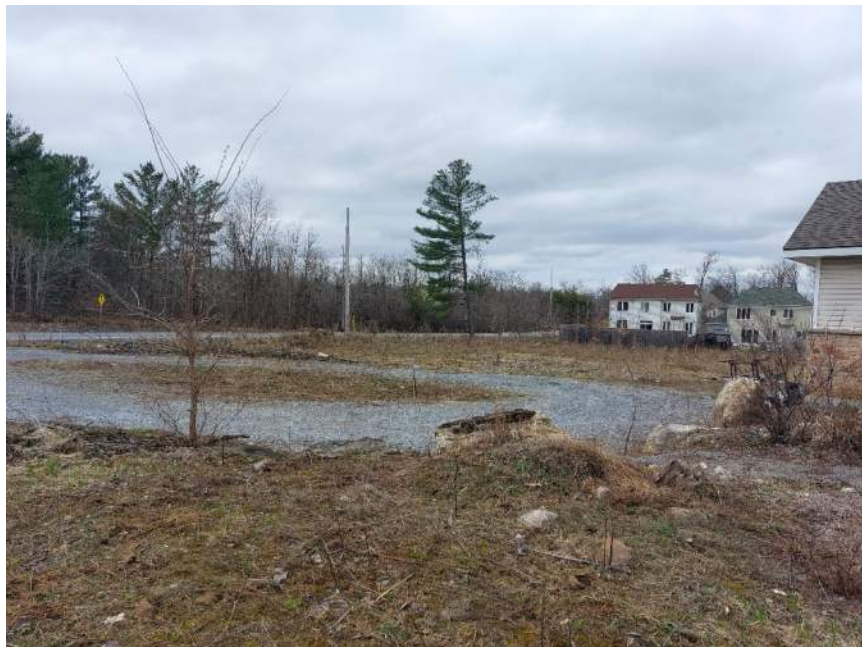
**Photograph No. 8**

View of the northwest part of the property.
