# Landslide Hazard Assessment

## Proposed Multi-Storey Building

3030 Saint Joseph Boulevard  
Ottawa, Ontario

Report PG6609 - 2 dated February 12, 2024

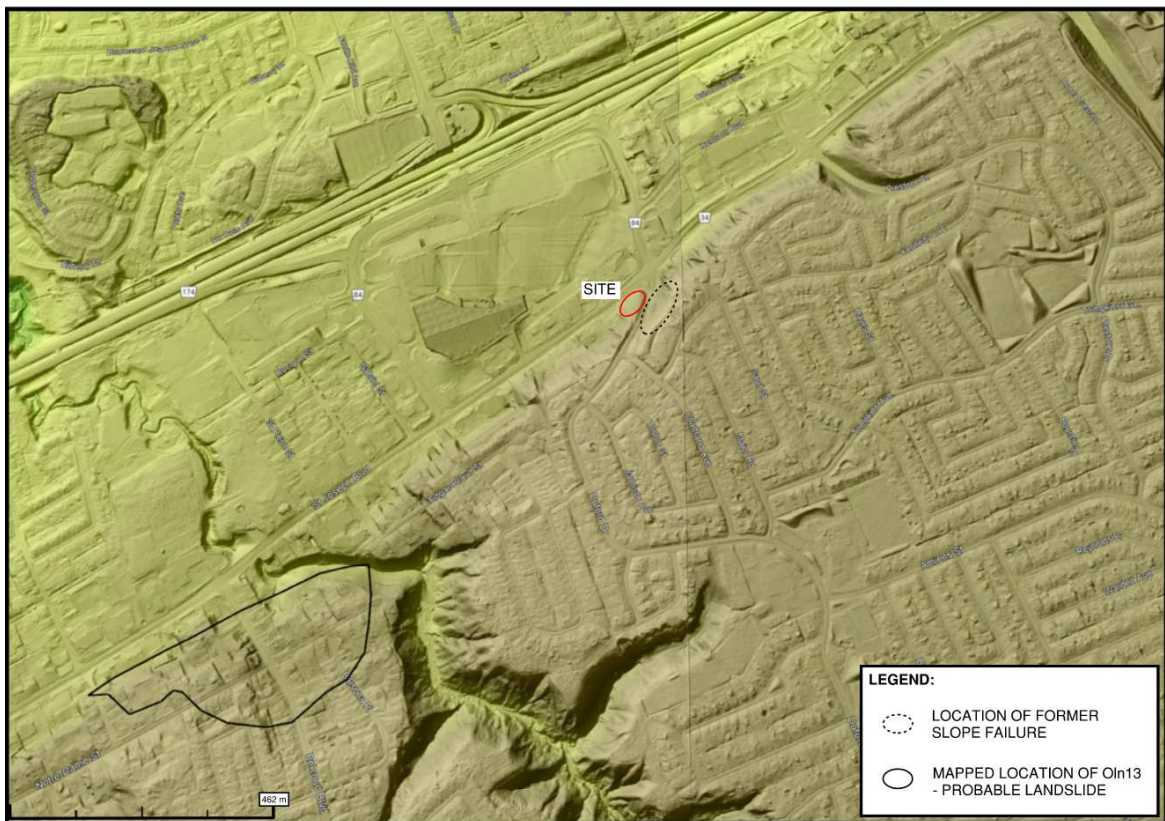
Landslides Oln10, Oln11, Oln12 and Oln13 are located approximately between 0.7 and 2.2 km to the southwest of the subject site. Landslide Oln13, characterized as probable, is the one located closer to the subject site and has been depicted in Figure 1, included below for reference. The totality of the group has been reported by GSC to have retrogressed into the scarp slope above a terrace surface of the proto-Ottawa River (GSC OF8600, 2019).

**Figure 1** – LiDAR Image of Subject Site and closest landslide and slope failure.

The totality of the group is heavily altered by urban development which results in challenges to complete a thorough characterization of the landslide scar. However, it can be estimated that the aforementioned landslides experienced a topographic relief of approximately 20 m.

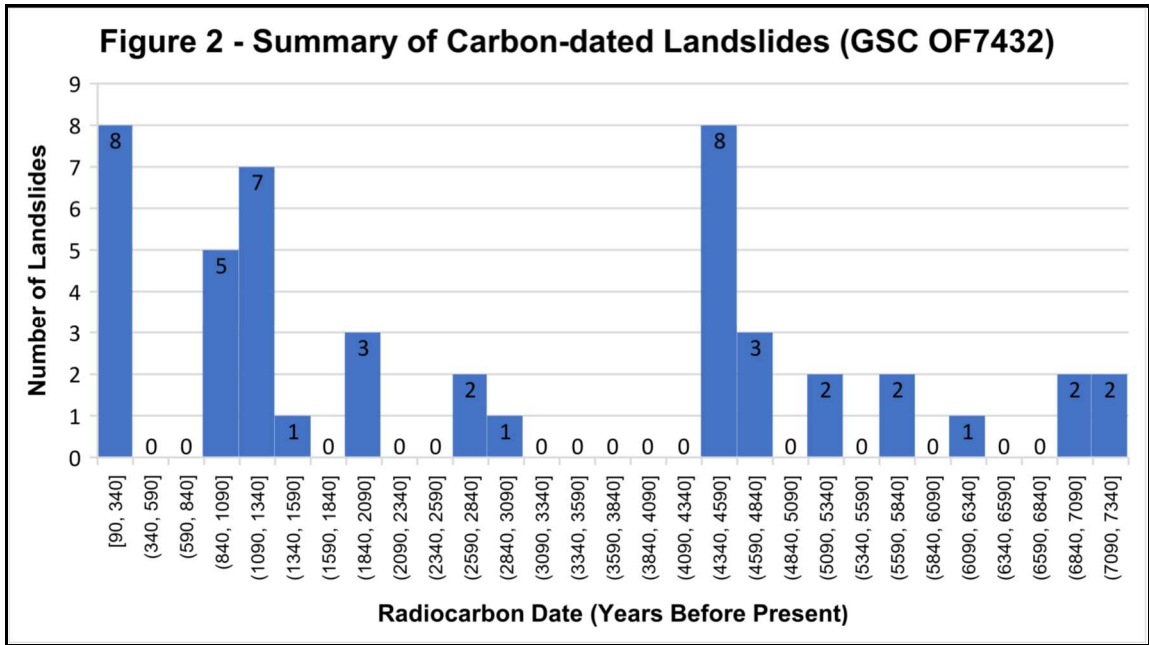
The results from the study and approximations provided by OF8600, neglecting the potential deviation and range of uncertainty, are summarized in Figure 2 below.

Temporal factors such as periods of increased earthquakes and climatic factors affecting these frequencies have been explored by others. Based on the above, more than half of the carbon dated landslides have occurred within the past 3,090 years, and over a quarter within the past 1,090 years.

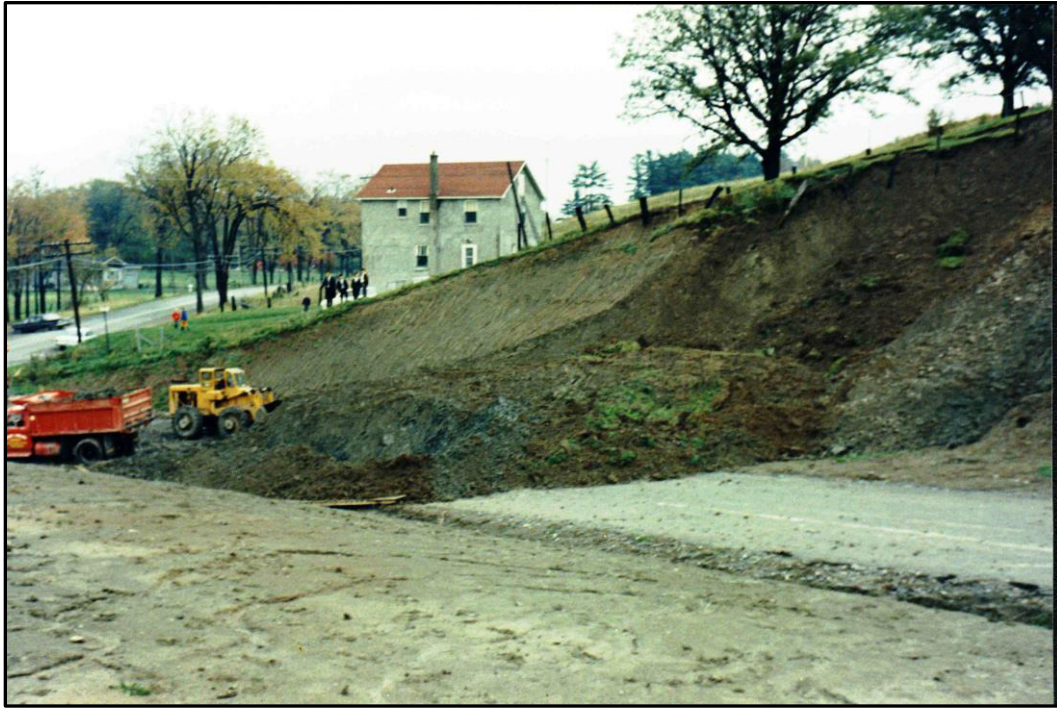
Section C was located within a former slope failure area. It is understood that a slope failure occurred along the east side of Duford Drive in the 1960s. Photographs of the slope failure were provided to Paterson for this response. Photographs 1 and 2 presented in Appendix 2 show a shallow slope failure across a limited section of overall slope face. Based on slope features noted in the photographs, such as lack of vegetation across the slope face and the soil surface in the area of Duford Drive, it appears that the slope failure occurred across a section of the slope, which had been recently re-shaped as part of the construction of Duford Drive.

The natural grade of the slope face was drastically changed during the construction of Duford Drive. It is expected that the slope failure can be directly contributed to the steepness of excavated slope face along with exposure to precipitation events before a vegetative layer could establish. It should be further noted that a vegetative layer across a slope face promotes surficial run-off during precipitation events and limits infiltration of rainwater into the slope soil. Infiltration of water from precipitation events into a slope reduces overall slope stability.

Photo 1: Localized slope failure occurring in the mid 1960s adjacent to Duford Drive. Subject site is located within the foreground of the photograph. St. Joseph Boulevard is in the background. Ground surface adjacent to Duford Drive is noted to be free of vegetation, which is indicative that construction of the subject roadway section and cutting of the subject slope was recently completed. It is suspected that the exposed slope was re-shaped to an unstable slope angle as part of the construction work at that time.

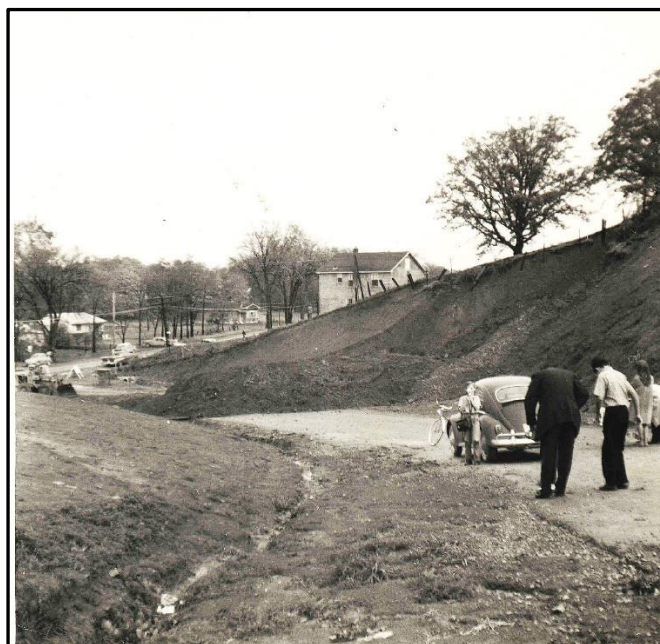
Photo 2: Same localized slope failure, which occurred in mid 1960s.

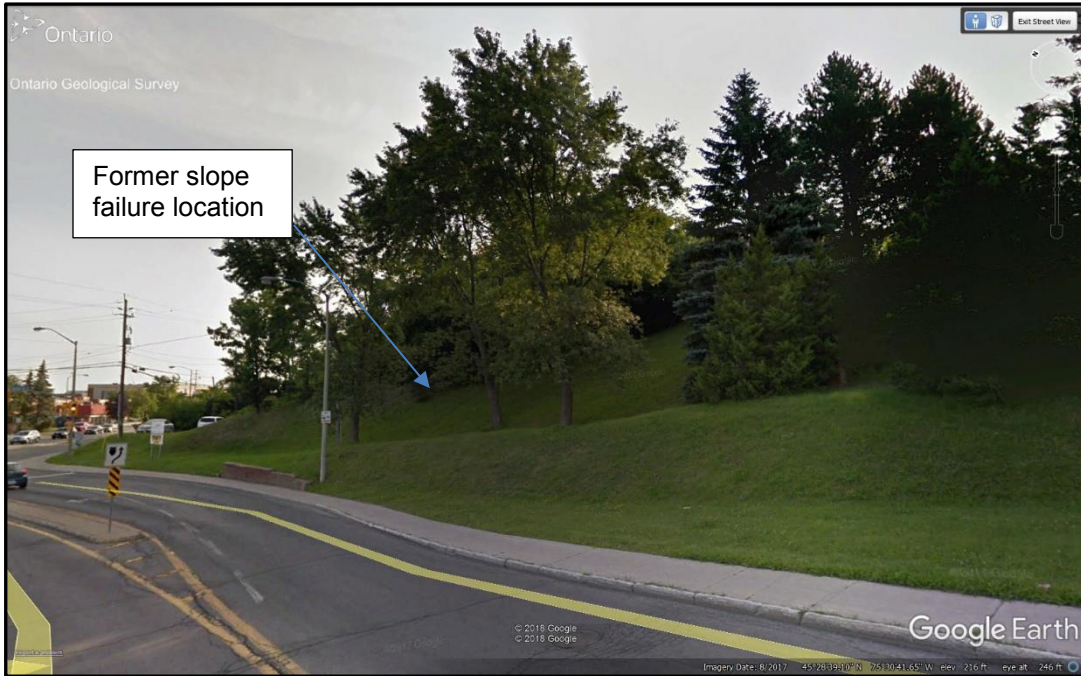
The current slope face was noted to include a terraced area along the base of the slope face in the area of the former slope failure (see Photos 3, 4 and 5 in Appendix 2). It is suspected that the terraced area was introduced after the initial slope failure to stabilize the reinstated slope. Currently, the slope face was noted to be grass covered with mature trees. No signs of slope instability were noted.

Photo 3: Street view image from Google Earth of former slope failure area (presented in Photos 1 and 2) adjacent to Duford Drive. Ground noted to be re-shaped with a terraced slope in front of reinstated slope.

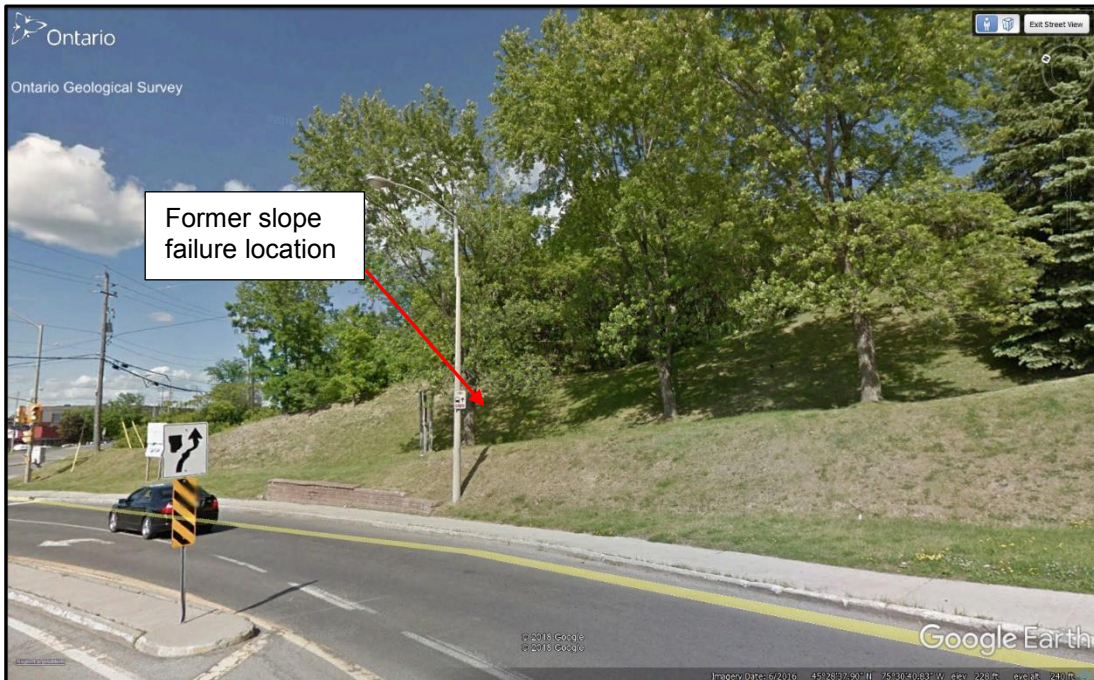
Photo 4: Street view image from Google Earth of the same former slope failure area presented in Photos 1 and 2. The ground surface is noted to be stable with no signs of slope instability.

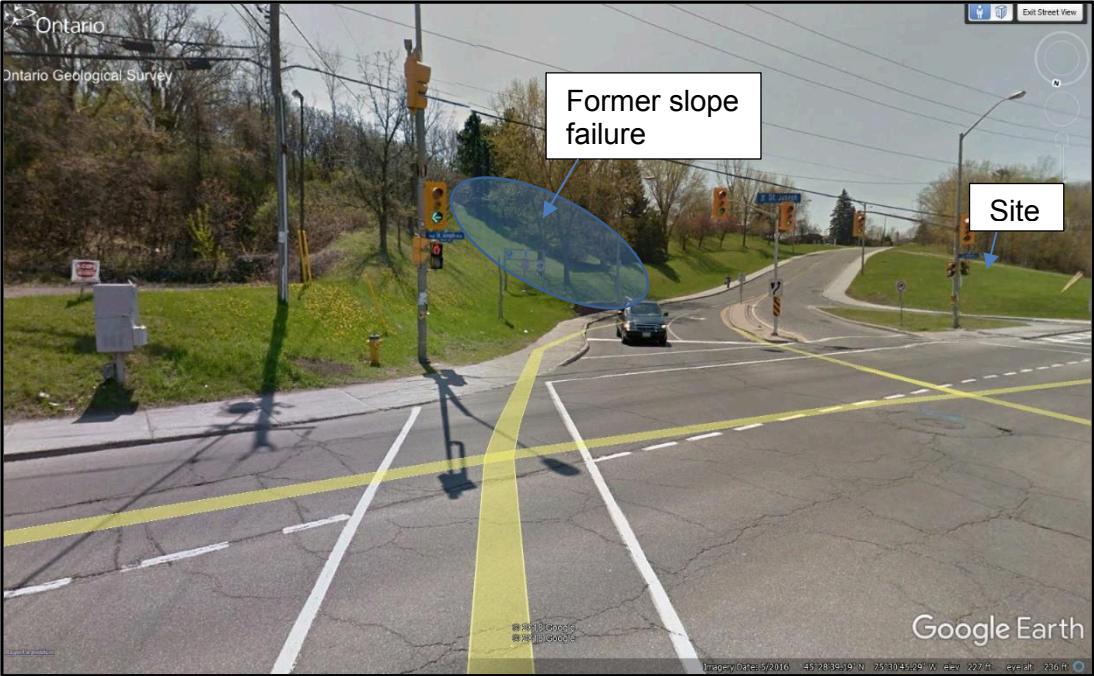
Photo 5: Area of former slope failure noted in Photos 1 and 2. Subject site is property along the right side of the photograph.

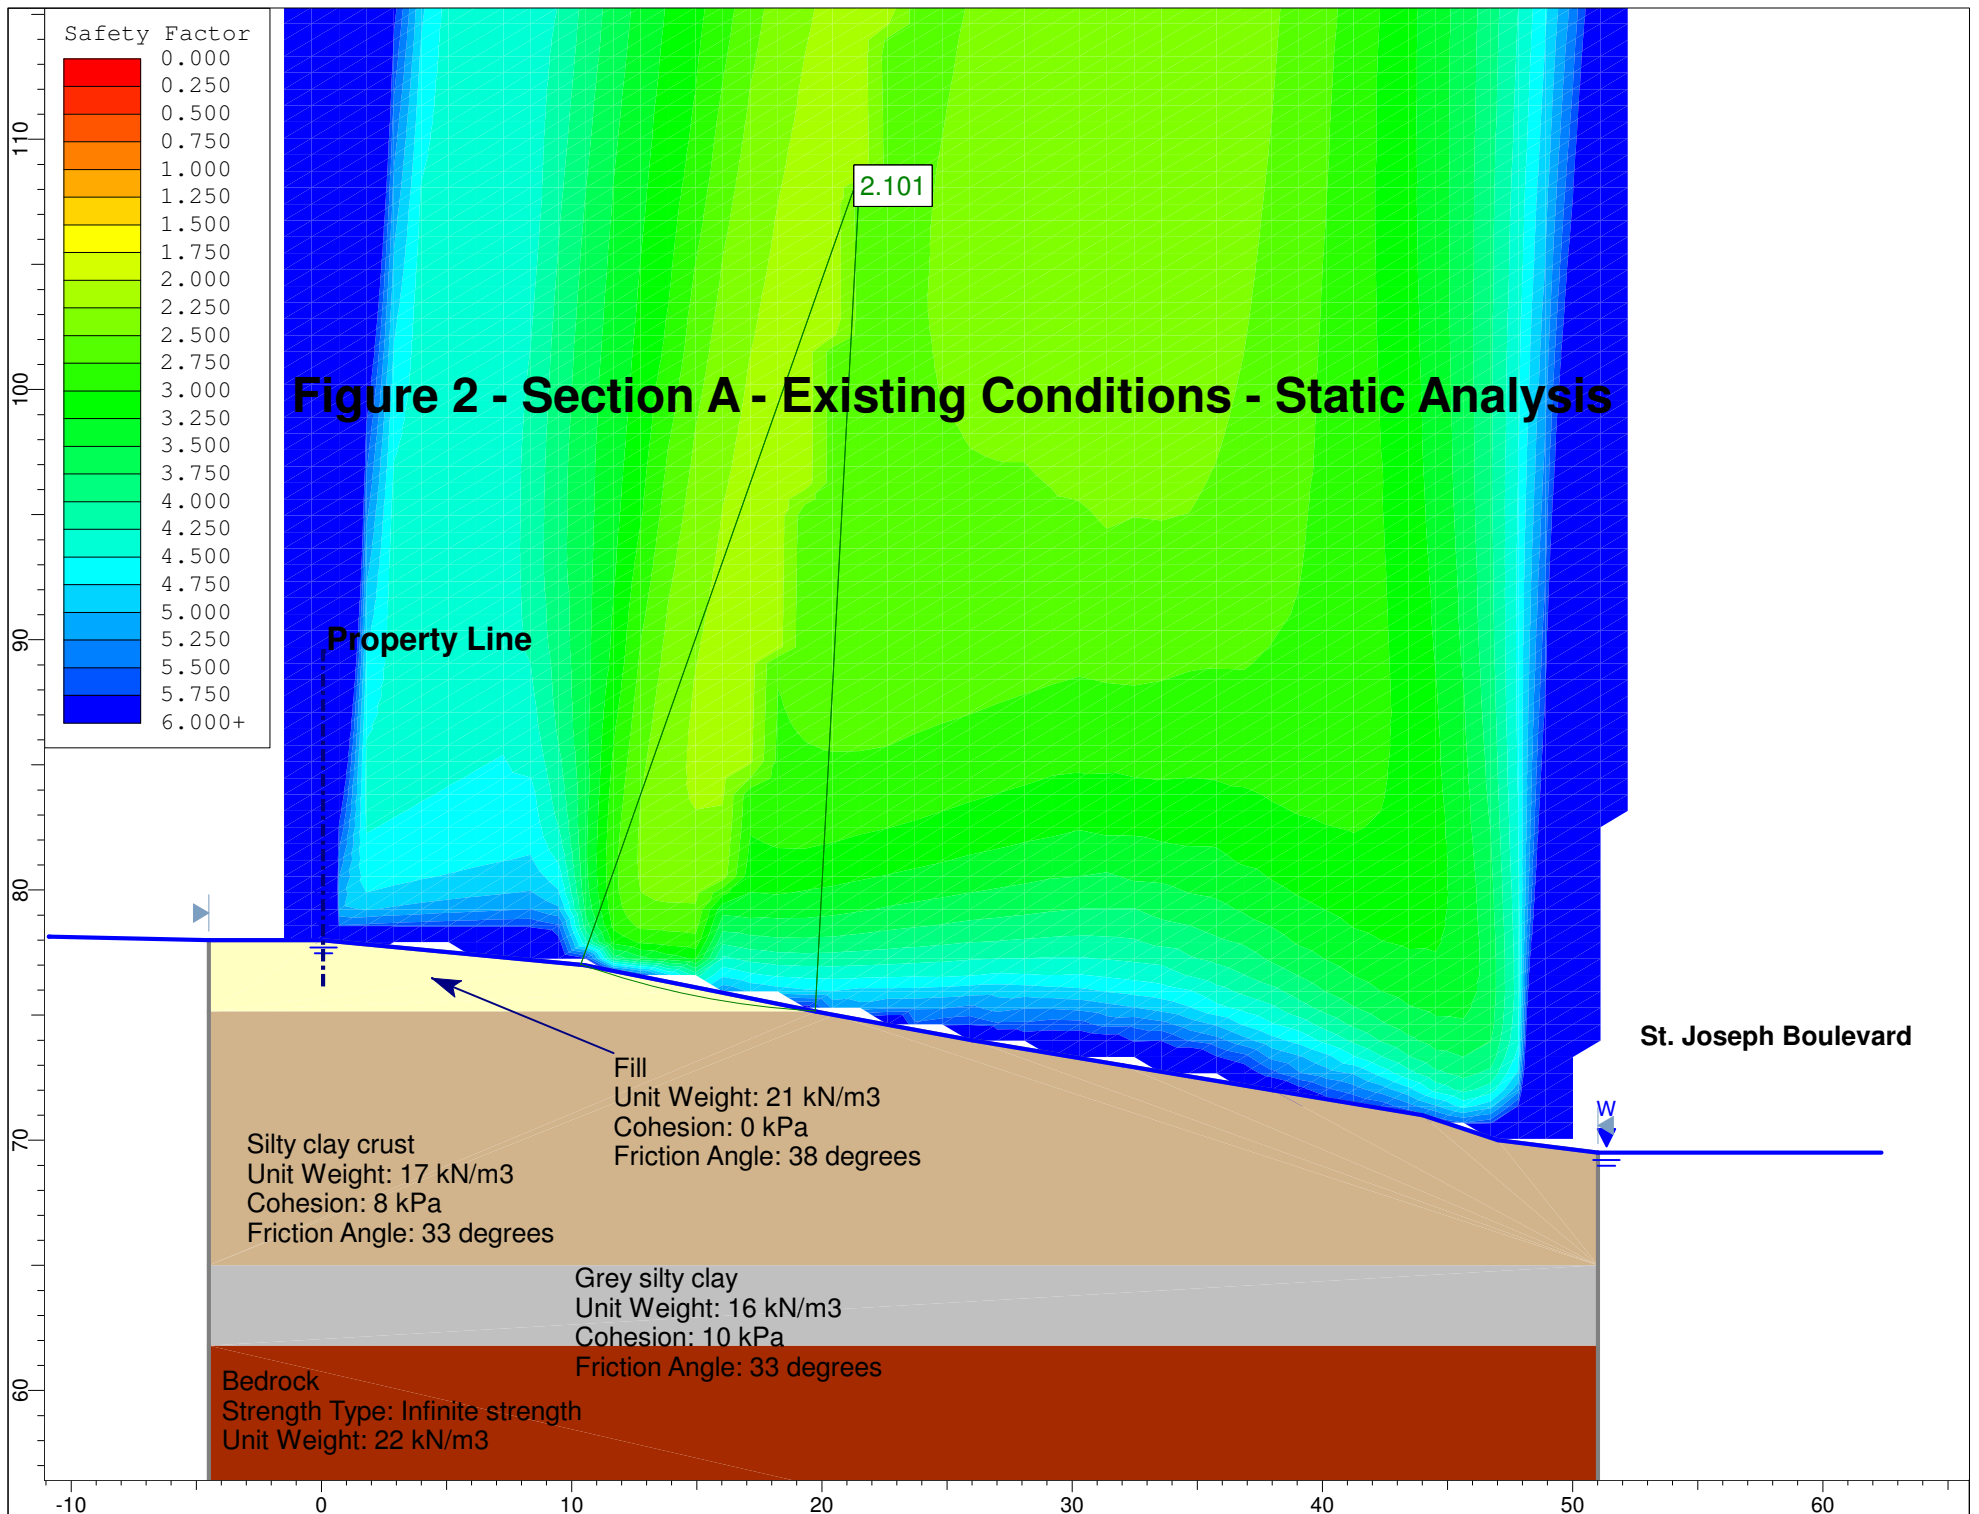
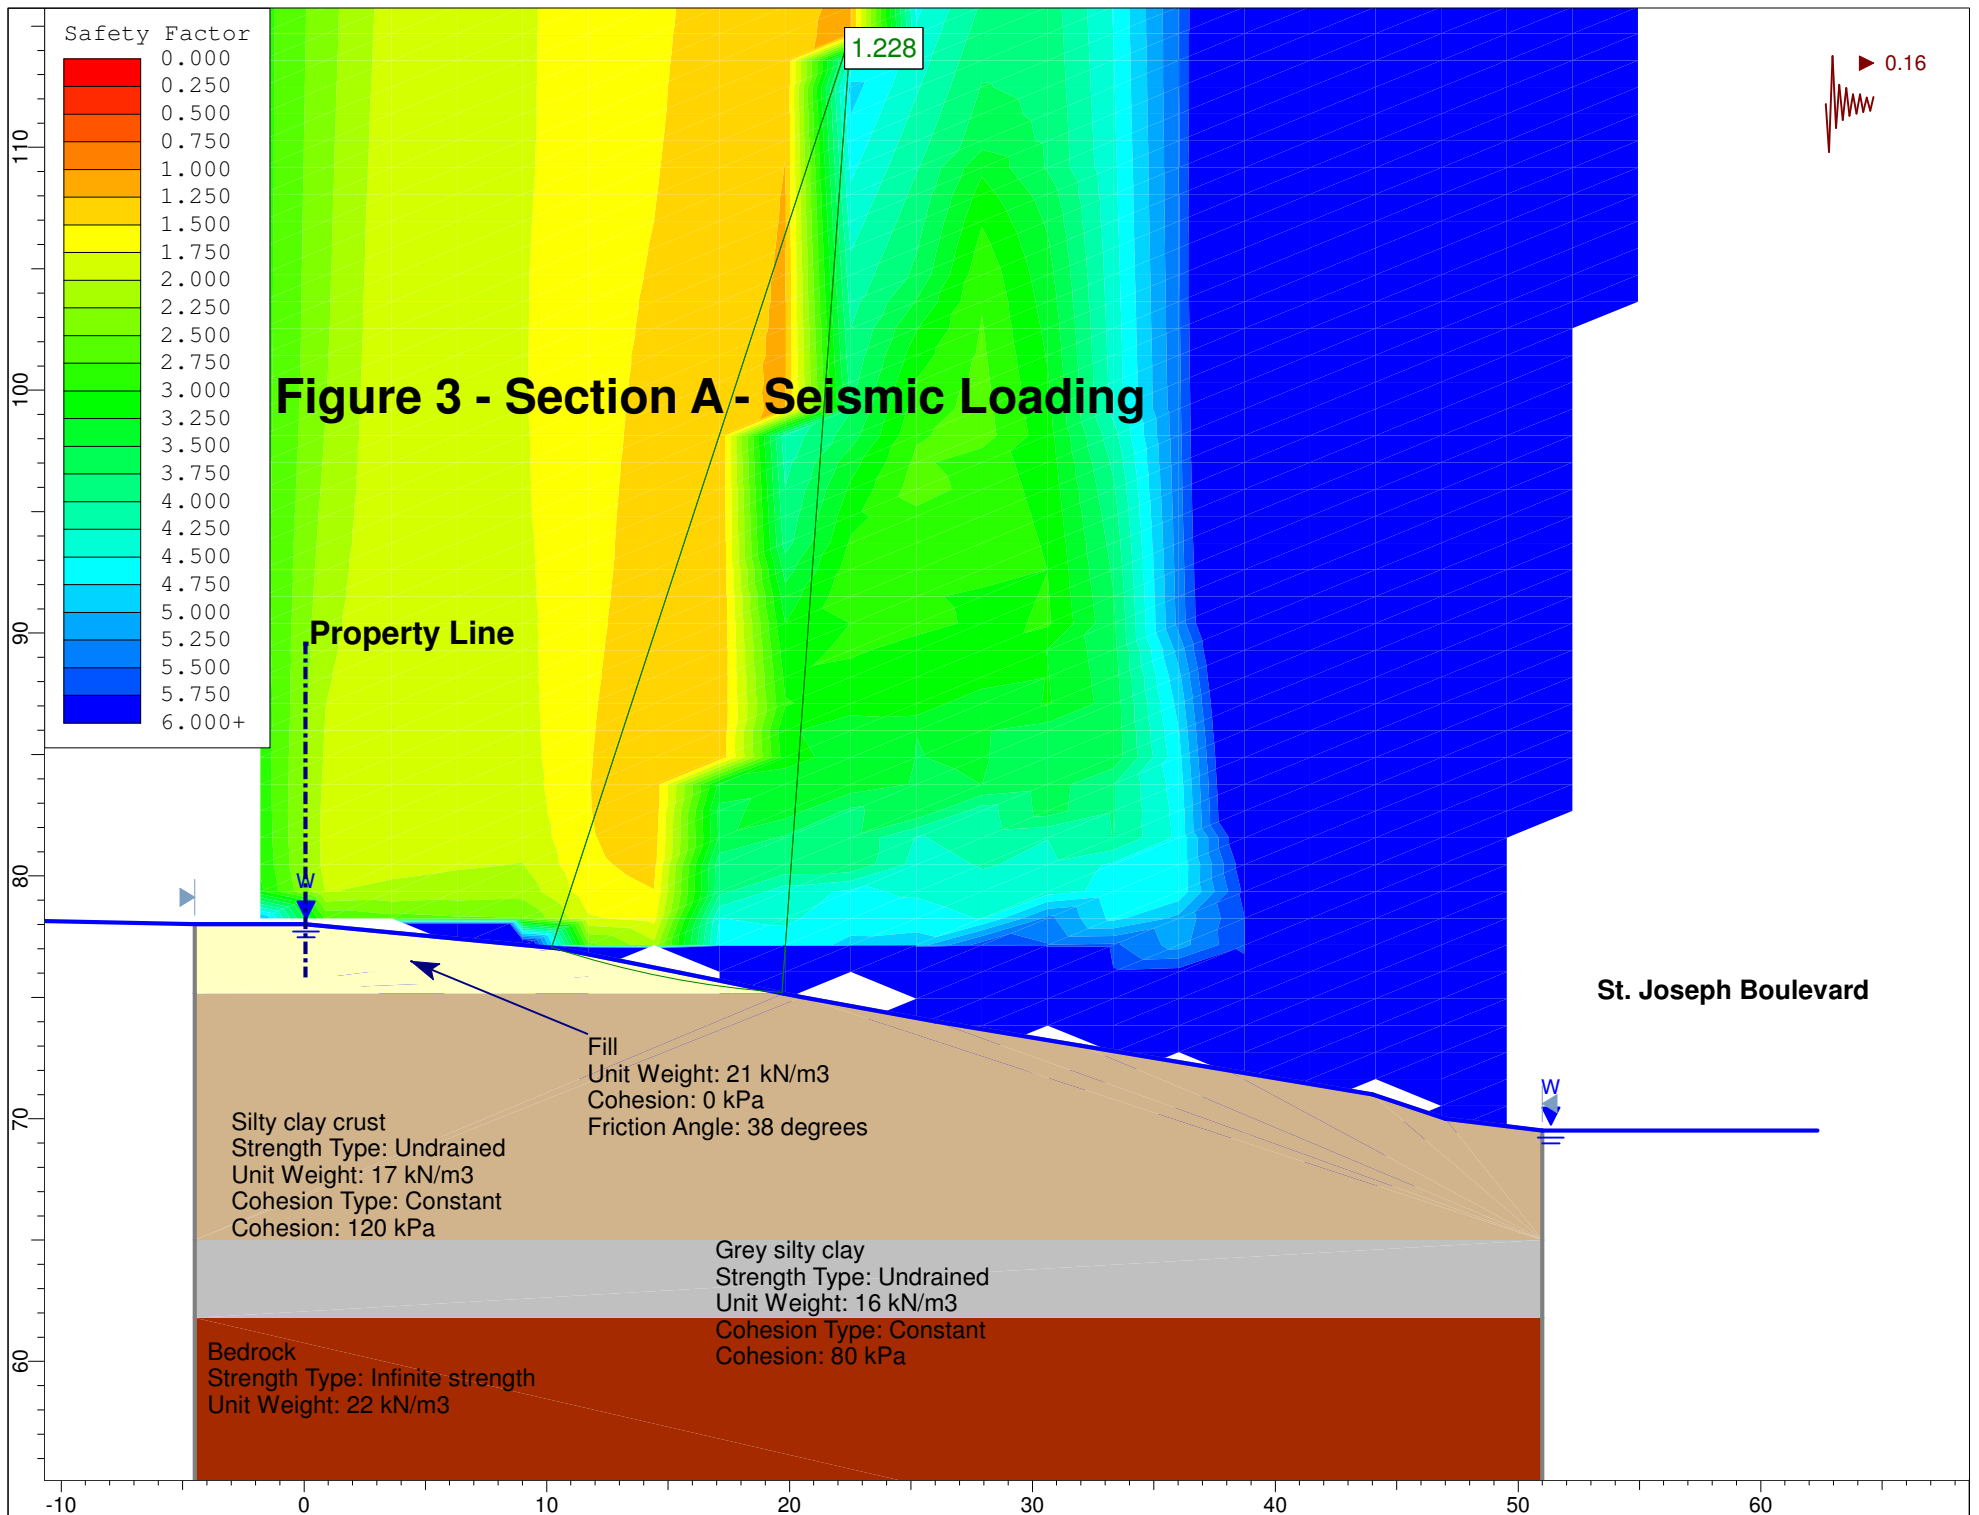
The results for the existing slope conditions at Section A and Section B are shown in Figure 2 and Figure 4 in Appendix 2. The factor of safety was found to be greater than 1.5 for Section A and B when analyzed under static conditions. It should be noted that a slope stability analysis was completed for Section A due to the steepness of the slope observed, which was considered to be a worst-case scenario for the subject site. Section B was analyzed to include the adjacent slope opposite of Duford Drive. Section C was analyzed considering the upper 2 m of the slope face to be fully saturated and the remainder of the slope is saturated below the long-term groundwater table at the former slope failure location. A global slope stability factor of safety of greater than 1.5 was determined for Section C based on our analysis.

As a result, the three slope cross-sections analyzed were above the recommended Factor of Safety of 1.5, and are considered stable under static conditions.

The overall slope stability factor of safety at the three slope cross-sections when considering seismic loading was found to be greater than 1.1, which is considered stable under seismic loading. Therefore, setbacks due to slope stability are not required from a geotechnical perspective at the subject site.
