# TREE CONSERVATION REPORT

121 Brae Crescent, Ottawa

Tree Conservation Report submitted as Partial  
Requirements for a Site Plan Control Application,  
January 17, 2023

# Tree Conservation Report v2.0

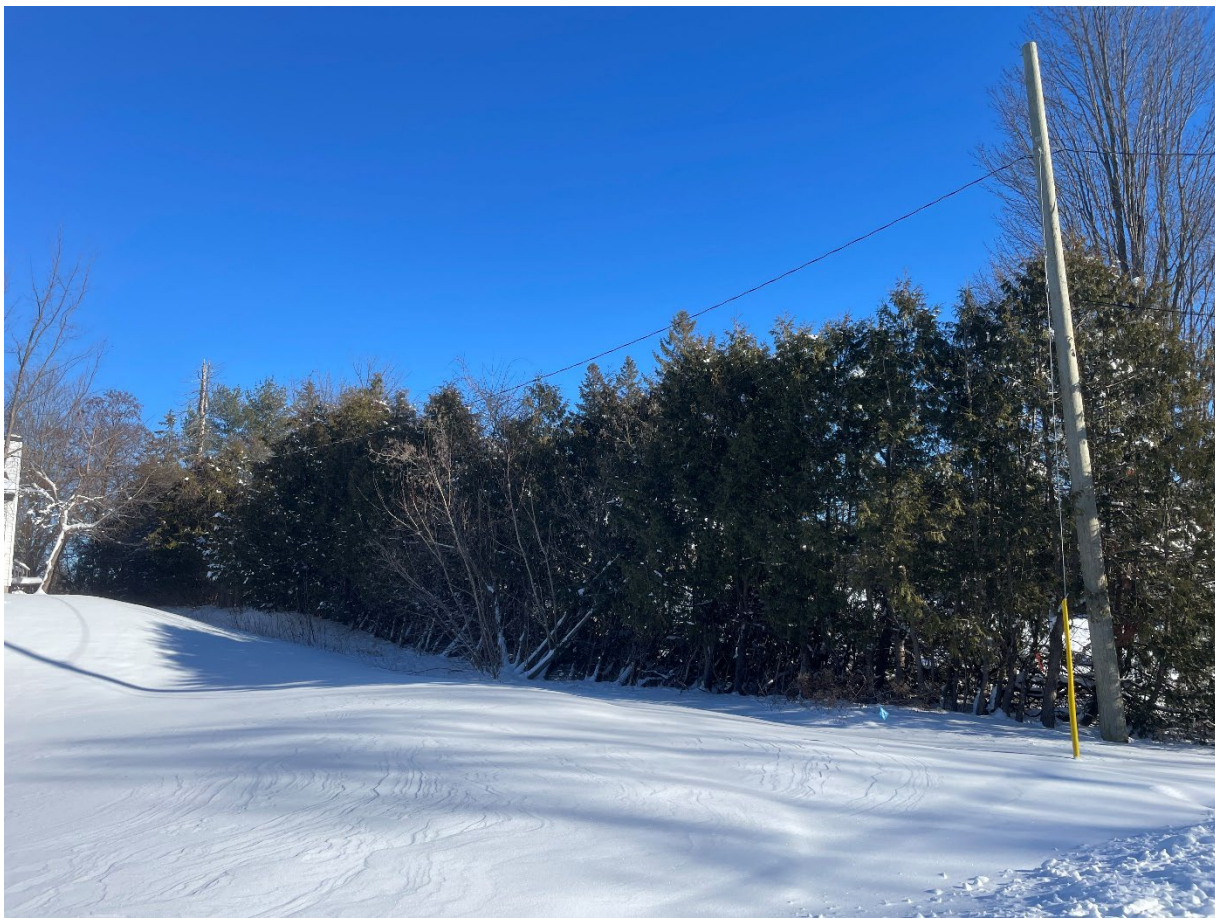
There are no trees or vegetation on the site except for a line of cedar hedges along the southern property line that are mostly on the adjacent property at 3 Norway Spruce. There is also a small grouping of Manitoba maple that have established themselves through natural seeding, on the property line, right beside the cedar hedge. There are no natural elements or species at risk observed at this site. This tree was originally labelled as jointly owned, but the client has indicated that it is fully on the private property, and this has been adjusted in the July 12, 2024 update.

Figure 1: Cedar hedge along the southern property line with Manitoba maple visible in the middle

In the previous iteration of this report, the cedar hedge was recommended for retention, but the client has advised that design of the parking area will require its removal due to excavation required for the retaining wall. The crabapple is still expected to be only minimally impacted, but clearance pruning may be required, and if large roots are damaged during excavation, a deep root fertilizer is recommended to help the tree recover from the stress. The multi-stemmed Manitoba maple will need to be removed to accommodate the new parking area. Removal of this tree is recommended regardless as it not an ideal urban tree, has poor form, and will shade out the adjacent cedar hedge.

Some root damage may occur to the cedar hedge along the southern property line when installing the pavement for the new parking area. To mitigate damage to the root system, digging the soil and cutting the roots manually is recommended. Any exposed roots should be covered with organic material immediately and be kept moist. There may be some roots within the excavation area for the new building of root 3. Root damage could be reduced by severing roots manually and/or applying a deep root fertilizer one year post construction if the tree is showing any signs of stress.

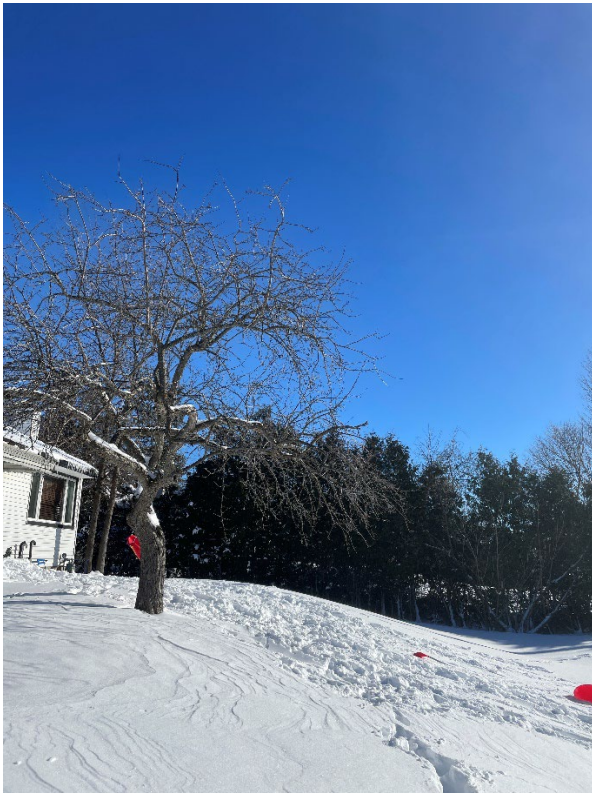
Figure 2: Tree 3, crabapple on adjacent property to be retained, some light pruning may be required

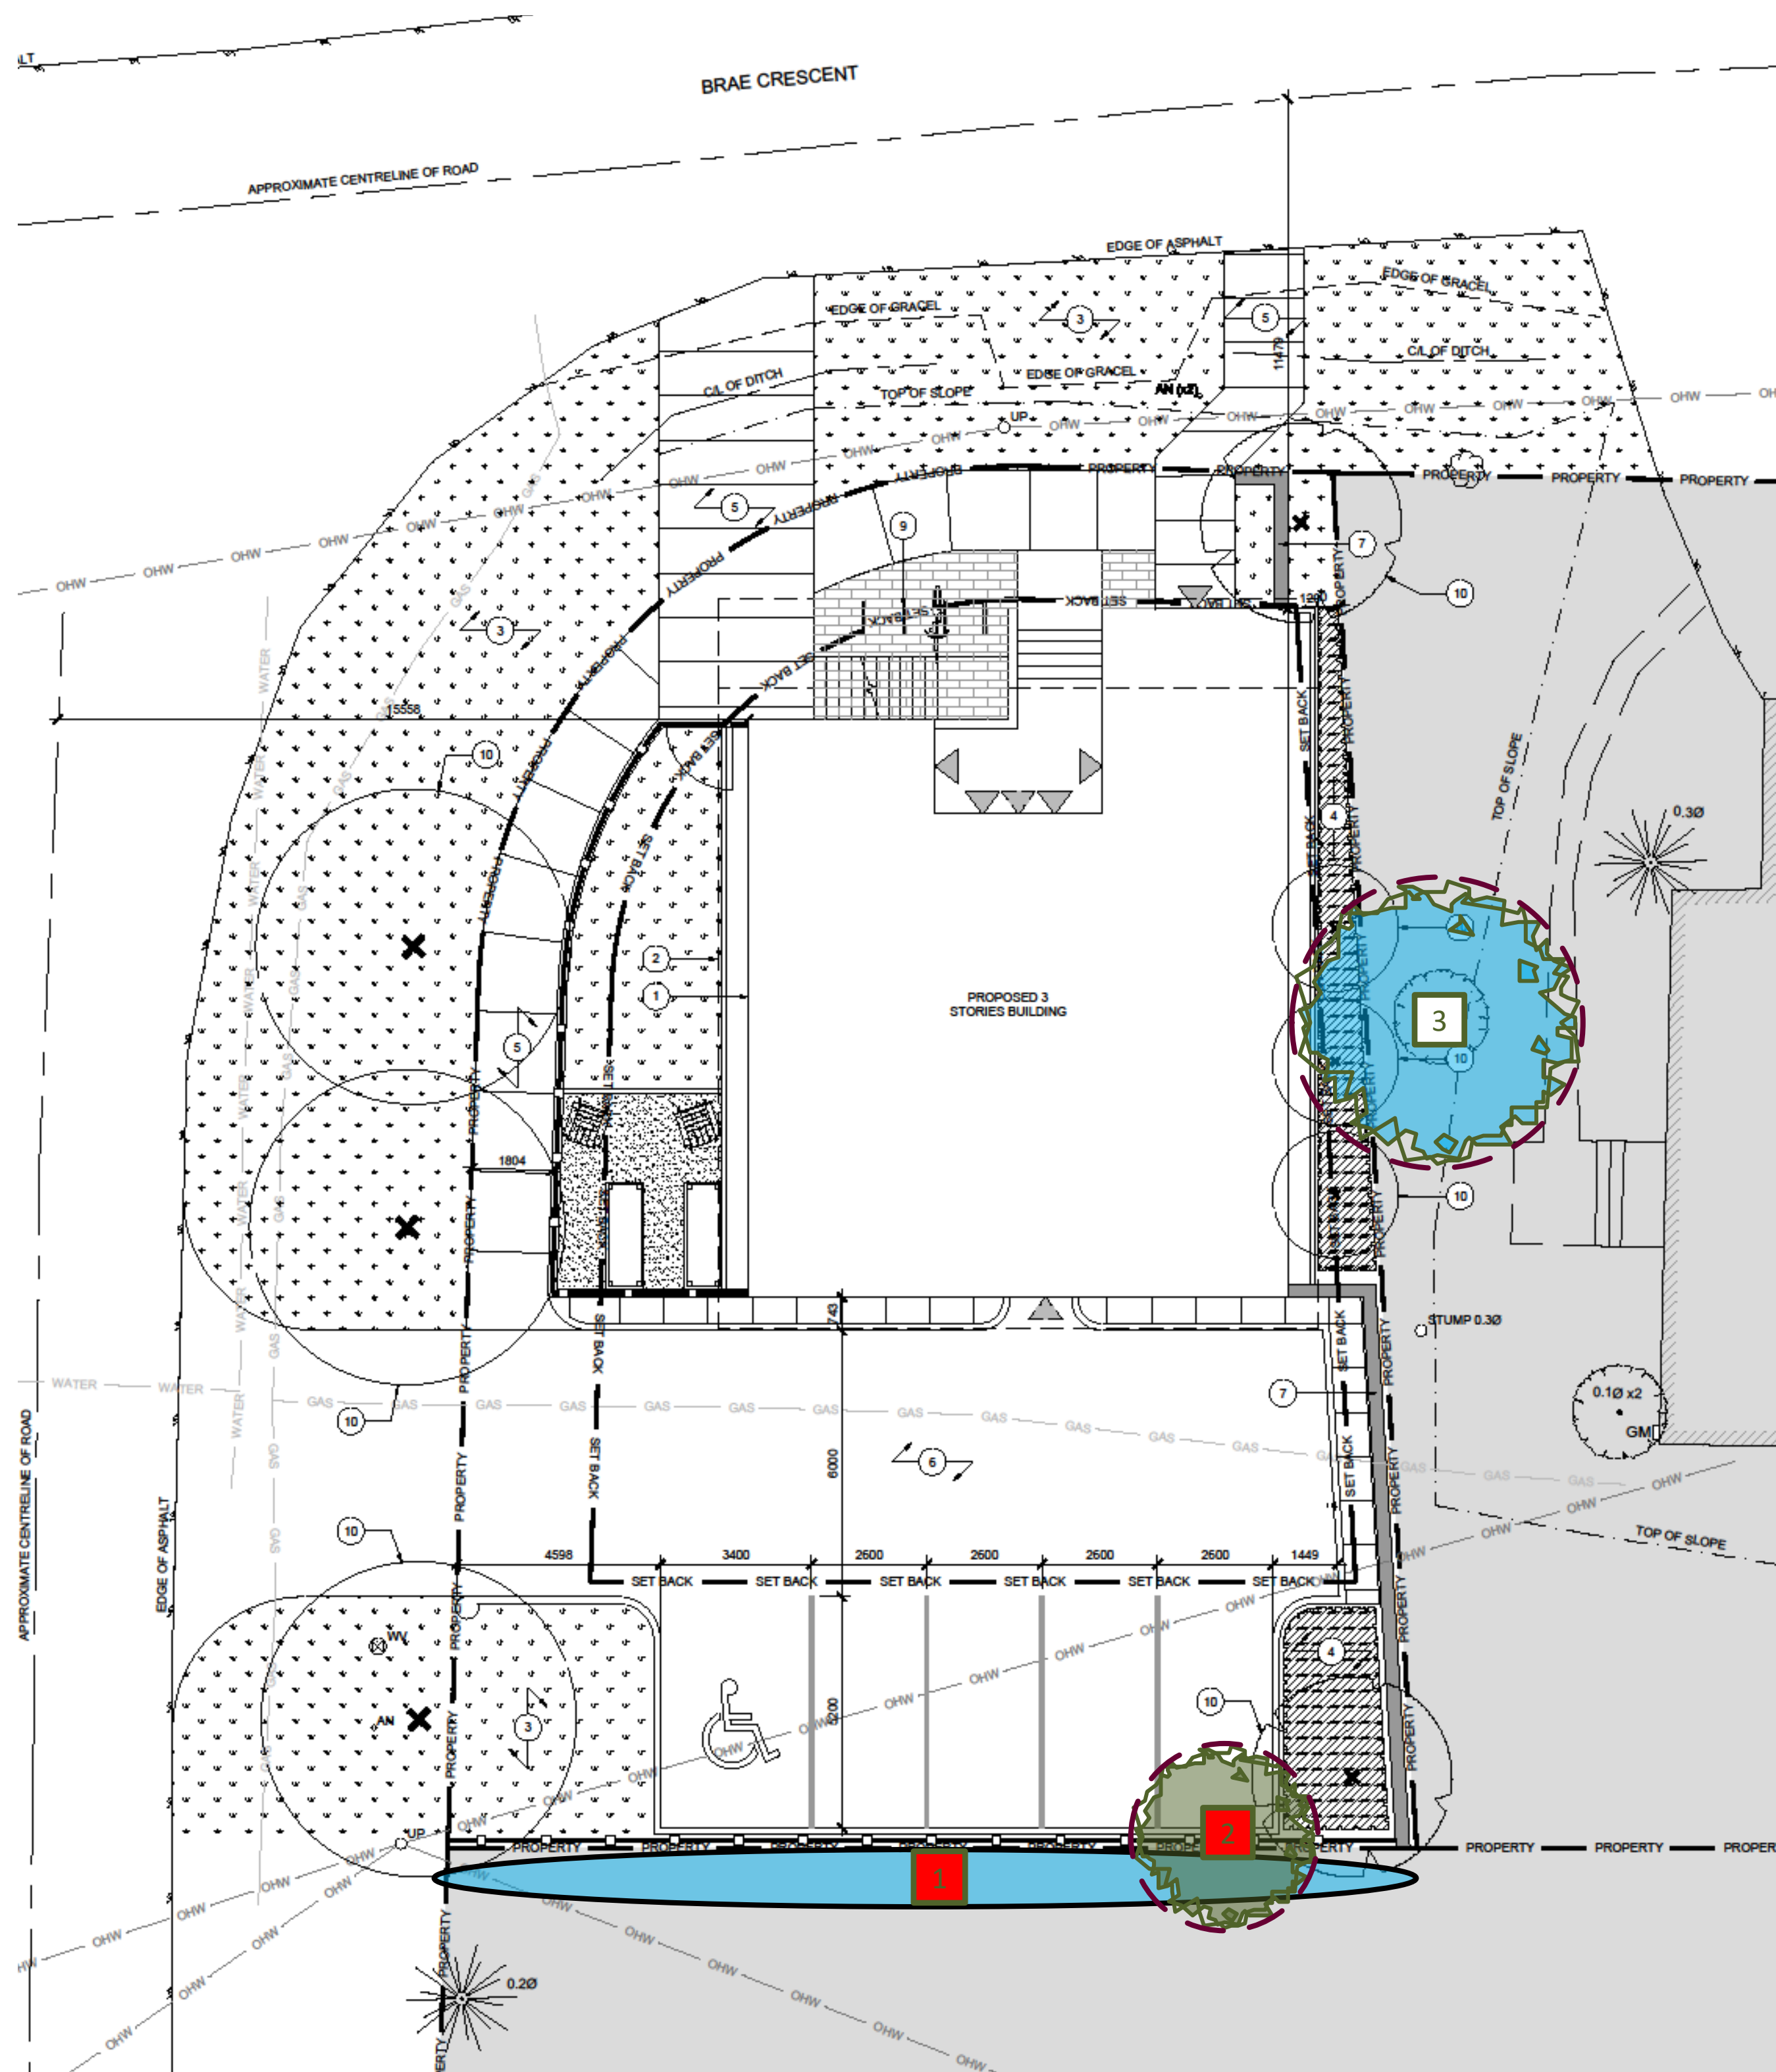
Tree Conservation Report – 121 Brae  
 Proposed Development and Conserved Vegetation  
 Tree layer prepared by Dendron Forestry Services  
 Version 2.0, April 24, 2023  
 For more information, please contact [info@dendronforestry.ca](mailto:info@dendronforestry.ca)

Tree <sup>1</sup>	Species	Diameter at breast height (dbh)	Ownership <sup>2,3</sup>	Condition	Action
1	Eastern white cedar ( <i>Thuja occidentalis</i> )	5-15 cm	Jointly owned, mostly on adjacent property at 3 Norway Spruce; approximately 6-8 m in height	Fair; has not been maintained on the subject property side recently	Remove due to design of parking area.
2 <sup>4</sup>	Manitoba maple ( <i>Acer negundo</i> )	Multi-stemmed, 5-15	Private	Good/fair; good vigour, poor form	Remove; conflict with proposed parking area
3	Crabapple ( <i>Malus spp</i> )	30 cm (estimate)	Adjacent property at 123 Brae	Good	Retain and protect; light pruning of branches may be required for clearance, if significant root damage occurs during excavation for the new building, consider a deep root fertilizer one year after construction
