Subject: Phase I Environmental Site Assessment Update

Vacant Land/Construction Staging Yard

**1034 McGarry Terrace**

Ottawa, Ontario

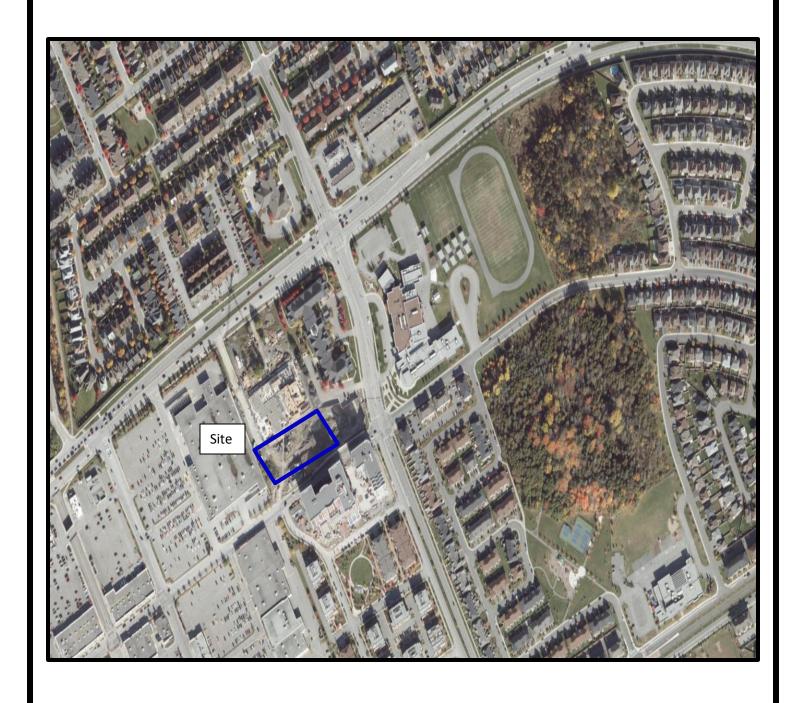
AERIAL PHOTOGRAPH 2019

An aerial photograph from 2019, accessed via the City of Ottawa's online mapping tool, was reviewed as part of the current Phase I ESA Update. The storage garage has been demolished and vegetation has been stripped from the subject site. The properties immediately east, north and south of the subject site are under construction.

No environmental concerns with respect to the subject site were identified by the air photo review.
