TREE CONSERVATION REPORT V2.0

1657 Carling Avenue

Tree Conservation Report submitted as Partial
Requirements for a Zoning Bylaw Amendment
Application, May 30, 2024

Address: 1657 Carling Avenue
Date of Report: May 30, 2024
Date of Site Visit: May 9, 2023
Prepared by: Kevin Myers, ISA Certified Arborist ®
Client: Jordan R. Bianconi - Inside Edge Properties; jbianconi@ieproperties.com

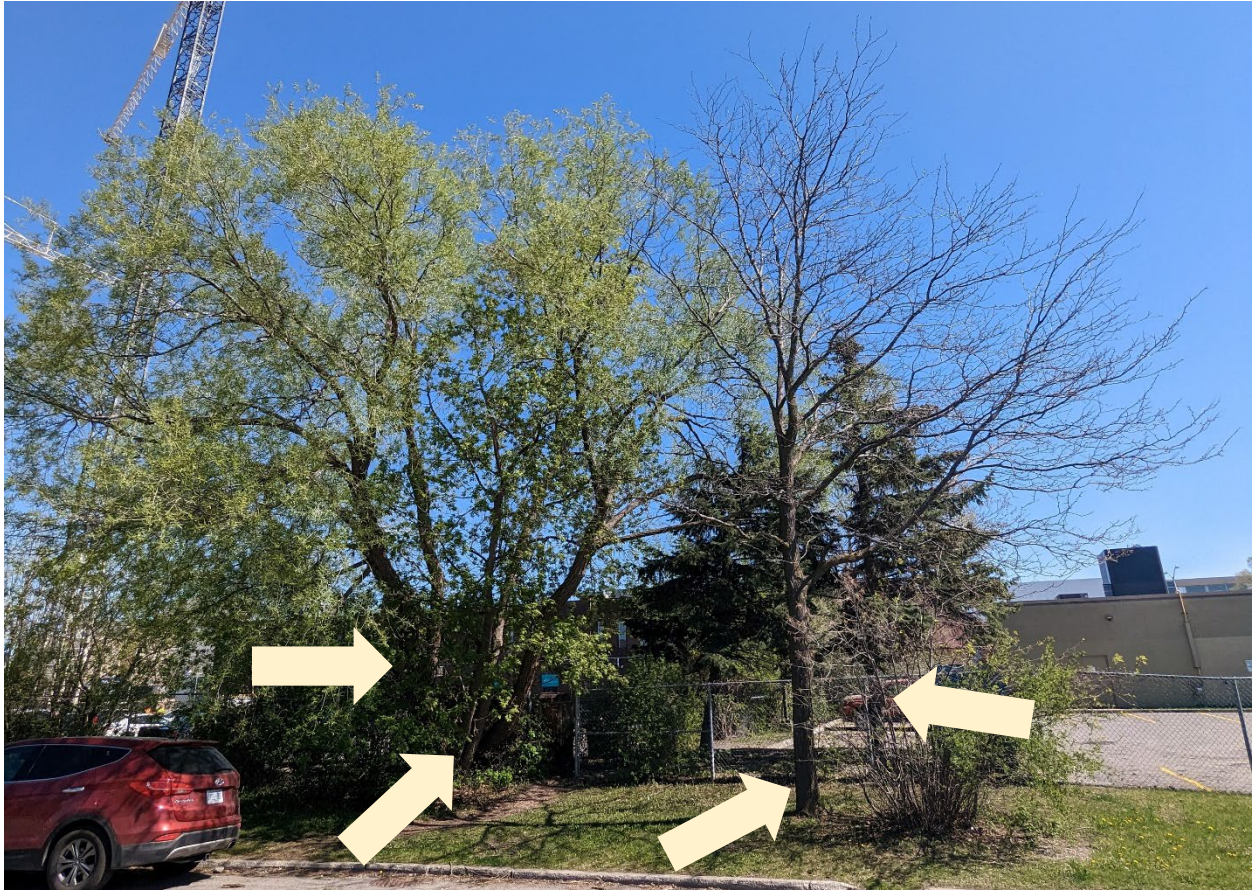
Trees 1-5 are far enough that impacts from construction will be lessened, however it is expected the CRZs will be affected by construction. Fencing should be erected as described below.

Figure 1 – (left to right) Tree 3: City willow, Tree 2: City Manitoba maple, Tree 1: City honey locust, Tree 4 and 5: adjacent Colorado spruces

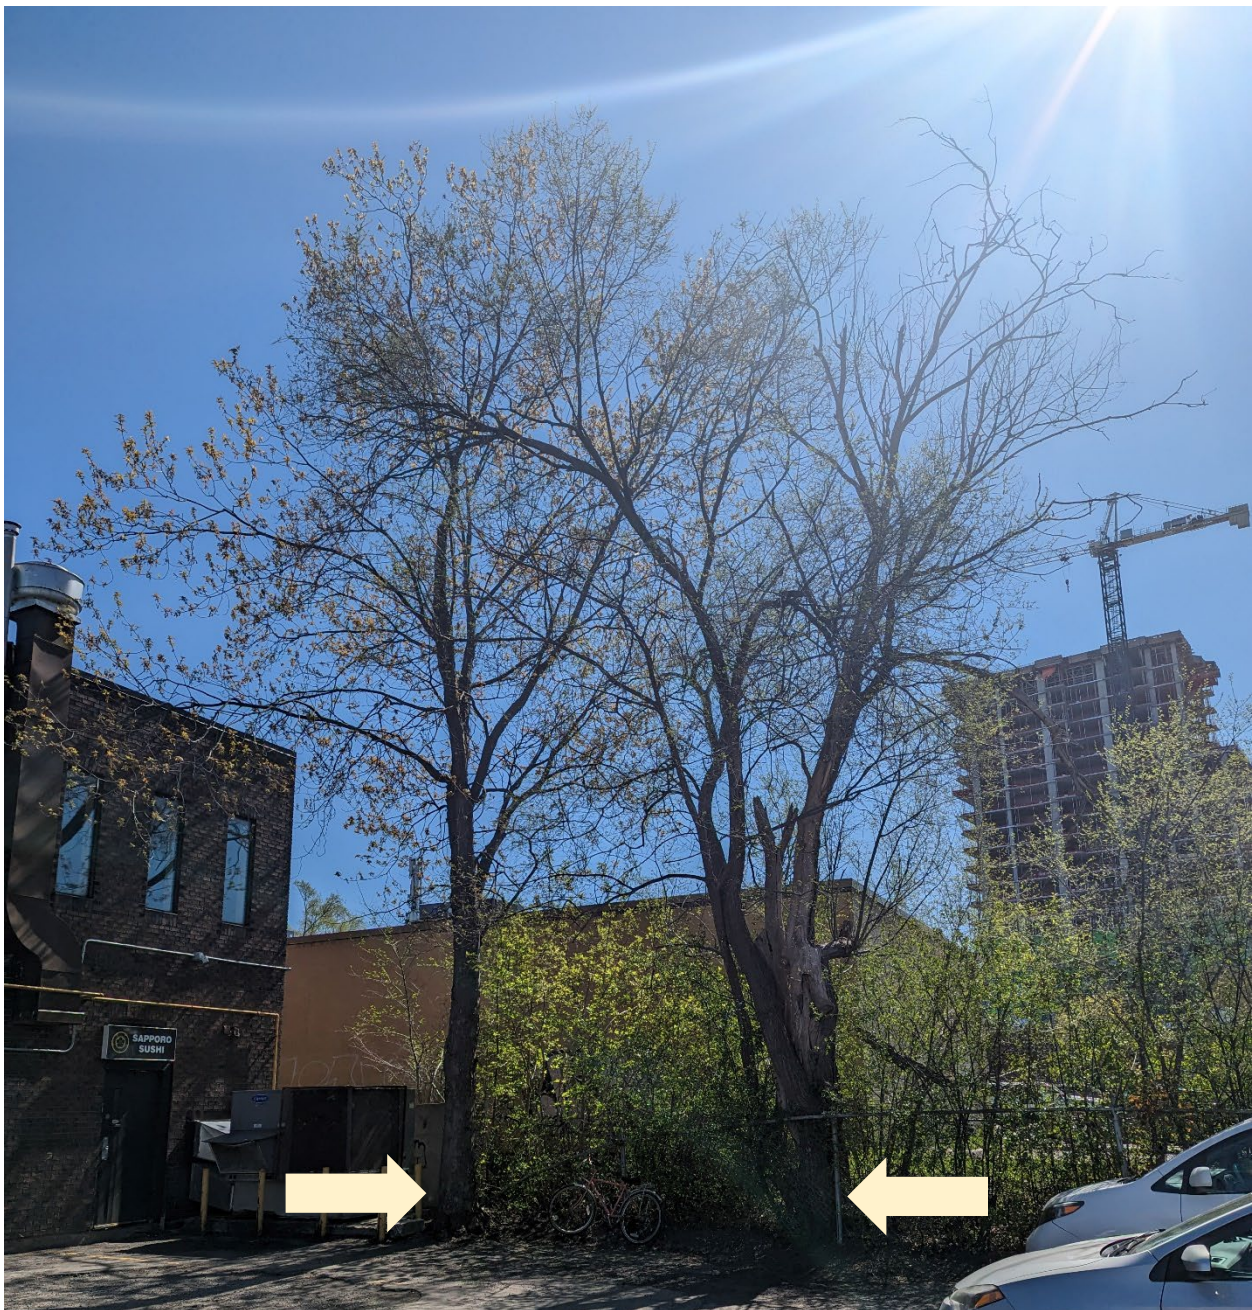
Trees 6-8, 16, 18 and 19 are in poor health and are not expected to endure the impacts of construction. Attempting to retain these trees during intense construction activities will not only be operationally difficult but could lead to safety issues.

6	Siberian elm (<i>Ulmus pumila</i>)	35 (estimate)	Boundary – 1677 Carling	Poor: only one branch with growth	Remove due to health status.
7 ⁴	Manitoba maple (<i>A. negundo</i>)	15, 15	Boundary – 376 Tillbury	Poor: old wounds have decay – tree nearly dead	Remove due to health status.
8	Red maple (<i>Acer rubrum</i>)	61	Subject property	Poor: significant dieback; ants in stem; old wounds not sealing – decay	Remove due to health status.

Figure 2 - (left) Tree 16: private maple (right) Tree 6: boundary elm

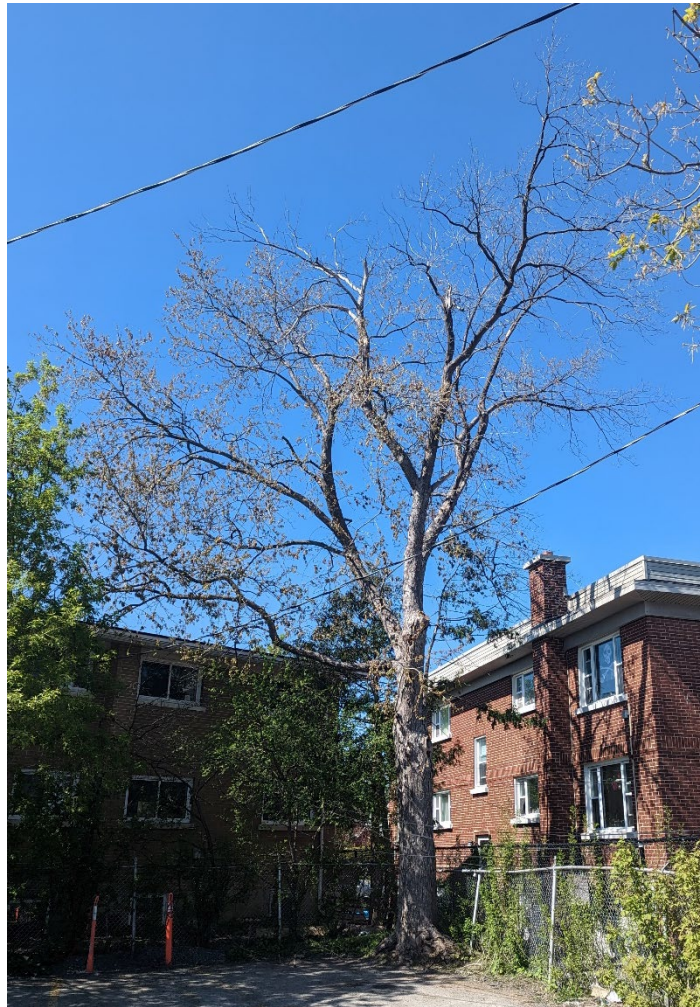
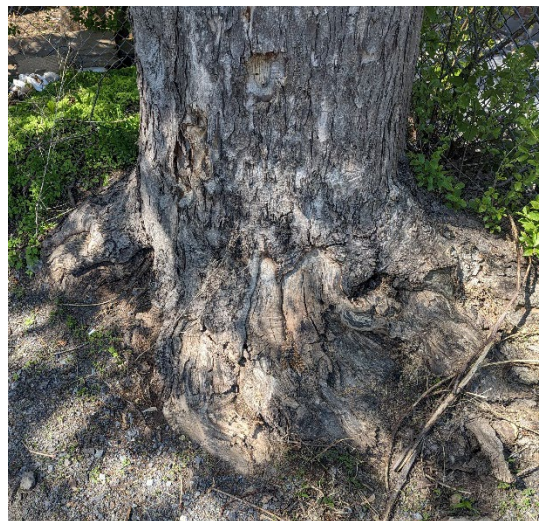
Figure 3 – (Above) Tree 8: Private maple

(Right) base of Tree 8

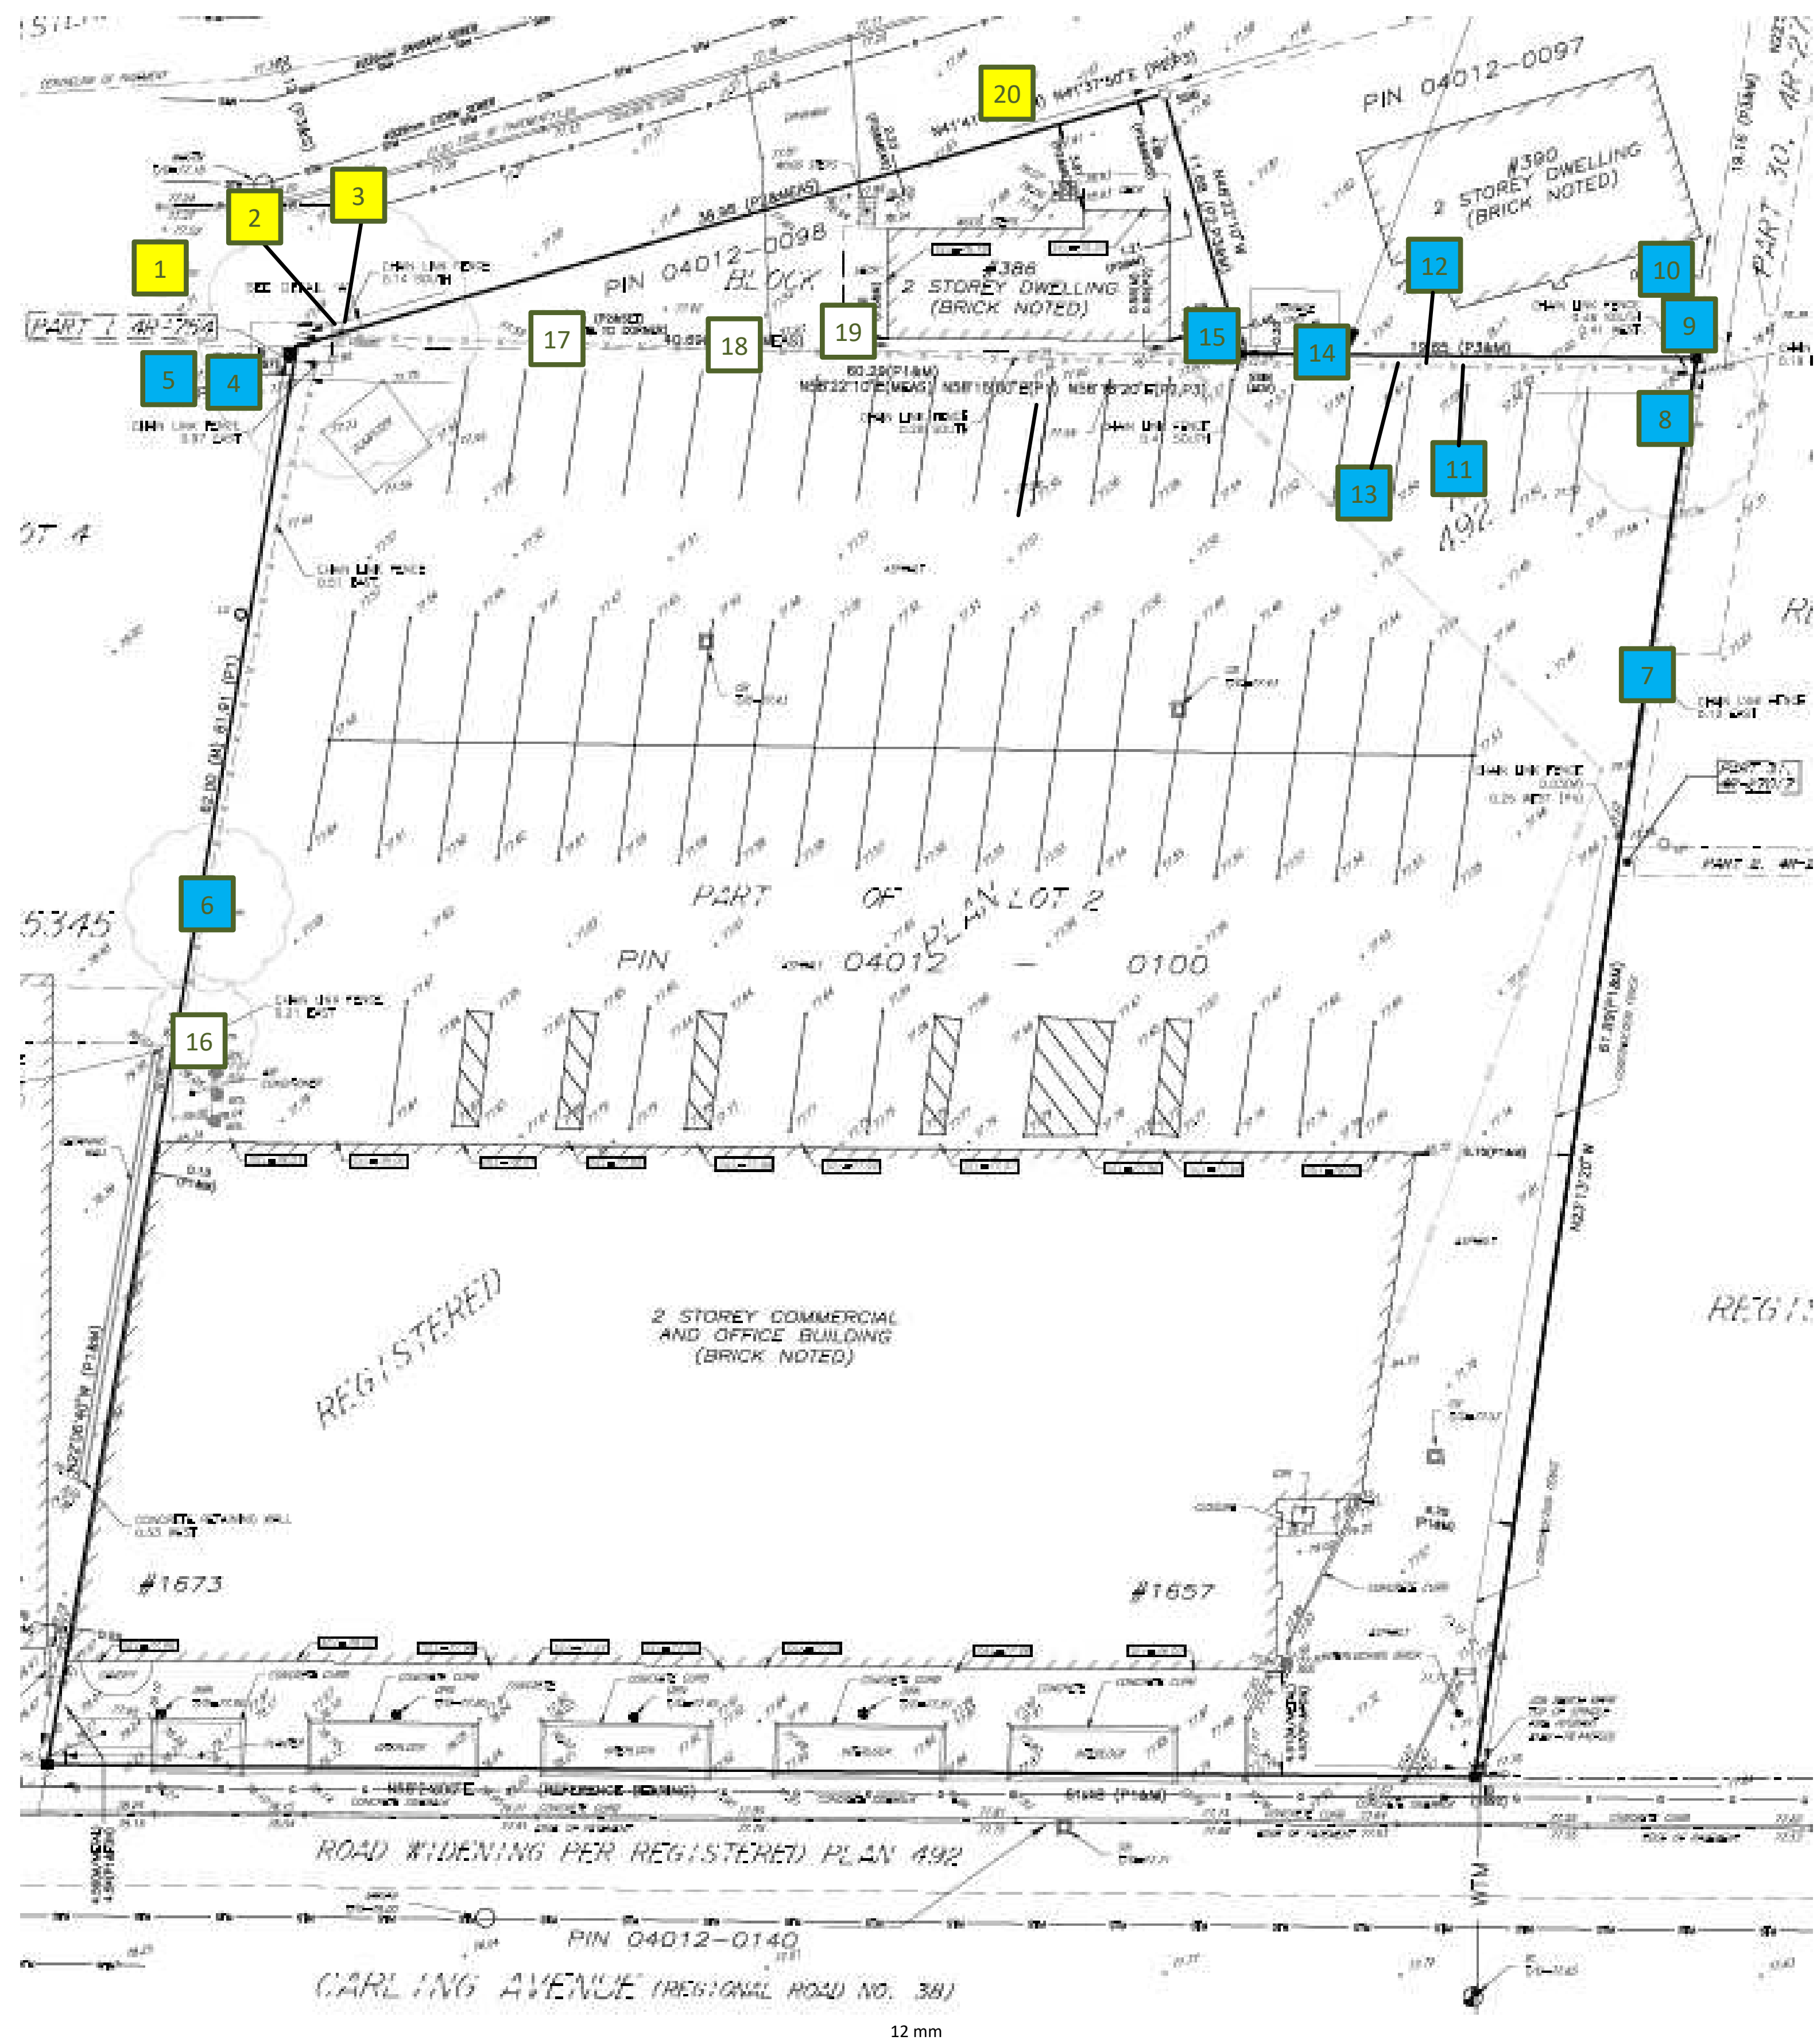
Tree Conservation Report – 1657 Carling Avenue
Map 1, Existing Conditions
Tree layer prepared by Dendron Forestry Services, May 15, 2023
For more information, please contact info@dendronforestry.ca

Tree ¹	Species	DBH (cm)	Ownership ^{2,3}	Condition
1	Honey Locust (<i>Gleditsia triacanthos</i>)	29	City	Good
2	Manitoba maple (<i>Acer negundo</i>)	25, 19	City	Fair: crack at union of stems; significant lean towards road
3	Willow spp. (<i>Salix sp.</i>)	35, 45, 42	City	Fair: large stems fusing – poor form; lean towards road; old wounds sealing slowly
4 ⁴	Colorado spruce (<i>Picea pungens</i>)	23	Adjacent – 1677 Carling	Fair/Poor: suppressed by Tree 3
5 ⁴	Colorado spruce (<i>Picea pungens</i>)	27	Adjacent – 1677 Carling	Fair/Poor: central leader is dead
6	Siberian elm (<i>Ulmus pumila</i>)	35 (estimate)	Boundary – 1677 Carling	Poor: only one branch with growth
7 ⁴	Manitoba maple (<i>A. negundo</i>)	15, 15	Boundary – 376 Tillbury	Poor: old wounds have decay – tree nearly dead
8	Red maple (<i>Acer rubrum</i>)	61	Subject property	Poor: significant dieback; ants in stem; old wounds not sealing – decay present; roots cut long ago for parking lot

9 ⁴	Easter white cedar (<i>Thuja occidentalis</i>)	15	Adjacent – 376 Tillbury	Fair: being girdled by wire; suppressed by Tree 8
10 ⁴	Easter white cedar (<i>Thuja occidentalis</i>)	12	Adjacent – 390 Tillbury	Fair: suppressed by Tree 8
11 ⁴	Manitoba maple (<i>A. negundo</i>)	12	Boundary – 390 Tillbury	Fair: growing around fence
12 ⁴	Manitoba maple (<i>A. negundo</i>)	10	Boundary – 390 Tillbury	Fair: lean
13 ⁴	Manitoba maple (<i>A. negundo</i>)	21	Boundary – 390 Tillbury	Fair
14 ⁴	Manitoba maple (<i>A. negundo</i>)	20, 20, 15, 13	Boundary – 390 Tillbury	Fair: growing on fence; poor form
15 ⁴	Manitoba maple (<i>A. negundo</i>)	14, 8, 11	Subject property	Fair/Good: very close to house and fence
16	Silver maple (<i>Acer saccharinum</i>)	45	Subject property	Fair: minor broken branch; some dieback in crown; very poor growing location
17 ⁴	Manitoba maple (<i>A. negundo</i>)	9, 12, 5	Subject property	Fair: growing on fence

18 ⁴	Ash spp. (<i>Fraxinus spp.</i>)	11	Subject property	Poor
19 ⁴	Siberian elm (<i>U. pumila</i>)	12, 14	Subject property	Poor: growing from under deck, out of concrete
20	Red maple (<i>A. rubrum</i>)	13	City	Good

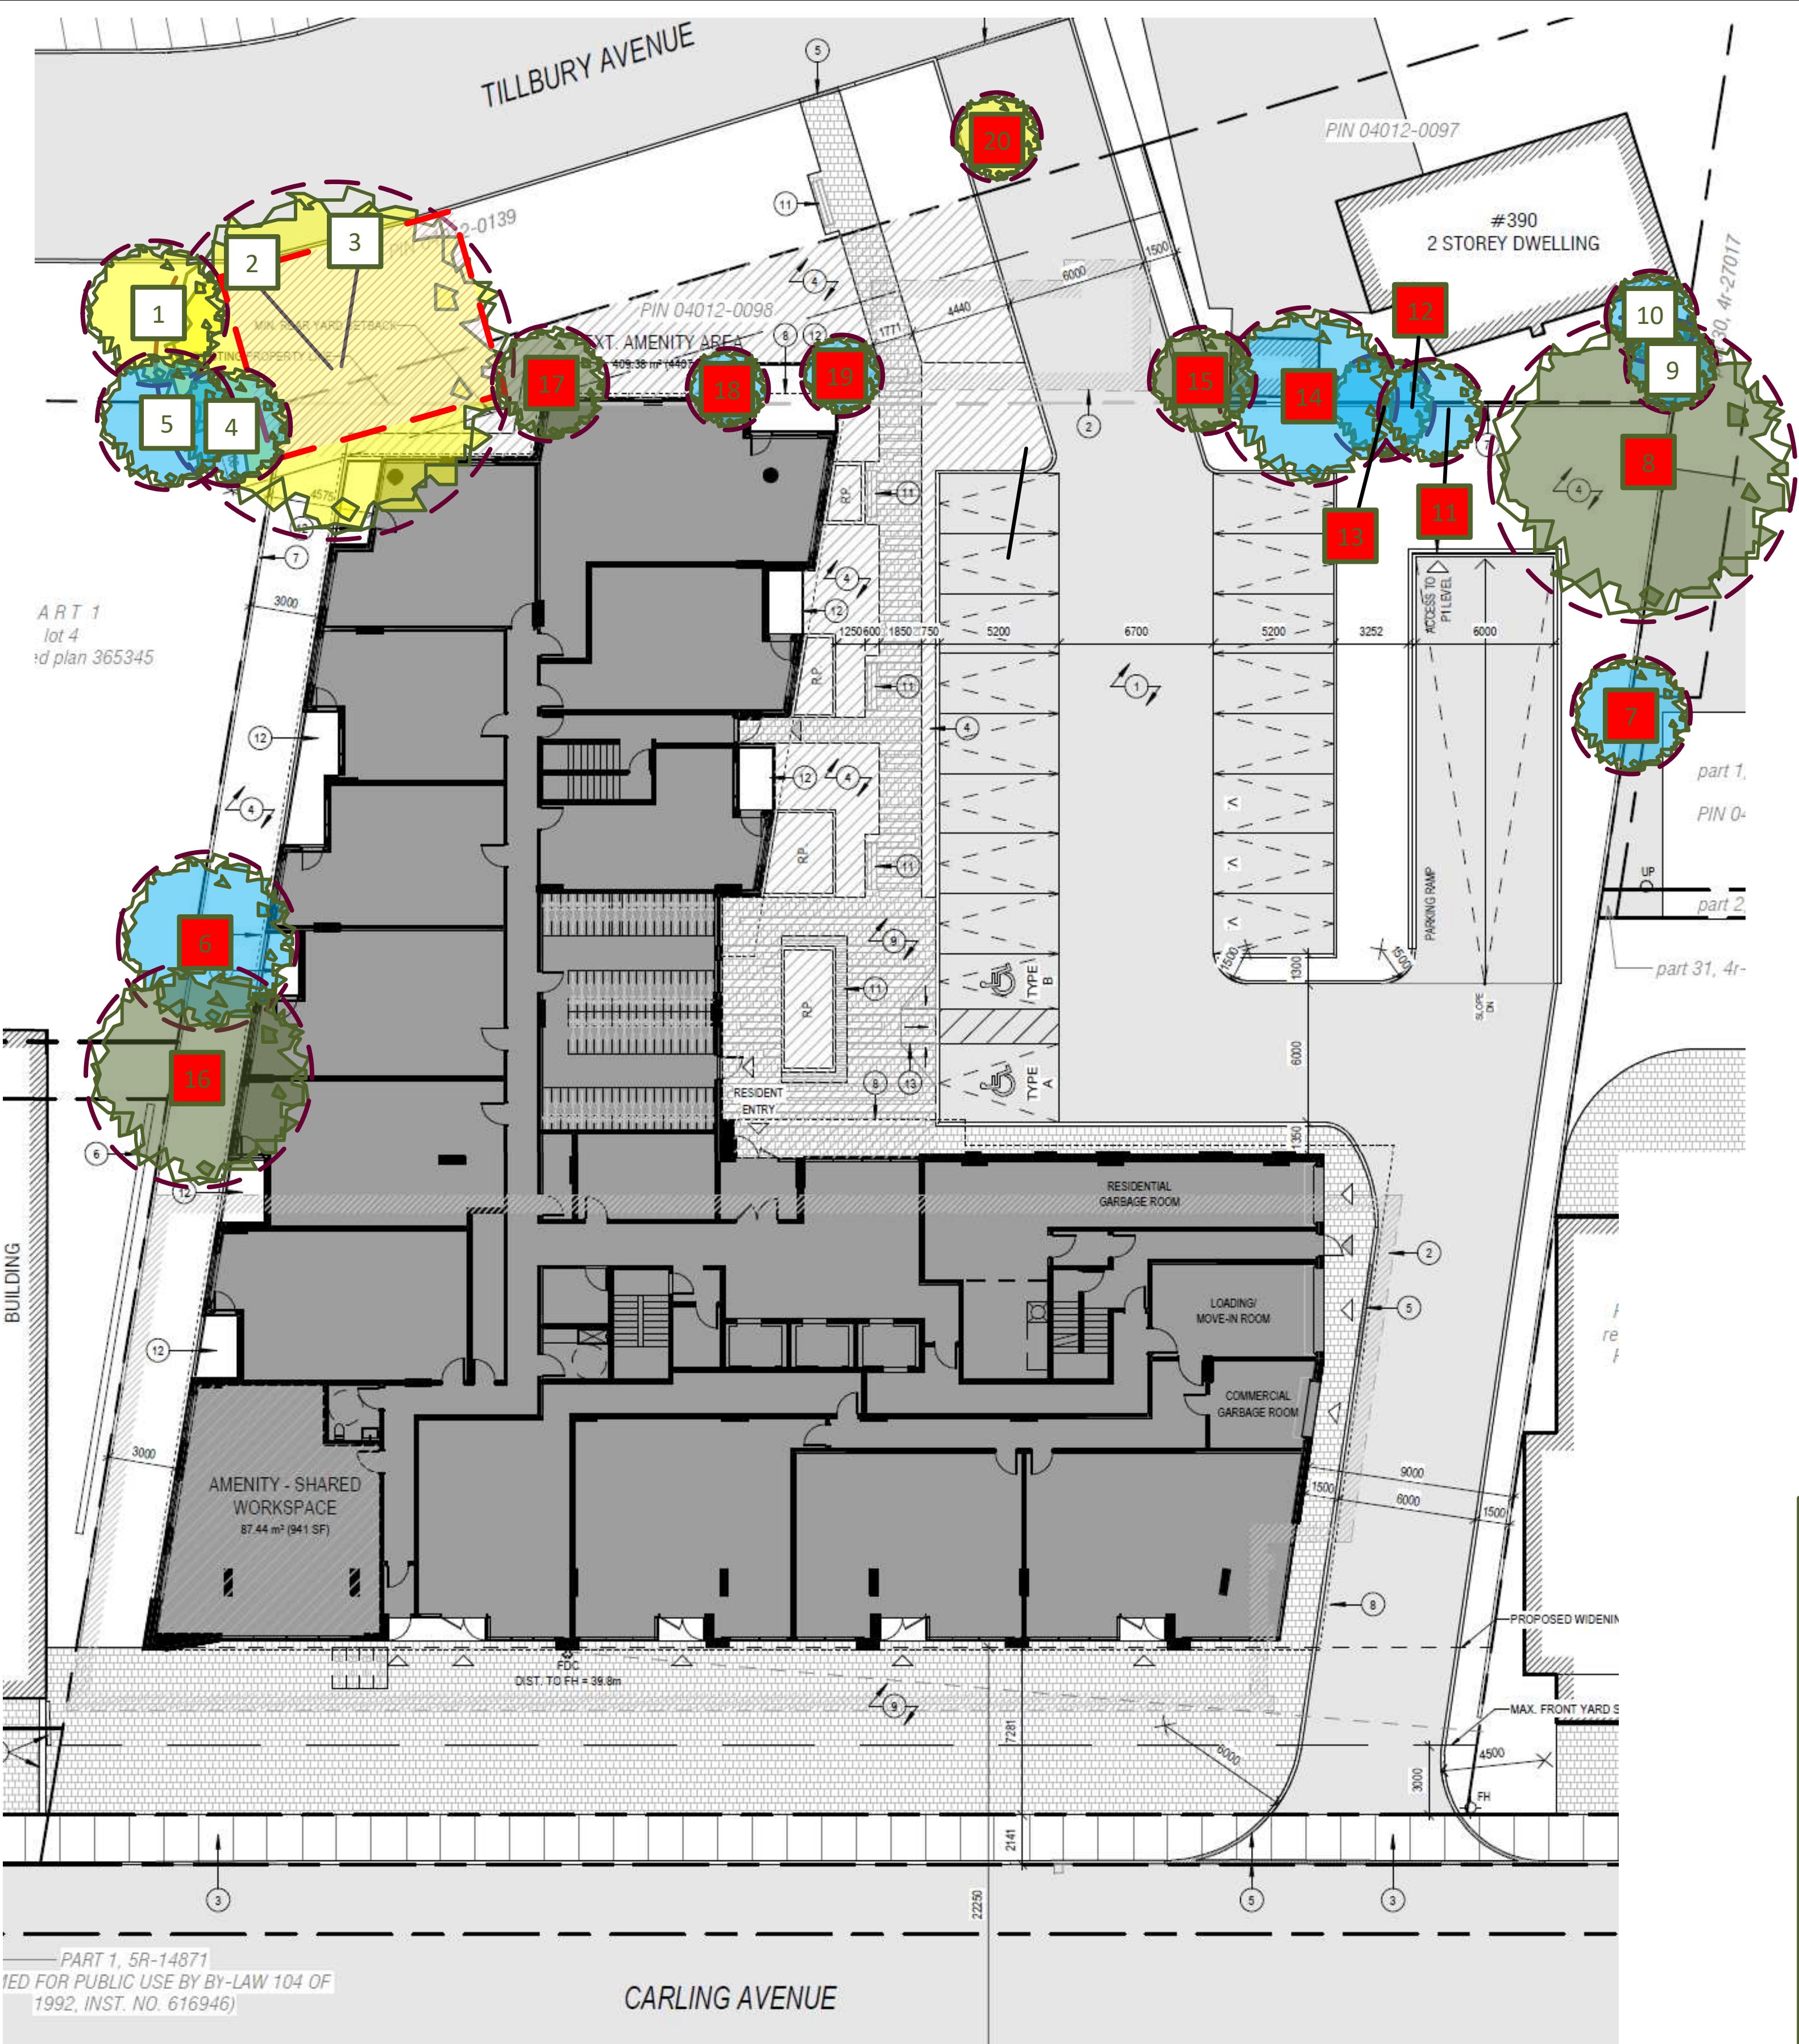
Tree Conservation Report – 1657 Carling Avenue
Tree layer prepared by Dendron Forestry Services
Version 2.0, May 30, 2023
For more information, please contact info@dendronforestry.ca

6	Siberian elm (<i>Ulmus pumila</i>)	35 (estimate)	Poor: only one branch with growth	Remove due to health status.
7 ⁴	Manitoba maple (<i>A. negundo</i>)	15, 15	Poor: old wounds have decay – tree nearly dead	Remove due to health status.
8	Red maple (<i>Acer rubrum</i>)	61	Poor: significant dieback; ants in stem; old wounds not sealing – decay present; roots cut long ago for parking lot	Remove due to health status.
9 ⁴	Easter white cedar (<i>Thuja occidentalis</i>)	15	Fair: being girdled by wire; suppressed by Tree 8	Retain and protect as per the City of Ottawa Tree Protection Specifications (March 2021)
10 ⁴	Easter white cedar (<i>Thuja occidentalis</i>)	12	Fair: suppressed by Tree 8	Retain and protect as per the City of Ottawa Tree Protection Specifications (March 2021)
11 ⁴	Manitoba maple (<i>A. negundo</i>)	12	Fair: growing around fence	Remove due to health status, poor growing location and impacts from construction.

12 ⁴	Manitoba maple (<i>A. negundo</i>)	10	Fair: lean	Remove due to health status, poor growing location and impacts from construction.
13 ⁴	Manitoba maple (<i>A. negundo</i>)	21	Fair	Remove due to health status, poor growing location and impacts from construction.
14 ⁴	Manitoba maple (<i>A. negundo</i>)	20, 20, 15, 13	Fair: growing on fence; poor form	Remove due to health status, poor growing location and impacts from construction.
15 ⁴	Manitoba maple (<i>A. negundo</i>)	14, 8, 11	Fair/Good: very close to house and fence	Remove due to health status, poor growing location and impacts from construction.
16	Silver maple (<i>Acer saccharinum</i>)	45	Fair: minor broken branch; some dieback in crown; very poor growing location	Remove due to health status and impacts from construction.
17 ⁴	Manitoba maple (<i>A. negundo</i>)	9, 12, 5	Fair: growing on fence	Remove due to poor growing location (removal of fence to create amenity space will necessitate removal of the tree)

18 ⁴	Ash spp. (<i>Fraxinus</i> spp.)	11	Poor	Remove due to health status and growing location
19 ⁴	Siberian elm (<i>U. pumila</i>)	12, 14	Poor: growing from under deck, out of concrete	Remove due to health status and growing location
20	Red maple (<i>A. rubrum</i>)	13	Good	Remove due to plans

Prior to any site works, protective fencing should be installed around the TPA as indicated in Map and maintained until all construction on site has been completed as per the City of Ottawa Tree Protection Specifications (March 2021). **Failure to install and maintain the indicated fencing may result in fines from the City.**

The tree protection fencing must be 1.2 m in height and constructed of a rigid or framed material (e.g. modulus – steel, plywood hoarding, or snow fence on a 2”X4” wood frame) with posts 2.4 m apart such that the fence location cannot be altered. All supports must be placed outside of the CRZ and installation must minimize damage to existing roots.

- Place a layer of 6-12 inches (15 to 30 cm) of woodchip mulch to the area
- Apply ¾ (2 cm) inch plywood, or road mats over a 4+ inch (10 cm) thick layer of the wood chip mulch
- Apply 4-6 inches (10 to 15 cm) of gravel over a taut, staked, geotextile fabric
