BGO Bank & Walkley  
Ottawa, ON

TREE CONSERVATION REPORT

TCR 01

TCR 02

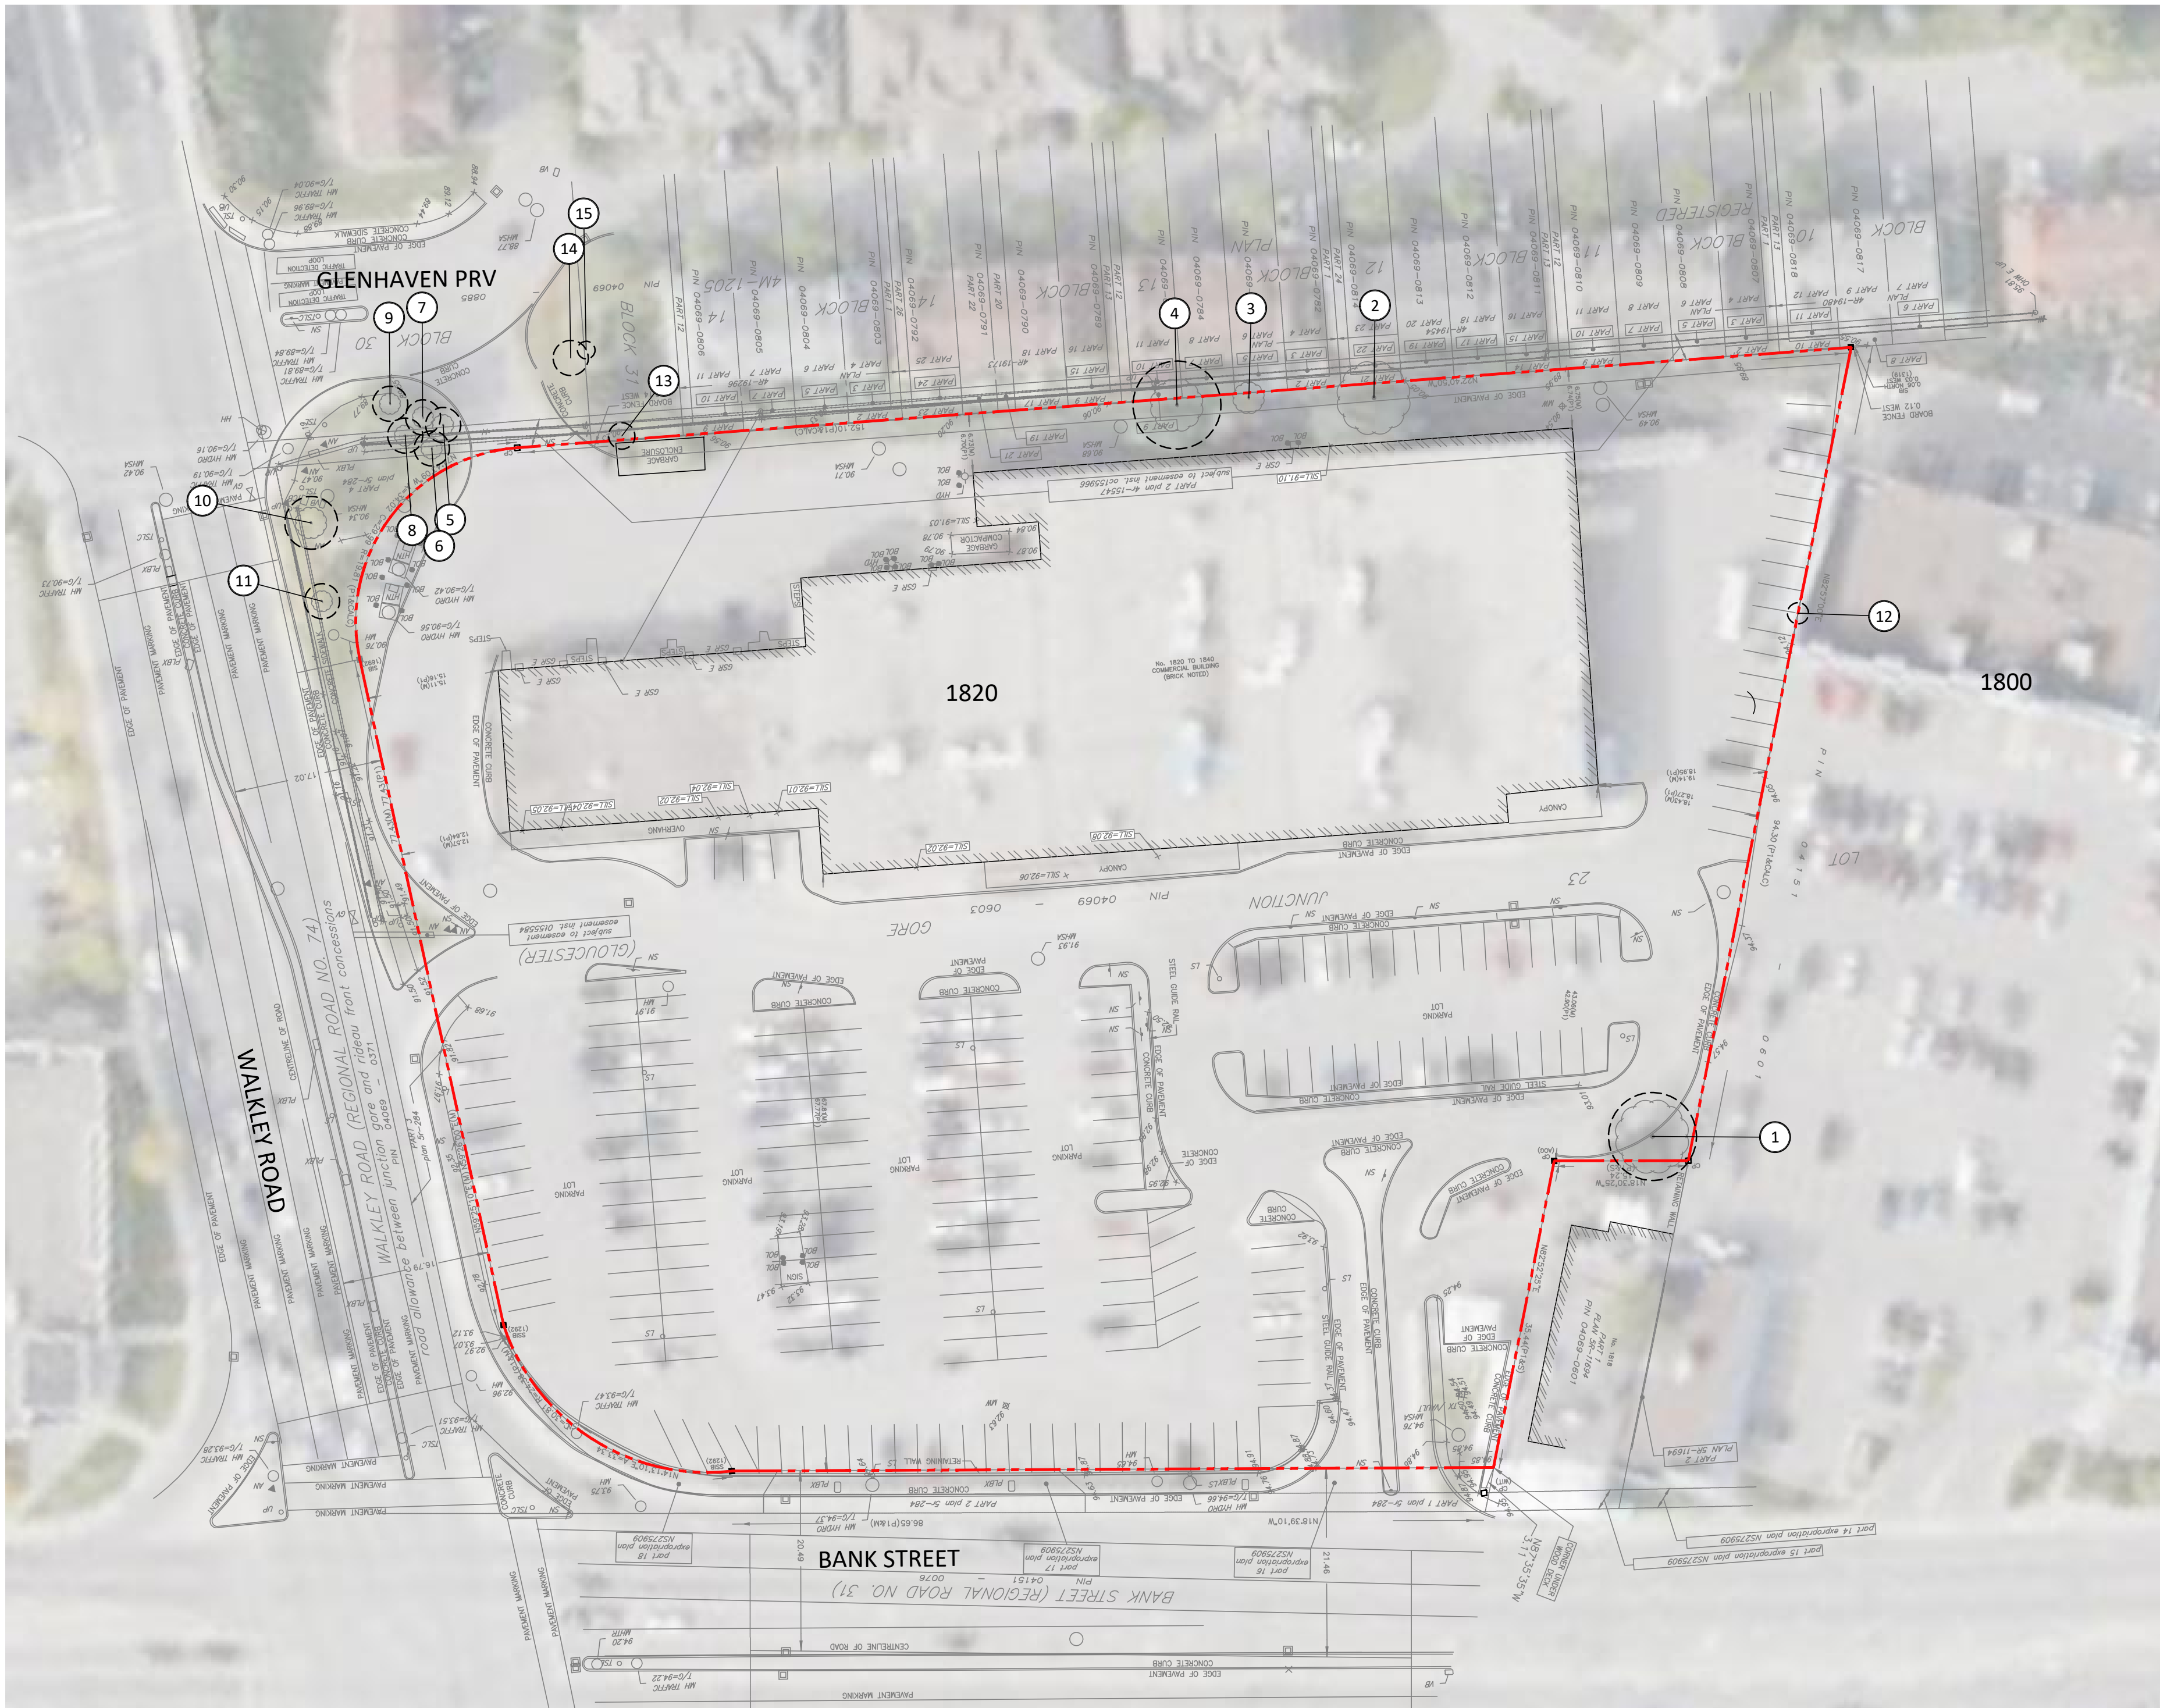
1 EXISTING CONDITIONS

| Tree # | Botanical Name | Common Name | DBH (cm) | Ownership | | Condition | NOTES | To Be Preserved |
|---|---|---|---|---|---|---|---|---|
| 1 | Acer platanoides | Norway Maple | 50 | Private | 1822 Bank St | Moderate | Asymmetrical canopy, Dieback ~15% @ canopy, Broken limbs, Single stem, Bark rot @ limbs, Girdled roots | NO |
| 4 | Ulmus spp. | Elm | 50 | Private | 1822 Bank St | Moderate | Asymmetrical canopy, Dieback ~10% @ limbs, Pruned @ O.H., Poor branch union, Multi-stem w/ 3 | NO |
| 5 | Acer platanoides | Norway Maple | 20 | Private | ROW Glenhaven Prv | Moderate | Asymmetrical canopy, Dieback ~30% @ Canopy, Pruned limbs, Single stem, Bark rot @ cavities | YES |
| 6 | Acer platanoides | Norway Maple | 20 | Private | ROW Glenhaven Prv | Moderate | Asymmetrical canopy, Broken limbs, Single stem, Pruned branches, Heart rot @ limbs, Girdled trunk from staking | YES |
| 7 | Acer platanoides | Norway Maple | 20 | Private | ROW Glenhaven Prv | Moderate | Asymmetrical canopy, Dieback ~10% @ canopy, Single stem, Included bark, Girdled roots | YES |
| 8 | Acer platanoides | Norway Maple | 20 | Private | ROW Glenhaven Prv | Good | Asymmetrical canopy, Pruned branches @ O.H., Single stem | YES |
| 9 | Acer platanoides | Norway Maple | 20 | Private | ROW Glenhaven Prv | Good | Asymmetrical canopy, Dieback ~10% @ canopy, Single stem, Girdled roots | YES |
| 10 | Acer platanoides | Norway Maple | 30 | City | | Moderate | Symmetrical canopy, Dieback ~15% @ canopy, Single stem, Girdled roots | NO |
| 11 | Acer platanoides | Norway Maple | 20 | City | | Good | Symmetrical canopy, Single stem | NO |
| 12 | Ulmus spp. | Elm | 12 | Boundary | 1822 Bank St/1800 Bank St | Moderate | Asymmetrical canopy, Broken limbs, Single stem, (2) Leaders @ 2m above grade, Included bark, Grown into C.L. fence | NO |
| 13 | Celtis occidentalis | Hackberry | 15 | Private | ROW Glenhaven Prv | Moderate | Symmetrical canopy, Single stem, Grown btwn 2 privacy fences | NO |
| 14 | Acer platanoides 'Crimson King' | Norway Maple | 20 | Private | ROW Glenhaven Prv | Moderate | Symmetrical canopy, Single stem, (3) Leaders @ 2m above grade, Large crack on trunk | NO |
| 15 | Picea pungens var. 'Glauca' | Colorado Blue Spruce | 10 | Private | ROW Glenhaven Prv | Poor | Asymmetrical canopy, Dieback ~80% @ canopy, Single stem | NO |

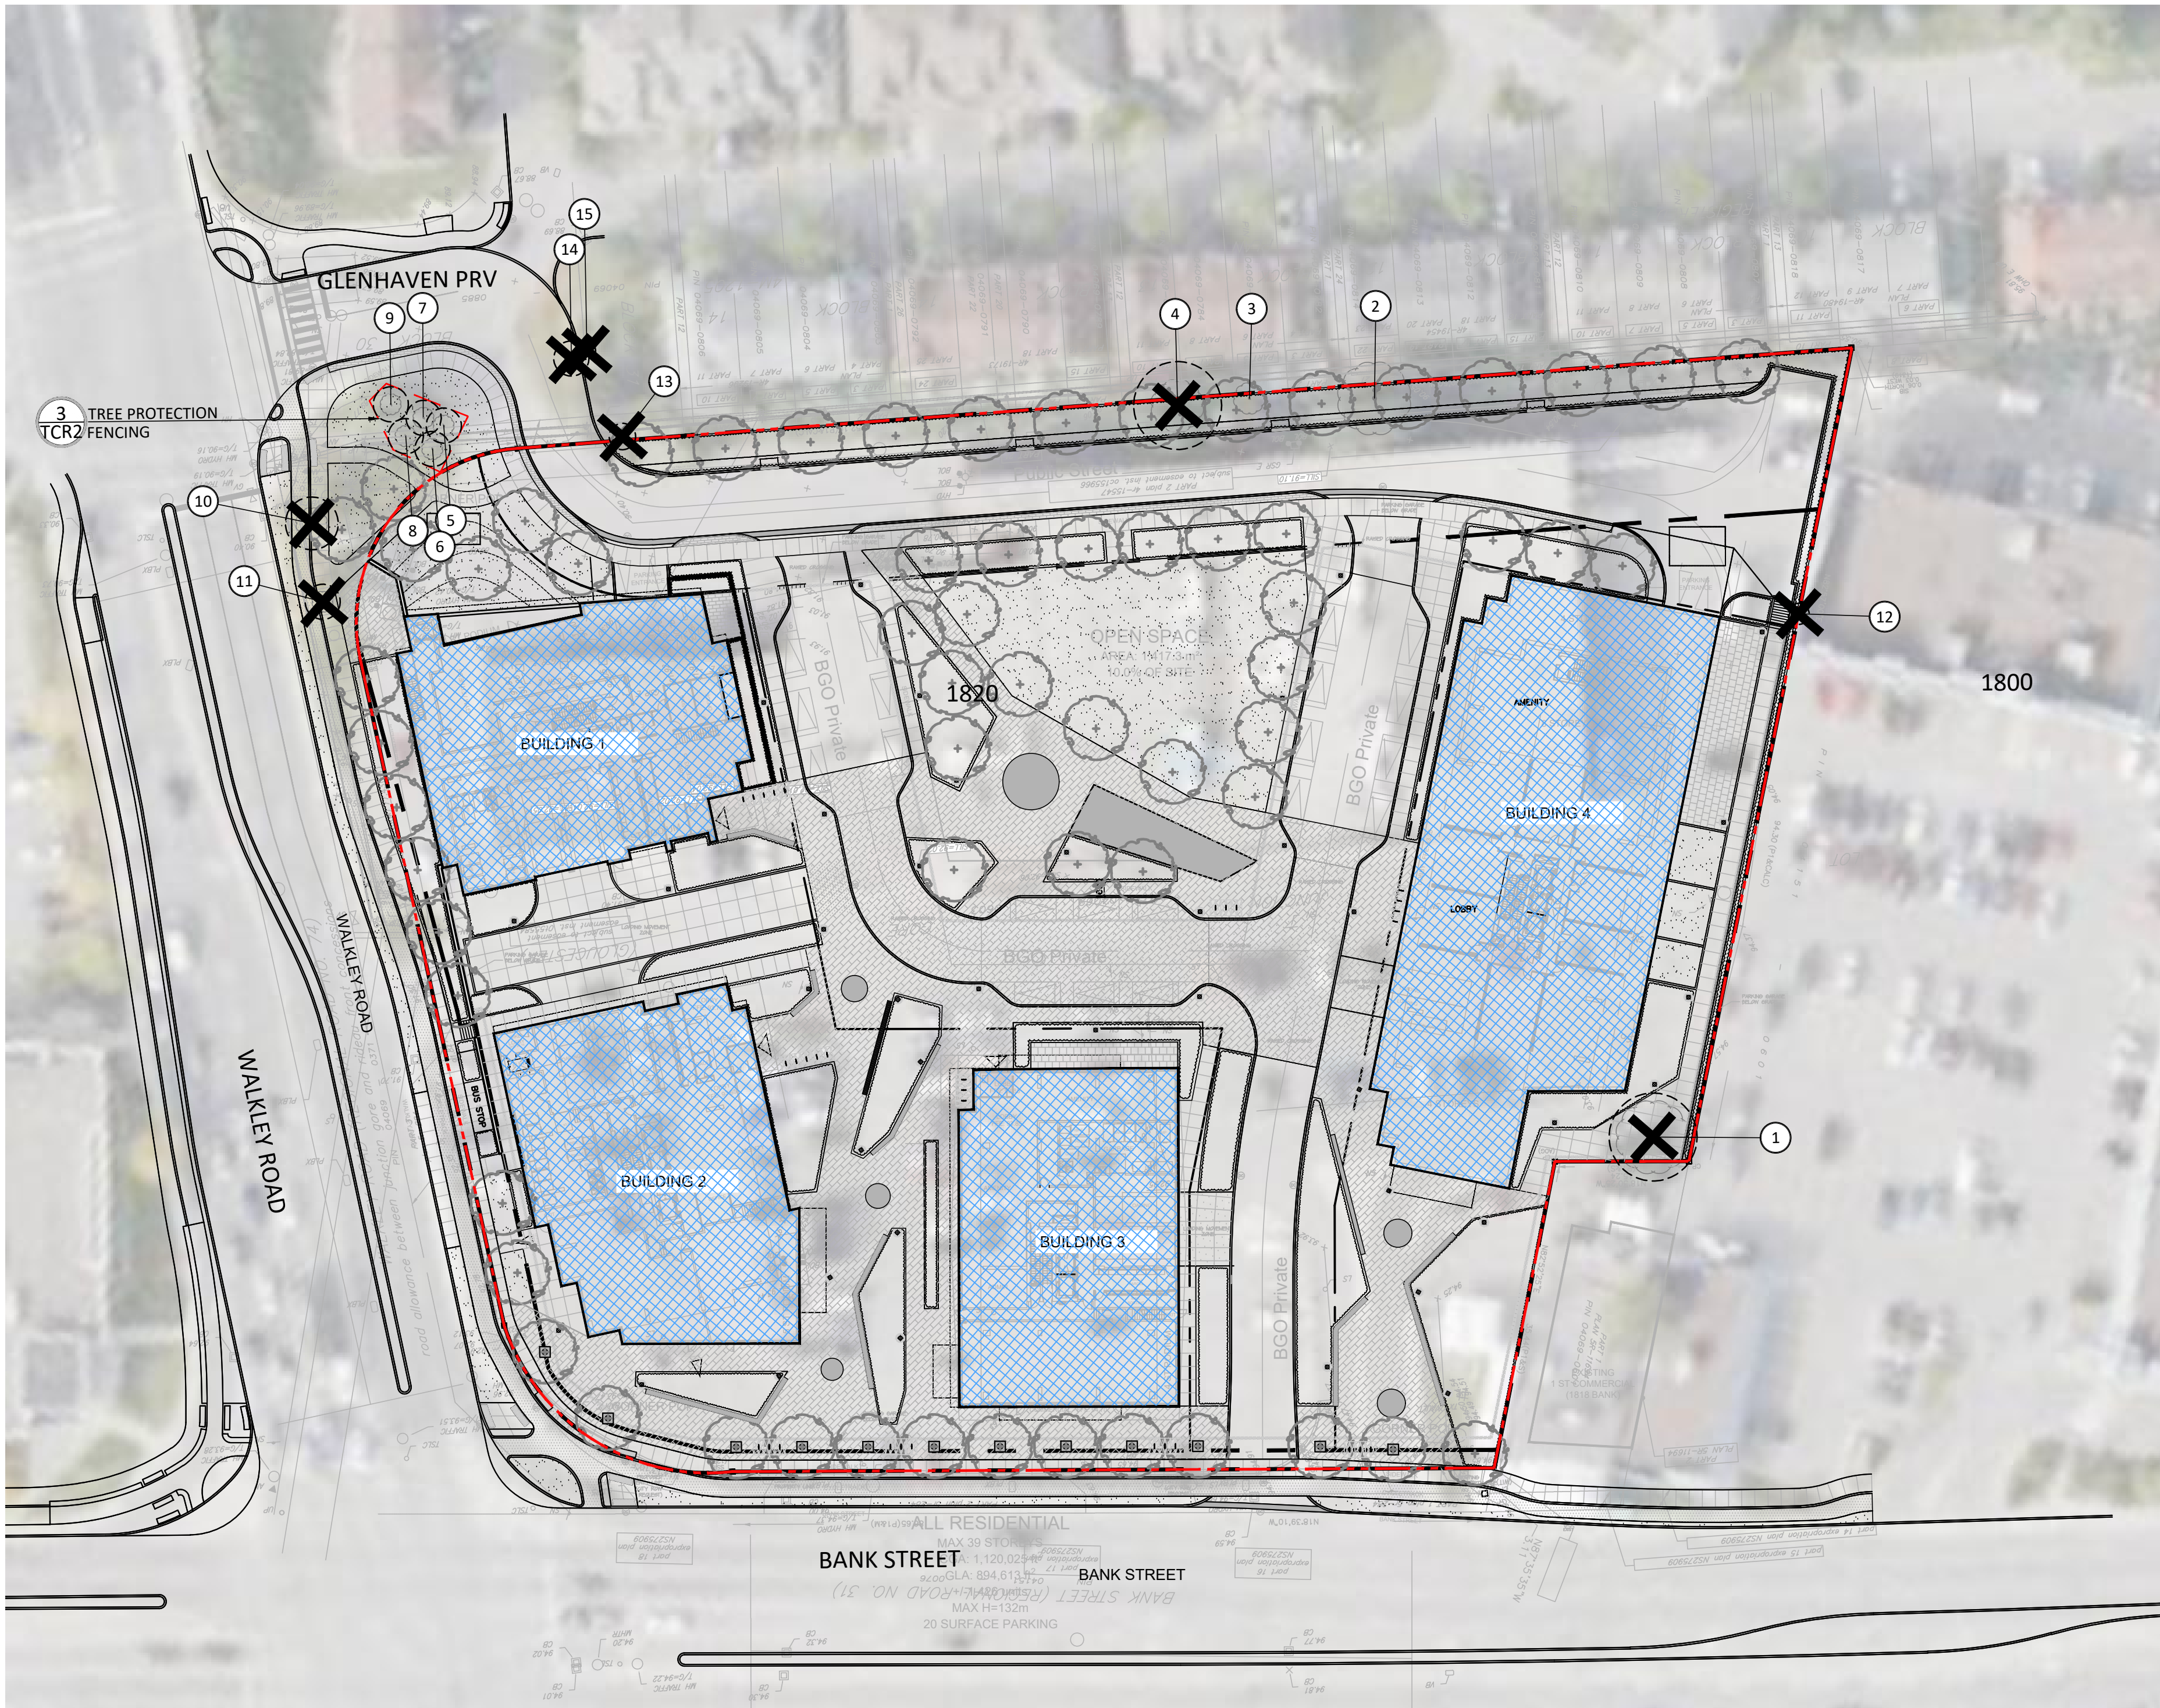
2 PROPOSED DEVELOPMENT

| Tree # | Botanical Name | Common Name | DBH (cm) | Ownership | | Condition | NOTES | To Be Preserved |
|---|---|---|---|---|---|---|---|---|
| 1 | Acer platanoides | Norway Maple | 50 | Private | 1822 Bank St | Moderate | Asymmetrical canopy, Dieback ~15% @ canopy, Broken limbs, Single stem, Bark rot @ limbs, Girdled roots | NO |
| 4 | Ulmus spp. | Elm | 50 | Private | 1822 Bank St | Moderate | Asymmetrical canopy, Dieback ~10% @ limbs, Pruned @ O.H., Poor branch union, Multi-stem w/ 3 | NO |
| 5 | Acer platanoides | Norway Maple | 20 | Private | ROW Glenhaven Prv | Moderate | Asymmetrical canopy, Dieback ~30% @ Canopy, Pruned limbs, Single stem, Bark rot @ cavities | YES |
| 6 | Acer platanoides | Norway Maple | 20 | Private | ROW Glenhaven Prv | Moderate | Asymmetrical canopy, Broken limbs, Single stem, Pruned branches, Heart rot @ limbs, Girdled trunk from staking | YES |
| 7 | Acer platanoides | Norway Maple | 20 | Private | ROW Glenhaven Prv | Moderate | Asymmetrical canopy, Dieback ~10% @ canopy, Single stem, Included bark, Girdled roots | YES |
| 8 | Acer platanoides | Norway Maple | 20 | Private | ROW Glenhaven Prv | Good | Asymmetrical canopy, Pruned branches @ O.H., Single stem | YES |
| 9 | Acer platanoides | Norway Maple | 20 | Private | ROW Glenhaven Prv | Good | Asymmetrical canopy, Dieback ~10% @ canopy, Single stem, Girdled roots | YES |
| 10 | Acer platanoides | Norway Maple | 30 | City | | Moderate | Symmetrical canopy, Dieback ~15% @ canopy, Single stem, Girdled roots | NO |
| 11 | Acer platanoides | Norway Maple | 20 | City | | Good | Symmetrical canopy, Single stem | NO |
| 12 | Ulmus spp. | Elm | 12 | Boundary | 1822 Bank St/1800 Bank St | Moderate | Asymmetrical canopy, Broken limbs, Single stem, (2) Leaders @ 2m above grade, Included bark, Grown into C.L. fence | NO |
| 13 | Celtis occidentalis | Hackberry | 15 | Private | ROW Glenhaven Prv | Moderate | Symmetrical canopy, Single stem, Grown btwn 2 privacy fences | NO |
| 14 | Acer platanoides 'Crimson King' | Norway Maple | 20 | Private | ROW Glenhaven Prv | Moderate | Symmetrical canopy, Single stem, (3) Leaders @ 2m above grade, Large crack on trunk | NO |
| 15 | Picea pungens var. 'Glauca' | Colorado Blue Spruce | 10 | Private | ROW Glenhaven Prv | Poor | Asymmetrical canopy, Dieback ~80% @ canopy, Single stem | NO |

- TREES IDENTIFIED FOR RETENTION ARE IN MODERATE TO GOOD CONDITION AND CAN BE REASONABLY PROTECTED FROM CONSTRUCTION ACTIVITIES, GIVEN ADEQUATE TREE PROTECTION MEASURES AS DESCRIBED ARE TAKEN.

- USE OF HYDRO VAC TECHNOLOGIES AND HAND PRUNING SHALL BE USED TO ENSURE A CLEAN INTERFACE FOR PROPER ROOT PRUNING BY A QUALIFIED ARBORIST (ISA CERTIFIED)

- A QUALIFIED ARBORIST (ISA CERTIFIED) OR OTHER TREE PROFESSIONAL AS APPROVED BY THE CITY OF OTTAWA MUST PRUNE ROOTS OR BRANCHES THAT EXTEND BEYOND PRESCRIBED TREE PROTECTION ZONE AS REQUIRED. ALL PRUNING OF TREE ROOTS AND BRANCHES MUST BE IN ACCORDANCE WITH GOOD ARBORICULTURAL STANDARDS.
