HERITAGE IMPACT ASSESSMENT & CONSERVATION PLAN*

168 -174 MURRAY STREET, OTTAWA

Owner: David Yoo
Address: 168 – 174 Murray Street, Ottawa, Ontario

Revised March 2025

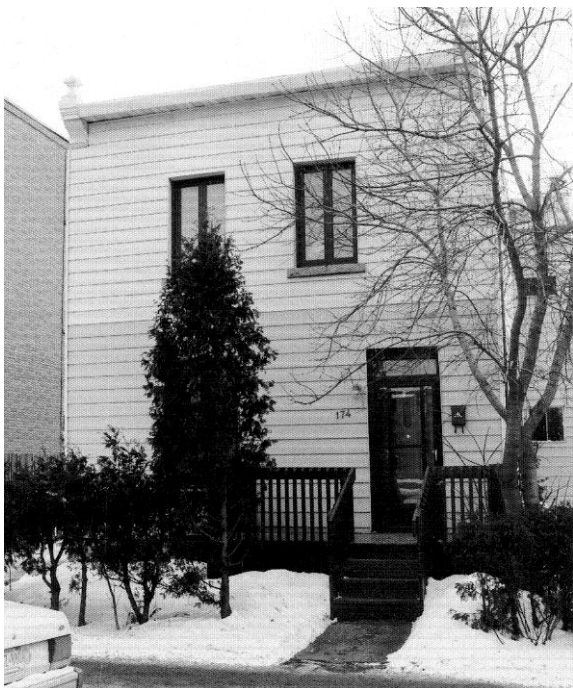
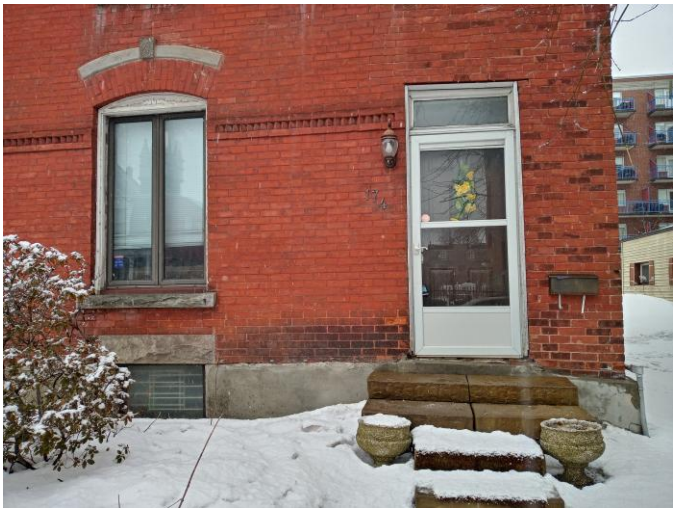
Figure 15 and 16: This collage of pictures documents the extensive alterations. Two views 1992 and 2022. 174 Murray (left) before the vinyl siding being removed and rehabilitated front. Note the different brick at the corner (both size and colour consistency) and the lack of corbelled banding and the transom treatment.

The house appears in a c.1949 photo, which highlights its attributes (Figure 14). The 1992 view of the building retains its form, with the exterior re-clad with a vinyl siding. The finials and a portion of the cornice detail are retained. The offset door is evident in the 1949 picture, but the distinctive hood has been covered or altered. In the 2022 view, the front door’s arched brickwork (voussoir), masonry hood and band of corbelled brickwork at the transom, were not incorporated into the replaced brick at the corner.

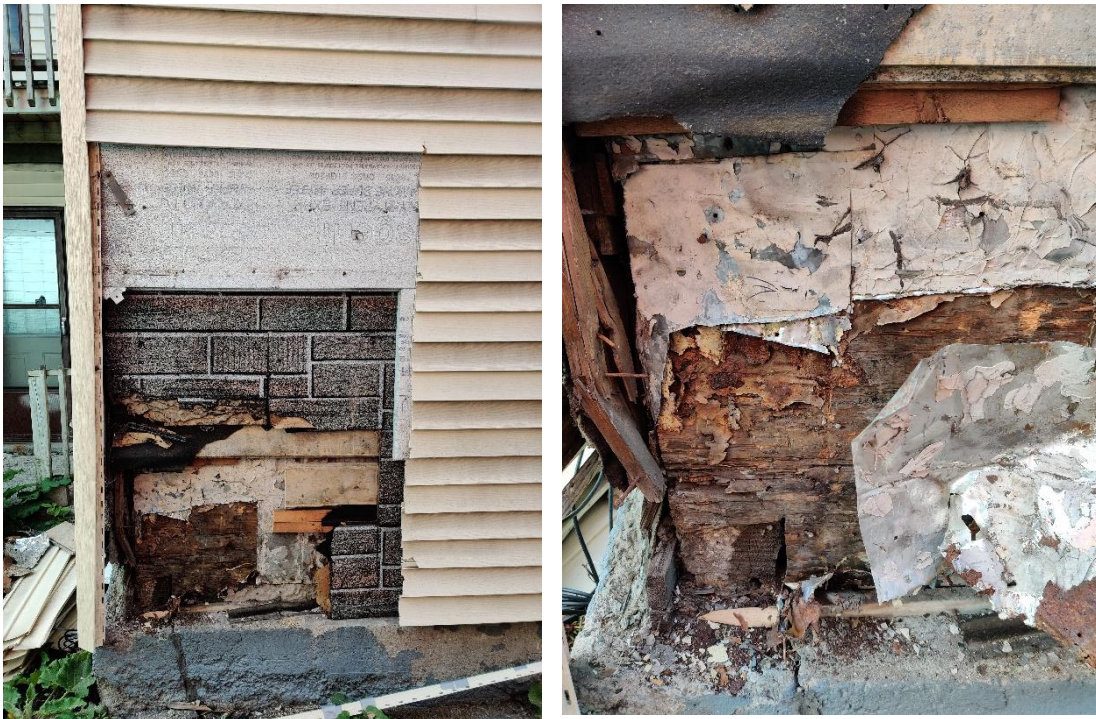
Figure 35: 1861 Census documents the McManus family owned a 66 x.99 lot at 168 Murray and were living in 1.5 storey log house. The Lowertown building inventory recorded that the building was constructed in 1876 based on Fire Insurance plans. The two views illustrate the multiple layers of finishes including squared timber, tin panels insulation, ridged insulation, and vinyl siding. Source David Yoo 2022.
