ADDENDUM #1: CONSERVATION PLAN

John Stewart Commonwealth
June 20, 2024

1.0 CONSERVATION PLAN FOR 168 & 174 MURRAY STREET

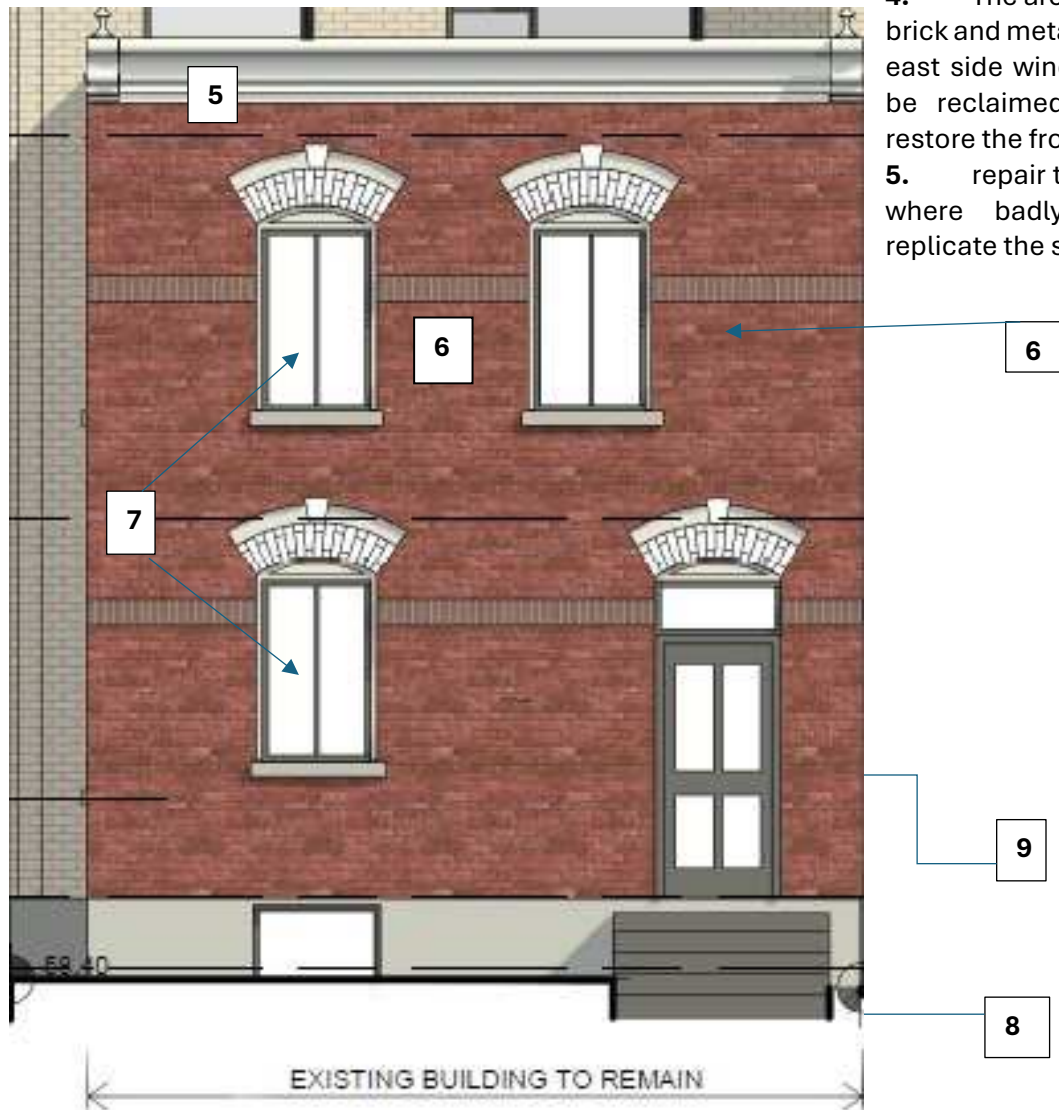
The main elements that will be addressed are on the exterior – the metal cornice, the brick work, repairs to the area on the second floor where it bulges out, the replacement of the brick around the front door including replacement of the transom and metal hood, stabilizing and realigning the foundation, replacing the front porch, and repairing windows. The additions on the rear of the building will be demolished to allow for the construction of a 4-storey addition. Potentially, the brick at the rear can be salvaged for reuse. The metal hood over the window on the west façade could be removed and used over the front door.

1. Undertake a structural assessment of the foundation, realign the foundation at the west corner, undertake jacking for levelling the floors and setting the building on a repaired foundation.
2. Engage a brick mason with expertise in conservation to assess the condition of the brick.
3. Undertake a program of removals followed by an assessment. As part of demolition of the rear additions, salvage brick as matching replacement for masonry at the front.

4. The arched segmented brick and metal hood from the east side window of 174 can be reclaimed and used to restore the front entry.

5. repair the cornice and, where badly deteriorated, replicate the section.

6. Dismantle the section of brick on the second floor where there is bulging and potential separation of brick from the backing wall. Repair and repoint façade as necessary.
7. Casement windows will be retained and painted.
8. Install a new stoop to provide access to the new front door
9. Undertake brick dismantling and replacing the salvaged decorative hood and segmented brick header over the front door, replace the brick between the door and the west corner and repoint as necessary.
