# TREE CONSERVATION REPORT

**168-174 Murray Street**

**Tree Conservation Report  
submitted as Partial  
Requirements for a Site Plan  
Control Application, March 30,  
2022**

**Dendron Forestry Services**

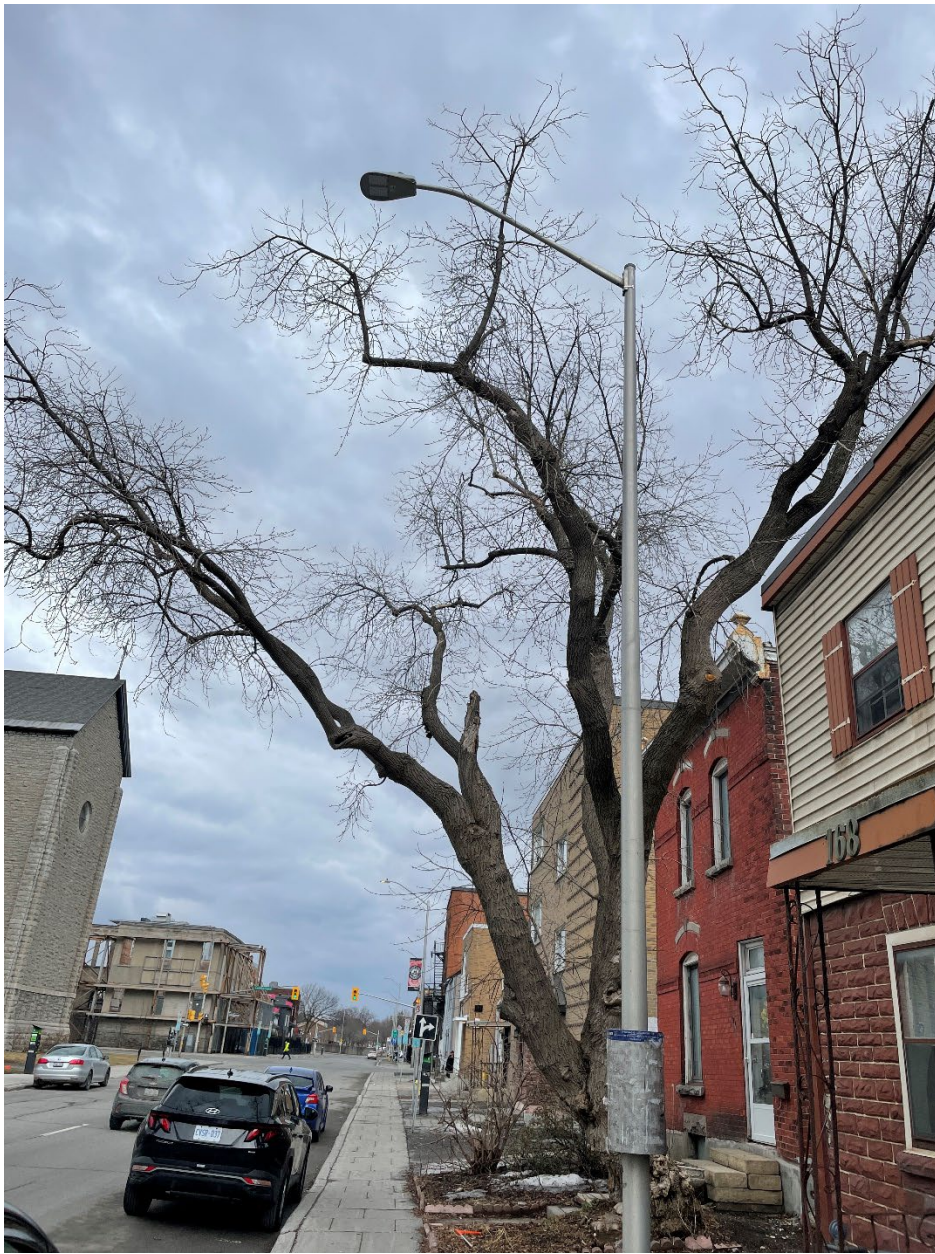
The two Manitoba maples at this site are both short lived species that are in the later stages of their life cycle and are in decline. Tree 1 is city owned and has likely been maintained by the city in the past. There is excellent coverage in Google Streetview since 2007 showing the decline of this tree based on the progression of crown dieback. Removal of this tree prior to any site works is recommended due to the risk of failure of branches combined with the close proximity of the existing residence that will undergo significant renovations.

Figure 1: Tree 1, Manitoba maple in poor health to be removed

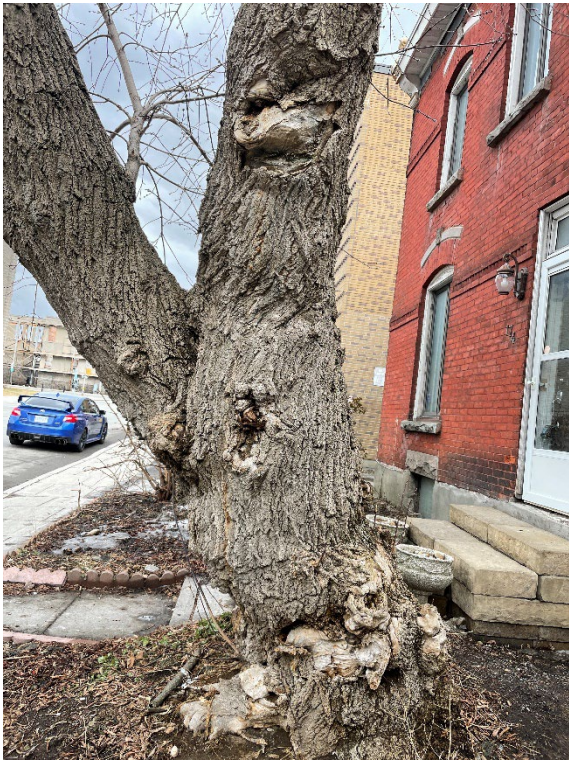
Figure 2: Close up of tree 1 on the west side

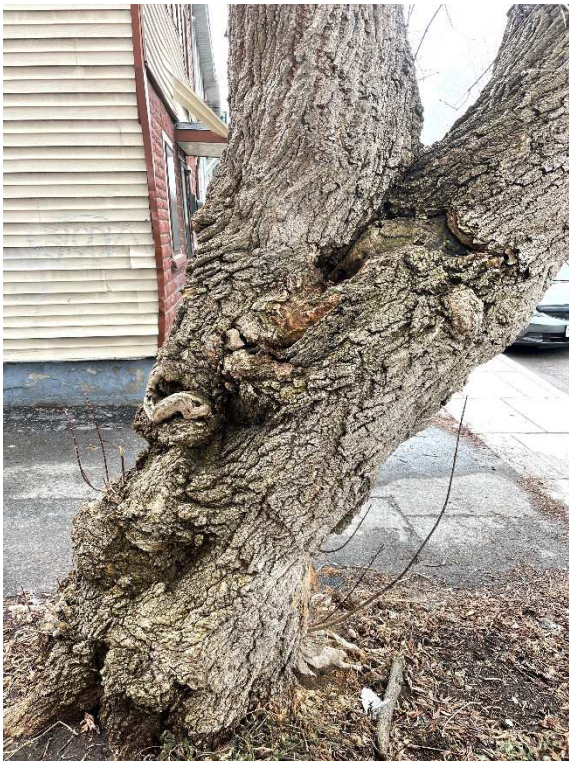
Figure 3: Close up on the east side of tree 1, showing decay and included bark in the main junction of the two stems

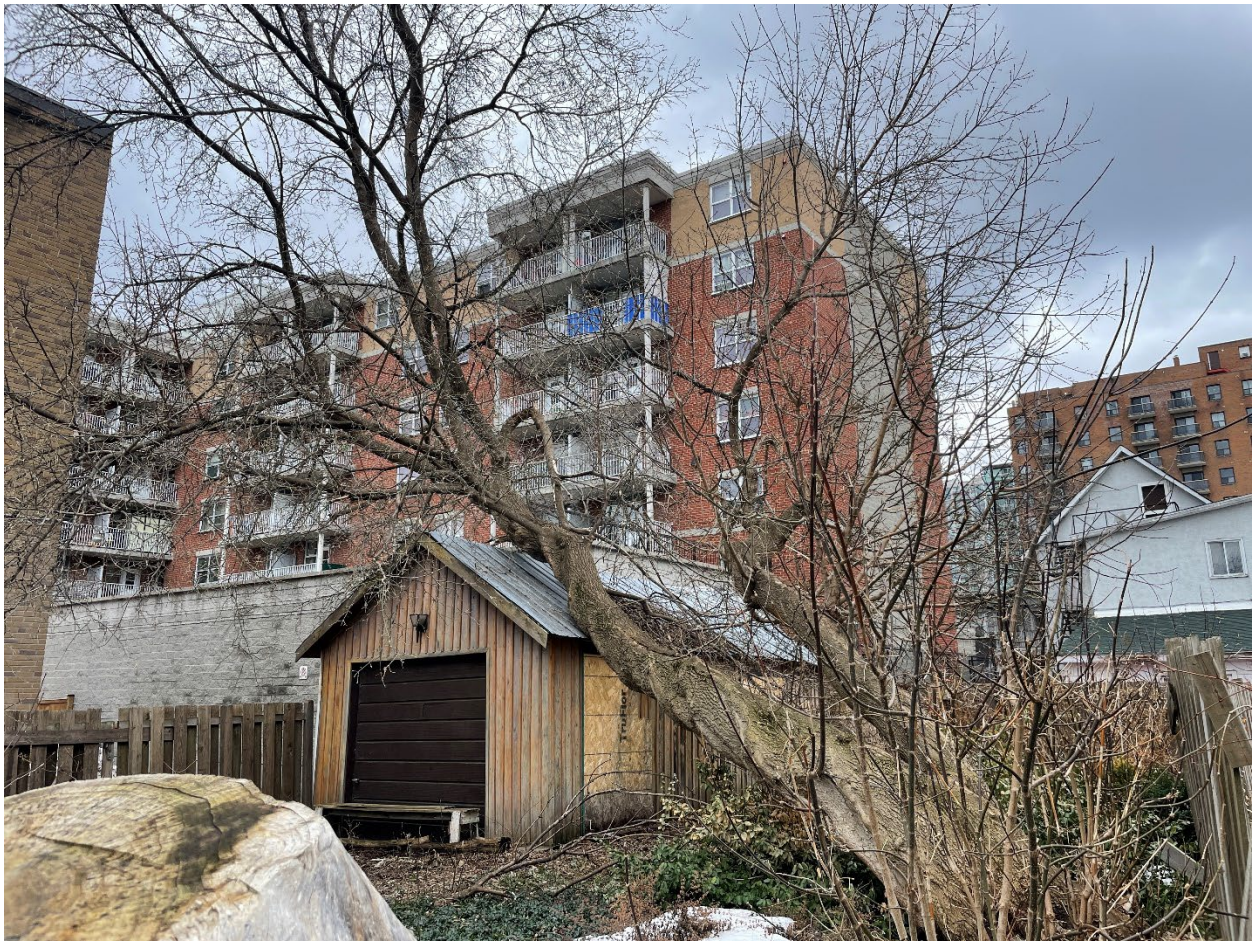
Tree 2 is a large, double-stemmed Manitoba maple in the rear yard that is leaning heavily over the existing garage. It is possible that this tree is relying on the garage for support, and it should be removed prior to the demolition of the garage.

Figure 4: Tree 2, Manitoba maple in rear yard growing at extreme angle on top of existing garage
