July 24, 2024

RE: TREE INFORMATION REPORT (FULL) FOR 388 RICHMOND ROAD, OTTAWA

This Tree Information Report (TIR) was prepared by IFS Associates Inc. (*IFS Inc.*) in support of a minor variance application for 388 Richmond Road in Ottawa. The need for this report is related to trees protected under the City of Ottawa's Tree Protection By-law (By-law No. 2020-340). The work proposed for this commercial property includes the removal and replacement of the existing building's facade.

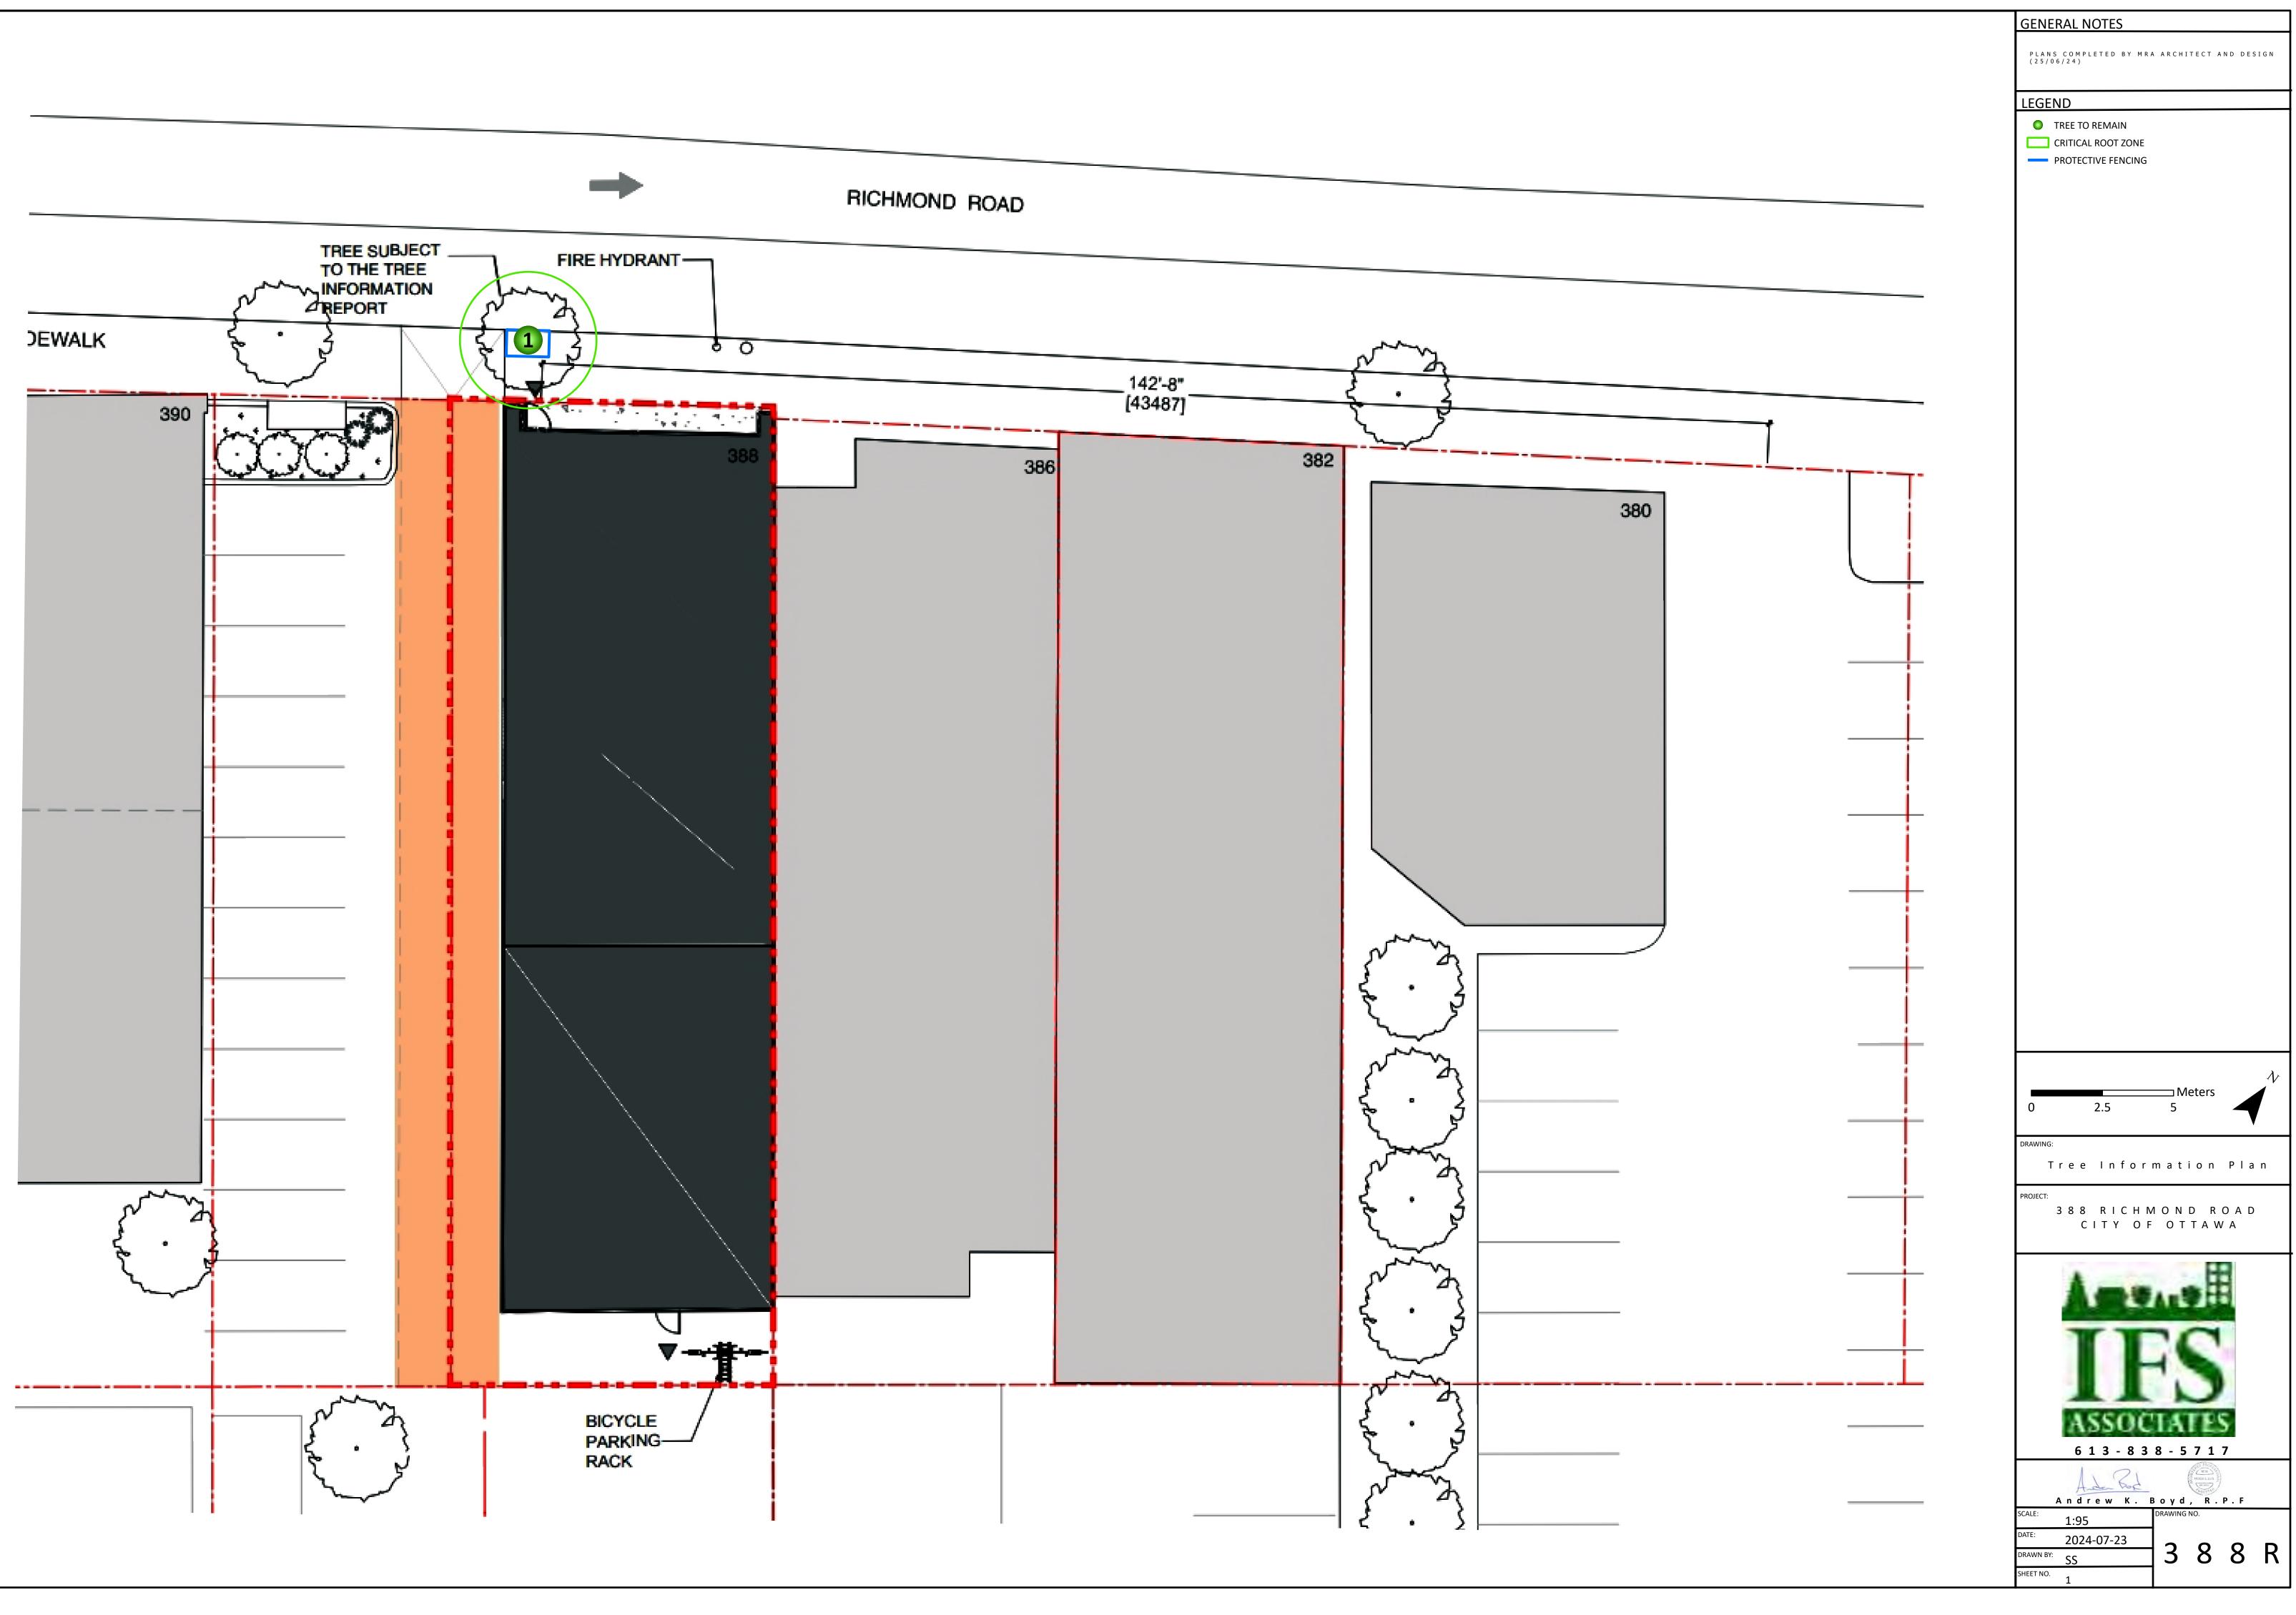
Table 1 on page 2 details the single tree found in proximity of the subject property. This tree is referenced by the number plotted on the tree information plan included on page 3 of this report. Picture 1 on page 6 shows the tree and its growing environment.

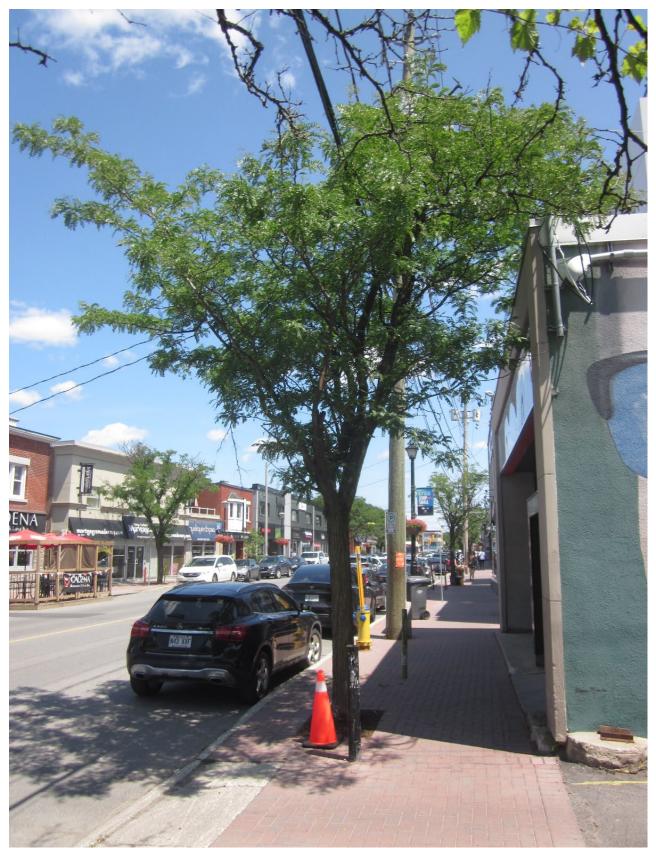
Tree	Tree species	Owner	DBH ²	CRZ ³	Distance to	Tree Condition, Age Class, Condition	Reason	Forester's
No.	/Tolerance to	ship	(cm)	(m)	excavation	Notes, Species Origin and Status (to be	for	Opinion re.
	Construction ¹				$(m)^4$	removed or preserved and protected)	removal	Removal
1	Honey-locust	City	24.3	2.4	NA	Fair; mature; tri-dominant leaders at 2.5m;	Not	NA
	(Gleditsia					stunted annual increment; scattered crown	applicable	
	triacanthos) /					dieback; abrasion damage and broken	– to be	
	Good					branches from passing trucks; overhead	preserved	
						utility and Hydro lines; very restricted		
						rooting zone; introduced species to		
						Eastern Ontario; to be preserved and		
						protected

Picture 1. Tree #1, city honey-locust to be preserved adjacent to 388 Richmond Road.

Protection measures intended to mitigate damage during construction will be applied to the single tree to be preserved. The following measures are the minimum required by the City of Ottawa to ensure tree survival during and following construction:

- 1. Erect a fence as close as possible to the critical root zone (CRZ) of trees (City of Ottawa tree protection barrier detail included on page 5).
- 2. Do not place any material or equipment within the CRZ of the tree.
- 3. Do not attach any signs, notices or posters to any tree.
- 4. Do not raise or lower the existing grade within the CRZ without approval.
- 5. Tunnel or bore when digging within the CRZ of a tree.
- 6. Do not damage the root system, trunk or branches of any tree.
- 7. Ensure that exhaust fumes from all equipment are NOT directed towards any tree's crown.
