September 25, 2024  
File: PE2709-LET.20

**Claridge Homes**  
505 Preston Street  
Ottawa, Ontario  
K1S 4N7

Subject: **Soil and Groundwater Remediation Program**  
**137-141 George Street and 110-116 York Street**  
**Ottawa, Ontario**

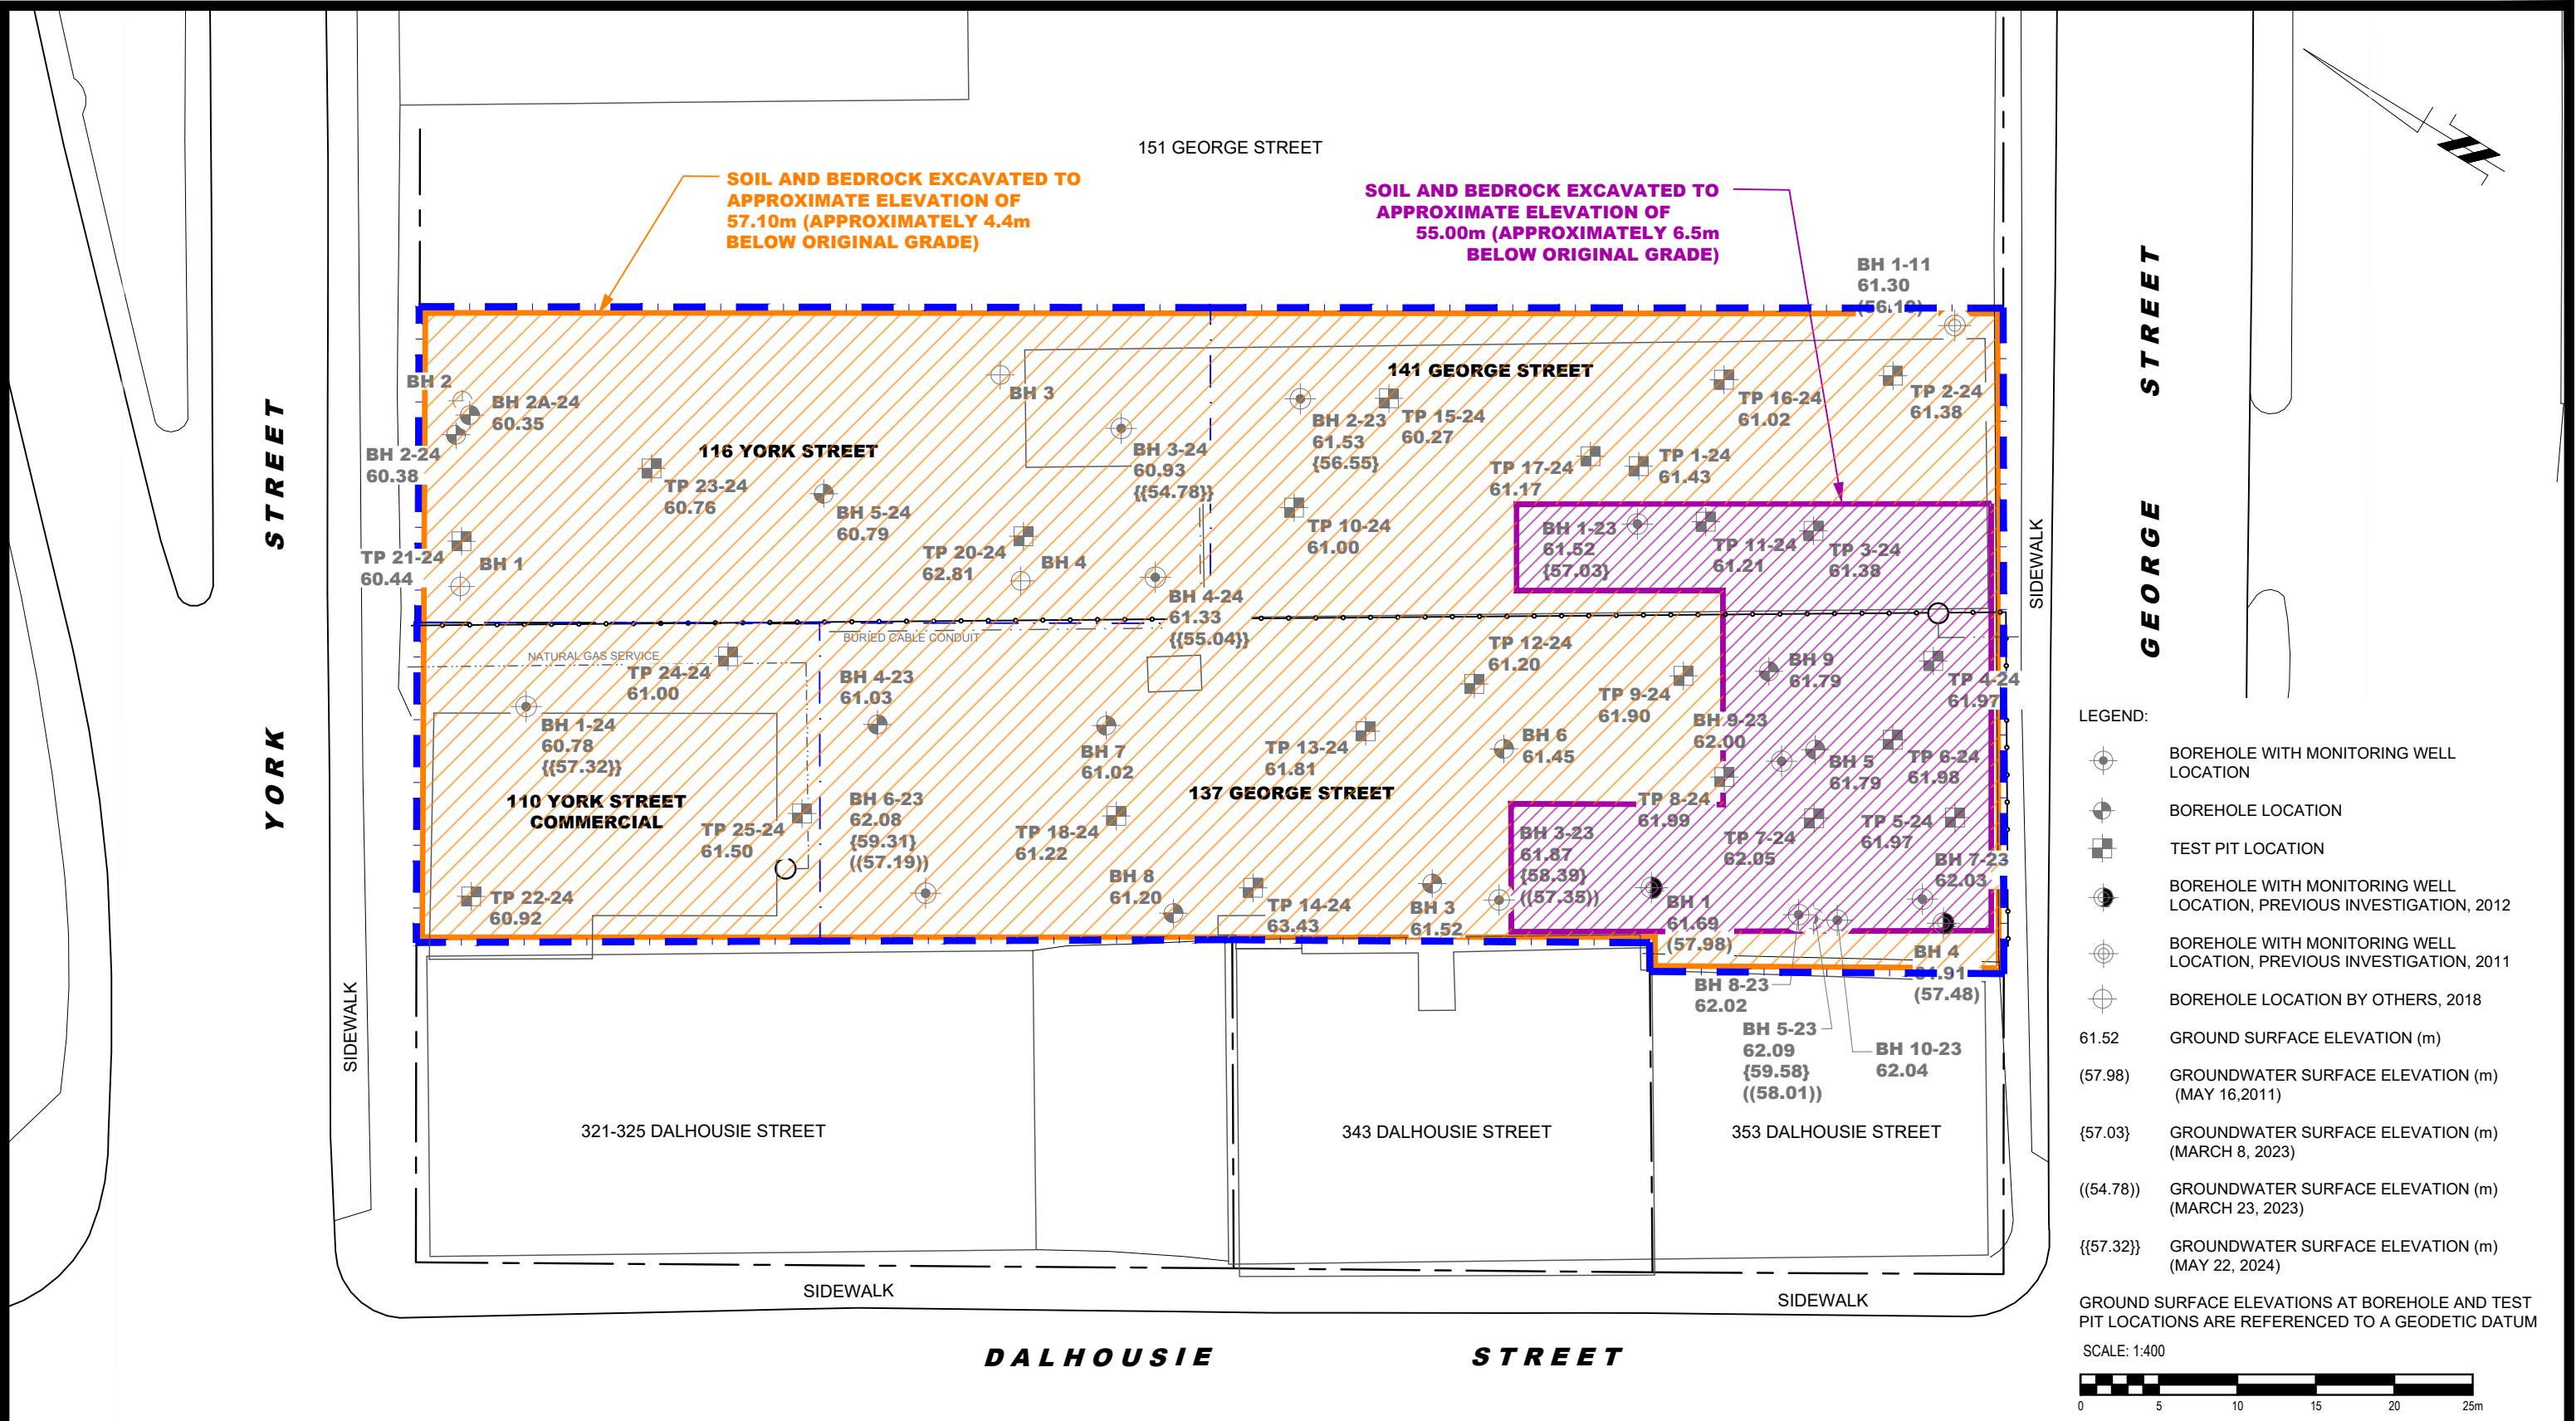
Based on the findings of the test pit programs in combination with grab sampling carried out in conjunction with the excavation program, full lateral and vertical delineation of contaminants exceeding the MECP Table 3 standards was achieved. Impacts extended laterally to the property boundaries. Impacts extended laterally to the bedrock on the southwestern portion of the site only; otherwise, a clean excavation base was achieved, and the soil was subsequently removed for off-site beneficial reuse.

The remediation excavation extended to the property boundaries in all directions. All soil was removed from the subject property. As such, no sidewall excavation or base samples were collected for analysis.

Bedrock on the southern portion of the site has been removed to approximately 55.00m asl (or approximately 6.5 m below original grade). The bedrock across the site will be removed to final excavation base of 50.40m asl (or approximately 11.10m below original grade).
