Report

Trail Road Battery Energy Storage System (BESS)  
Fluvial Geomorphology Assessment

H375035-0000-2B0-066-0001

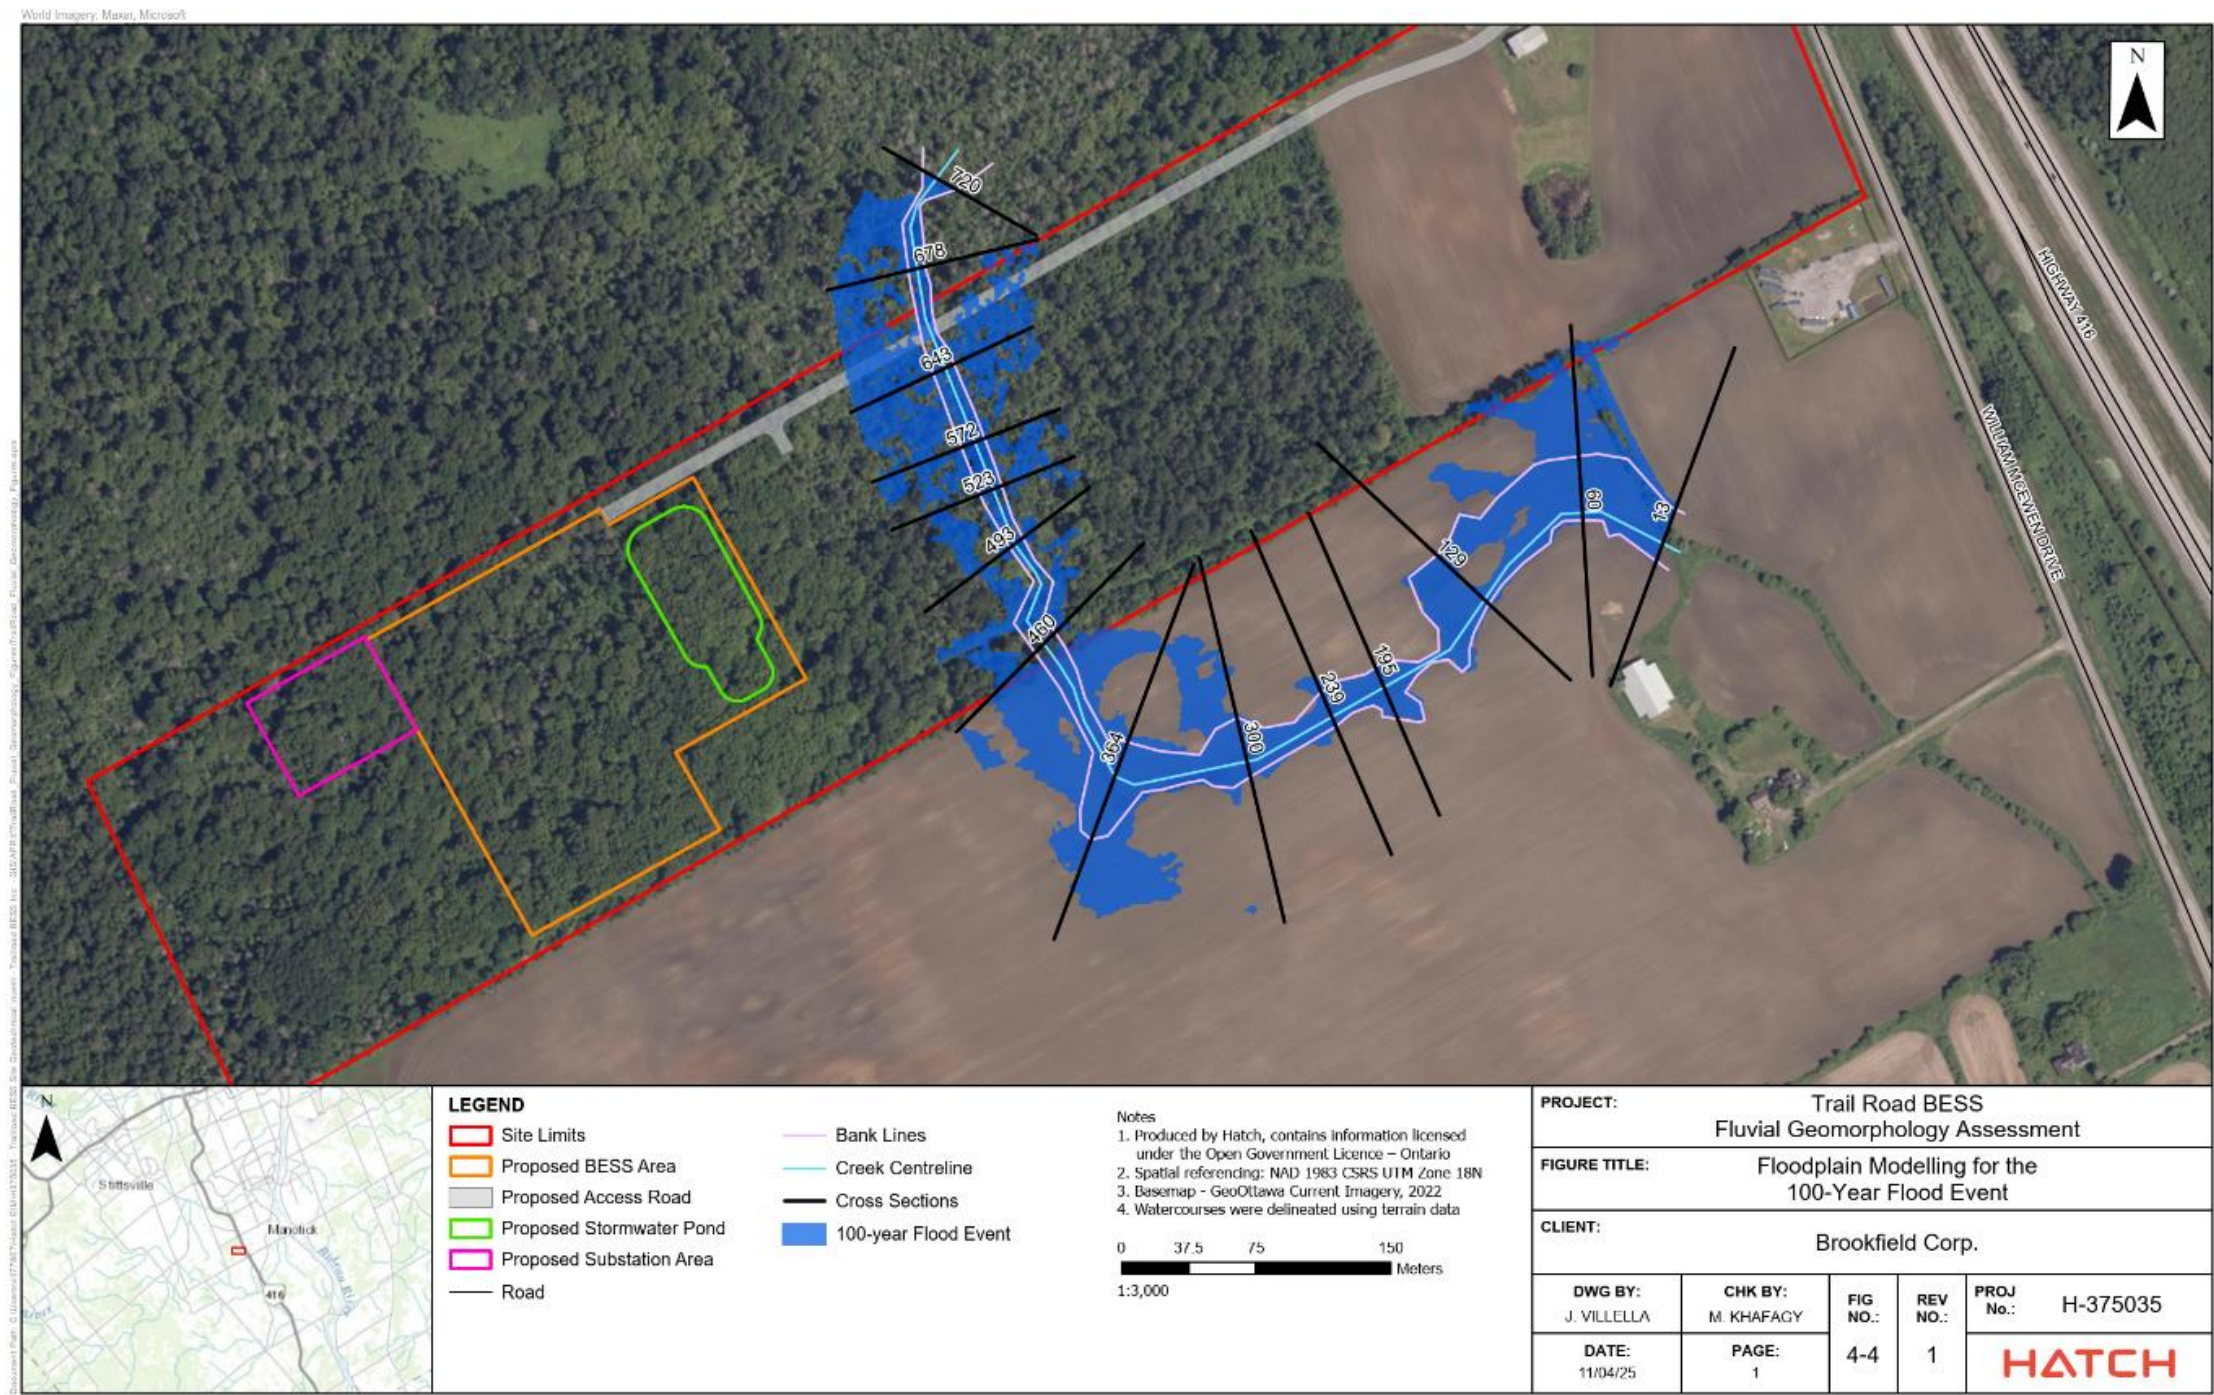
Figure 4-4: Results of Trail Road Creek Floodplain) Modelling for the 100-year Flood Event

- HEC-RAS 1D hydraulic modelling was performed to estimate floodplain extents under various design flow scenarios. The 100-year floodplain delineation supported the erosion hazard assessment and confirmed no encroachment into the proposed development footprint.

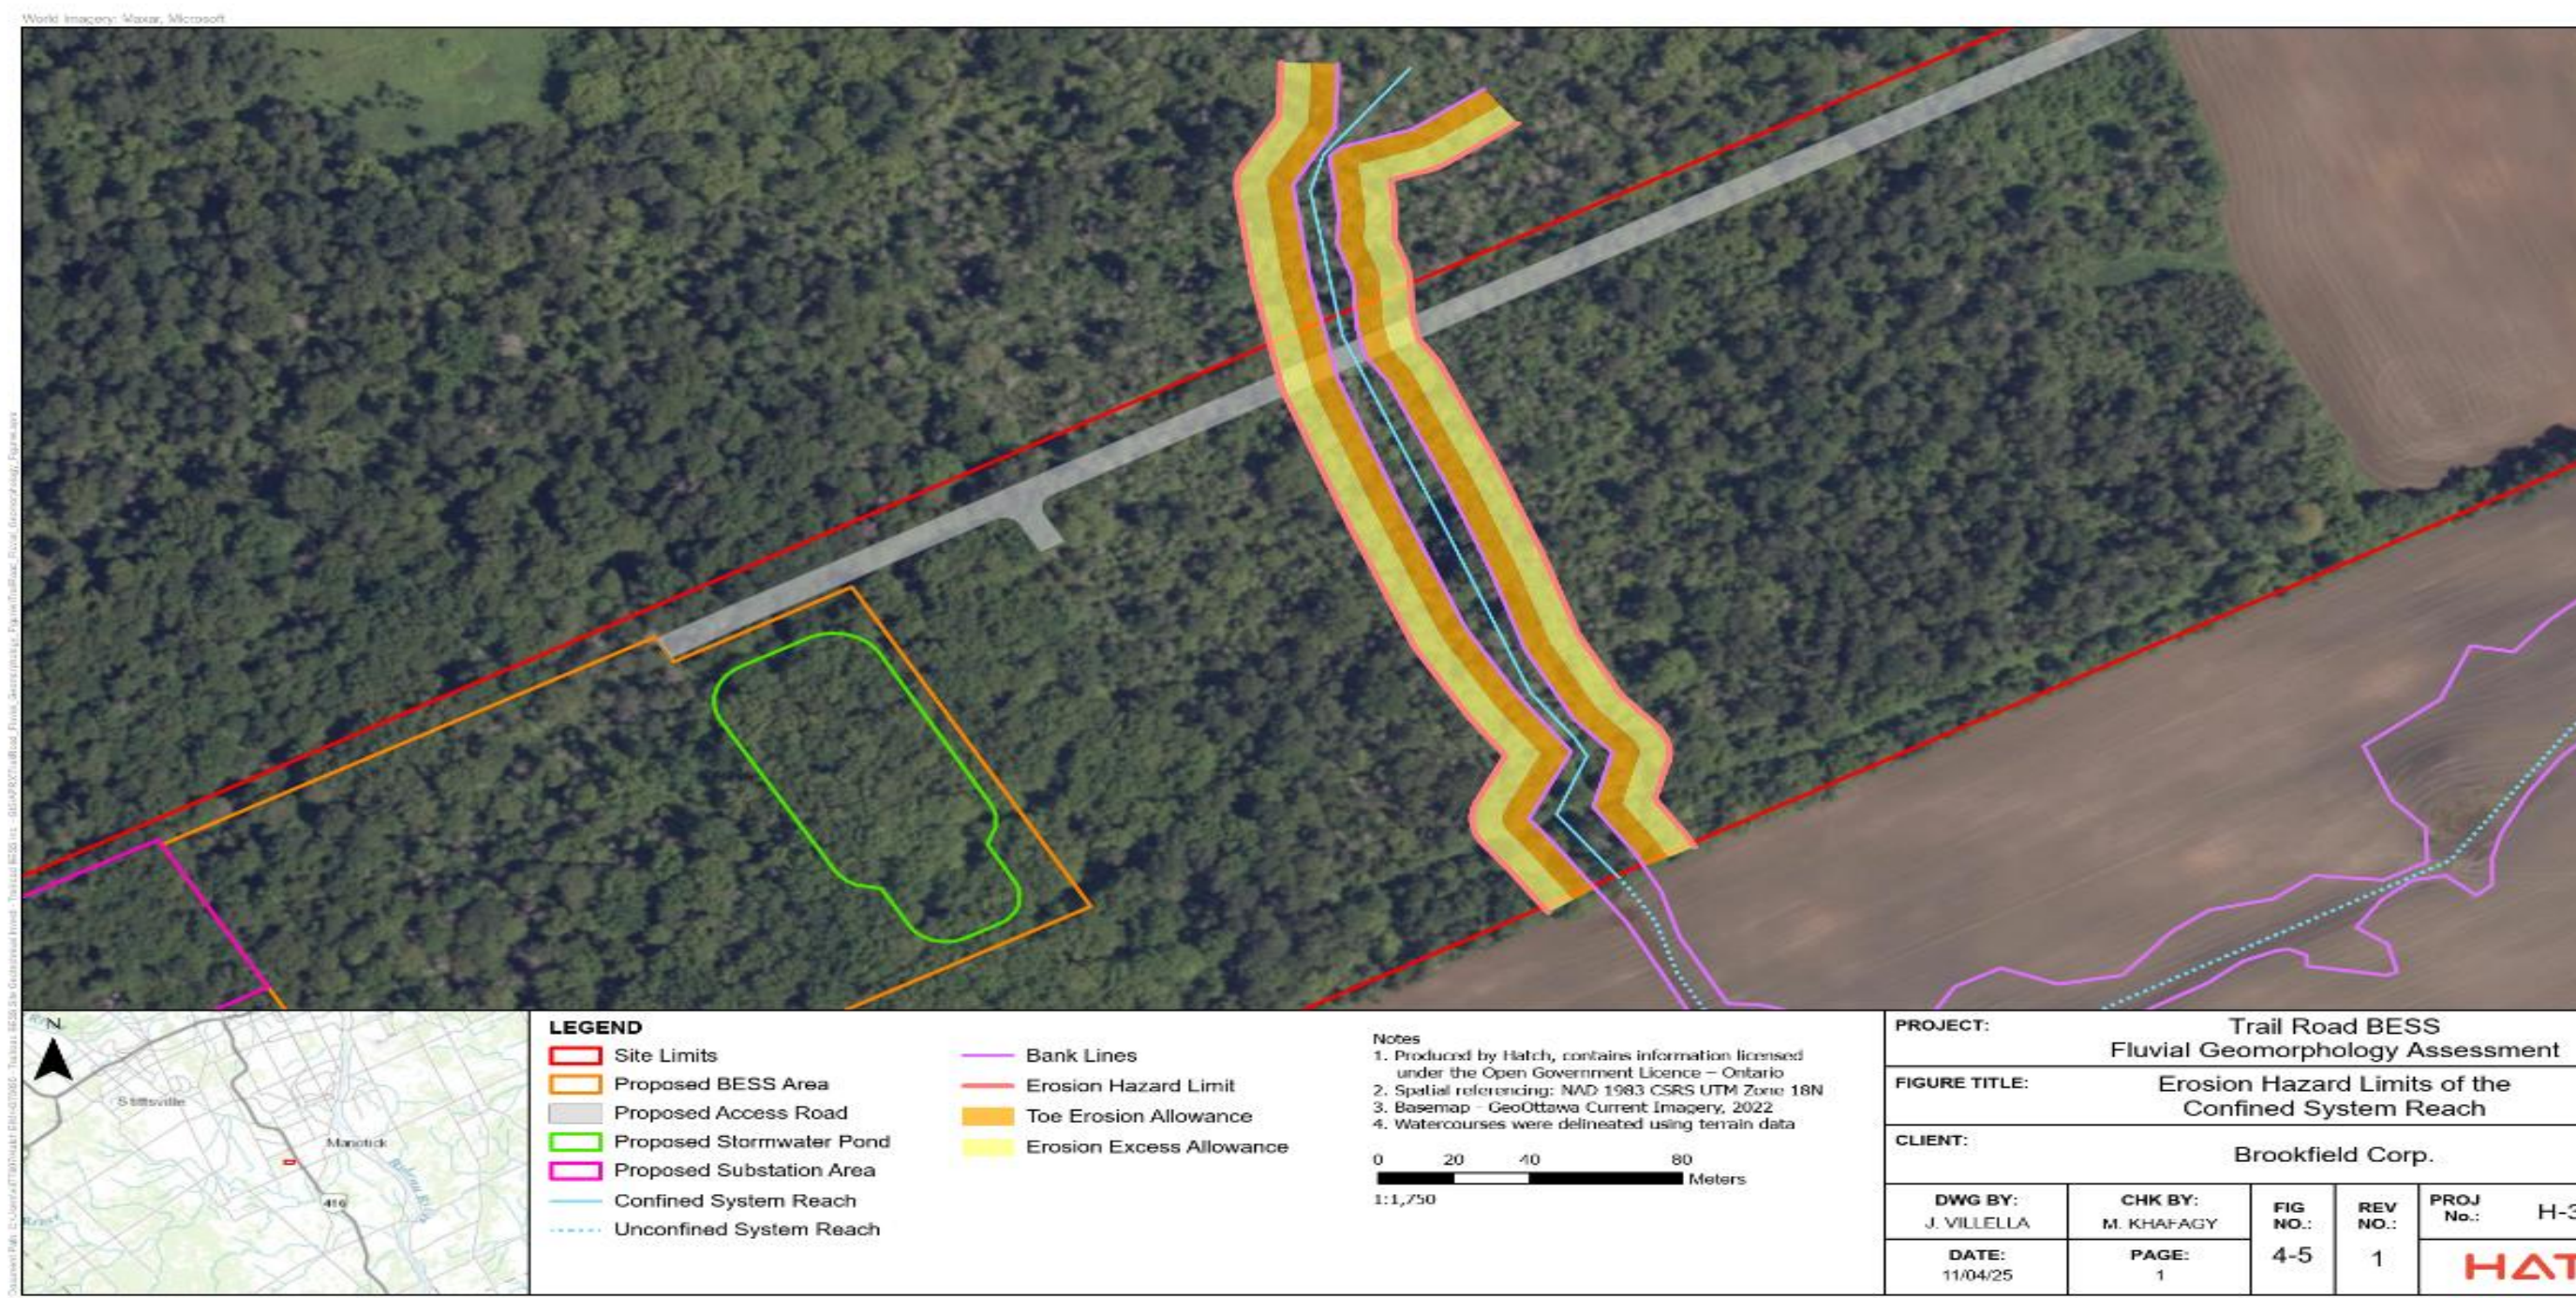
Figure 4-5: Erosion Hazard Limit of the Confined System Reach

Therefore, a stable slope allowance is not considered necessary for this reach of the watercourse. Erosion Access Allowance is a minimum access distance is typically applied at the top of the valley slope to allow space for maintenance or future stabilization works. Regarding the erosion access allowance, MNR Technical Guide (2002) guidelines note that for stiff/hard cohesive soil (clays, clay silt) and coarse granular (gravels) tills, a 5 to 8 m erosion access is to be applied. Given the evidence of erosion along the Creek, erosion access allowance of 8 m is recommended.

The proposed development area is located entirely outside the delineated erosion hazard limit associated with the confined system reach of the Creek. As shown in Figure 4-5, there is no overlap between the development footprint and the defined erosion hazard components, including the toe erosion allowance and erosion access allowance. Some considerations should be applied for the proposed service road crossing the Creek and discussed in Section 4.6. This confirms that the development, as currently planned, does not encroach upon areas identified as geomorphologically sensitive or at risk of fluvial erosion.

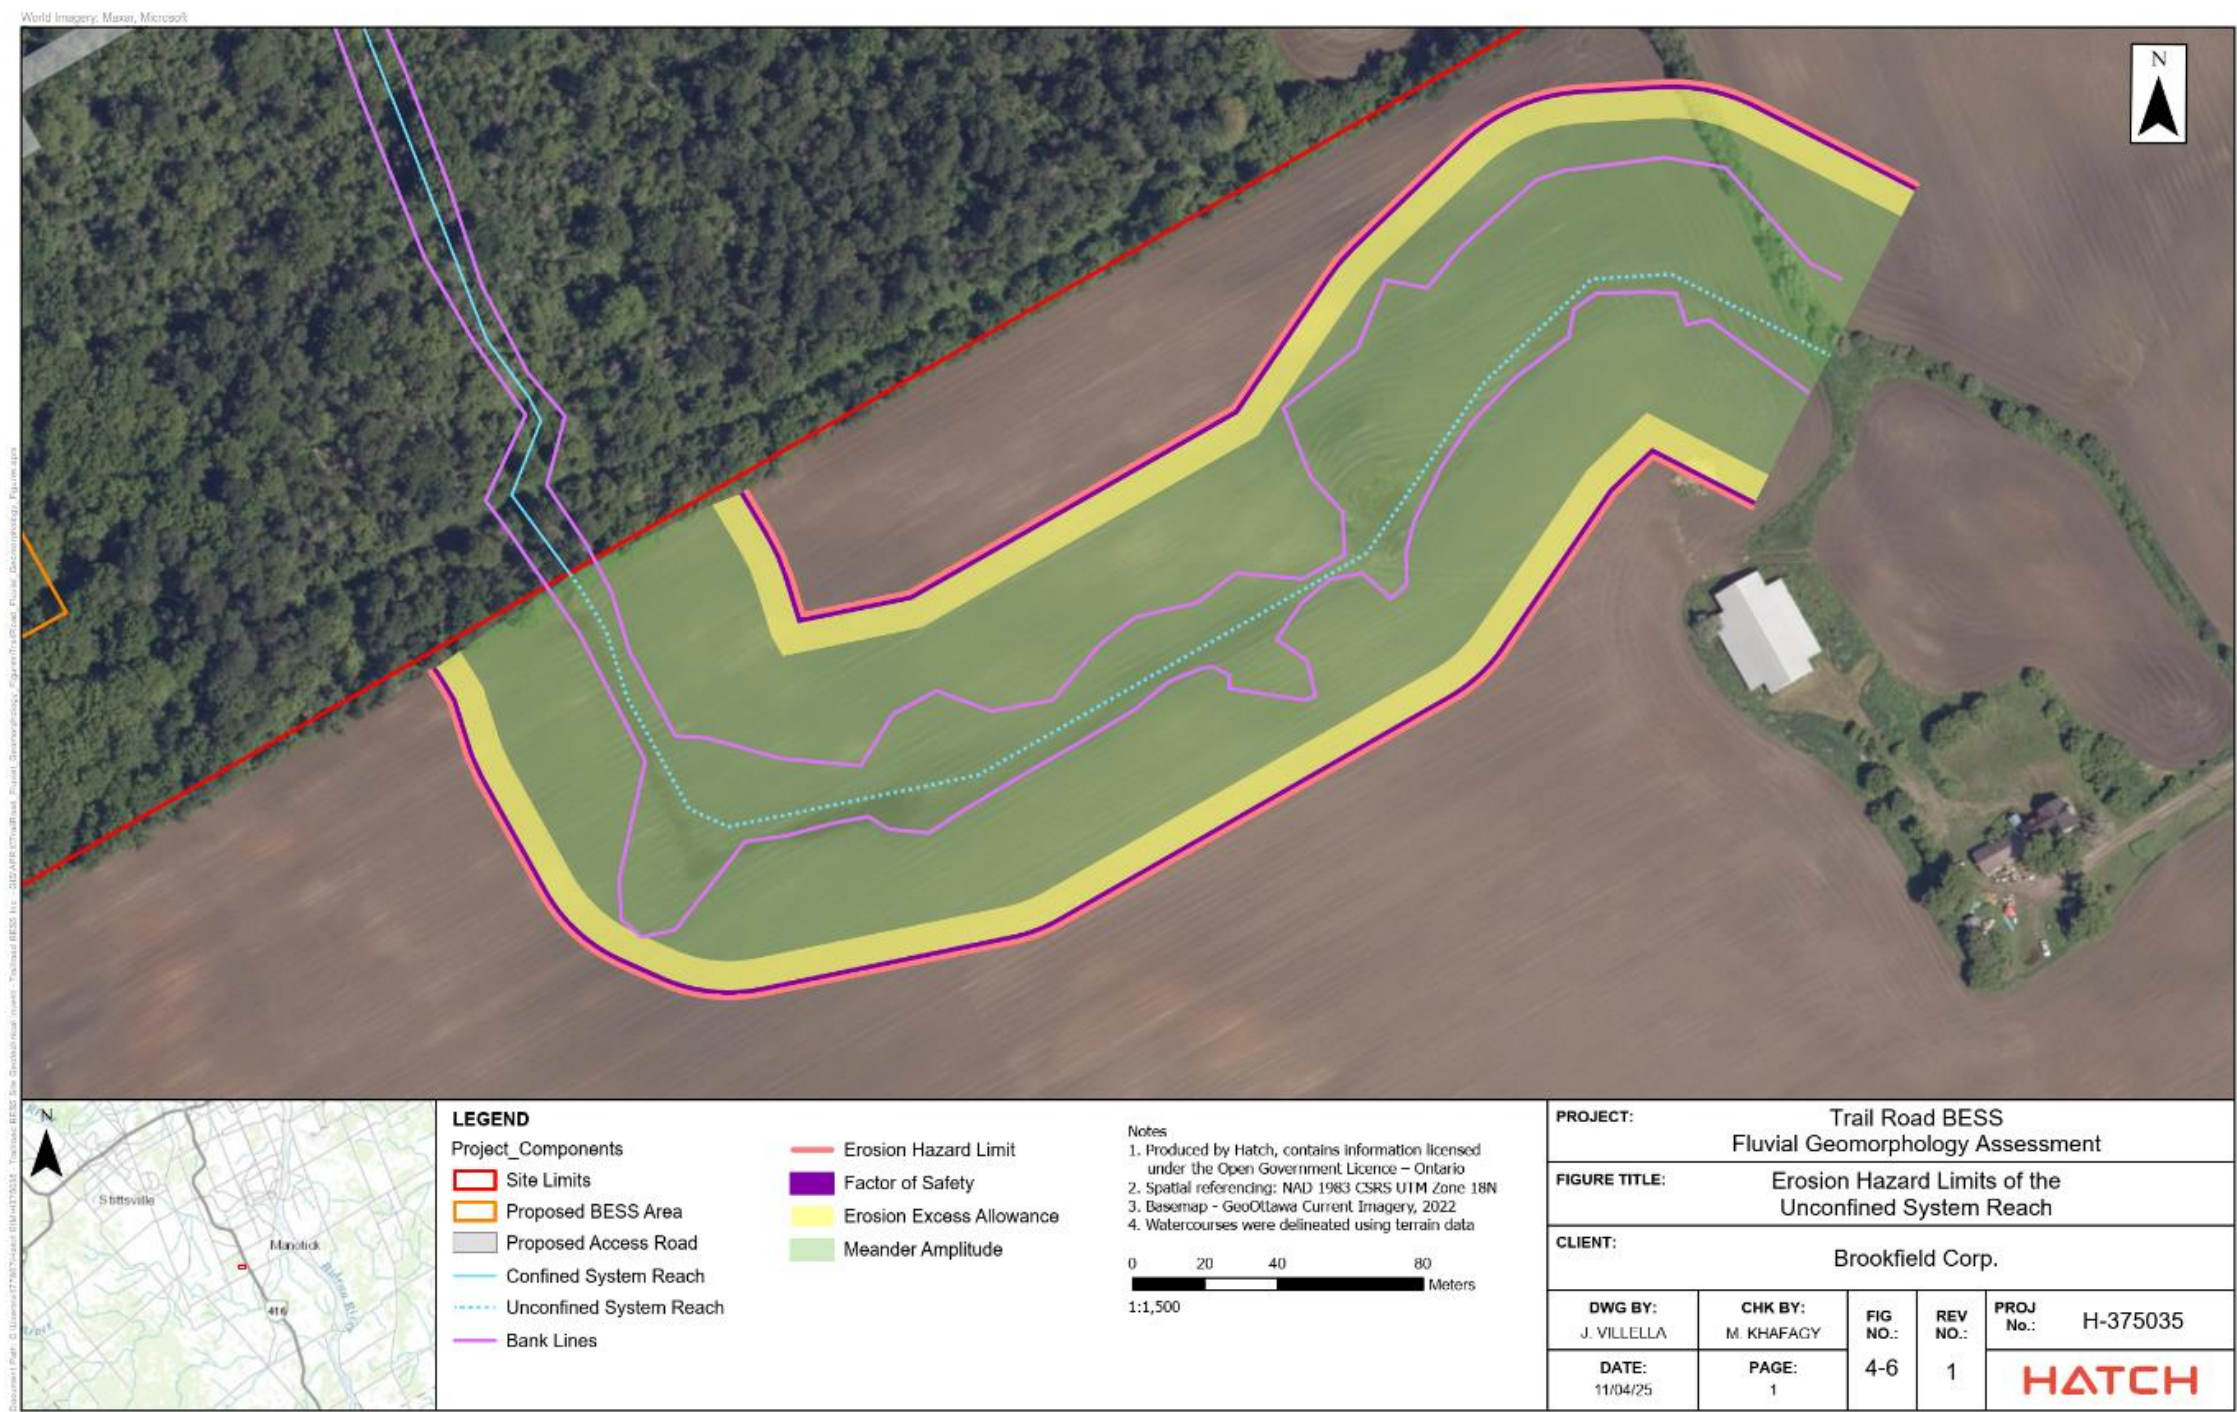
Figure 4-6: Erosion Hazard Limit of the Unconfined System Reach

The downstream reach of the Creek transitions into an unconfined system. In such systems, the erosion hazard is better assessed using a meander belt width approach, which reflects the maximum fixed lateral extent of historical and potential future channel migration. As per MNR Technical Guide (2002), the meander belt width is defined as the summation of meander amplitude and erosion access allowance. In this case, the historical aerial photograph analysis confirms lateral channel migration and expansion of the channel and adjacent wetland features over time. An erosion access allowance of 8 m is recommended for the unconfined system reach. Figure 4-6 shows the erosion hazard limit for both reaches of the Creek (Unconfined System) including the Meander belt Width and erosion access allowance.

An appropriate safety factor can be applied to the Erosion Hazard limit as per guideline recommendations. A 2 m safety factor has been applied to both reaches of the creek (the confined and unconfined systems).

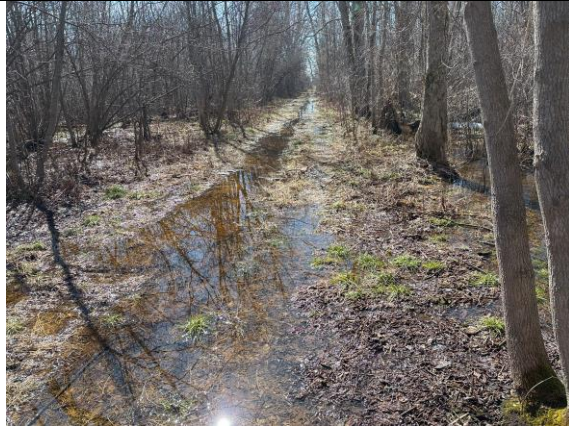
At the north boundary of the Project site, along the property line shared with the adjacent parcel, stagnant water was observed accumulating in a depressed corridor perpendicular to the main Creek alignment as shown in Photo 2 (Appendix B) from location S1. The presence of standing water outside the defined channel zone may also suggest the existence of secondary flow paths or backwater effects during wet periods, although no defined channel is visible in this area.

**Photo 2:** View looking northeast at the north site boundary (perpendicular to the creek), showing stagnant water on April 7, 2025.

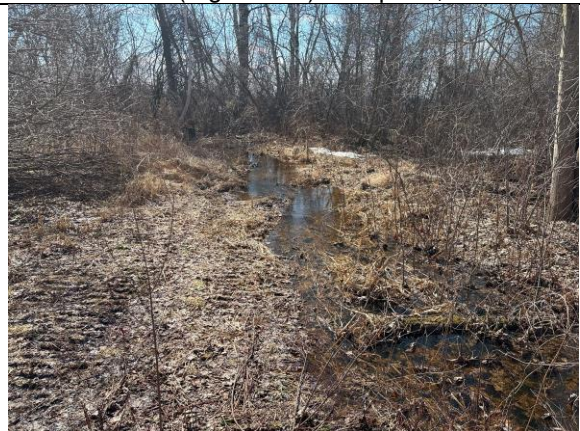
In several locations, including the area shown at location S8 (Photo 16 in Appendix B), evidence of localized channel adjustment and planform variability was observed. The Creek exhibits minor sinuosity, with lateral deflections of the low-flow channel that suggest active, albeit limited, fluvial processes. These deviations in flow alignment are likely the result of small-scale bank erosion and scour occurring along the outer margins of emerging meander features. While the degree of meandering is minimal due to the confined nature of the corridor and limited stream power, these features may represent the early development of a meander belt within the system.

**Photo 16:** View looking southeast (downstream) at location S8 (Figure 3-1) (minor sinuosity) on April 7, 2025.

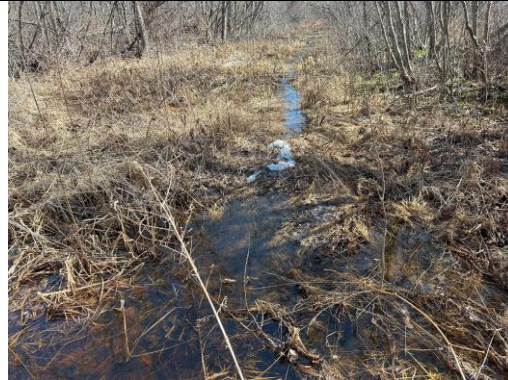
**Photo 20:** View looking east at the south site boundary from location S9, showing the head of a secondary reach of the creek that initiates on-site and flows eastward on April 7, 2025.
