File: PE5304-LET.01

Subject: Phase I - Environmental Site Assessment Update Noise and Vibration Studies

560 Hazeldean Road

Further to your request and authorization, Paterson Group (Paterson) carried out a Phase I – Environmental Site Assessment (Phase I ESA) Update for the aforementioned site (Phase I Property). This report updates a previous Phase I ESA, completed by Paterson in May 2021.

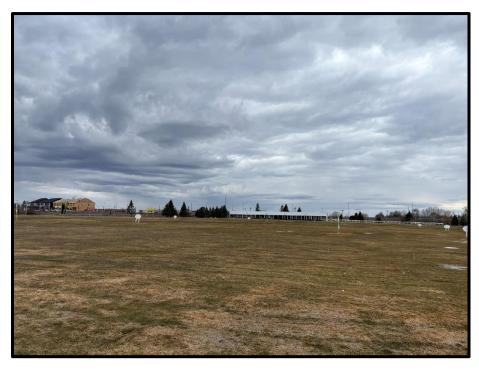
Photograph 1: View of the southeastern portion of the Phase I Property, facing northwest.

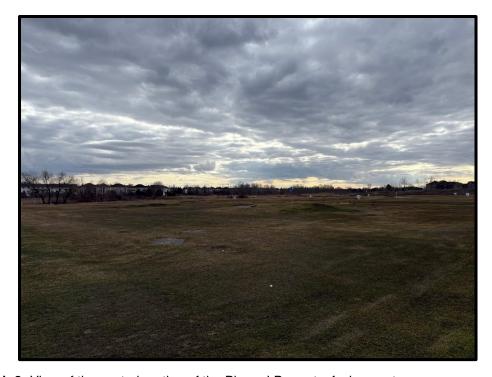
Photograph 2: View of the central portion of the Phase I Property, facing east.

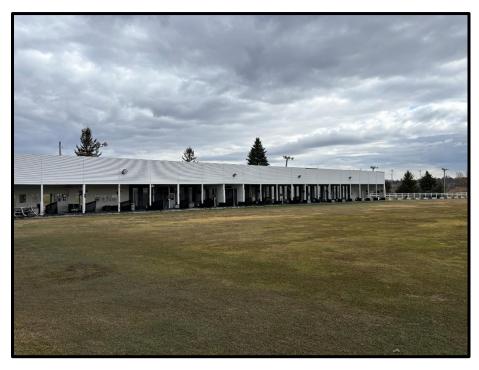
**Photograph 3:** View of the gold driving range pro shop building, facing north.

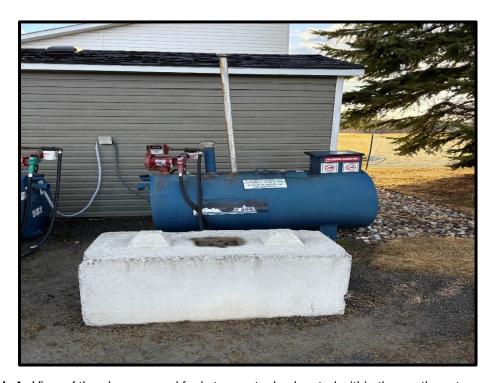
APEC #1 – The presence of two (2) aboveground fuel storage tanks, located in the northwestern portion of the Phase I Property, adjacent to the south side of the subject building.

At the time of the site inspection, two aboveground fuel storage tanks were identified adjacent to the south side of the subject building. The tanks were each noted to be constructed and vacuum sealed with double-steel walls and contain a capacity for 1,360 litres of gasoline and coloured diesel fuel. The tanks were observed to be in good condition, with no signs of fuel leakage or corrosion visible on the exterior shell or underlying ground surface. In addition, the pressure gauges on the tanks were noted to display negative pressures, indicating that the interior vacuum seals were intact. Due to the potential for soil and/or groundwater impacts resulting from fuel leaks and/or spillages, these fuel tanks are considered to represent an APEC on the Phase I Property.

**Photograph 4:** View of the aboveground fuel storage tanks, located within the southwestern portion of the Phase I Property, adjacent to the south side of the golf driving range pro shop building.
