**March 2018**

# **Preliminary Geotechnical Assessment Proposed Development Hunt Club Road and Riverside Drive Ottawa, Ontario**

**Submitted to:**  
Taggart Realty Management  
225 Metcalfe Street, Suite 708  
Ottawa, Ontario  
K2P 1P9

**Report Number:** 1670692-1000

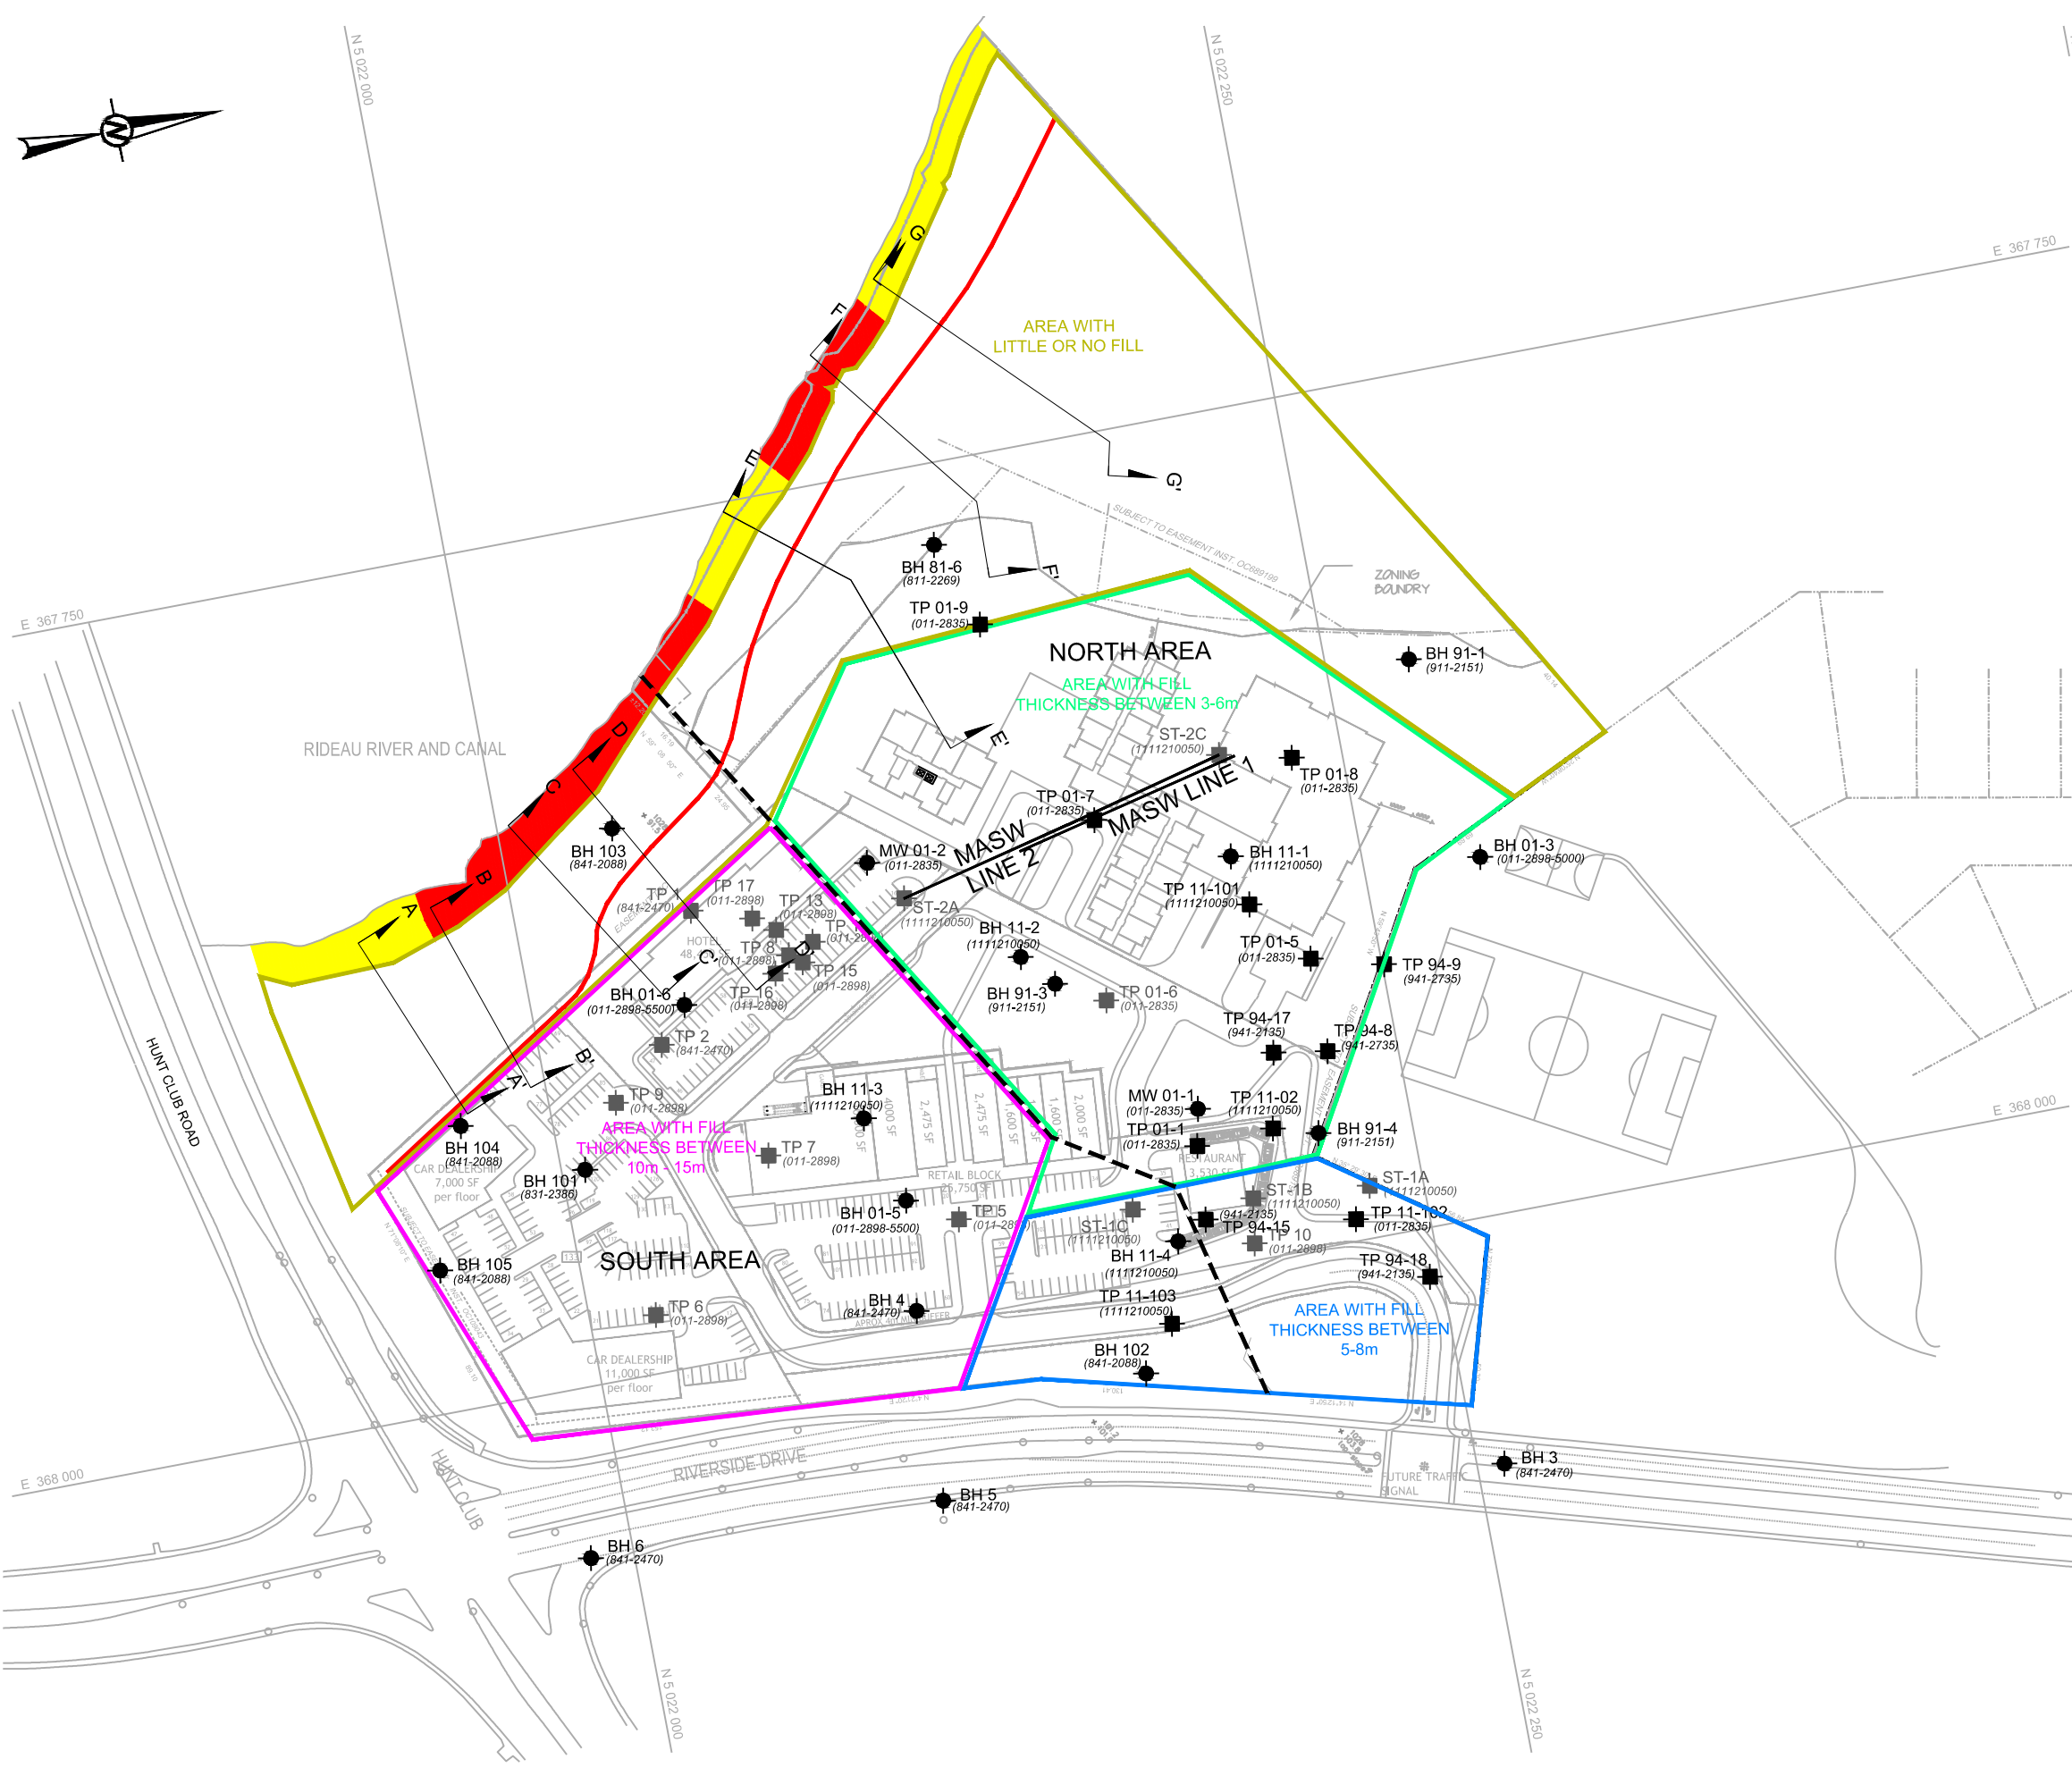
Figure 1 - Site Plan

Observations were also made on the state of erosion at the slope toe/river bank in July 2009. Locations of minor to moderate to severe erosion observed at that time are also shown on Figure 1.

No erosion protection is present along the Rideau River bank bordering the site. Areas of active erosion were noted at several locations along the Rideau River bank, which have resulted in over-steepened slope toes along the River bank. The results of the erosion mapping (from the 2009 slope reconnaissance) along the Rideau River bank are provided on the Site Plan, Figure 1.

Some moderate to severe active erosion of the Rideau River bank (over its 1 to 2 metres height) was observed at the locations of cross sections EE' and FF' during the 2009 slope reconnaissance. Several small drainage gullies also exist which discharge into the Rideau River (i.e., cut into the bank). It appears that large trees and shrubs present along the Rideau River bank are responsible for maintaining the stability of the bank.

In view of the low factors of safety against slope instability obtained for the slopes in the South Area, a setback from the slope crest for development was assessed at the cross-section locations. This setback was developed by carrying out further stability analyses to assess the limit beyond which there is an acceptable factor of safety (i.e., greater than about 1.5 static or 1.1 seismic) against slope failure. This setback is shown on Figure 1 as the “Limit of Hazard Lands.”

The resulting Limit of Hazard Lands based on the stable Slope Allowance and Erosion Allowance is shown on Figure 1. Based on the current development plans and this preliminary assessment, the proposed development plans do not appear to conflict with the Limit of Development.

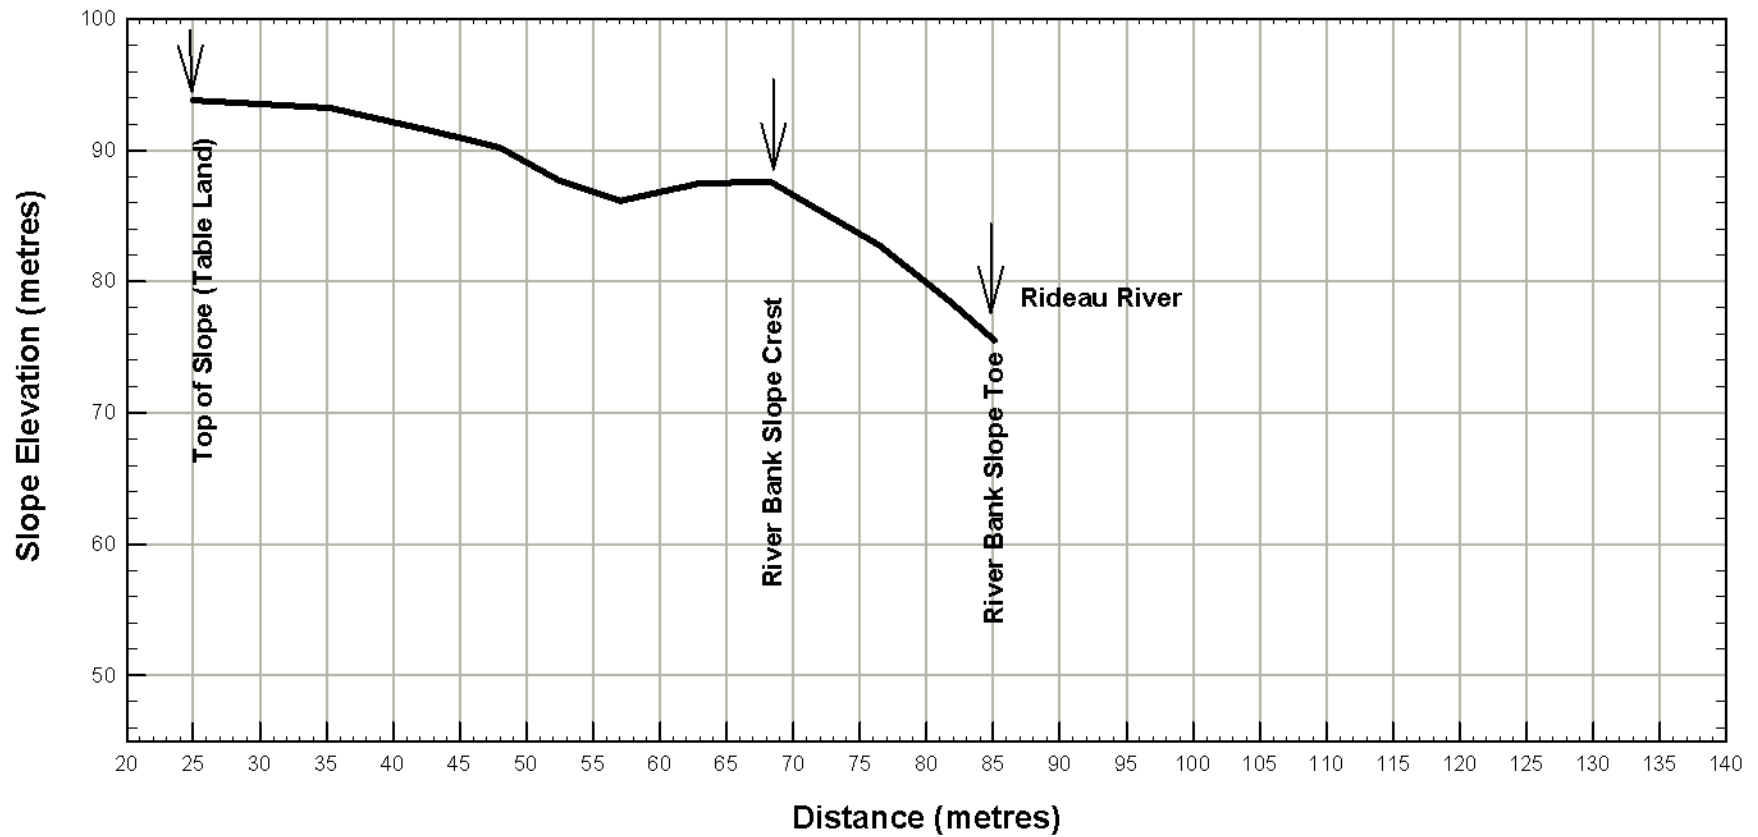
# Cross Section A-A'

Above the zone of active erosion at the river bank toe, the remaining portion of the slope appeared to be quite dry and stable (surficially) at the time of the survey in 2009, with the exception of the slope at section AA'. At a height of about 6 to 7 metres above the river bank (i.e., slope toe), the slope at section AA' exhibits some evidence of soil softening and minor seepage. The soil within this area was observed to be bare of vegetation, indicating active erosion due to surface and seepage water runoff. However, this localized zone does not appear to be experiencing any deep-seated instability.

The results of the stability analyses carried out under static conditions for the sandy slopes indicate that the factor of safety against global instability of the existing Rideau River bank slopes (cross sections AA' to DD') within the South Area is generally less than 1.0 (i.e., potentially unstable).

For the South Area, the factors of safety against instability under seismic loading are less than 1.1. The slopes could therefore fail under the design seismic loading event.

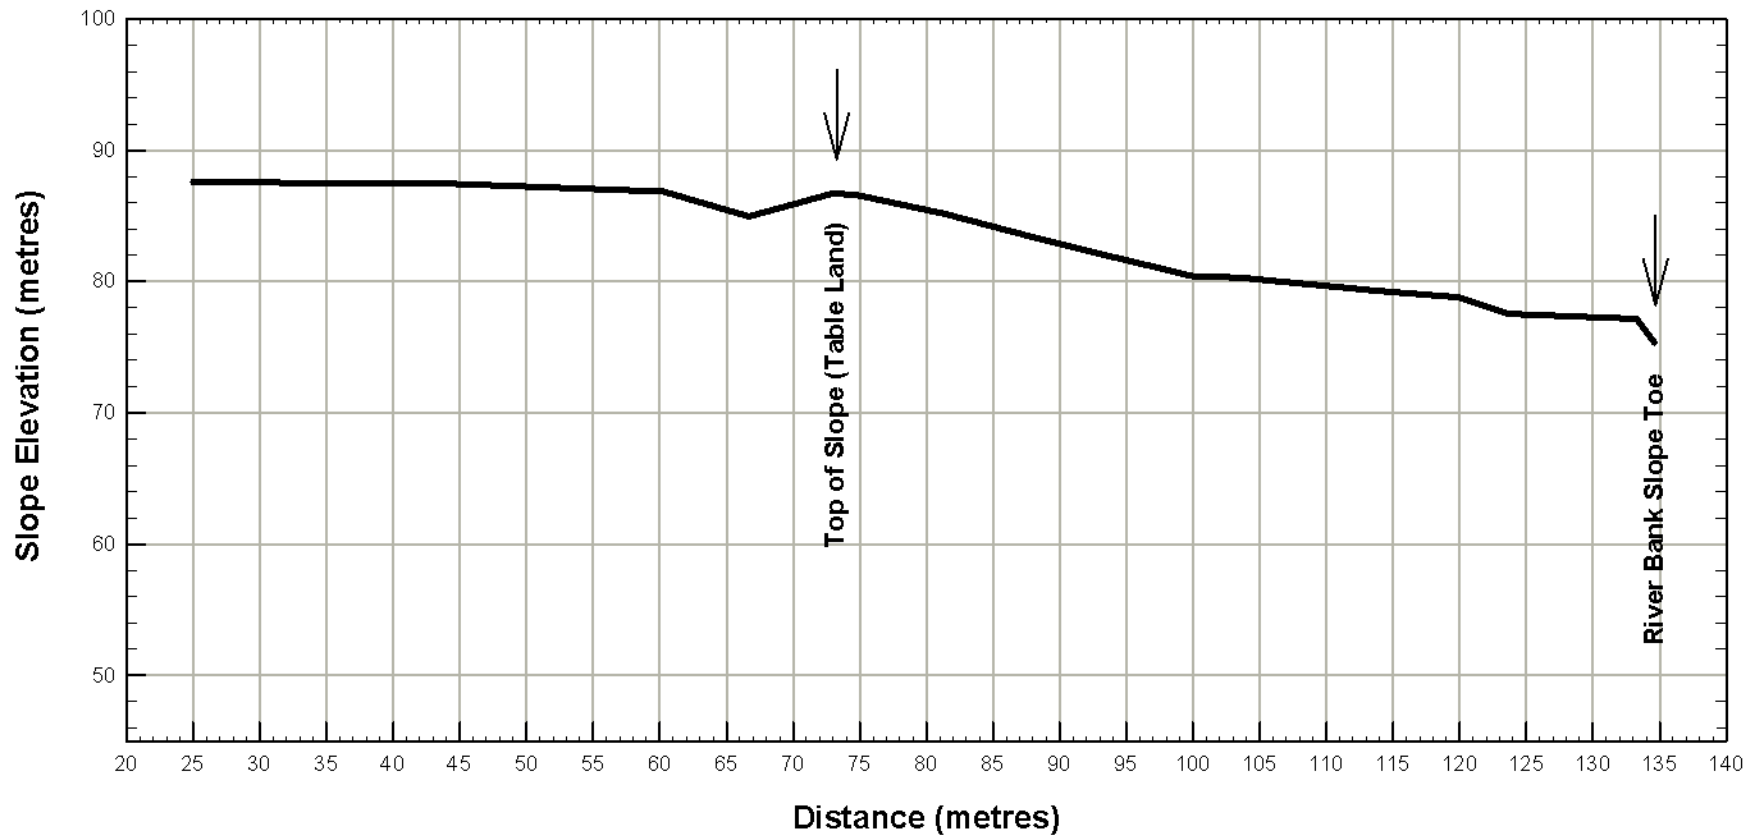
# Cross Section E-E'

Both the Rideau River and table land slopes are generally covered with thick vegetation (tall grass, shrubs and trees). A broken drainage pipe was encountered at some distance (about 50 metres) to the east of the river at the location of slope section EE'. A relatively deep gully has been formed between the pipe outlet and the Rideau River. Some sporadic rip rap erosion protection is present along the Rideau River bank at the locations of slope sections EE' and FF'.
