BUILDING CONDITIONS REPORT
163 PARKDALE AVENUE

A review was conducted on the above noted property on November 27, 2015 to assess the building for the following criteria:

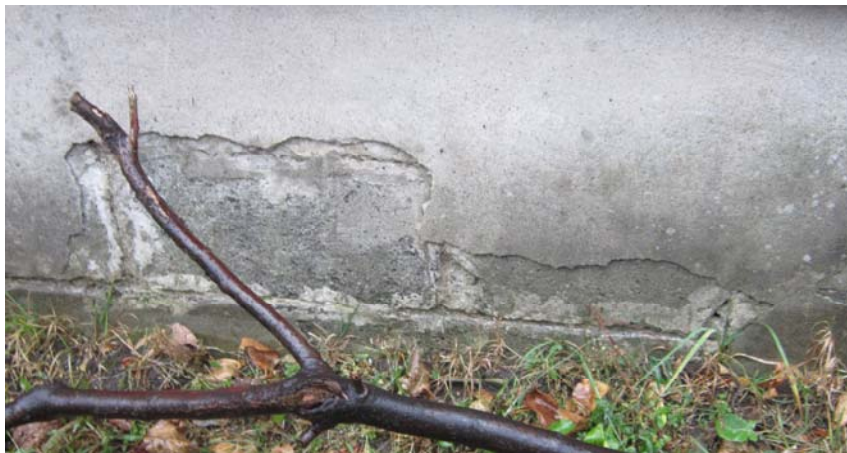
The parging on the exterior of the building is cracking or has spalled off in numerous areas (see Photo 1 for details). Concrete block foundation behind parging also appears to be cracked in some locations.

Photo 1 - Cracked Parging & Concrete Block

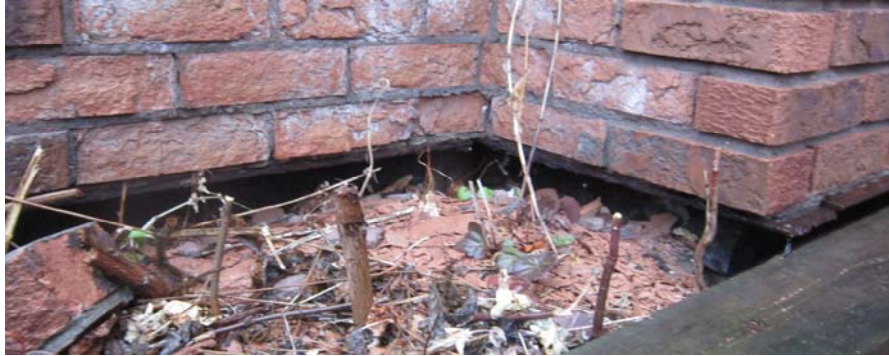
Exterior masonry brick veneer on the west side (facing Parkdale Ave) is supported with a post fastened steel angle. The masonry is crumbling/deteriorating in some areas and the steel is corroding (see Photo 2 for details). The decorative masonry entrance is also corroding and numerous bricks have fallen off (see Photo 3 for details).

Photo 2 – Base of Brick Wall & Support Angle

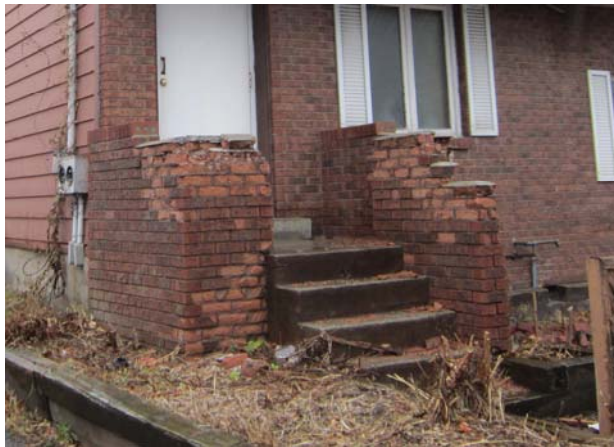
Photo 3 – Brick Entry Feature

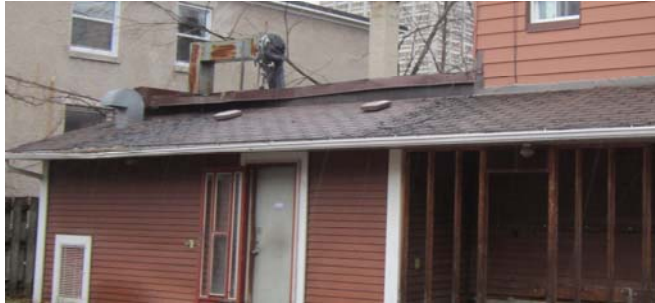
The roof is nearing the end of its life cycle and is leaking in numerous areas. The rear section of the low roof contains badly deteriorated shingles (see Photo 4). The flat section of the roof on the south side has areas containing organic growth (i.e. moss) and roof drains do not appear to be working properly. The west side of the roof awning is deflecting where it is cantilevered over the entry (see Photo 5). The soffit of the front awning has collapsed in numerous areas.

Photo 4 - Curled Shingles

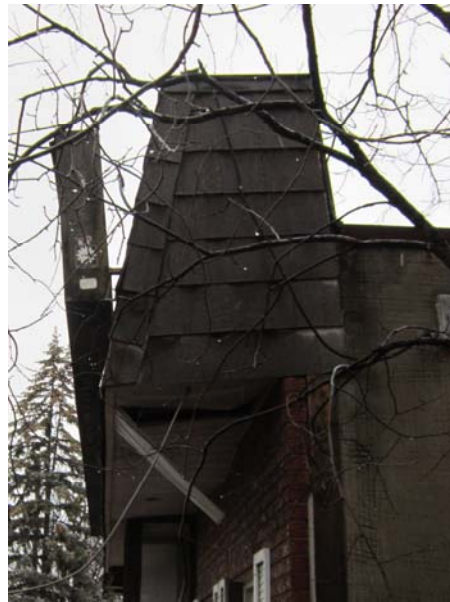
Photo 5 - Sagging Awning

Also, I recommend that the front awning (see Photo 5) be remediated prior to full snow loading being applied to this area. This includes either:

1. Removing awning structure completely
2. Cordon off area to prevent risk of injury if awning collapses
3. Demolish building completely

I recommend that the work to the awning be completed prior to full snow loading being applied to the building. If Option 2 is to be taken, then this work could be done immediately.
