**BUILDING CONDITIONS REPORT**  
**167 PARKDALE AVENUE**

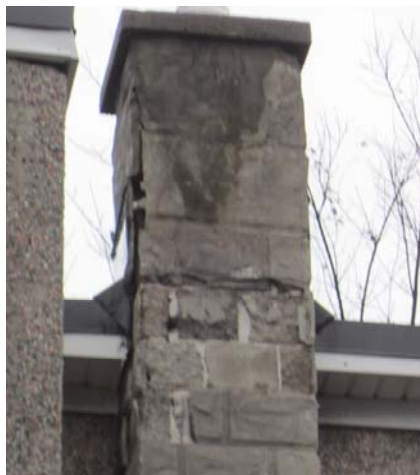
Area 1: The chimney on the east side (rear) of the building appears to be constructed with architectural concrete masonry block. The top section of the chimney has been parged at some point and is now spalling (see Photo 1 for details). Block face is deteriorating and joints of block are cracked in some areas.

Photo 1 - Damaged Chimney

Item 1: Remove chimney projecting above roof line where damaged masonry was indicated above. Alternatively, this area could be cordoned off or hoarding (i.e. plywood) could be placed around damaged part of chimney to prevent any loose masonry from falling to ground below.

I recommend that the work to the chimney and awning be completed within a reasonable time frame so as to prevent any further damages from occurring. Access around these areas should be cordoned off immediately.

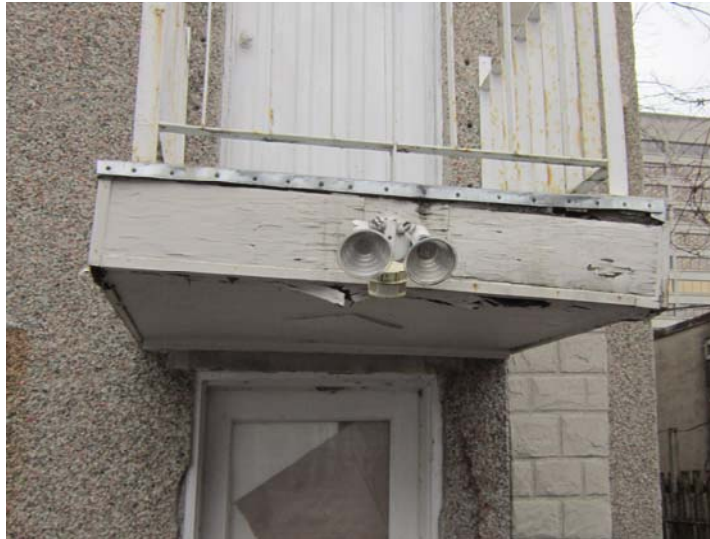
Area 2: The wood framed awning over the rear ground floor door (second floor balcony) is deflecting a fair amount (see Photo 2 for details). This item has been identified in section at end of report for immediate remedial solution.

Photo 2 - Rear Door Awning/Balcony

Item 2: Remove rear awning that is deflecting. Alternative, this could be shored up to prevent further damage from occurring. In addition, access to 2nd floor (i.e. top of awning) in this area should be prevented by blocking access door.

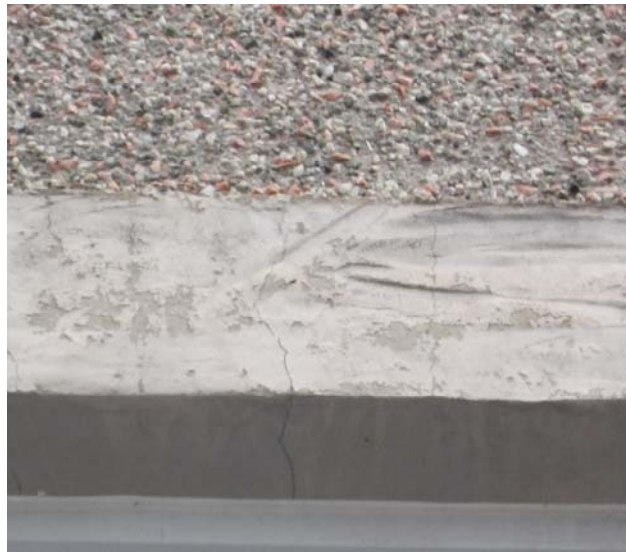
Area 3: Lintels over many windows are cracked (see Photo 3 for details) at the midspan, likely due to deflection. It was unclear during review (without damaging finishes) if cracking is in parging over wood lintels only.

Photo 3 - Cracked Lintels

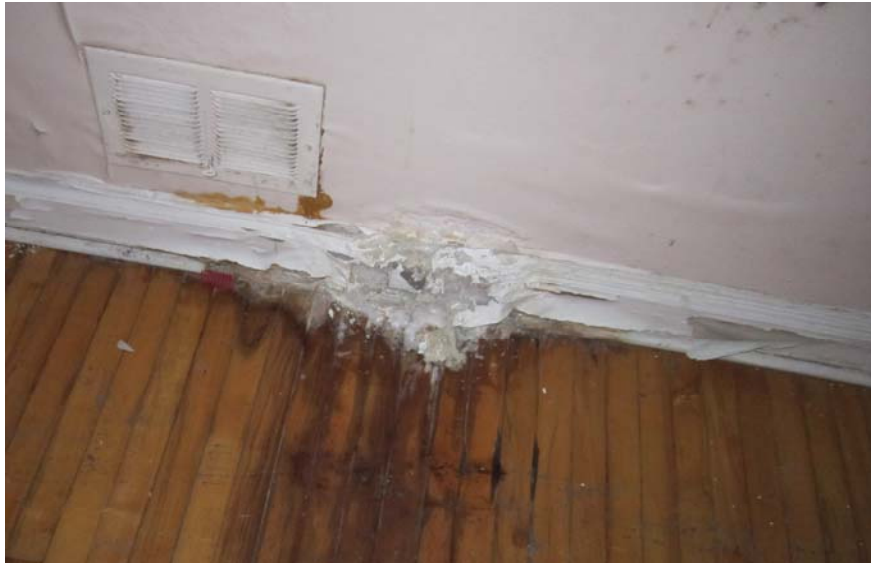
As indicated above, the interior of the building appears to have water damage throughout. Drywall finishes, ceilings and hardwood floors have been affected (see Photo 4 for details).

Photo 4 – Interior Water Damage

This building would require extensive renovations to the interior finishes in order to deem it safe. In addition to this, I recommend that 2 items be remediated without delay to prevent possible further damages from occurring.
