**BUILDING CONDITION ASSESSMENT
& CAPITAL RESERVE FUND FORECASTS**
Ottawa, Ontario
TS Job #11226

Prepared for:
CENTRETOWN CITIZENS OTTAWA CORPORATION

Prepared by:
ALTUS GROUP LIMITED

Re: 143-153 Arlington Street, Ontario
Building Condition Assessment & Capital Reserve Fund Forecasts

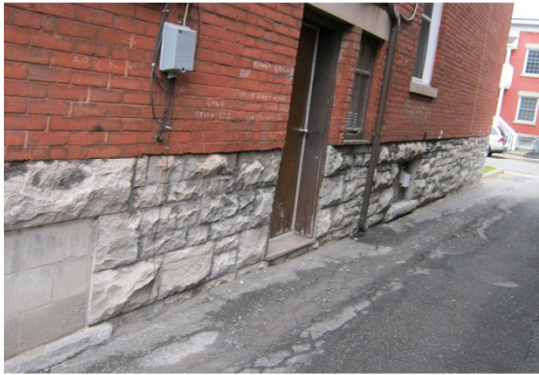
Photo: F01085_A10 Foundations_Sept 2011_1

Description: Stone foundation walls near front.

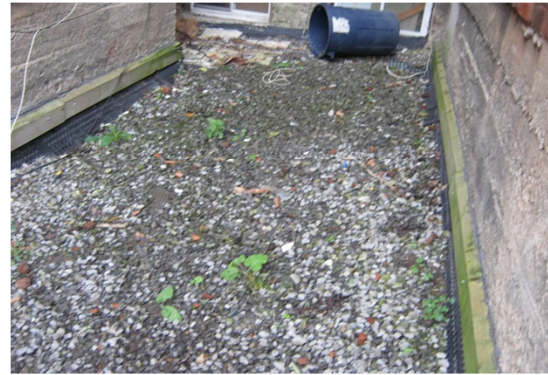
Photo: F01085_A10 Foundations_Sept 2011_2

Description: Rear drainage modifications at rear.

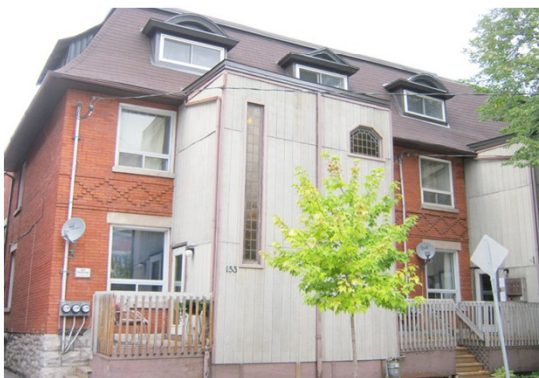
Photo: F01085_A10 Foundations_Sept 2011_3

The front porches and decks were concealed and the review of the foundations was limited. The decks are framed on concrete piles. At the interior of the enclosures, there are signs of movement.

Description: Front entrance enclosures.

It was reported that other properties have experienced issues with unstable soils or other underlying conditions. All cracks and movement should be closely monitored. A further investigation is recommended of all foundation walls and the stairwell enclosure structure.

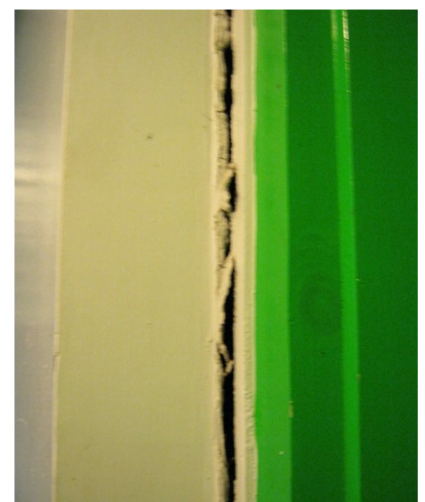
Photo: F01085_A10 Foundations_Sept 2011_4

Description: Interior finishes - debonding joints/cracking.

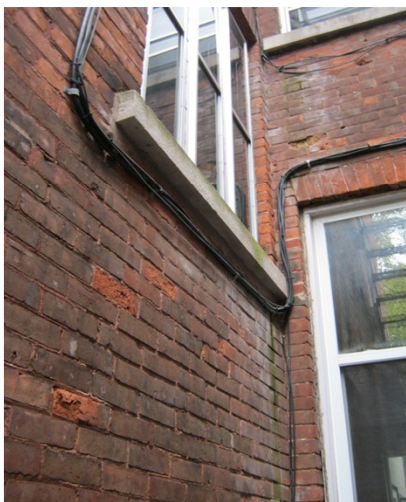
The exterior walls are comprised of solid-brick masonry construction. Repairs have been already conducted at a number of step-cracks. Minor repairs are anticipated during the study period. An allowance is carried for future brick masonry repairs including tuck-pointing and brick replacement. Vandalism is considered under regular building maintenance.

Photo: F01085_B201001 Exterior Closure - Brick_Sept 2011_1
 Description: Spalled brick masonry.

As noted above, all cracks should be monitored for movement.

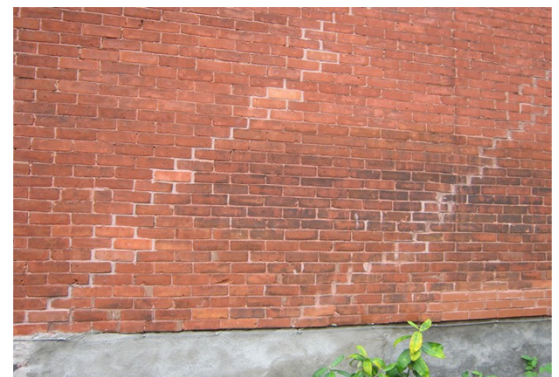
Photo: F01085_B201001 Exterior Closure - Brick_Sept 2011_2
 Description: Previous step-cracking repairs.

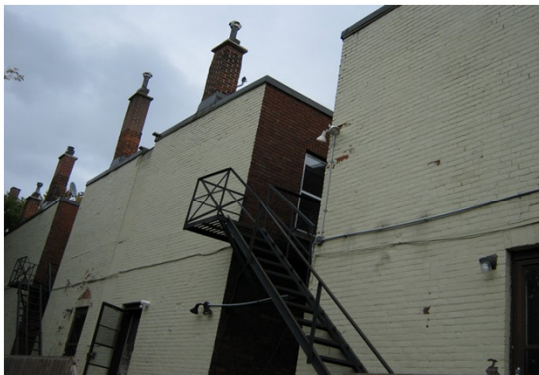
Photo: F01085_B201001 Exterior Closure - Brick - Chimney Sept 2011_1

The chimneys have been partially rebuilt. The top side of the chimneys could not be reviewed. Re-sealing is considered under regular building maintenance.

Description: View of chimneys from grade level.

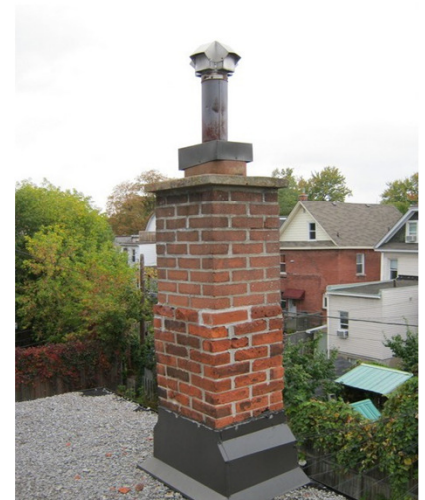
Photo: F01085_B201001 Exterior Closure - Brick - Chimney Sept 2011_2

Description: Typical chimney.

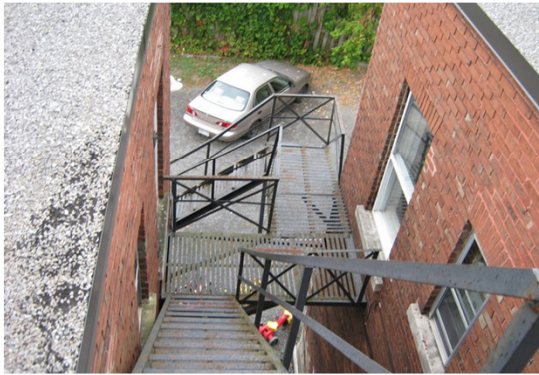
Photo: F01085_B201002 Exterior Stair Construction
 - Fire Escapes Sept 2011_1

There are three (3) sets of metal fire escapes located at the rear of the property. Signs of corrosion was observed and repairs are needed. The replacements is anticipated during the study period.

Description: Typical fire escape

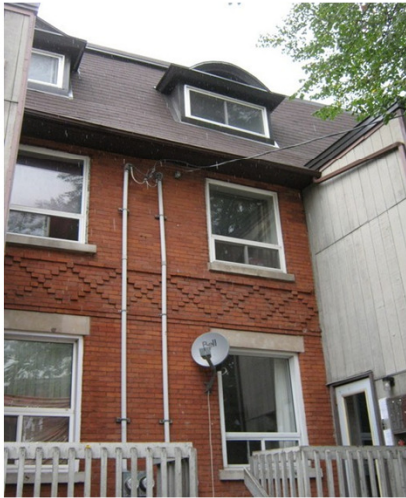
Photo: F01085_B202001 Windows - Vinyl Sept 2011_1

The windows are in good condition and anticipated for replacement in the long term.

Description: Front elevation windows.

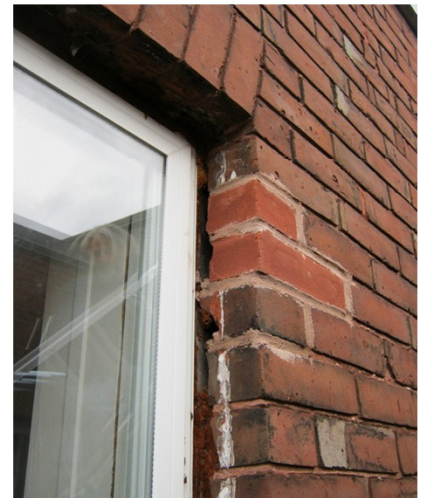
Photo: F01085_B202001 Windows - Vinyl Sept 2011_2

Description: Poorly fitted, sealed unit.

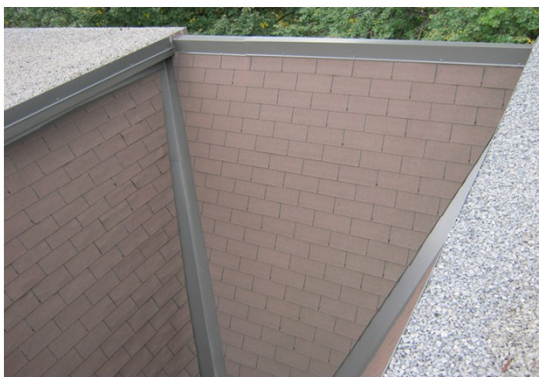
The mansards are shingled and have prefinished metal open-valley flashings and perimeter flashings. No significant signs of deterioration was observed. Minor deterioration is present. Staining was observed at the interior. The item is near the end of its normal life span.

Photo: F01085_B3010 Roof Coverings - Shingled_Sept 2011_1
Description: Mansard shingled.

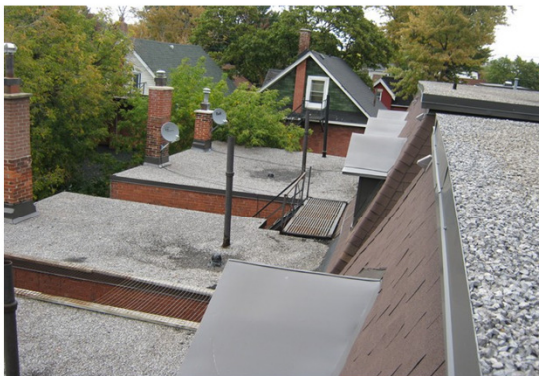
Photo: F01085_B3010 Roof Coverings - BUR_1

The roof systems are combination of roof types. There is a conventional built-up roof (BUR) located on multiple levels with mansard shingles and modified bitument 2-ply membranes at the stairwell enclosures. The roof perimeters includes prefinished-metal flashing. It was reported that the roof is approximately 8 years old. The roof is showing signs of deterioration such as "blueberries." No ponding water was observed that would suggest roof draining issues.

Description: View of overall roof.

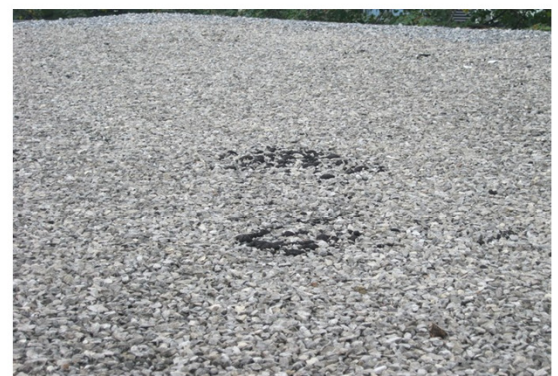
Photo: F01085_B3010 Roof Coverings - BUR_2

Description: Roof edge deficiencies.

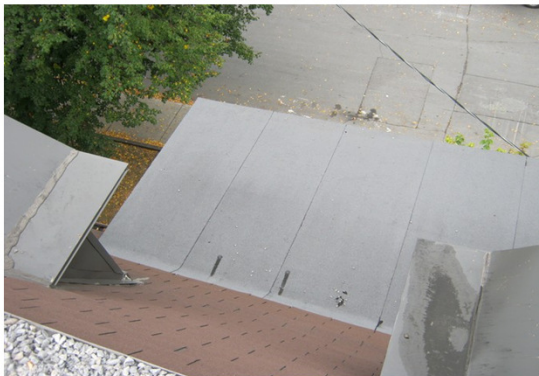
Photo: F01085_B3010 Roof Coverings - Mod Bit_1

The stairwell enclosures have a 2-ply modified bitumen roof membrane. The roof could not be accessed for review. No issues were reported. However, non-active staining is present at the interior spaces. Replacement is scheduled to coincide with stairwell replacement.

Description: View of modified bitumen.

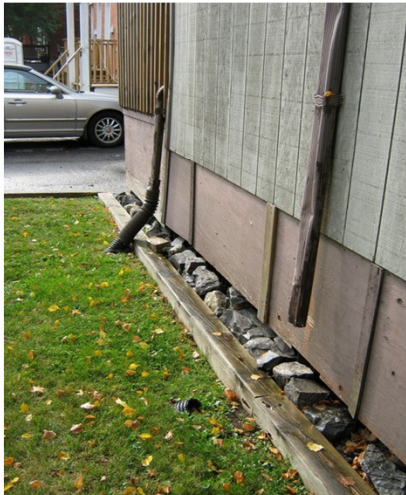
*Photo: F01085_B3010 Roof Coverings - Roof Drains -
Downpouts BUR_1*

There are prefinished aluminum eavestroughs and downspouts that collect and dispose of stormwater. There are eavestroughs at the front stairwell enclosures. Downspouts terminate below grade and should be sealed at the connections. Some connections are missing. The downspouts are due for replacement during the short term. Minor repairs are considered under regular building maintenance and carried out in the meantime.

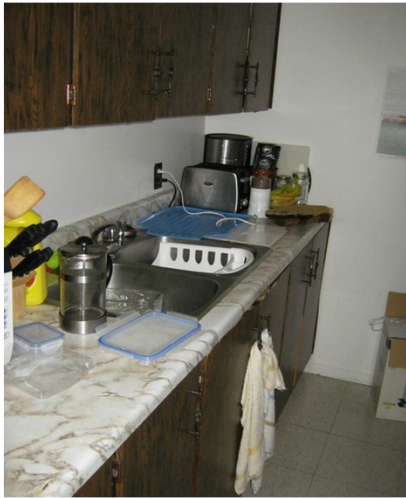
Photo: F01085_C1060 Kitchen Refurbishment - Countertops_1

Of the units reviewed, 33% are older kitchens. The findings are extrapolated accordingly.

Description: Old kitchen finishes.

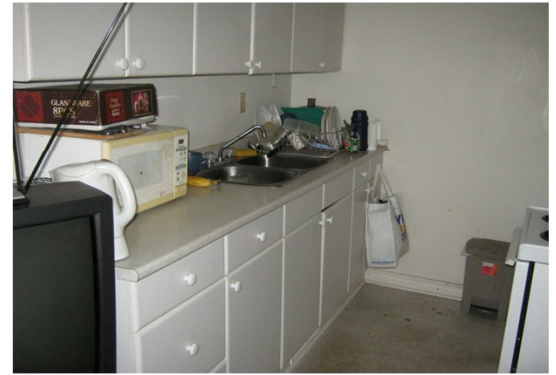
Photo: F01085_C1060 Kitchen Refurbishment - Countertops_2

Description: Newer kitchen finishes.

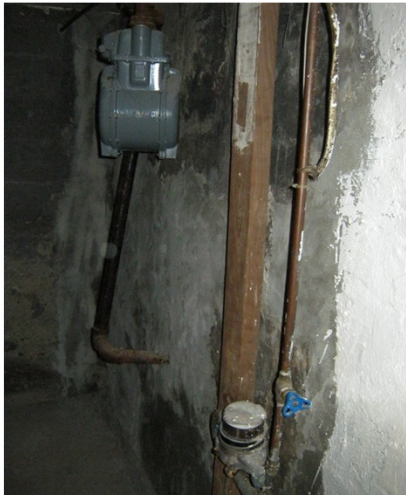
No anomalous conditions were observed or reported that would suggest this systems is not functioning as intended. Minor repairs are considered under regular building maintenance. Repairs are carried below.

Photo: F01085_B202001 Domestic Water Distribution_Sept 2011_1
Description: Incoming water main and metre at Unit 153-2.

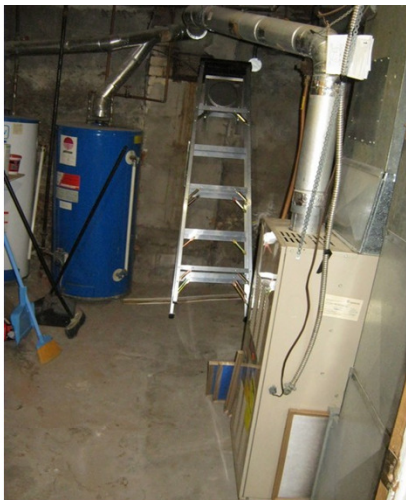
Photo: F01085_D302003 Furnaces_Sept 2011_1

Description: Gas-fired forced-air furnace.

CCOC has already employed energy-efficiency undertakings such high-efficiency furnaces with recent replacements. We recommend continuing to upgrade furnaces with high-efficiency types.

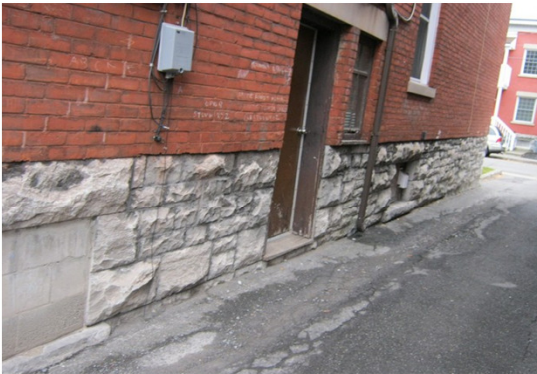
Photo: F01085_GA10 Foundations_Sept 2011_1

The asphalt is showing its age. Replacement is carried.

Description: Asphalt driveway.
