**DESIGNATED SUBSTANCE SURVEY
143-153 ARLINGTON AVENUE, OTTAWA, ONTARIO**

Centretown Citizens Ottawa Corporation
PO Box 2787, Station D
Ottawa, Ontario
K1P 5W8

September 2013

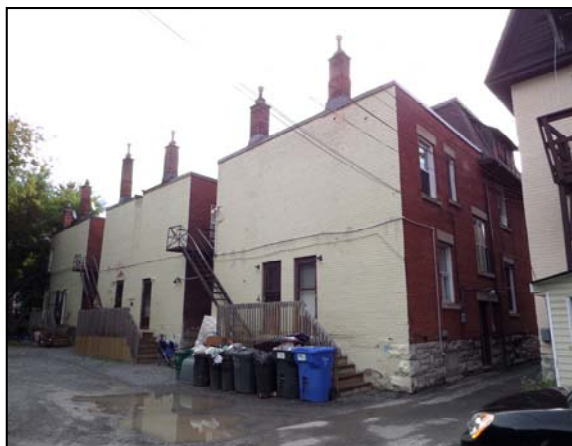
Photograph 1 – 143-153 Arlington Ave., Ottawa, ON, showing the Northern (rear) additions.

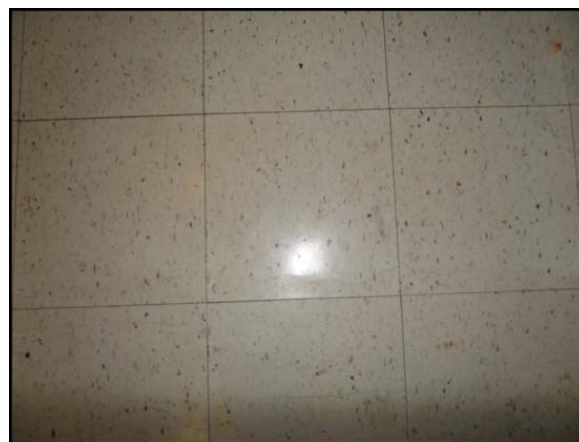
According to the analytical results, the following flooring building materials are **NON DETECT** for asbestos (Photograph 2):

- 12" x 12" vinyl floor tiles (light beige with blue streaks), Kitchen, 1-145 Arlington Avenue;
- 12" x 12" vinyl floor tiles (light beige with brown specks), Kitchen, 2-145 Arlington Avenue.

Photograph 2 - Flooring **NON-DETECT** for asbestos.
TOP: 12"x12" vinyl floor tiles (light beige with blue streaks) from the Kitchen at 1-145 Arlington Avenue.
BOTTOM: 12"x12" vinyl floor tiles (light beige with brown specks) from the Kitchen at 2-145 Arlington Avenue.

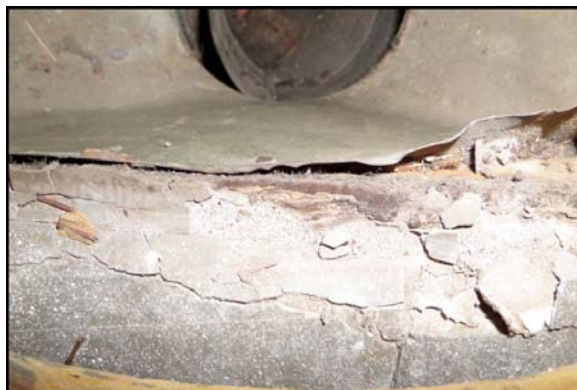
The flooring (dark brown) located at 1-151 Arlington Avenue is **ASBESTOS CONTAINING** according to the analytical laboratory (Photograph3). The following sample confirms the presence of asbestos in the flooring:

Sample Collected September 16th 2013 (Photograph 3):

- **SA-29 –Flooring (Dark Brown) – First Floor North Bedroom, 1-151 Arlington Avenue – 5% Chrysotile (floor tile).**

Photograph 3 – ASBESTOS CONTAINING flooring (dark brown) located at 1-151 Arlington Avenue, under the carpet in the 1st Floor, North Bedroom.

- **DRYWALL JOINT COMPOUND** – If greater than 1m² of drywall finishes are likely to be disturbed then Type 2 asbestos abatement measures and procedures should be implemented. If less than 1m² of drywall finishes are likely to be disturbed then Type 1 procedures may be implemented.
- **VINYL FLOOR TILES** –Type 1 asbestos abatement measures and procedures are sufficient for the removal of vinyl floor tiles. However, no power tools may be used. If power tools are required, KCI recommends Type3 measures and procedures be implemented, as per O.Reg. 278/05.
