**DRAFT**  
**Baseline Property**  
**Condition Assessment**

240 Montreal Road, Ottawa,  
Ontario

March 8, 2018

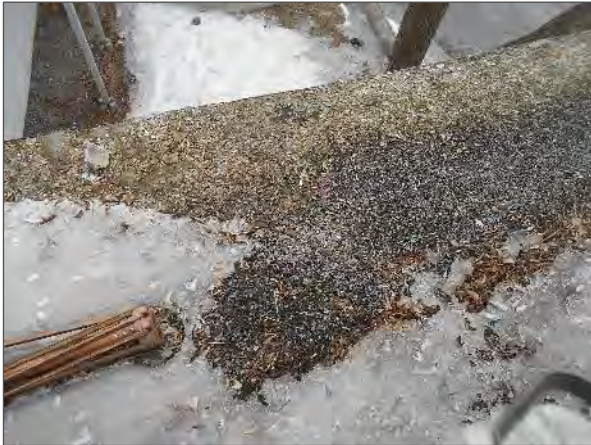
View of the BUR system atop the single storey portion of the Site Building.

It has been Pinchin’s experience that the Projected Useful Life (PUL) of BUR system typically ranges between 20 to 25 years, depending on the quality of building materials used, the quality of workmanship during installation and the level to which the roof system has been maintained. The roof systems atop the Site Building are estimated to be over 20 years old. Pinchin anticipates the replacement of the roof system within the early portion of the term of analysis.

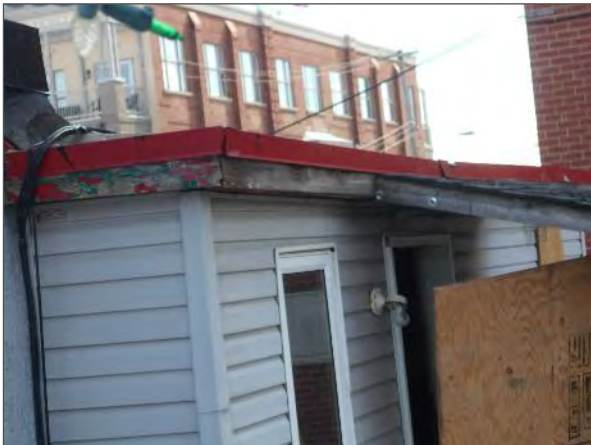
View of fascia wood rot on the two storey portion of the Site Building.

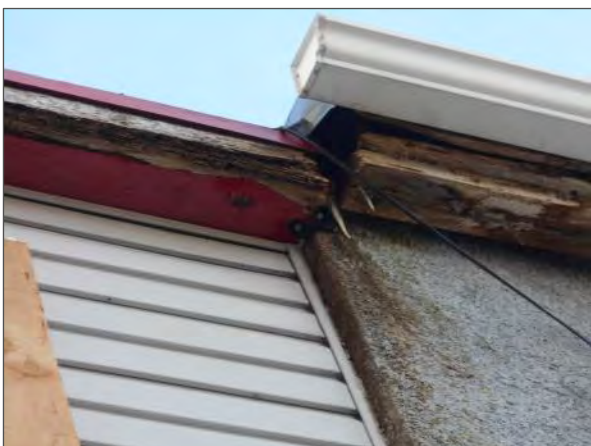
View deteriorated wood fascia on the east elevation of the Site Building.

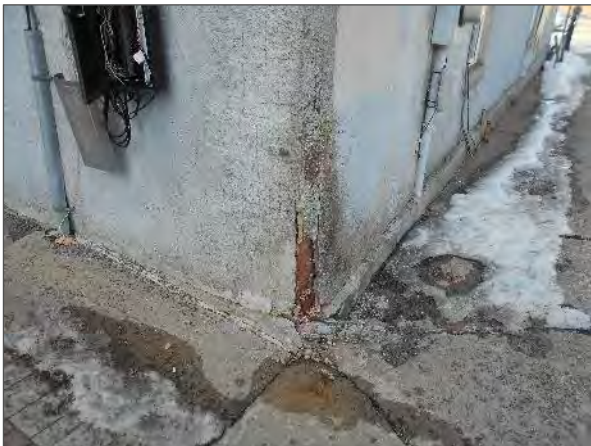
View of damaged and deteriorated stucco noted on the southeast corner of the Site Building.

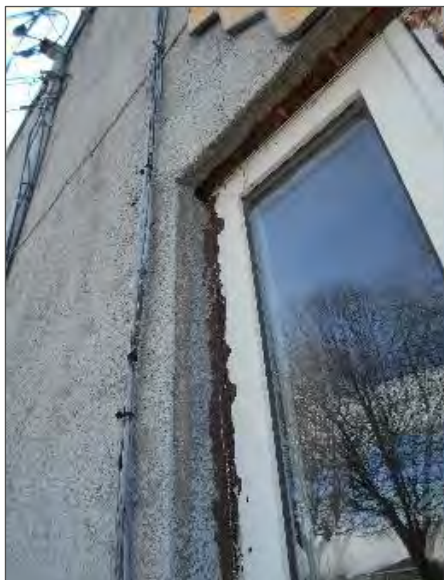
View of cracked stucco on the north elevation wall.

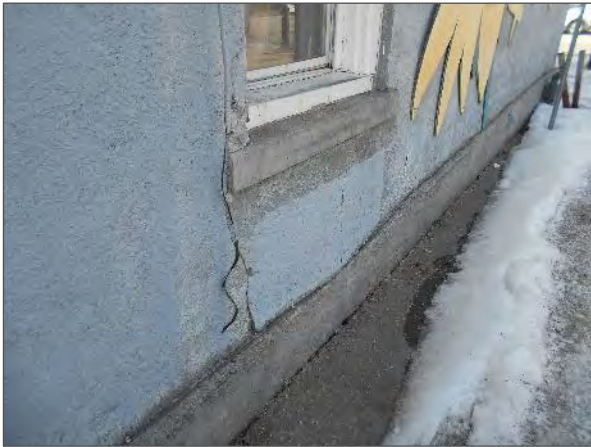
View of stucco bowing noted on the north elevation wall.

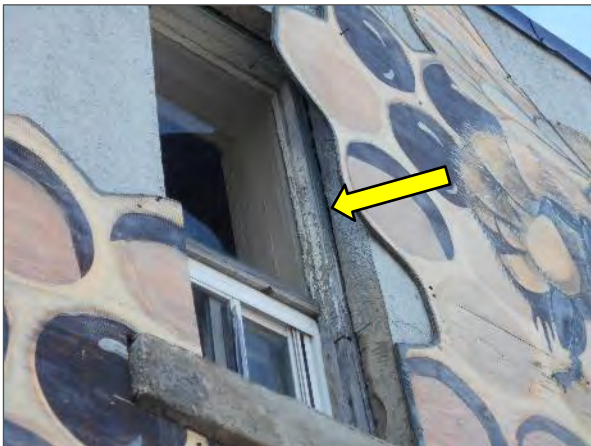
View of deteriorated window frame and sealant at perimeter of the window frame.

Due to the visual failure of sealants around windows and cracking of the stucco cladding the presence of mould within the wall assembly is possible. The presence of the mould cannot be determined since intrusive testing to determine the presence of mould within wall system was not part of the scope of work.

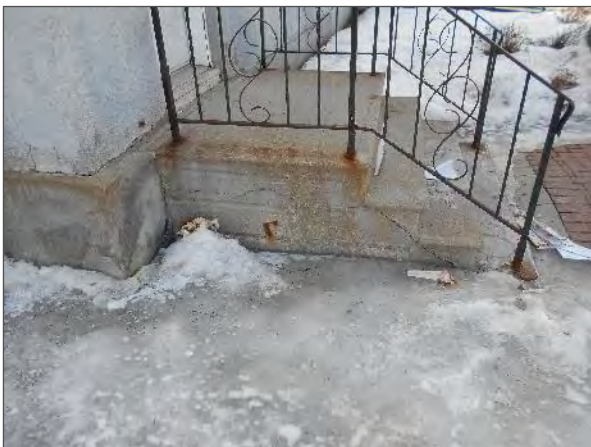
View of damaged pre-cast concrete steps located on the northeast corner of the Site Building.

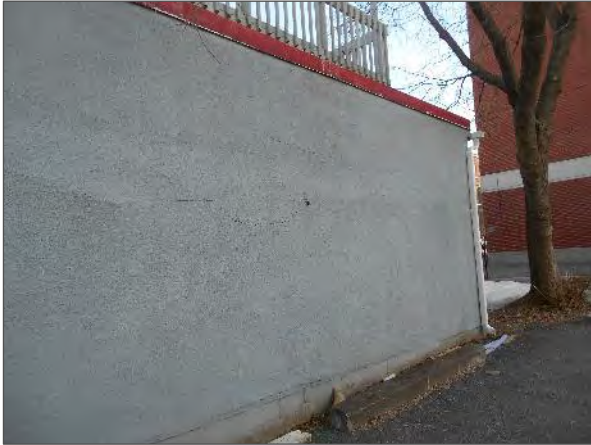
View of cracked delaminated stucco on the west elevation wall.

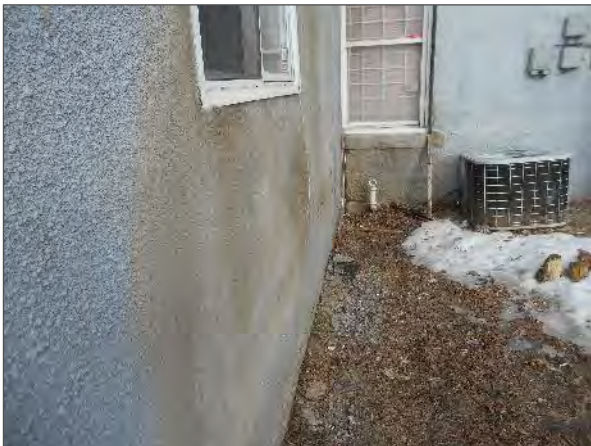
View of the stucco bowing noted on the west elevation wall.

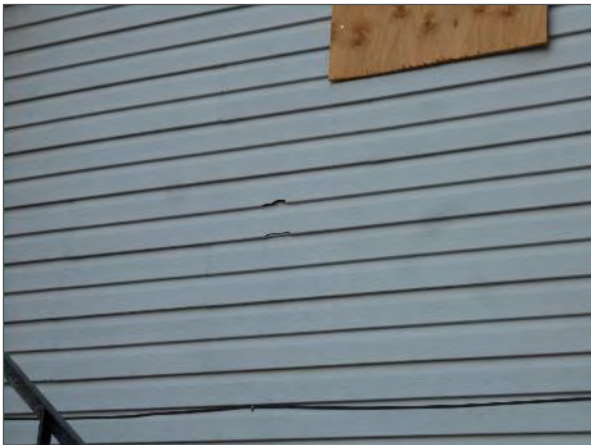
View of damaged vinyl siding on the west elevation wall.

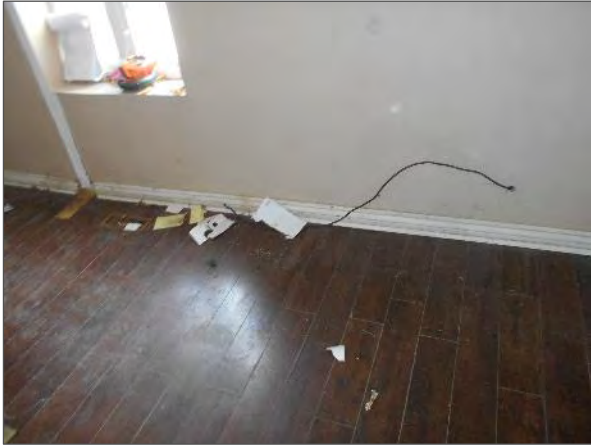
View of vertically misaligned floor.

Note: First floor apartment.

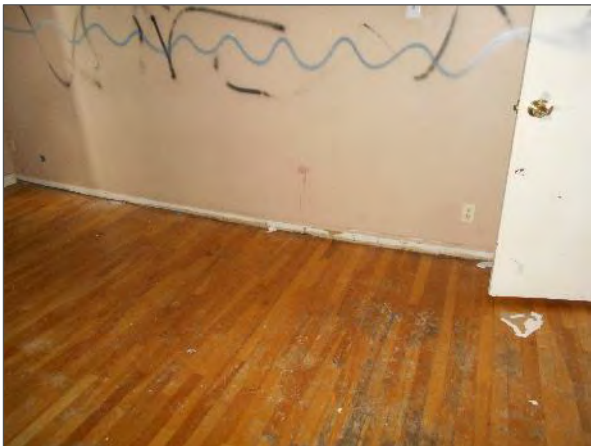
View of vertically misaligned floor.

Note: Second floor apartment.

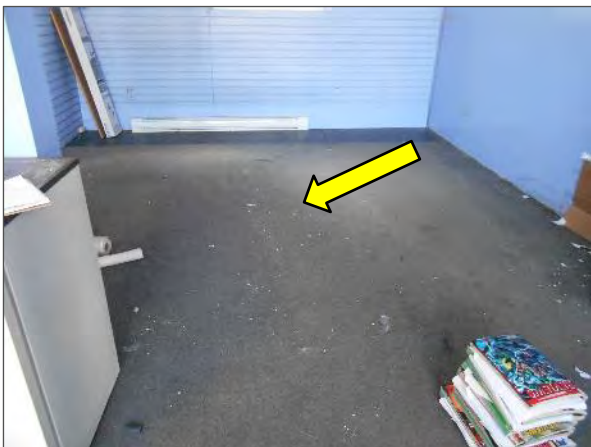
View of slab heaving in commercial unit on the northwest elevation of the Site Building.

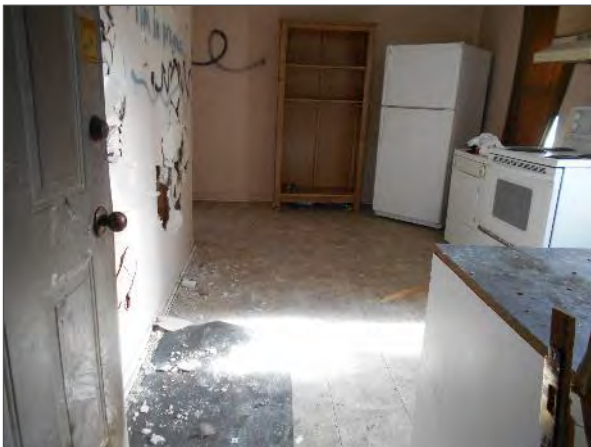
View of damaged drywall in the second floor apartment unit.

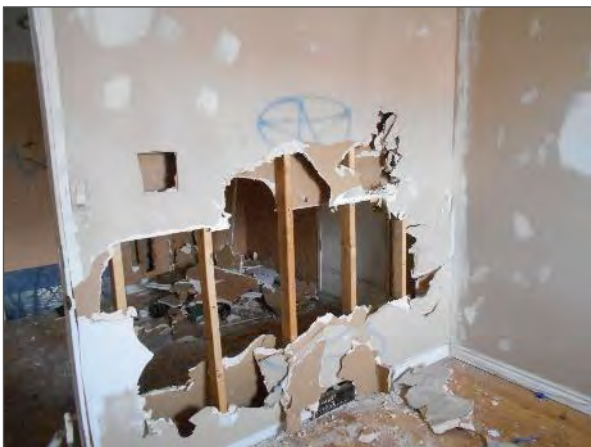
View of damaged drywall in the second floor apartment unit.

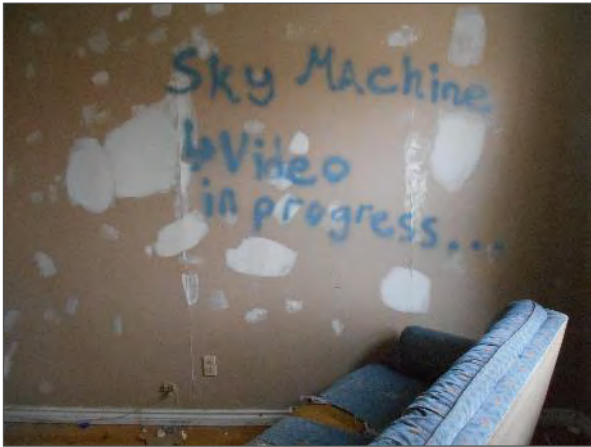
View of graffiti on the second floor apartment unit wall.

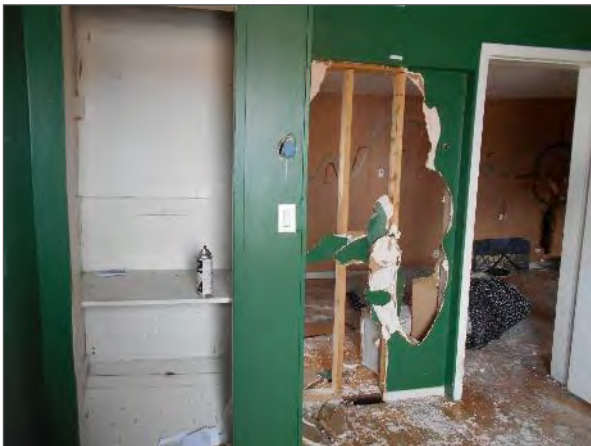
View of damaged drywall in the second floor apartment unit.

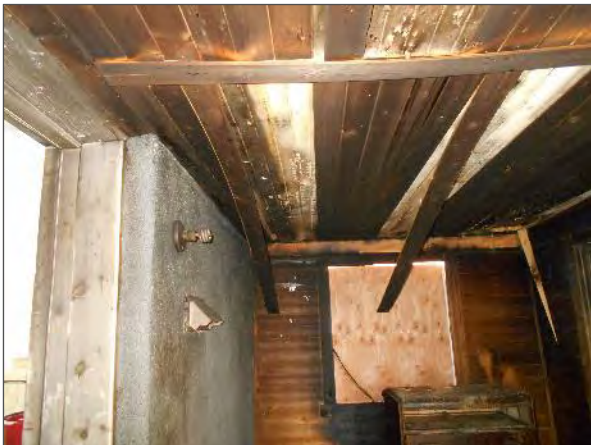
View of charred finishes in second floor apartment unit.

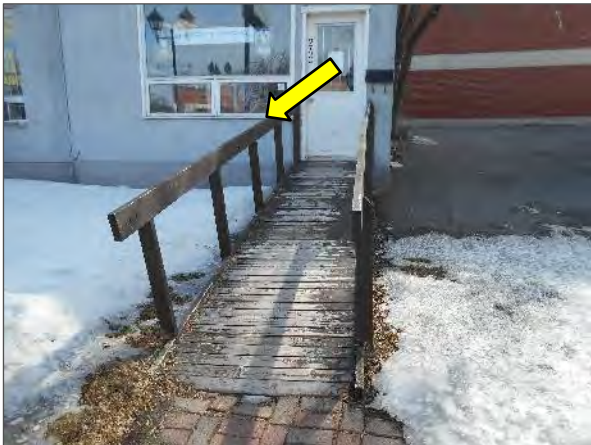
View of the wheel chair access ramp on the northwest corner of the Site Building.

Note: The leaning railing.

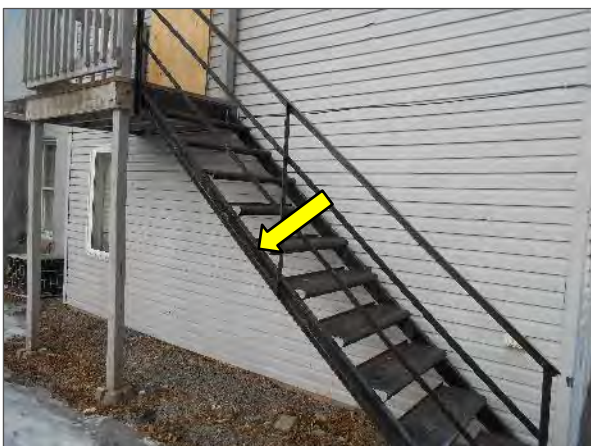
View of the metal stair case located on the west elevation of the Site Building.

Note: Corrosion on the stringer.

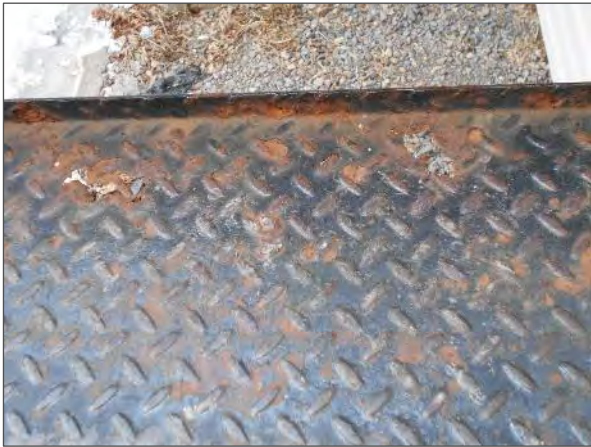
View of corroded metal tread.
